Causes of failure in total hip prostheses

E. SMETHURST, R. B. WATERHOUSE

Department of Metallurgy and Materials Science, University of Nottingham, Nottingham, UK.

This paper reports a study of nine total-hip replacements removed from patients for infection, widespread loss of bone substance and fracture of the stem of the femoral component. The surfaces of the metal, the polymethylmethacrylate (PMMA) bone cement and the attached bone were examined by a variety of techniques, including scanning electron microscopy (SEM) and energy dispersive X-ray analysis (EDXA) produced by bombardment of the sample with electrons. Evidence of corrosion of the metal was found in both cobalt-chrome-molybdenum alloys and stainless steel. It is suggested that the products of metal corrosion may alter the balance of bone formation/resorption to produce a loss of bone substance. Two of the femoral stem fractures were considered to have developed from faults originating in manufacture; a third fracture originated from fretting between the wire used to re-attach the trochanter and the femoral stem; and the fourth fracture from high cyclic stress fatigue of the femoral stem induced through a previous fr

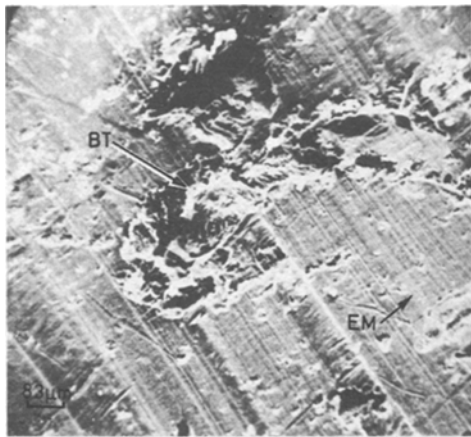
Figure 2 Tissue removed from Patient 1, embedded and examined in the optical mode of the SEM. The arrows point to embedding medium (EM) and the bone tissue (BT).

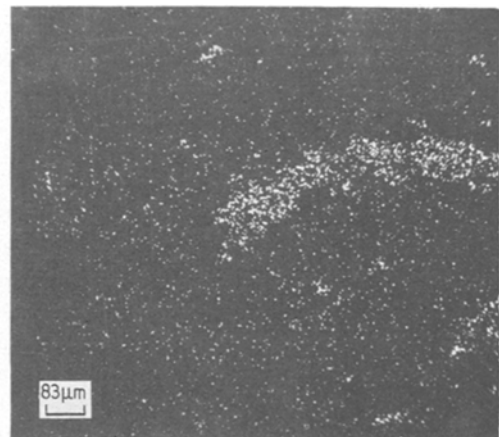
Figure 3 Tissue removed from Patient 1, embedded and examined in the analytical mode (EDXA) of the SEM for Ca. The bright areas show Ca enrichment.

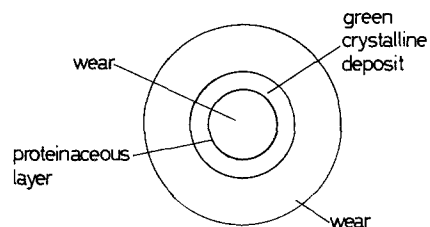
Figure 4 Schematic diagram of articular surface of the acetabular component removed from Patient 1 (not to scale). Note the four distinct areas as recorded in the test.

Fig. 4 shows schematically the appearance of the articulating surface of the acetabular component. There are four distinct areas; an inner surface showing wear, a green crystalline deposit, a thin ring of green proteinaceous material, and an outer zone of wear. The green crystalline deposit observed by SEM is shown in Fig. 5, which reveals the layering and its crystalline nature.

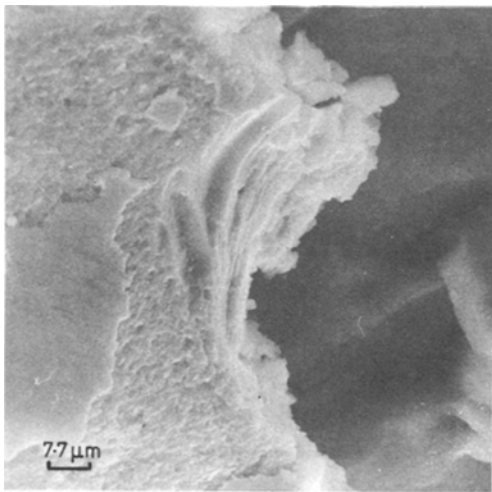
Figure 5 Scanning electron micrograph of green crystalline deposit on the articular surface of the acetabular component (patient 1). See Fig. 4.

detected. These figures are only to be interpreted semi-quantitatively. However, the presence of Ca, Cr, P and S in approximately equal proportions suggests a mixed crystal of chromic sulphate and calcium phosphate (apatite). This is consistent with the view that chromium is not easily soluble in the body fluids; in contrast cobalt and molybdenum more readily dissolve and become dispersed throughout the body.

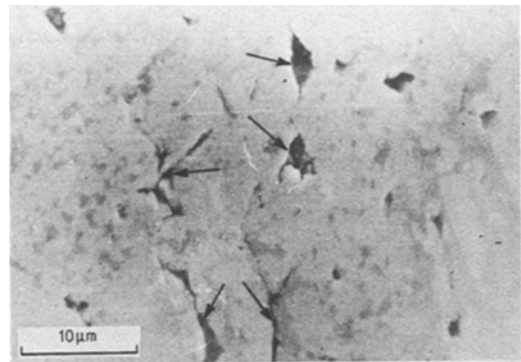
A closer examination of one of the screws showed mild corrosion, or etching, both of the tip (Fig. 6) and of the first few threads which were screwed directly into the pelvis. A corrosion pit and areas of etching were found on the first thread and Ca was detected in the bottom of this corrosion pit. This finding suggests that the type of attack present in the acetabular component and the screws is similar. It is also to be noted that the screws were not manufactured by the commercial supplier of the prosthesis, so that the chemical reactions observed are likely to be specific to the Co–Cr–Mo–C alloy, rather than to the mode of manufacture.

A comparison of the type of attack observed at the screw tip (Fig. 6) with metallographic sections of the screw and the tip of the femoral stem showed that the distance between corrosion pits was of the order of microns whereas the grain, or crystallite, sizes of the screw and the stem were hundreds of microns and thousands of microns respectively – that is the attack was general rather than intergranular. The screw has a cored equiaxed

Figure 6 Scanning electron micrograph of the attacked surface at the tip of the Co–Cr–Mo–C alloy screw removed from Patient 1. The arrows point to areas of corrosion.

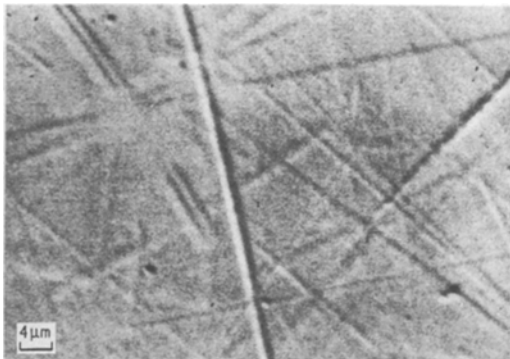
SEM of the articulating surface of the acetabular component removed from Patient 3 showed the normal type of wear behaviour as previously reported [11]. This type of wear was also present in the implant from Patient 1. Fig. 7 shows the articulating surface present in Patient 2. It is seen that the scratches are broadened and pitted, which is indicative of the presence of some form of corrosion. The articulating surface present after

Figure 7 Scanning electron micrograph of the articular surface of the acetabular component removed from Patient 2. Note the broad scratches resulting from corrosion.

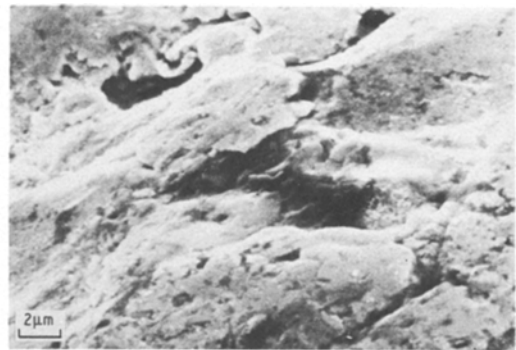
Figure 8 Scanning electron micrograph of the pelvic surface of the acetabular component of the prosthesis removed from Patient 3. Note the irregular surface resulting from corrosion.

manufacture of a McKee–Farrar cup was also examined by SEM. The surface examined exhibited the normal type of finish that would be expected from polishing the metal. In Patient 3, the outer unpolished surface of both components of the prosthesis appeared to be attacked (Fig. 8).

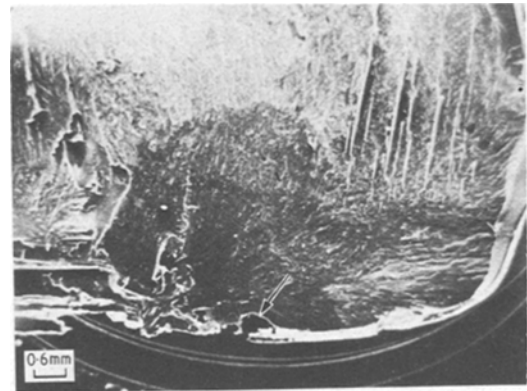
Figure 9 Scanning electron micrograph of the fracture surface of the metal stem removed from Patient 4. The arrow points to the area of porosity.

The surface of the metal fracture was examined by SEM (Fig. 9). A large area of porosity is shown in the lower and middle part of the figure, and this area acted as a “stress-raiser” and eventually the fracture was initiated there.

This phenomenon has also been observed by other workers [8]. It should be noted that this fault, attributed to shrinkage, occurs during manufacture. Since all manufactures claim 100% visual examination, 100% radiographic examination, and 100% dye penetration examination by illumination with

ultra-violet light, it is difficult to understand how such a large defect was allowed to pass the thorough quality control methods adopted. One approach to improve quality control with these alloys would be for the manufacturers to adopt the rigorous investment casting production procedures used in the aerospace industries.

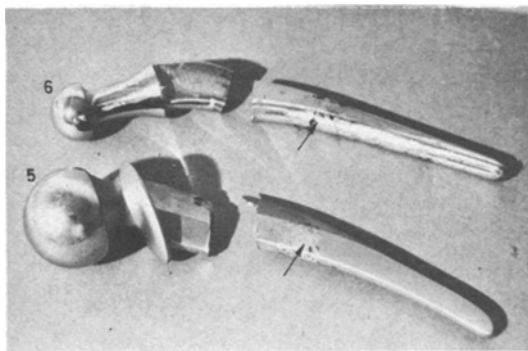
Figure 10 Physical appearance of femoral components removed from Patients 5 and 6. The arrows point to the areas of corrosion.

The other point of note about this failure was the presence of corrosion 1 to 2 cm away from the fracture on the medial side of the metal stem (Fig. 10). This figure also shows corrosion at a similar site in the next patient in which the alloy used was an austenitic stainless steel. It is possible that the corrosion present on the Co—Cr—Mo—C alloy stem was caused by micro-organisms, since rod-shaped particles, tentatively identified as bacilli, were found by SEM of this area of corrosion. The finding needs further detailed investigation before one can be certain that the corrosion was caused in the body by bacilli.

Fig. 10 shows that corrosive attack on the metal stem of the prosthesis has also occurred. The microstructure, revealed by chemical etching of a polished section, showed that the stainless steel was austenitic and in a 'sensitized' condition (Fig. 13). Further metallurgical examination of the wire and stem showed that the wire consisted of a lightly worked austenitic stainless steel. The chemical composition of the femoral stem as revealed by wet chemical analysis and direct reading vacuum spectroscopy is shown in Table V. While this steel conforms to the standard specifications of chemical composition and mechanical properties (BS 3531 : 1968 and 1972 unadopted), it is in a sensitized condition.

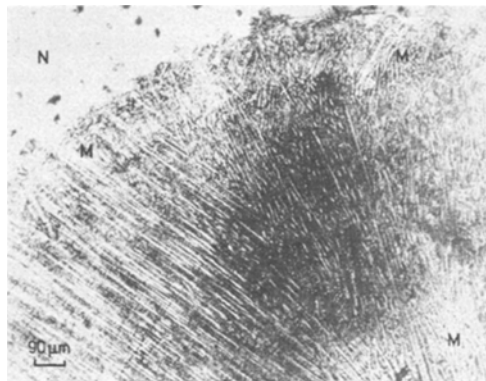
The fractured surfaces of the metal were too damaged by fretting to isolate successfully the origin of the fracture, although the fracture itself is of a torsional nature (Fig. 10). It is possible that the fracture initiated from some type of surface flaw which had been sealed up by a welding process giving locally a much finer grain structure, Fig. 11. The high cyclic stresses occur in this situation if any cement loosening and/or cement fracture occurs in use around the upper third of the femoral stem as described in the specimen from Patient 7. Stresses can be as high as 54% of the yield stress in the extreme case of cantilever loaded prostheses in PMMA bone cement [12] and at such stresses the Co—Cr—Mo—C alloys could fail due to fatigue. The presence of surface markings and a microweld (Fig. 11) through which the fracture had propagated is thought to be of enough significance to

Figure 11 Optical micrograph of the polished and etched surface of the metal (Co—Cr—Mo—C alloy) stem through the fracture. This stem was removed from Patient 5. The microweld (M) and the more normal as-cast structure (N) are labelled. The area filled in by the manufacturer as a microweld occupies almost the whole field of view.

suggest that either of these faults would act as stress-raisers and could be the origin of the fracture.

In this patient it is suspected that a surface flaw was already present before the insertion of the femoral stem; the type of loads normally present at the cement/metal interface in a completely uncracked PMMA bone cement surrounded metal stem would readily lead to crack propagation in this specimen and eventual fracture of the stem. The industrial practice whereby surface porosity in air cast Co—Cr—Mo—C alloy stems is corrected by welding up with material of the same composition is unsatisfactory since a region of material of different grain size and therefore different properties is introduced into the surface and is likely to be the source of a fatigue failure.

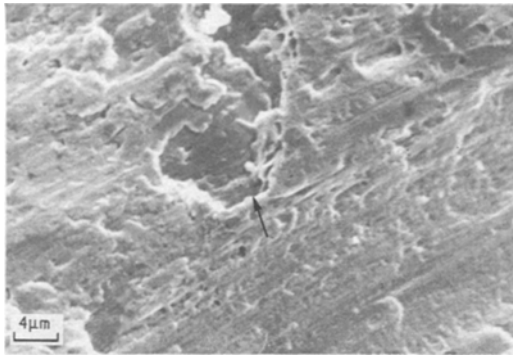
Figure 12 Scanning electron micrograph of fretted area from which the fracture of the metal stem occurred. This specimen was removed from Patient 6. The arrows shows the area of fretting.

This specimen was from a 58 year old male patient of about 80 kg body weight who had a bilateral total-hip replacement. 6 years later the metal femoral stem in the left hip fractured and was replaced. At the time of the first operation a stainless steel wire was used to re-attach the greater trochanter and placed in contact with the metal stem of the prosthesis. Movement of the wire loop during use wore the metal surface by fretting, a type of damage which commonly occurs at amplitudes of movement of less than 0.001 in. or 25 μ m. The fretting initiated a fatigue crack and the stem failed after 6 years. A conservative estimate of the fatigue life in this case, which assumes that the patient walked an average of 4 miles per day over the period, is 15×10^6 cycles. The appearance of the fretted surface is shown in Fig. 12.

Fretting corrosion is known as a source of fatigue failure. It is particularly damaging on a corrosion resistant material since the action disrupts the otherwise protective film and exposes the underlying metal to the corrosive environment, thereby enhancing the attack by corrosion fatigue [13]. It is therefore inadvisable to allow metal-to-metal contacts of this type in operative procedures.

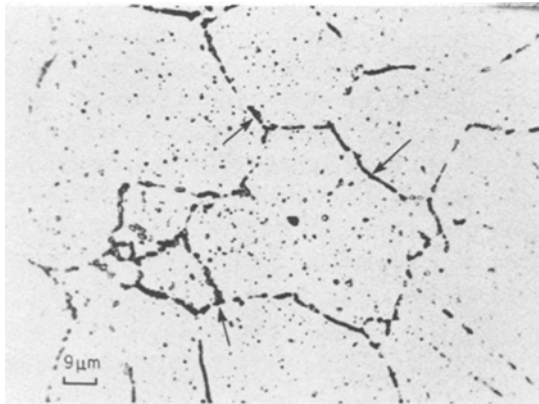
Figure 13 Optical micrograph of the polished and etched stainless steel stem removed from Patient 6. The arrows point to the areas of $Cr_{23}C_6$ precipitation.

The evidence that the stem of the prosthesis was in a sensitized condition is also a disturbing feature of this case. Tests in the laboratory to compare the corrosion rate of sensitized and non-sensitized austenitic stainless steel are reported in Table VI. The specimens, in the form of small bars, were refluxed in 65% nitric acid, a routine corrosion test, for 36 h. The sensitized metal lost two to three times more weight than the low-carbon stainless steel.

approach would therefore be the determination of crack propagation rates in these alloys at low frequencies in simulated body environments. More attention needs to be paid by manufacturers to routine microstructural sampling as well as to the tests for intercrystalline corrosion to eliminate sensitized material being supplied to hospitals.

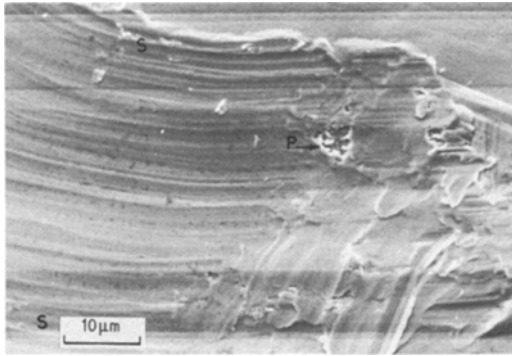
Fig. 14 shows an aggregation of corrosion pits on the flat polished surface of a sensitized stainless

Figure 14 Scanning electron micrograph of a scratch (S) on the surface of 316 S16 sensitized stainless steel in buffered 0.17 NaCl solution (pH = 7.4) at 0 mV with respect to the standard calomel electrode. The arrow shows where the pitting (P) has occurred. This steel had been treated in the same way as stainless steel implants are treated before being supplied to hospitals.

steel which had been treated in nitric acid to produce a passive surface layer and then immersed in buffered 0.17 M NaCl solution (pH = 7.4). These corrosion pits had formed at the site of contact between a diamond stylus and the metal. The diamond stylus rested on the surface of the metal for 10 min. During this period the chloride ions had initiated corrosion at the point of contact even though the potential at the surface was 0 mV with respect to the Standard Calomel Electrode, i.e. the potential at which stainless steel implants passivate *in vivo*. The smeared material in which the pits are visible was produced by sliding the diamond over the surface. This formed part of a study of the repassivation of these materials after suffering mechanical surface damage, which will be reported elsewhere.

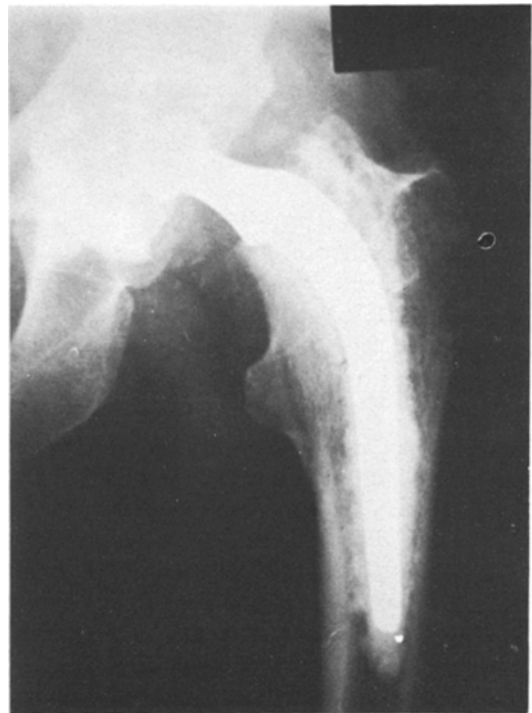
The final specimen concerns a femoral stem failure in which the stainless steel metal stem failed due to high cyclic stresses induced through fracture of the PMMA bone cement. This male patient at the age of 76 years had a Charnley type stainless steel/high density polyethylene total-hip replacement inserted. His body weight was about 80 kg and he was actively disposed. 18 months later the patient suffered a heavy fall onto his knees, at which fall it was suspected that the PMMA bone cement, which held the femoral stem in place, had fractured. Fig. 15 and 16 show radiographs taken respectively after the fall and 8 months after the fall. These radiographs show the progressive bending of the femoral stem and the fracture. The implant was then replaced.

Figure 15 Radiograph of left hip of Patient 7 immediately after the injury.

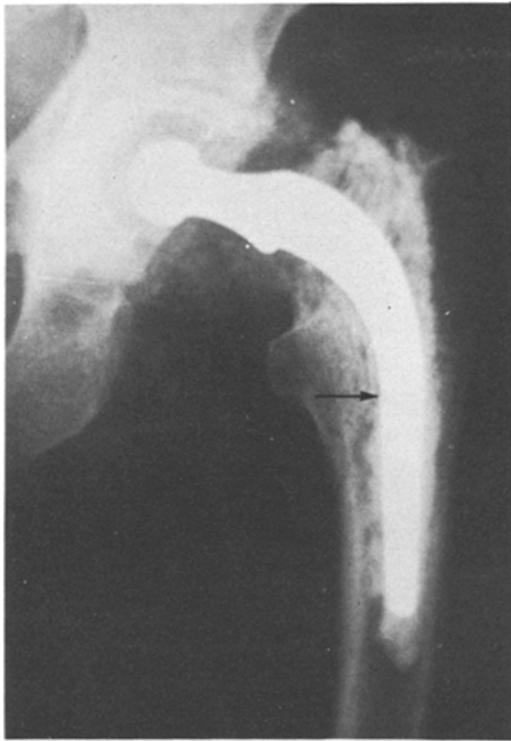
Figure 16 Radiograph of left hip of Patient 7–8 months after injury. Note firstly the deformation and, secondly, the fracture (arrow) of the metal stem.
