Investigation of failure in paint films

D. H. SMELT, D. A. SMITH

Direct "pull-off" tests have been carried out on mild steel plates coated with an "Alloprene"-based lacquer. Several unusual features were observed on the fracture surfaces, and attempts have been made to interpret these markings, and the implications of their origin on the test methods employed. Preliminary results led to an improved testing method but new markings were produced which have been interpreted, and appear to be caused by the interaction of periodic stress waves with the fracture. This technique has the advantages of reproducibility and simplicity.

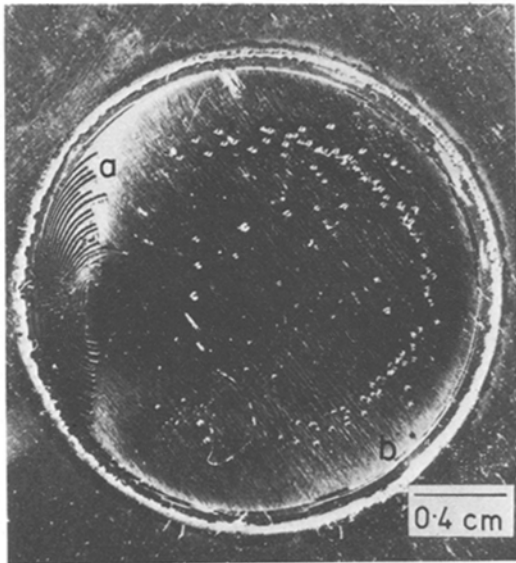
Figure 1 Typical example of a tested area. a, Rib markings; b, area of "adhesive" failure showing lumps of lacquer remaining on the surface.

(ii) that the surface markings on all the tested areas were very similar (Fig. 1);

(A) Each specimen contained an area of rib markings as shown in Fig. 1 and each one was in the same position on the tested area. These are caused by "stick-slip" propagation of the crack within the body of the film [11].

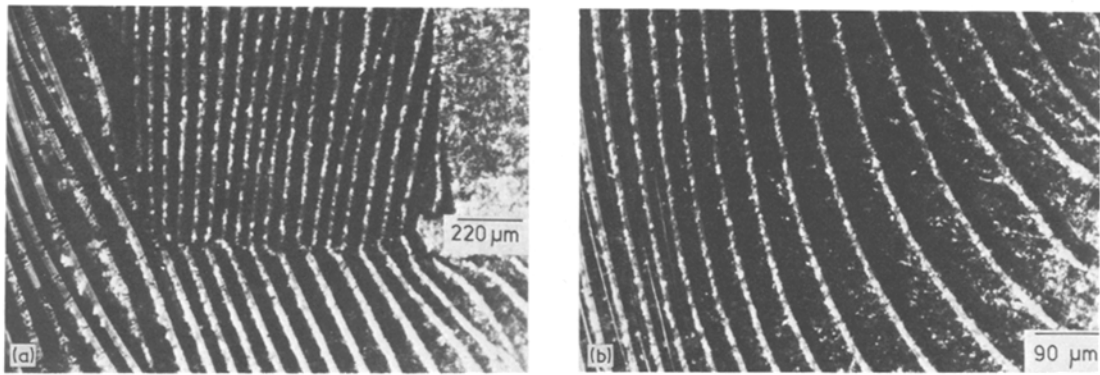
Figure 3 (a) Area of “stick-slip” fracture showing intersection of two fracture fronts. (b) Area of “stick-slip” fracture showing the typical curvature of the markings and their periodicity.

or both of the loci of maximum stress (a). This causes forking at the crack tip. As the crack grows in this way it will encounter lower and lower stresses, and will come to a halt unless the overall stress in the specimen is increased to compensate for this. When a high overall stress is achieved, the conditions maintaining the steady state are overcome, and as the stress in the test piece is far in excess of that necessary for propagation, a catastrophic phase of fracture will follow. The process occurs many times, and the “stick-slip” fracture is thus accounted for. Fig. 3a and b show typical areas of “stick-slip” fracture observed in the specimens, and as described by Andrews [11].

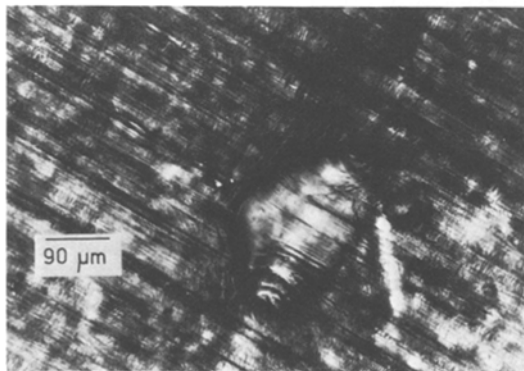
lacquer on the steel surface. However, on closer examination, using an optical microscope, these “lumps” were found to have a particular structure, and showed clear surface markings (Fig. 4).

This structure will be described as “nose-and-tail”, and it was found that all the “noses” of the “lumps” pointed towards one particular area of the tested surface – this point was also the focus of the “stick-slip” markings. This is illustrated in Fig. 5. It was inferred that this was the point at which the initial failure occurred, and it is suggested that the surface features were formed in the following way (Fig. 6): assume that crack x is propagating at constant velocity at the interface between the lacquer and the substrate. Area y is an area of enhanced adhesion, for example where the lacquer is strongly keyed into the surface. When the crack reaches y those parts of it to the right and left of

Figure 4 A typical example of an area of lacquer remaining on the substrate surface, showing the “nose-and-tail” structure.

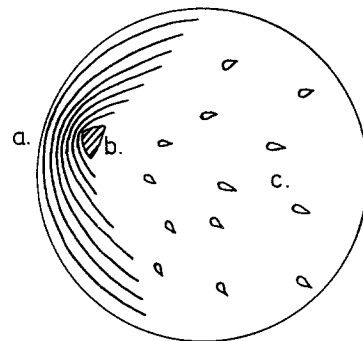
Figure 5 Diagram of a typical tested area. a, rib markings; b, focus of all fracture markings; c, exaggerated view of the pattern of the remaining lumps of lacquer.

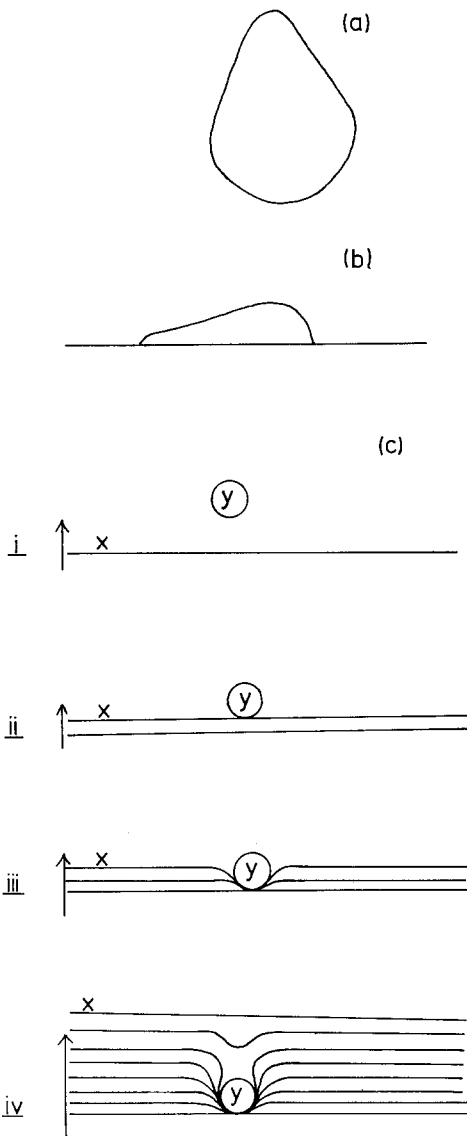
Figure 6 Typical shape of a remaining lump of lacquer (a) plan view. (b) Cross-section view. (c) Schematic representation of the process by which the lumps are formed.

this area continue to propagate, but the portion at y is held up, as the stress is insufficient to cause fracture here. As the crack moves further across the specimen the stress at y builds up until it is sufficiently high either to cause interfacial failure here or for the crack to climb through the film to a region of lower strength and move past the hold-up. It is the latter case which causes the “nose-and-tail” structure of the “lumps” because once the hindrance to crack propagation is by-passed, the crack front moves rapidly forward and down

through the film to rejoin the main fracture front propagating at the weakest level in the film/substrate system.

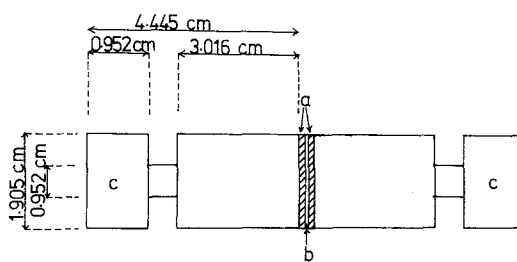
Figure 8 Preparation of a specimen for test. a, "Araldite"; b, steel disc with lacquer on one face; c, mild steel cylinders with dimensions shown.

Fifteen discs were selected from each set, avoiding any which contained obvious defects on the film; for example, bubbles or solid particles. Each disc was bonded between two cylinders as shown in Fig. 8, using "Araldite" as before, and all surfaces to be bonded were cleaned using methanol, as this is not a solvent for the lacquer. These specimens were then laid on specially designed alignment jigs and end-stops were screwed up to exert a force of approximately 5 kg along the axis of each cylinder.

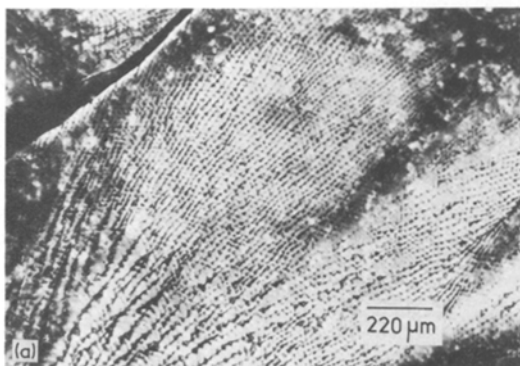
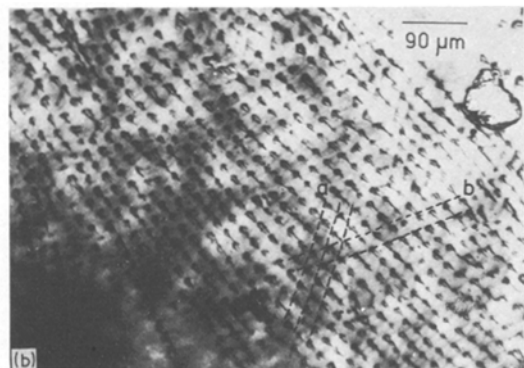
The markings observed can be shown to occur at the intersections of two circular wave patterns, probably the first reflected stress wave from the top surface and the first from the bottom surface, as described in Fig. 11.

Figure 9 (a) Markings observed in areas of cohesive failure. (b) Markings observed in areas of cohesive failure showing periodicity in two directions, illustrated by lines a and b superimposed on the photograph.

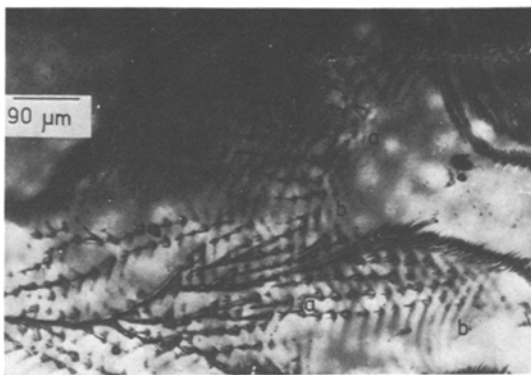
Figure 10 Points of intersection of stress waves can be clearly observed, a. Conventional Wallner markings appear in areas, b.

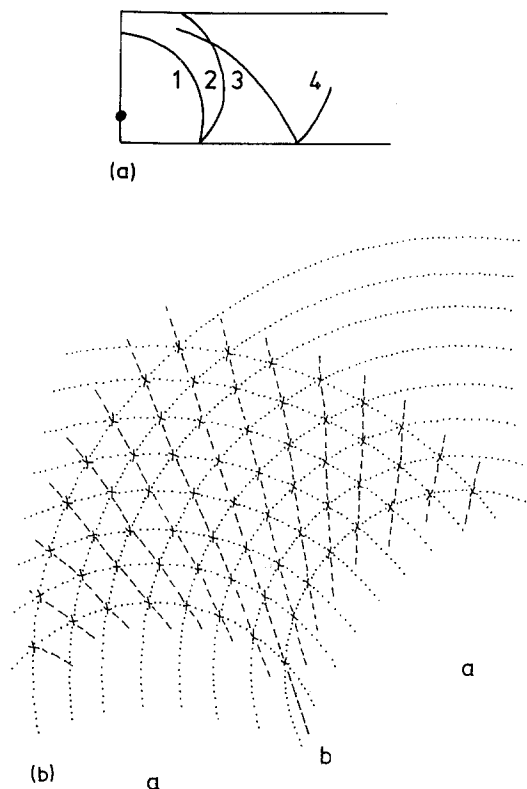
Figure 11 (a) Reflection of stress waves. (1) System concentric with fracture front. (2) First reflection from upper surface of specimen. (3) First reflection from lower surface. (4) Second reflection from upper surface [13]. (b) Schematic representation of the formation of the observed markings (a) Foci of periodic stress waves (. . . .) (b) Focus of surface markings (-x-x-). (Representation first suggested by Keith Reading while a member of the "Interfaces" group in Oxford).
