# Scanning electron microscopy of epoxy-glass laminates exposed to humid conditions

K. A. KASTURIARACHCHI, G. PRITCHARD

Glass-epoxy laminates were exposed to high relative humidities at temperatures up to 80° C for long periods. The degradation processes (notably fibre-resin debonding, cavitation, and crack formation) were observed by scanning electron microscopy. Cracks were eventually induced, especially at high temperatures (a) near the surfaces, (b) between plies, (c) within plies. The second and third classes of crack were generally found to initiate from regions of cavitation. It is proposed that the cavities were formed by dissolution of embedded particulate residues. Evidence is presented that these residues consisted of unreacted dicyandiamide curing agent. Microscopic observations suggested that the breakdown of fibre-resin adhesion was substantially reversible. Large decreases in shear strength were found on hygrothermal ageing, but reversed completely by slow, careful drying. Small decreases in flexural modulus were also reversed, but the flexural strength was decreased permanently, presumably because of defect formation.

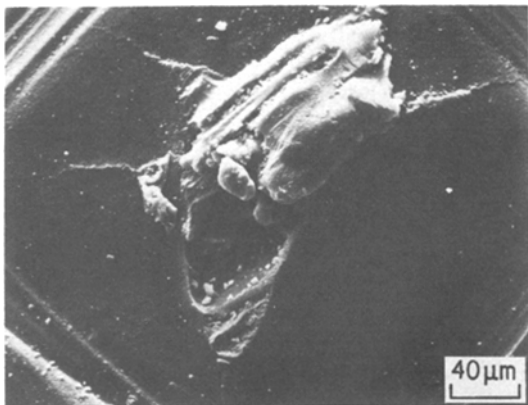
*Figure 1* Surface cavity in one of the depressions caused by the bleed cloth. Note the exposed fibre and the loose resin fragments. (Control specimen,  $\times 158$ .)

The bleed cloth imparted an appearance reminiscent of that of woven roving laminates. Close examination showed that there were numerous surface scratches within the many depressions caused by the bleed cloth. There were also deeper scratches revealing exposed fibres. The deeper ones were often associated with resin fragments, which had become almost completely detached. Fig. 1. shows a detail of the bleed cloth impression, with a broken surface region, loose resin fragments, and an underlying fibre.

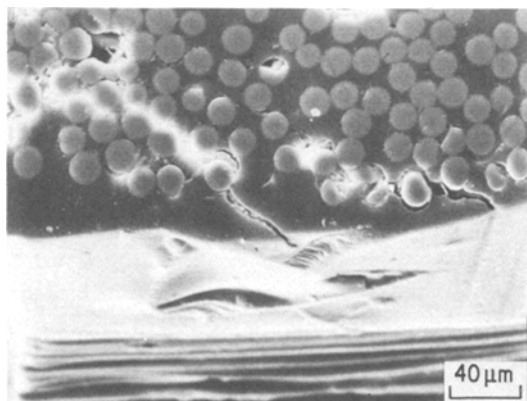
Water accumulated in the surface depressions caused by the bleed cloth, and entered surface scratches, causing detachment of loosely bound resin fragments, exposing fibres. Two surface features, namely (1) the weft and warp markings from the bleed cloth, and (2) the depressions in the rectangles caused by the fabric pattern on the surface, acted as crack initiators. Cracks such as those shown in Fig. 2 propagated from a part of

*Figure 2* Cracks in hygrothermally exposed sample, originating from surface marks introduced by the bleed cloth. The cracks start at (1) the weft or warp marking of the cloth, (2) the depressions in the surface.  $\times 310$

the surface well covered with resin. They could accelerate water absorption.

5. Minor blemishes were apparent on the laminate surfaces. They were apparently caused by the bleed cloth during fabrication, and led to the propagation inwards, from the surface, of cracks which could accelerate water ingress.

6. The hygrothermal stability of the material could be much improved by: (a) reducing or eliminating the phase-separated dicyandiamide; (b) avoiding the bleed cloth impression; (c) reducing the width of the inter-ply boundaries. It should be stressed that the damage features mentioned were induced by severe test conditions. They were caused by exposure for extensive periods at 80° C and 95% RH. Subjection to less severe conditions resulted in very much slower deterioration.

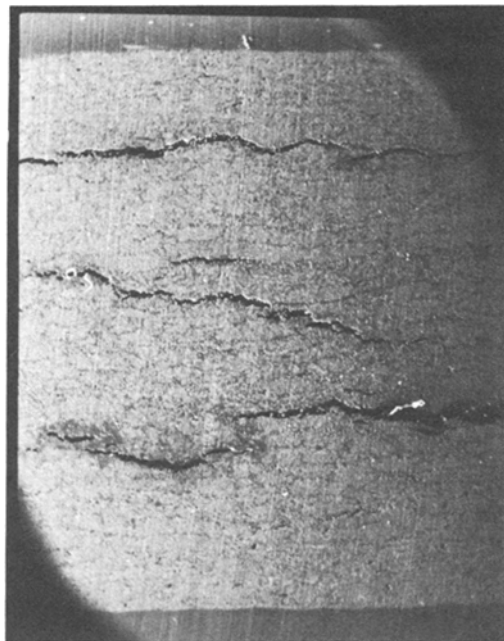
Figure 3 Gross interlaminar cracking (delamination cracking) after several months at 80° C. The whole specimen thickness of 2 mm can be seen.  $\times 38$

Cavities were formed extremely slowly at 24° C, more quickly at 45° C, and rapidly at 80° C. They were most plentiful in the inter-ply regions. Cracks eventually appeared in these regions, running parallel to the major surfaces along ply boundaries. Fig. 3 shows a low magnification micrograph covering the entire 2 mm thickness of a laminate strip. The cracks in this sample could be observed with difficulty without a microscope, and were formed only after prolonged exposure for several months at 80° C/95% RH. Their widths often exceeded 50  $\mu\text{m}$ . Close examination showed that these delamination cracks were associated with severe cavitation.

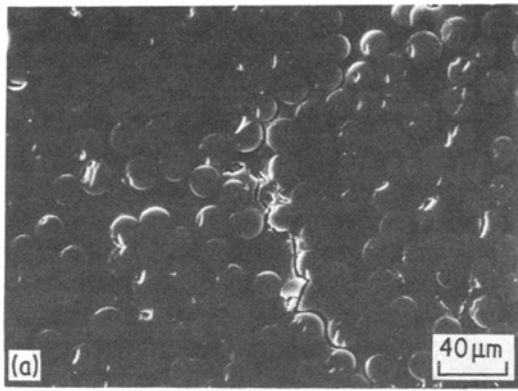
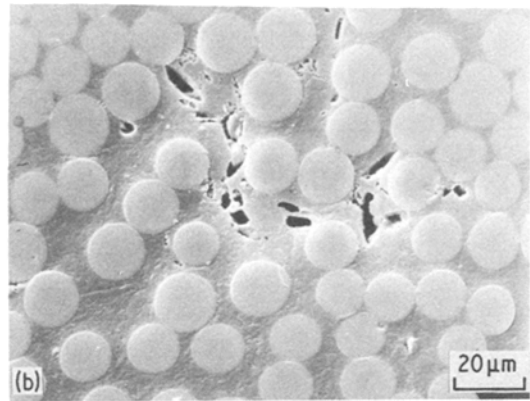
Much finer cracks propagated from regions of moderate cavitation within a single ply. An example of an intra-ply crack is shown in Fig. 4a and a typical cavitation region in Fig. 4b. Such cracks propagated around the contours of the fibre-resin interface, with some jumps across resin-rich regions.

Figure 4 (a) Intra-ply crack originating from a cavity,  $\times 340$ ; (b) Intra-ply cavitation,  $\times 620$ .

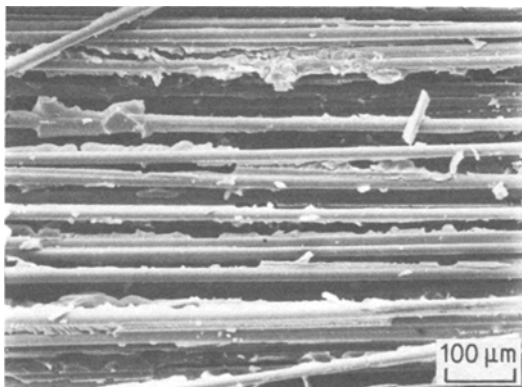
Figure 5 Inter-laminar section, showing good adhesion between fibres and resin. (Control specimen,  $\times 122$ .)

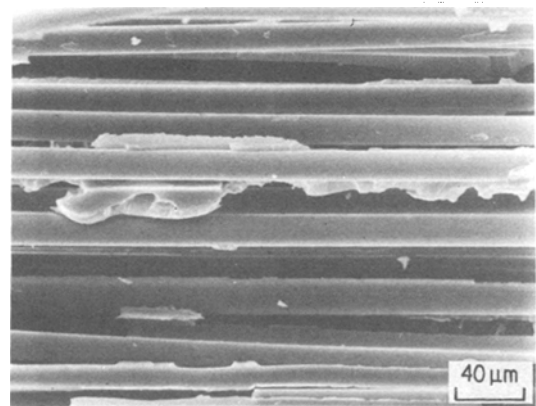
There was a sharp contrast between the appearance of inter-laminar sections from control samples (Fig. 5), in which adhesion was good, with nearly all the fibres showing resin fragments attached to them, and that of analogous sections from samples which had experienced prolonged hygrothermal exposure, as in Fig. 6. The latter sections showed substantially clean fibre surfaces, with only a few resin fragments attached to the fibres. Debonding would be expected to result in a lower short-beam shear strength for the composites. The shear strength was therefore measured by ASTM-D-2344. The decrease in shear strength was large, i.e. about 50% after 2.5% water absorption at  $80^{\circ}\text{C}$ , and about 60% after 4.0% water absorption which took 21 days.

Figs. 5 and 6 are photomicrographs of sections prepared by carrying out three-point bend tests, as described in Section 2.3. They demonstrate that hygrothermal exposure weakened the fibre–resin interface. There was also another indication. White lines began to appear and develop progressively on specimen surfaces during the exposure period, always parallel with the fibres. Sections through the affected areas revealed interfacial damage.

Figure 6 Interfacial weakening in a 2 mm thick specimen exposed in a humidity chamber at  $80^{\circ}\text{C}$  for 30 days.  $\times 291$

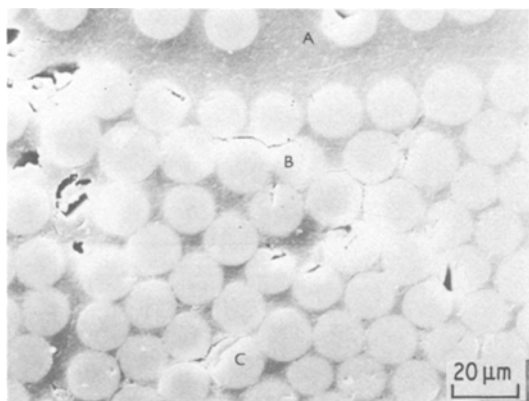
Figs. 7 and 8 show two adjacent areas of a trans-fibre section through a specimen exposed at  $45^{\circ}\text{C}$  for 90 days. The feature marked “C” is common to both figures. The inter-ply boundary region shown as “A” in Fig. 7 was unaffected by hygrothermal ageing. This region was also free of delamination cracks of the kind observed in more severely exposed cases. The debonding crack at B travelled through one of the fibres instead of

Figure 7 Interfacial breakdown in a specimen exposed at 45°C for 90 days. Fig. 8 shows an adjacent region. The letters are explained in the text.  $\times 589$

around it, and could be seen to connect with the debonding crack on the other side of the fibre cross-section circumference. This is quite different, and easily distinguished from, the scratch marks at C and F, believed to be caused during sample preparation.

Examples of interfacial weakening were apparent at fibre-rich zones B, C and D, and also at resin-rich zones such as E. After long periods of exposure, when water uptake had reached about 1.4% wt/wt the debonding cracks propagated around the circumferences of several fibres, to travel considerable distances (Fig. 9).

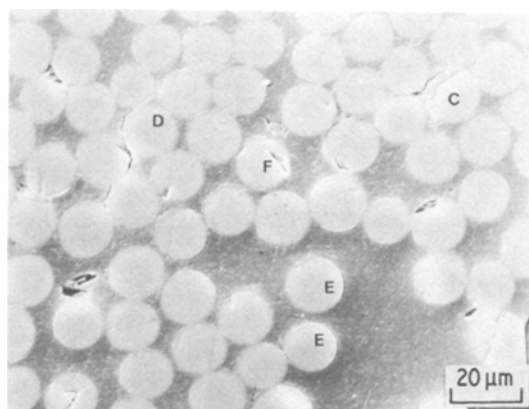
Figure 8 Interfacial breakdown in a specimen exposed at 45°C for 90 days. Fig. 7 shows an adjacent region. The letters are explained in the text.  $\times 589$

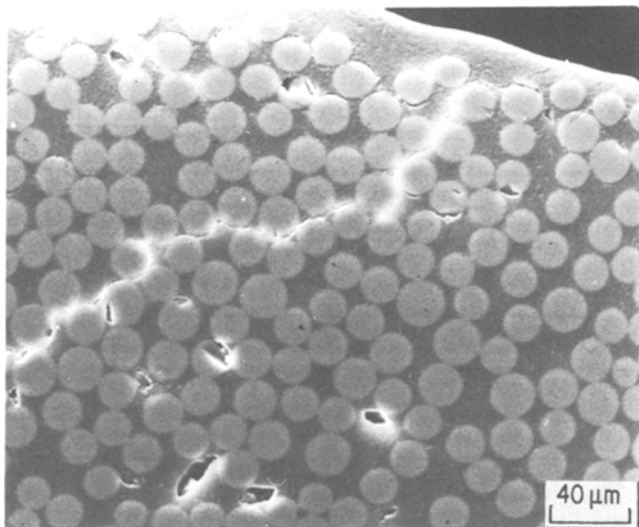
*Figure 9* Debonding crack in a specimen exposed at 45° C until a 1.4% weight increase had occurred. A second crack, nearly parallel to the edge, can also be seen. × 408

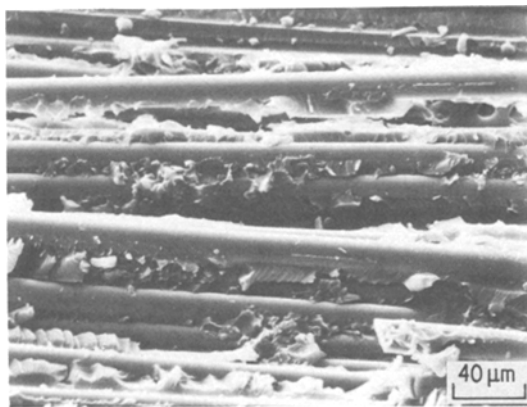
Interlaminar sections of the dried specimens showed resin adhering to the fibres almost as extensively as in the control specimens (compare Fig. 10, a re-dried sample, with Fig. 5, control, and Fig. 6 a wet sample). Similar results were found after drying specimens previously exposed to 45°C/95% RH for 90 days. Interfacial recovery was also reflected in the trans-fibre sections, even in regions close to permanent damage features such as cavities.

*Figure 10* Inter-laminar section showing good interfacial recovery on drying, after exposing at 80° C until a weight increase of 2.5% was reached. × 372

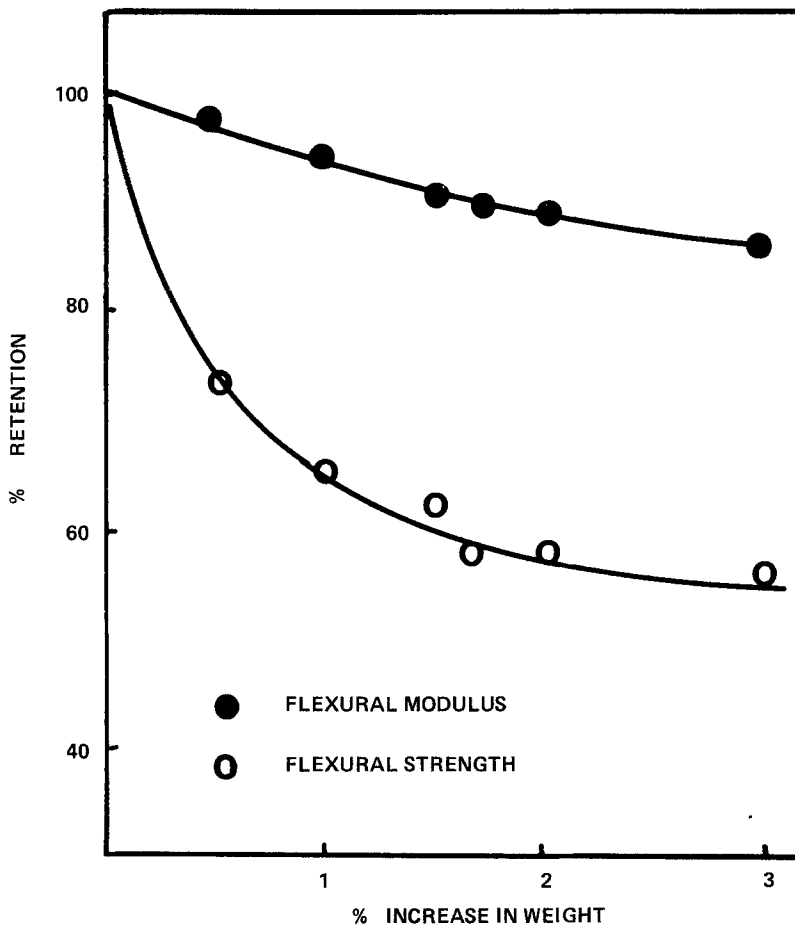
Changes in flexural strength and modulus in three-point bending were also observed, using ASTM-D-790. Fig. 11 shows the decline in these properties consequent upon hygrothermal exposure at 80°C/95% RH. Flexural modulus levelled off at slightly more than 85% retention while flexural strength fell below 60% of its original value when the material had absorbed 3.0% water.

On drying, the recovery in flexural modulus was almost complete (Table II). This is consistent with the theory that the lowering of modulus is mainly a reversible effect related to matrix plasticization and debonding. Flexural strength was not completely restored on drying, as it is affected by the introduction of cracks and cavities.

Figure 11 Effect of hygro-thermal exposure at 80°C/95% RH on the flexural strength and modulus in three-point loading.
