The effect of 42 year immersion in sea-water on natural rubber

K. AB-MALEK, A. STEVENSON

Malaysian Rubber Producers' Research Association, Hertford, Hertfordshire SG13 8NL, UK

A study has been made of the physical condition of vulcanized natural rubber retrieved after 42 yr exposure to sea-water at a water depth of 80 ft (24.3 m). Drying experiments show the maximum amount of water absorbed in the 42 yr period to have been less than 5% of the dry rubber mass. No effect of marine life was observed and the physical properties of the rubber were found to be as good as for new rubber moulded to a similar formation.

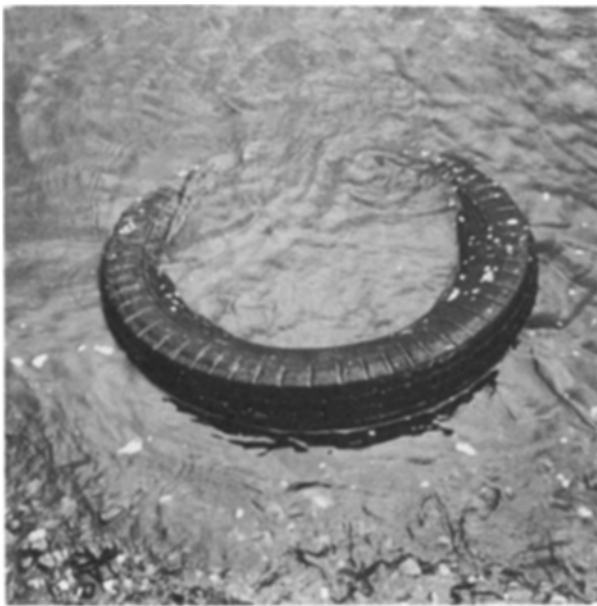
Figure 1 General view of tyre during recovery after 42 yr immersion in sea-water.

Both tyre (Fig. 1) and the inner tube (Fig. 3) appeared to be in excellent condition on removal from the sea. Neither showed any evidence of attack by marine organisms. The tyre tread was still clear and sharp (Fig. 2) and the inner tube was still capable of inflation, although leakage through the valve area caused it to remain inflated only for 1 day. Markings on the tyre

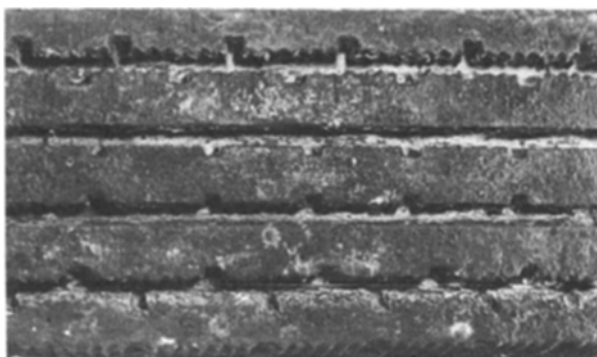
Figure 2 Enlarged view of the tread of the tyre shown in Fig. 1. Tread pattern is still clear and tread depth is 10mm

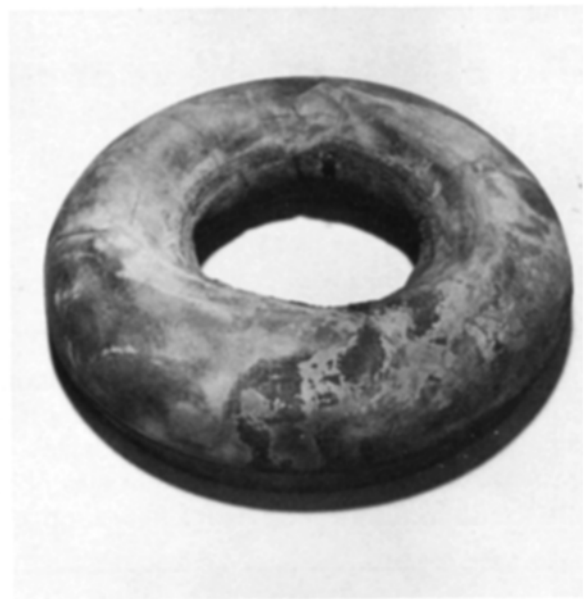
Figure 3 General view of truck inner tube after 42 yr immersion in sea-water — shown inflated in the laboratory.

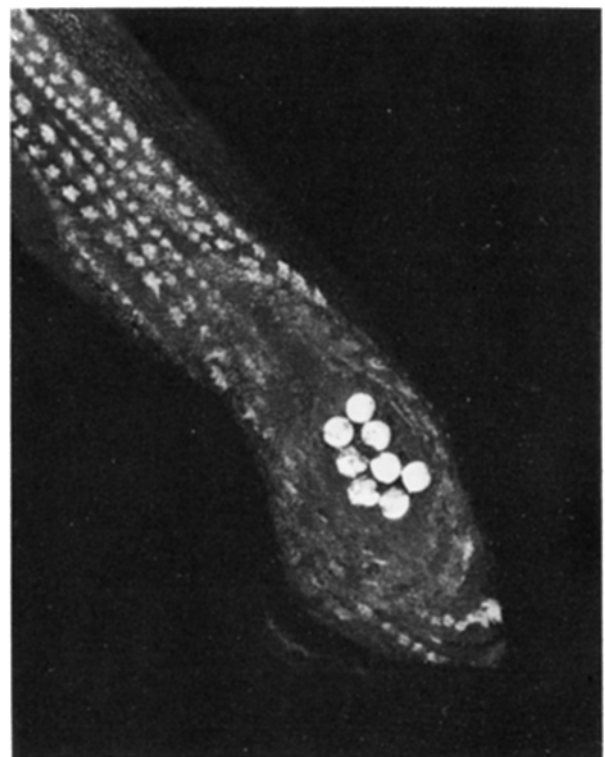
sidewall were still clear enough to read that it had been manufactured by Dunlop in Great Britain. When radial cuts were made through the tyre to cut it into segments, the steel beading thus revealed was bright and completely free from corrosion (Fig. 4) although it was then easy to pull it away from the tyre wall, suggesting poor rubber/metal bonding.

Figure 4 Section cut through tyre showing steel beading still uncorroded after 42 yr sea-water immersion.

Analysis was also carried out of the metal beading around the rim of the tyre (see Fig. 4). This was found to be predominantly iron, with traces of aluminium, manganese and silicone. The analysis suggested the beading composition to be typical for ordinary mild carbon steel.

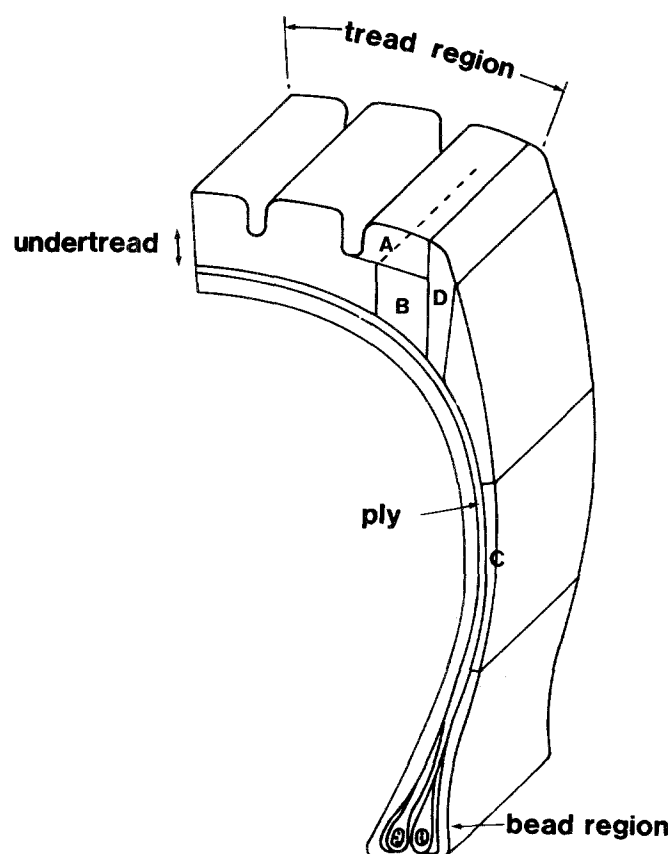
Figure 5 Schematic view of tyre section showing location of regions A (tyre tread), B (shoulders under tread) C (tyre sidewall) and D (tread plus shoulder) from which rubber samples were taken for analysis.

An indication of the state of cure of rubber in the tyre was obtained by sulphur analysis. No free sulphur was found in samples from any of the three locations A, B or C (see Fig. 5) indicating the rubber to be everywhere fully cured. Analysis of sulphide content (S^{2-}) and combined sulphur (S_c) may be used [12] to provide information concerning the state of cure by consideration of the ratio $S^{2-}/(S_c - S^{2-})$. The results are presented in Table V.

The generally low values of $S^{2-}/(S_c - S^{2-})$ suggest that a good state of cure exists throughout the tyre. However, this ratio is higher for A than for B suggesting that some polysulphidic crosslinks in the tread region may have degenerated into sulphides. This could be an ageing process due to the proximity of the tread to the external environment, or it could again reflect initial differences in processing methods between the tread and under-tread regions.

Analyses were also carried out of the oxygen content in the rubber from segment D of Fig. 5: (i) at the tread surface (ii) just below the tread surface, and (iii) in the centre of the tyre segment D. The results were (i) 3.7, (ii) 3.6 and (iii) 4.0% w/w†, respectively indicating no significant difference in oxygen content throughout the tyre. Tests on new rubber discs yielded oxygen contents of 2.1 to 2.3% w/w 3 h after moulding, rising to 2.5 to 2.6% w/w after 38 day in air. Extensively oxidized rubber, produced for example by air ageing at elevated temperatures, can typically show an increase greater than 10% O_2 w/w. These results thus

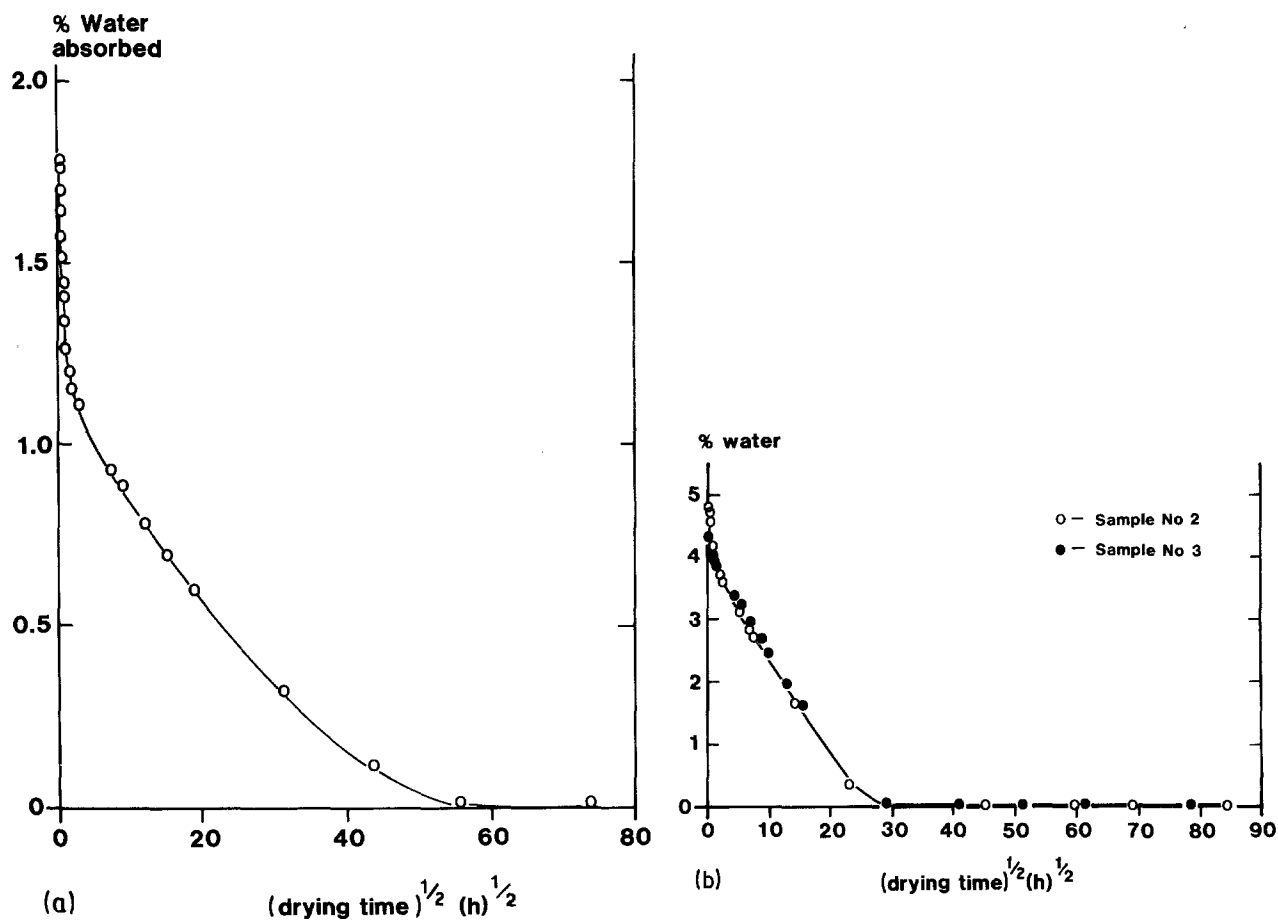
Figure 6 Drying curves showing per cent residual water in the rubbers plotted against square root of drying time. Residual water is expressed as a percentage of final dry weight of rubber, (a) for sample cut from tyre tread, (b) for two samples from inner tube.

Samples of rubber from both the tyre and the inner tube were dried under controlled laboratory conditions immediately following removal from sealed sea-water containers. Weighing at time intervals up to about 300 days produced values of mass loss as a function of drying time in air. The results are shown in Figs. 6a (tyre) and b (inner tube) where mass loss has been plotted against the square root of the drying

time. Mass loss is expressed as a percentage of the final dry weight and thus represents the amount of water in the rubber. The tyre samples showed an initial amount of water of 1.8% which reached equilibrium "final" dry weight after about 135 days drying. The inner tube samples showed an initial amount of water of 4.7% and reached final dry weight after about 33 days drying. All drying experiments were continued for 300 days, but no further changes were observed beyond the above times. In both cases at least the initial stages of drying were approximately linear with the square root of time as would be expected from the usual diffusion theory. The tyre sample geometry was $10 \text{ mm} \times 10 \text{ mm} \times 7 \text{ mm}$ whereas the inner tube samples were $50 \text{ mm} \times 50 \text{ mm} \times 2.5 \text{ mm}$. The shortest path length for water evaporation for the tyre sample was thus twice that of the inner tube samples. The four-fold longer drying time is thus also explained by standard diffusion theory. Less easy to understand is the significantly lower level of water uptake observed in the tyre samples.

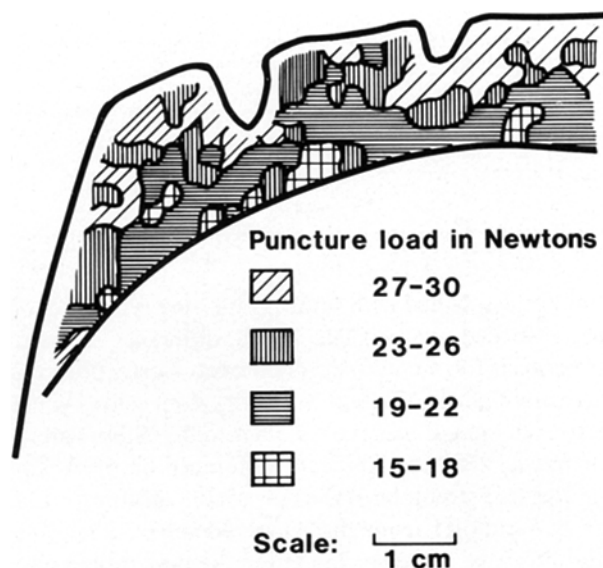
In addition to standard physical tests, a series of puncture tests was performed on a section cut through the tyre. This test [9] enables a large number of values for puncture load to be collected over the whole surface by performing successive indentation/punctures at 2 mm intervals. A contour map of the resulting puncture loads is shown in Fig. 7. This test is more sensitive in detecting local differences in strength than any of the standard physical tests. Indeed the results show higher puncture loads over part of the tread region than deeper towards the carcass. Similar tests on a flat moulded block of the new vulcanizate over a similar area yielded values of 20 (± 2)N. The difference is just large enough to be significant and may indicate some ageing towards the outer tread surface. Alternatively, the difference could have been caused

Figure 7 Contour map of puncture strength across a section through the tyre.

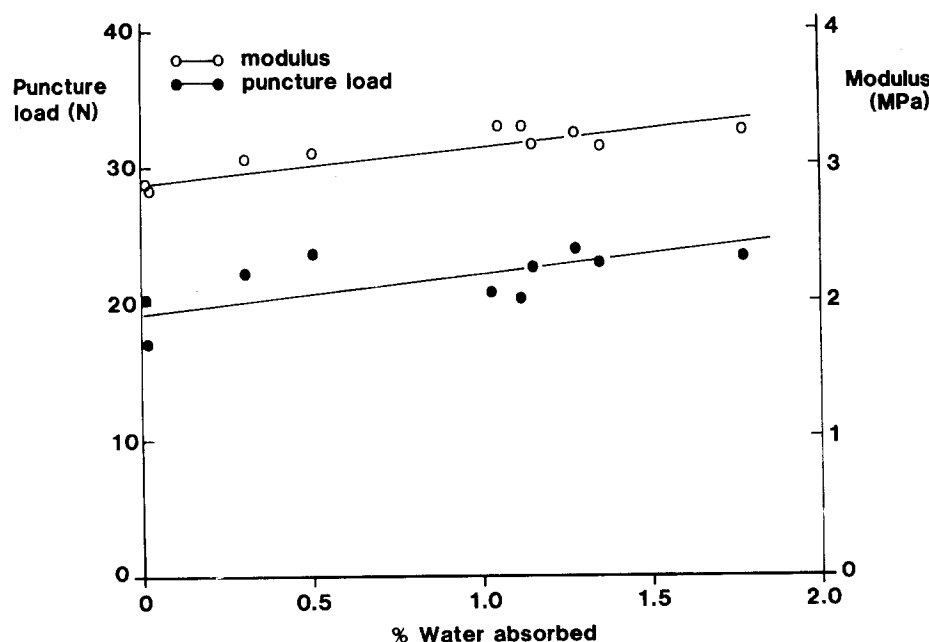
For one tyre segment, puncture tests were performed wet (before drying) and then at timed intervals, together with corresponding weight measurements as the segment was dried in a controlled laboratory environment. Thus puncture load and modulus could be plotted as a function of the amount of adsorbed water. The results, shown in Fig. 8, do not suggest any substantial effect. There may be a slight tendency towards higher puncture loads and higher modulus values with increasing amounts of absorbed water – but the difference is barely significant.

Figure 8 Puncture load and modulus as a function of the percentage of water absorbed by the rubber tyre.

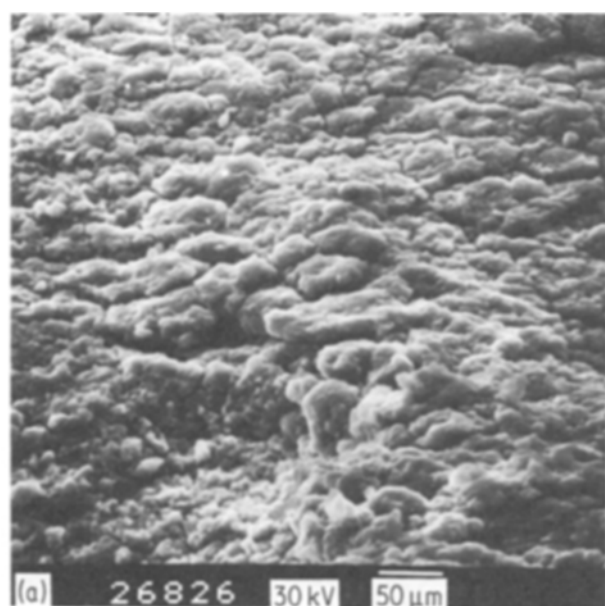
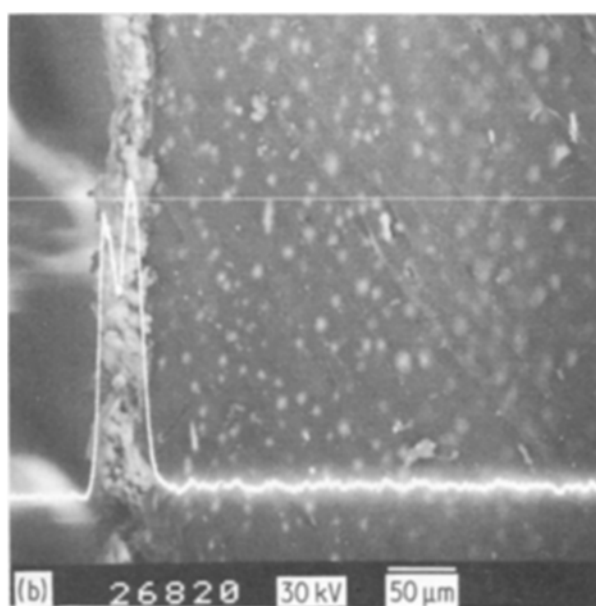
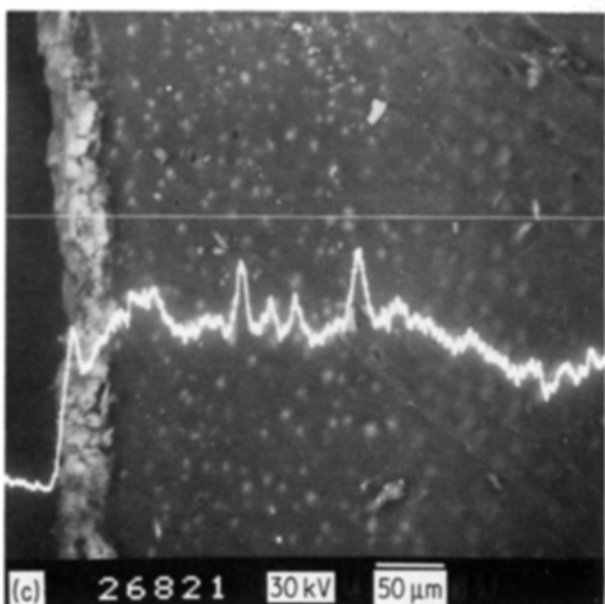
Figure 9 Scanning electron micrographs of tyre tread (region A). (a) Outer tread surface with particulate "crust" (b) Profile of section through the tread segment showing outer layer of particulate material of maximum thickness 50 μm . The superimposed line scan for iron shows the outer layer to be of different composition from the underlying rubber. (c) Similar micrograph to (b) with line scan for sulphur.

the intensity of the appropriate K_{α} X-ray peak. There is clearly no significant difference between the surface layer and the "bulk" rubber. The corresponding photograph with iron content (Fig. 9b) clearly shows a strong presence of iron only in the surface layer.

There was no trace of iron in the analysis of the rubber compound itself and indeed no reason for it to be there. There was, however, a strong presence of iron in the silt-like material recovered from the deck of the vessel from which the tyres were obtained. The most likely explanation of the surface layer is then that there was a sediment over the years of iron oxide from corrosion products of the vessel structure. This formed a fine layer which interacted slightly with the rubber surface to form a very thin skin of some 0.05 mm thickness. This skin then seems to have had some protective value and even (as discussed in Section 3.3) have retarded the absorption of water by the rubber. Because of the topography of the surface it is difficult to say from the evidence whether this fine surface layer is purely the result of accretions of extraneous matter or whether some mild chemical degradation of the rubber surface may also have occurred. The unchanged sulphur content in this layer is not instructive since sulphur was also detected in silt samples at similar concentrations. In any case if there is some degradation it has been restricted to a very thin surface layer of maximum thickness 0.05 mm.

A section through the tyre tread was also examined by scanning electron microscopy. The tread surface appeared highly particulate in character (see Fig. 9a) and most unlike that of a degraded rubber surface although the surface texture was not dissimilar to some recent new tyre tread surfaces. Examination of the section revealed a layer of aggregated particulate material with a maximum thickness of 50 μm (Fig. 9b). Electron probe analysis of both the tread surface and the "bulk" rubber beneath the surface showed normal levels of sulphur in each case but an increased amount of aluminium in the tread surface. In addition the tread surface sample showed a strong presence of iron which was not detected at all in the bulk rubber. A scan for iron is shown superimposed on Fig. 9b. The full element scan for samples from each region are shown in Fig. 10. There may also have been a slightly reduced level of zinc in the tread surface sample. Fig. 9c shows a section through the sample with a coincidental plot of sulphur content as measured by

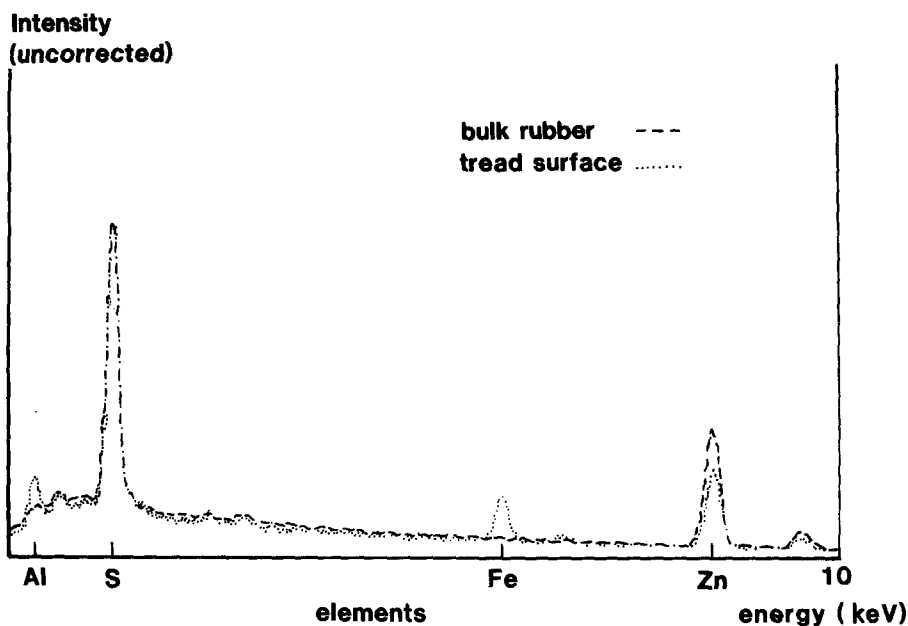
Figure 10 Element scans for tread surface (including surface "crust") and bulk rubber (no "crust") under tread. Obtained using a Hitachi S500 scanning electron microscope with a Link energy dispersive spectrometer.
