Corrosion phenomena on evaporated metal layers under electric stress

C. BRINKMANN

Department of Elektrische Energietechnik, Technical University of Darmstadt, West Germany

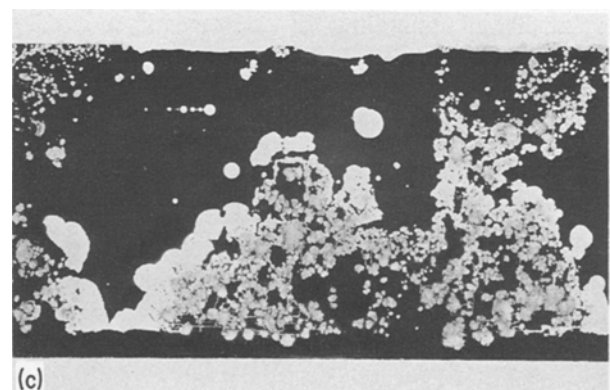
There is no uniform optical appearance of the corrosion phenomena, but two fundamentally different processes can be distinguished. Fig. 2 shows a few examples. Irregular shapes can be observed (Fig. 2a) growing from the edges. A reason for this may be the increased field strength at the edges, and also the fact that air can penetrate into the roll from these edges. Such corrosion phenomena are characterized by self-healed breakdowns with the well-known circular insulating areas [1, 2] on the twin metal layers. In this way, parts of the layers situated one upon the other are also damaged, so that the optical appearance of superposed layers is often rather similar. In between the irregularly corroded zones, small discharge paths are often formed (Fig. 2a) which means that this corrosion path is caused by creepage currents. Less frequent are transparent circular corrosion sites with diameters of up to 10 mm (Fig. 2b). These zones can grow together or lead to a retreat of the edges of metal layers (marked by arrows in Fig. 1). It is remarkable that the substrate shows no damage at these spots, and thus there is no mark on the layer of the adjacent film. However, it was a disadvantage for a detailed investigation that some of the corroded

Figure 2 Corrosion phenomena on metal layers of capacitor-rolls of foils of polypropylene (thickness $12 \mu\text{m}$). (a) Self-healed (Schlieren-type) destruction of a zinc layer. (b) Circular corrosion sites on an aluminium layer. (c) Both self-healed and circular corrosion of a zinc layer.

Section 3. The first kind (Fig. 2a) is caused by a self-healing effect in which the metal layer is evaporated so much that around the breakdown district a circular metal-free area is formed, which then once more electrically insulates the layers [1, 2]. This process is dependent on the breakdown strength of the dielectric, which is influenced by factors such as the ambient atmosphere. For the rolls studied the a.c. voltage had to reach a value of at least 300 V. Below this level there was no damage.

In the second case (areal-type corrosion) the metal layer is converted to an insulating layer without breakdown (Fig. 2b). This is true for the roll and to a greater degree for freely suspended specimens, for which corrosion occurs over the whole area. A planimetric measurement of the corroded spots shows that their share is equivalent to the measured decrease in capacitance. Thus, the decrease in capacitance is a measure of the amount of metal layer destroyed; in other words, when the layer loses its metallic character the body loses capacitance by the same amount. This is of particular interest.

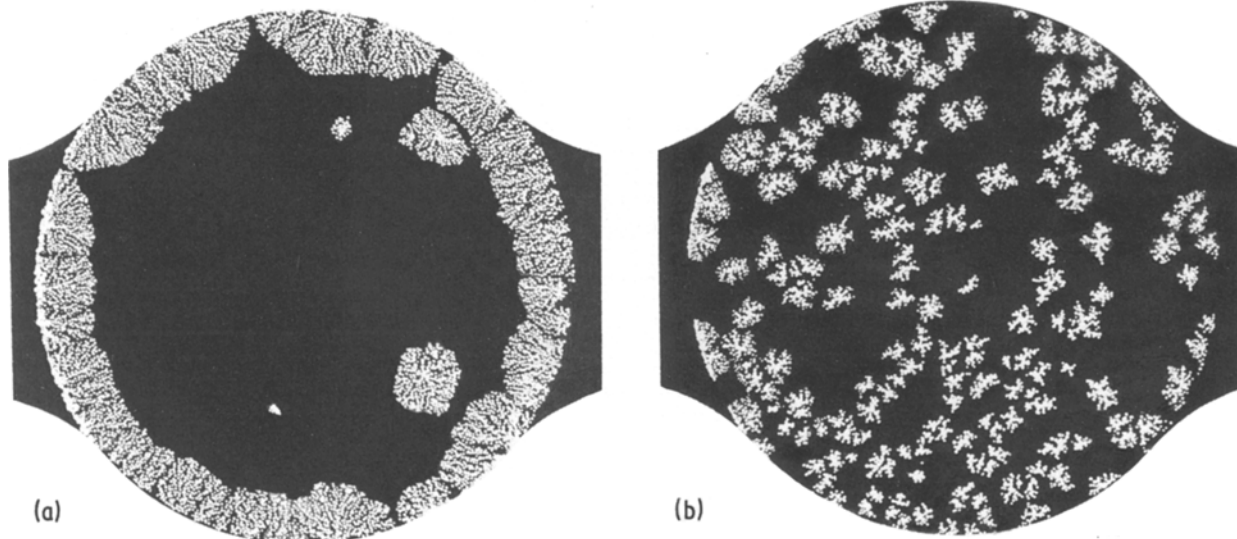
Figure 5 Corrosion on foils of polycarbonate coated with aluminium and stressed under pressure. $d = 12 \mu\text{m}$, $U = 500 \text{ V}$; $t =$ (a) 380 h (b) 600 h.

For specimens which are stressed under pressure (Fig. 4) corrosion also grows from the borders in the form of brushes towards the centre, and has the same appearance on both sides. Such radiating corrosion patterns occur more rarely in the centre of the surface. They also consist of self-healed breakdowns which happen one after the other, and can be detected by blue flashes and short sounds. Such a breakdown damages the dielectric in its neighbourhood, so that further breakdowns occur in radial directions starting from the centre and increasing in number, which leads to a star-like picture. Pictures of this kind are shown in Fig. 5 for two polycarbonate films coated with aluminium. The damage increases with time in more than a proportional manner, so that the decrease in capacitance can reach up to 30% after a month. With an increase of the mechanical pressure (up to e.g.

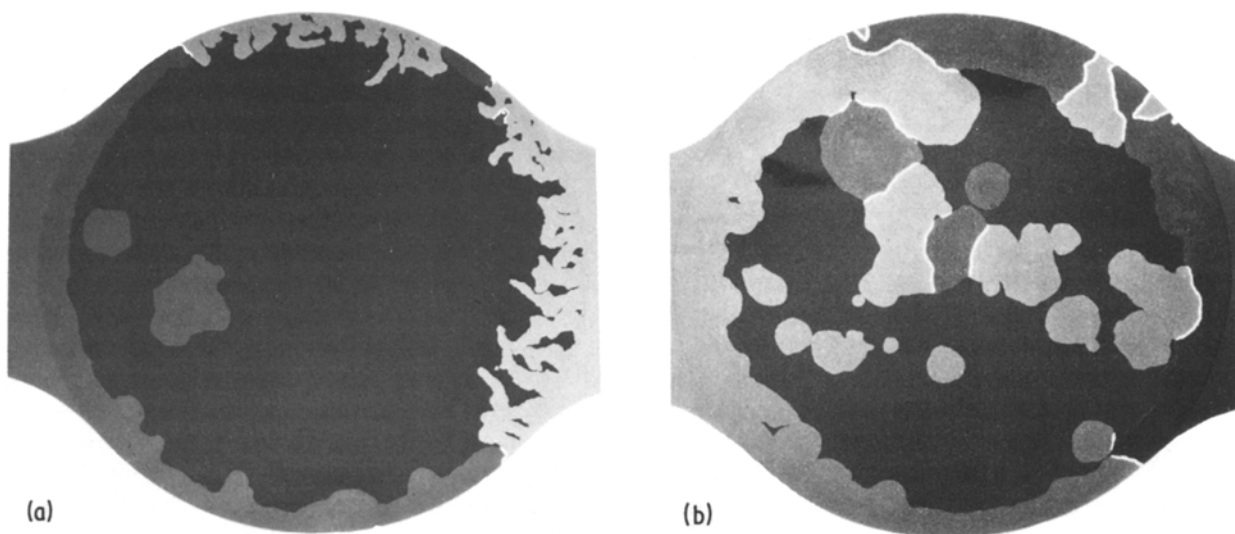
Figure 6 Corrosion phenomena of freely suspended foils with aluminium layer. (a) CAB foil ($d = 20 \mu\text{m}$, $U = 450 \text{ V}$, $t = 240 \text{ h}$). (b) PI foil ($d = 12 \mu\text{m}$, $U = 500 \text{ V}$, $t = 25 \text{ h}$).

The freely suspended specimens usually show on both sides these alternatively corroded zones, which in the case of aluminium and zinc are transparent and non-conductive. This is shown in Figs. 6 and 7. In the black zones the metal layer remained undamaged on both sides. Depending on the intensity of the grey tone it can be recognized on which side the damage occurred (e.g. Fig. 6b). When there is no metal on either side very slender transparent lines appear (see Figs. 6b and 7). Here, corroded zones on the two sides meet and corrosion must necessarily come to a stop, since no opposite layer under voltage is present. Thus, it can occasionally lead to an isolation of undamaged metallic zones which then have no electrical contact with the electrode and can no longer contribute to the capacitance. Such wide zones of corrosion of the areal type are typical for CA, CAB, PP, PS, PETP, PC and PI. A similarity with the transparent zones in Figs. 2b and c is clear. Furthermore, the dielectric losses vary over a wide range. Depending on the substrate and on its specific state (ambient climate), respectively, even with equal composition of material half of the original area can be lost after 300 h. PI suffers little destruction, while for PP and PETP relatively strong corrosion occurs.

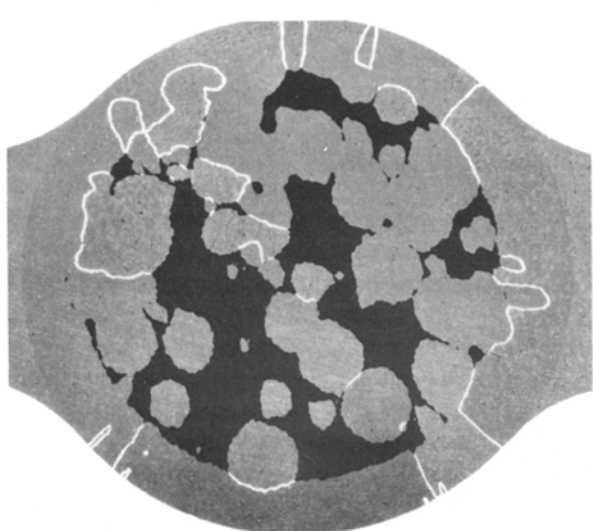
Figure 7 Corrosion of an aluminium layer on mica for freely suspended arrangement. $d = 15 \mu\text{m}$, $U = 500 \text{ V}$, $t = 25 \text{ h}$.

Under the conditions described above no breakdown (and also no self-healing breakdown) occurs with mica sheets. Both for aluminium layers (Fig. 7) and for nickel layers, corrosion on mica is of the areal type and very strong. In the case of silver there are intermittent zones of corrosion (Fig. 9). For aluminium coated sheets corrosion can be complete after only one day, while the process lasts one month for nickel and silver. Gold layers on mica substrates remain undamaged after several months, even under aggravated conditions. This clearly indicates that besides the metal layer, the substrate influences corrosion significantly.

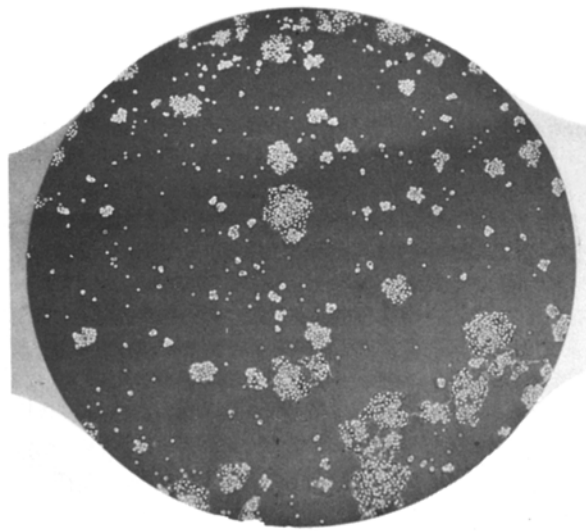
Figure 8 Corrosion of a silver layer on polyimide for freely suspended arrangement. $d = 12 \mu\text{m}$, $U = 400 \text{ V}$, $t = 170 \text{ h}$.

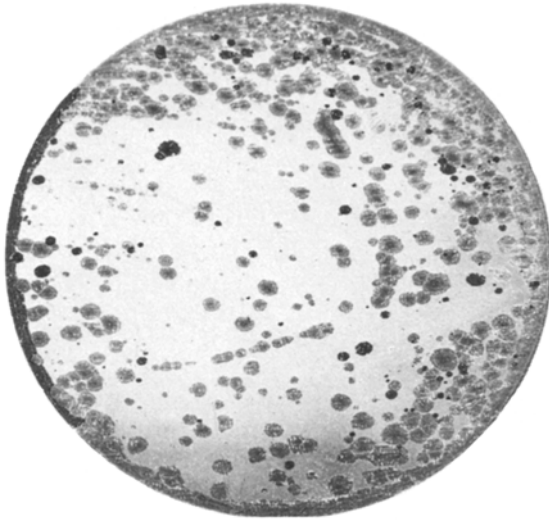
Figure 9 Corrosion of a silver layer on mica for freely suspended arrangement. $d = 19 \mu\text{m}$, $U = 600 \text{ V}$, $t = 850 \text{ h}$.

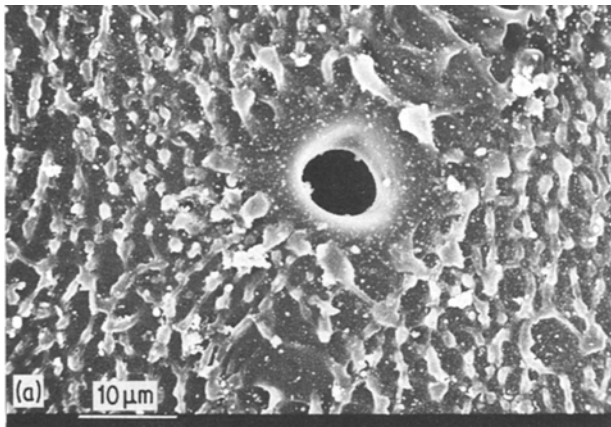
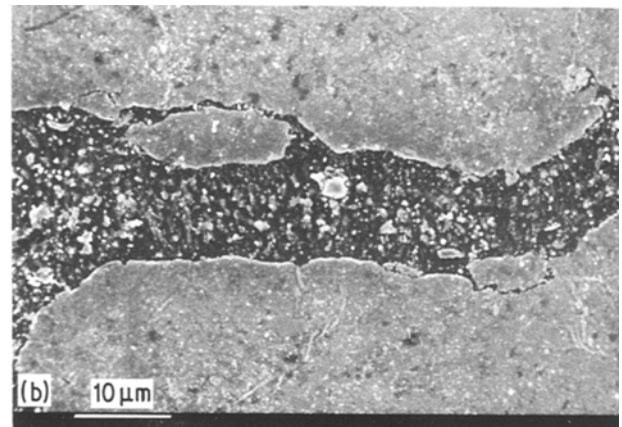
Figure 10 SEM photographs of self-healed breakdowns on polypropylene rolls. (a) With aluminium evaporation ($d = 8 \mu\text{m}$). (b) With zinc evaporation (filament discharge path from Fig. 2a).

If the corroded specimens are investigated with the help of a scanning electron microscope (SEM), holes of self-healed breakdowns can be identified with diameters of $8 \mu\text{m}$ in the case of Fig. 10a. Around these spots there is a clear zone which is succeeded by more

corroded metal. This is a self-healed process [1, 2] in which the breakdown is interrupted by evaporation of the thin aluminium layer. All this leads to an increased amount of corrosion. Fig. 10b shows a discharge path (creepage current path) from Fig. 2a, for a zinc layer without breakdown in a zone of self-healed discharges.

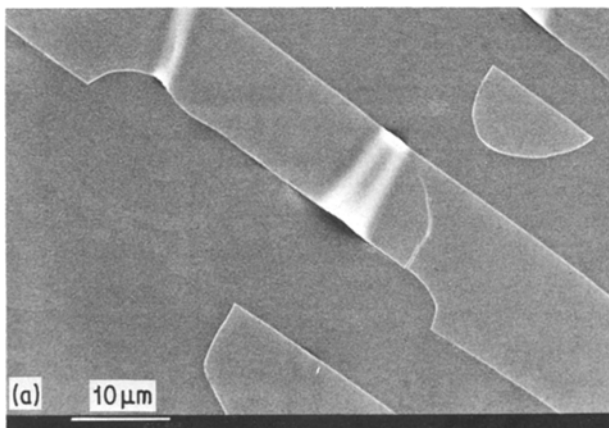
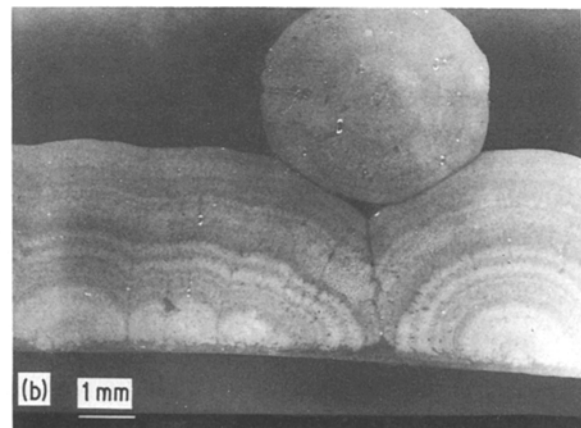
Figure 11 SEM photographs of transparent sites of corrosion on polypropylene rolls. (a) With aluminium evaporation (as Fig. 2b). (b) With zinc evaporation (as Fig. 2c).

(sapphire). During unwinding of the roll this layer ruptures slightly along the edges of the hexagonal crystal and is partly lifted from the substrate. Fig. 11a shows a photograph taken with an SEM of the remaining uniformly aligned parts of the crystal. The transverse stripes are folds which are caused by crystal growth. In the case of zinc layers (Fig. 11b) a completely different structure but also transparency can be recognized.

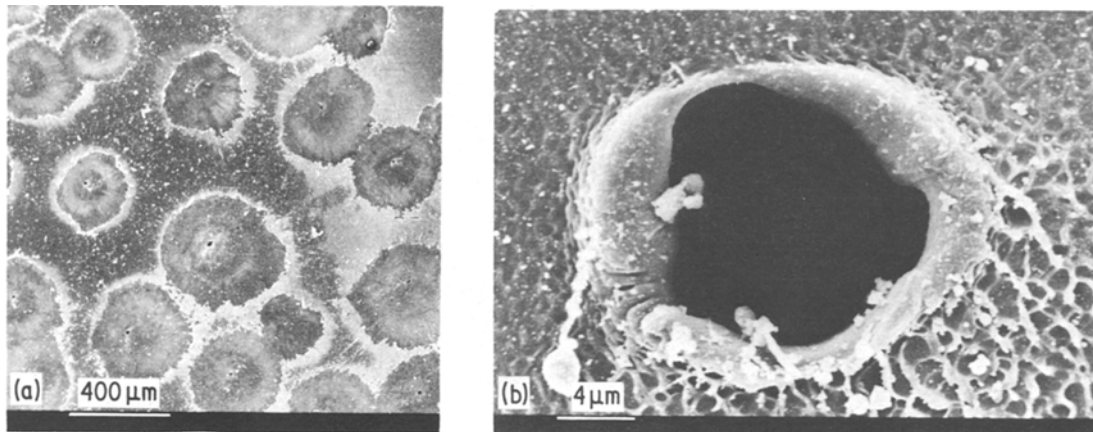
Figure 12 (a) SEM photographs of corrosion on a polycarbonate foil metallized with aluminium and stressed under mechanical pressure (as Fig. 5a). (b) Higher-magnification view of one of the spots of breakdown.

Fig. 12a shows an SEM photograph of the polycarbonate specimen previously depicted in Fig. 5a at lower resolution. Around the points of breakdown, circular insulating zones with diameters ranging from 300 to 500 μm can be recognized. As shown in Fig. 12b the spots of breakdown have diameters of approximately 15 μm with distinct border warpings, for substrates with thicknesses of 12 μm .

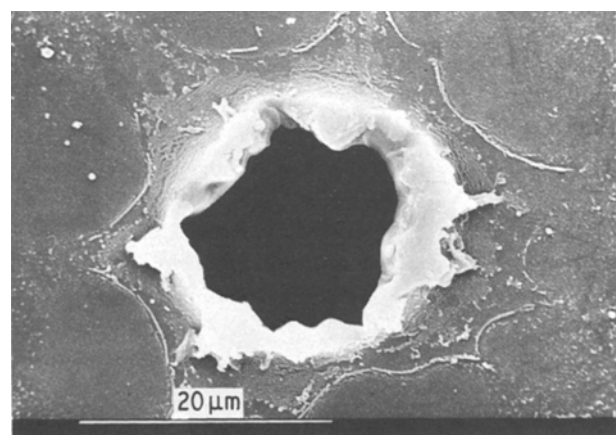
Figure 13 SEM photograph of a self-healed breakdown of a polyimide foil metallized with aluminium for freely suspended arrangement. $d = 12 \mu\text{m}$, $U = 400 \text{ V}$, $t = 4300 \text{ h}$.

The freely suspended specimens coated with aluminium exhibit also self-healed breakdowns (Fig. 13). More significant, however, are the areal-type corrosion processes. On one side of the specimen (e.g. Fig. 14 for a foil of cellulose acetobutyrate), a

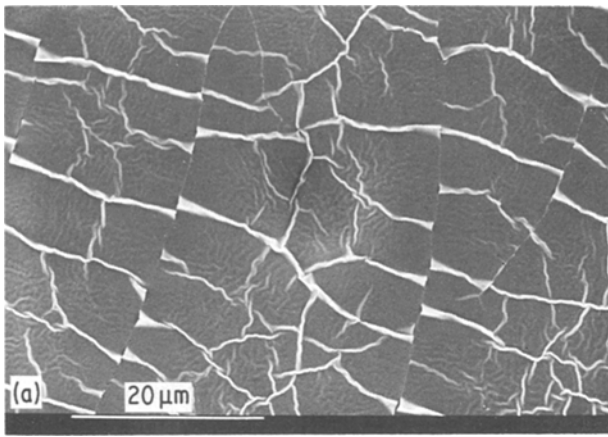
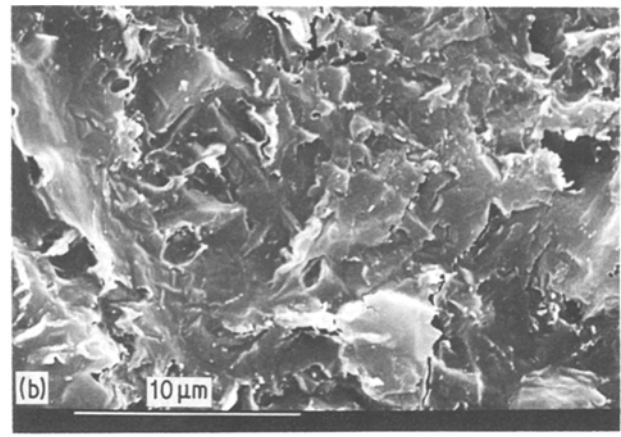
Figure 14 SEM photographs of areal corrosion on a cellulose acetobutyrate foil metallized with aluminium (as Fig. 6a). (a) Smooth side. (b) Mat side.

similarity with the corrosion phenomena of the polypropylene roll of Fig. 11a is often found. On the other side, however, irregular flakes (variably oriented crystallites) can be observed which obviously is connected with crystal formation. Possible reasons are forces of attraction or repulsion between electrostatically charged crystallites, which cause considerable mechanical tensions in the layer and can lead to the strange structure. Further SEM photographs (Figs. 15, 16 and 17) show similar phenomena. Often the large transparent corrosion sites are not structured at all, which may be caused by a monocrystal.

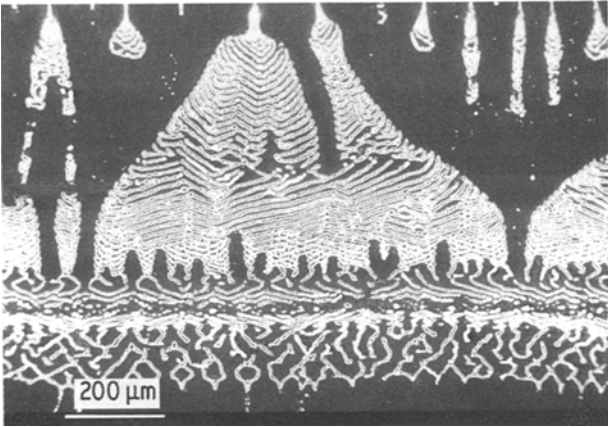
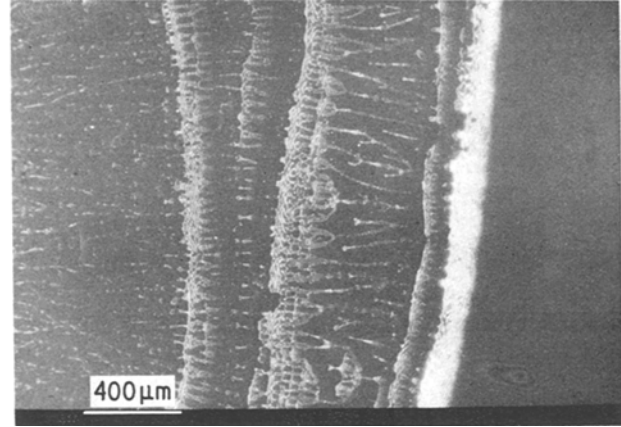
Figure 15 SEM photograph of areal corrosion on a polypropylene foil metallized with aluminium for freely suspended arrangement. $d = 25 \mu\text{m}$, $U = 600 \text{ V}$, $t = 1100 \text{ h}$.

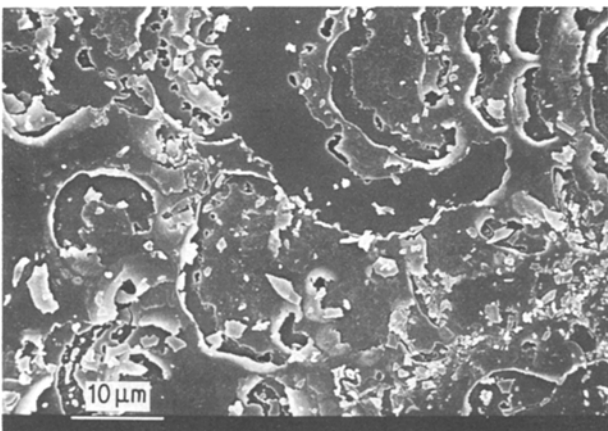
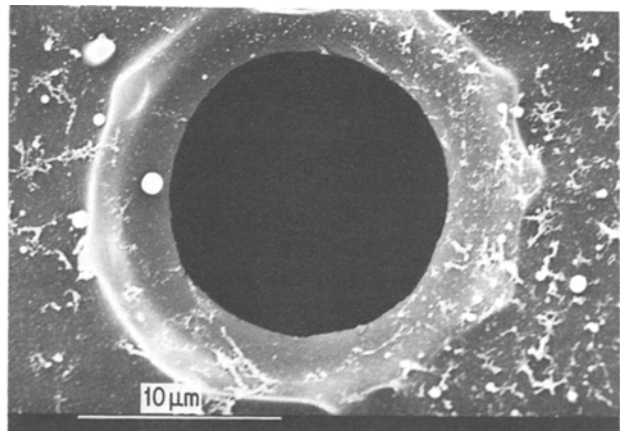
Figure 16 SEM photograph of areal corrosion on a polyethylene terephthalate foil metallized with aluminium for freely suspended arrangement. $d = 12 \mu\text{m}$, $U = 500 \text{ V}$, $t = 300 \text{ h}$.

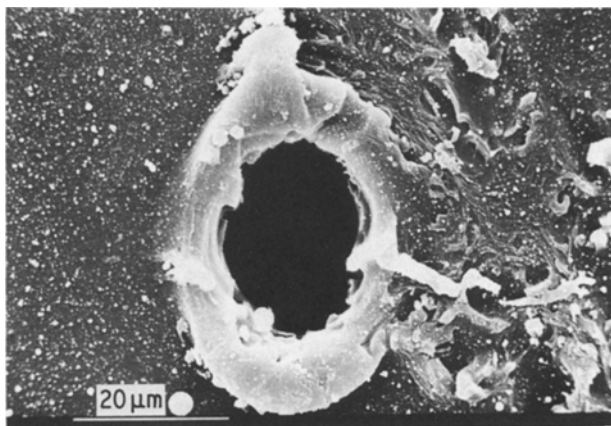
Figure 19 SEM photograph of a self-healed breakdown of a poly-styrene foil metallized with silver for freely suspended arrangement. $d = 12 \mu\text{m}$, $U = 400 \text{ V}$, $t = 1990 \text{ h}$.

Different effects can be expected for nickel and silver. These metals oxidize much slower than aluminium or zinc, so that in the case of a plastic dielectric, corrosion is only determined by an accumulation of self-healing processes. Examples of this kind are shown in Figs. 18 to 21. Sometimes an elongated shape of breakdown hole is noticeable; this is caused by the previous stretching of the foil during the fabrication. There are no areal-type oxidation processes for plastic substrates like in those of Figs. 6 and 7. For gold, corrosion can only occur at weak points of the plastic substrate in the form of self-healing breakdowns (Fig. 22).

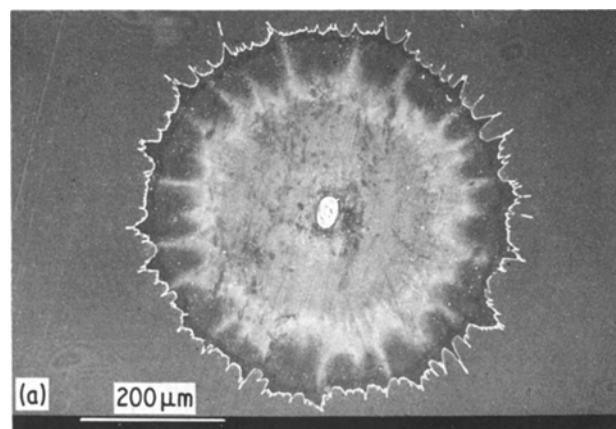
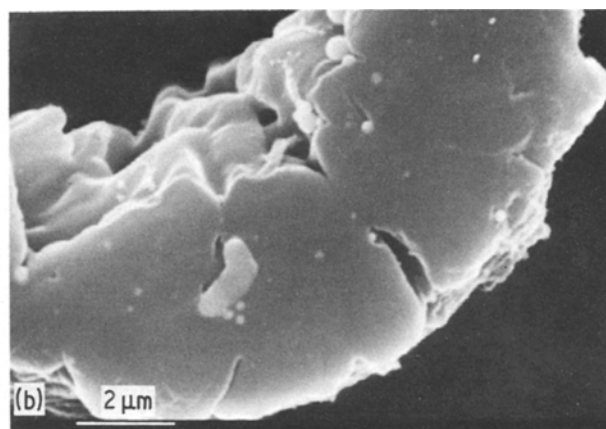
Figure 20 SEM photographs of a self-healed breakdown of a polycarbonate foil metallized with silver for freely suspended arrangement. $d = 12 \mu\text{m}$, $U = 450 \text{ V}$, $t = 45 \text{ h}$. (a) Low and (b) high magnification.

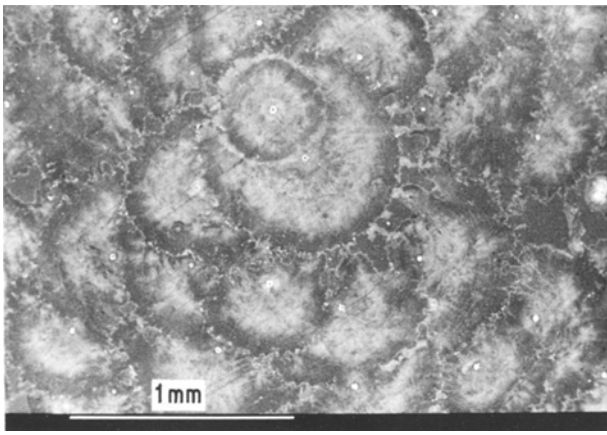
Figure 21 SEM photograph of corrosion on a polyimide foil metallized with silver (as Fig. 8).

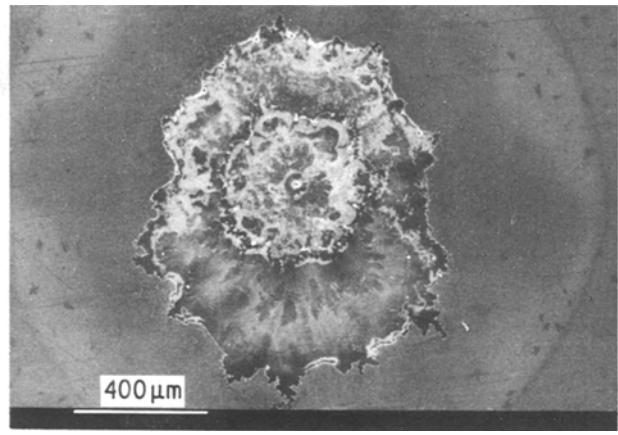
Figure 22 SEM photograph of a self-healed breakdown of a polyimide foil metallized with gold for freely suspended arrangement. $d = 12 \mu\text{m}$, $U = 400 \text{ V}$, $t = 1100 \text{ h}$.

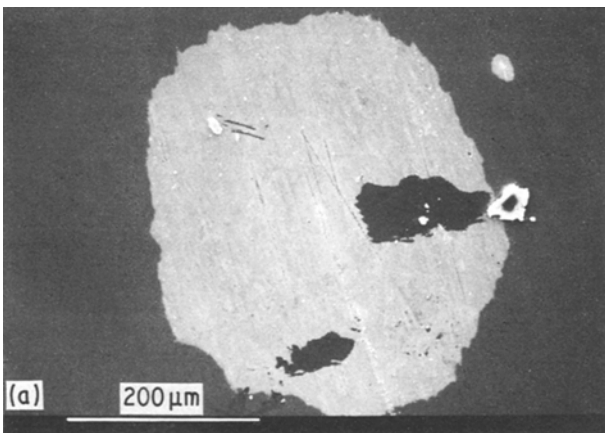
The corrosion of an aluminium coating on a mica sheet is areal, occurs very fast and only rarely shows zones with any structure. For nickel, corrosion is also areal and displays hardly any structure in the SEM. For silver, corrosion on mica occurs in discrete areas (Fig. 23). Naturally, the picture differs from one side of the specimen to the other.

Figure 23 SEM photographs of corrosion on mica metallized with a silver layer (as Fig. 9). (a, b) first side; (c) second side).
