Fractography of unidirectional CFRP composites

L. SHIKHMANter, I. ELDROR, B. CINA

Metallurgy Group, Materials and Process Engineering, Engineering Division, Israel Aircraft Industries Ltd, Ben-Gurion International Airport, Tel Aviv, 70100 Israel

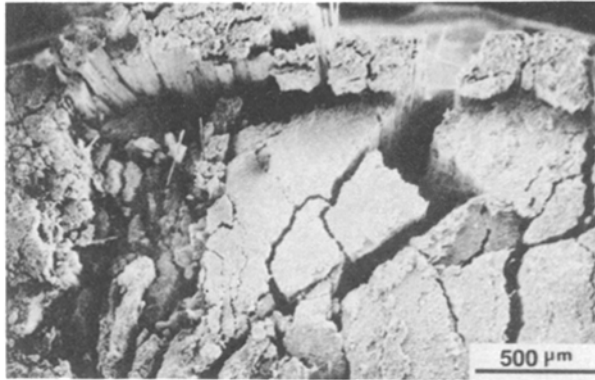
A typical view at low magnification of the surface of a fracture in compression is shown in Fig. 1. The fracture is transverse and is accompanied by extensive longitudinal cracking in the direction of the fibres within, and at the boundaries of the plies. The latter cracks are delaminations. The macroscopic surface of the fracture is stepped. Fig. 2 shows such a step as observed in the SEM. This feature is typical of failure of the fibres by microbuckling, which, as a rule, is the main mode of failure in compression [1, 2].

Figure 1 A typical fracture surface in an axial compression failure.

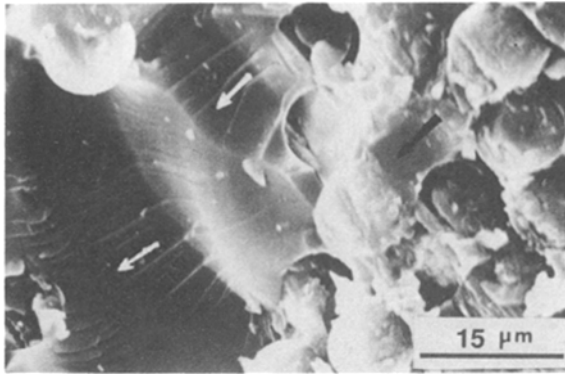
When the fracture passes through a resin-rich area, it produces a relatively smooth fracture surface with flow lines in the direction of propagation of the fracture, resembling the "river" pattern observed in the cleavage fracture of metals, see Fig. 4. Such a surface indicates brittle fracture of the resin matrix.

Figure 4 The compressive fracture of a resin-rich area on the left-hand side of the electron micrograph. The arrows show the direction of crack propagation through the fibres and resin.

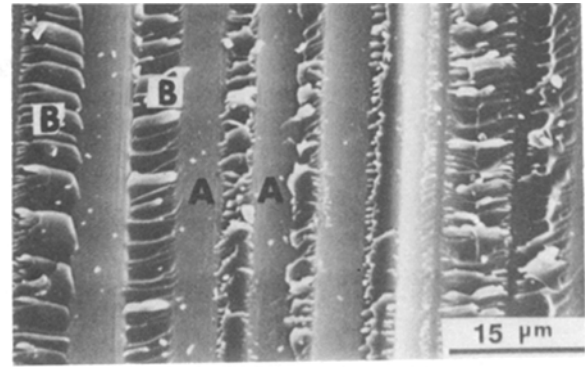
Longitudinal cracks propagate along the fibre-matrix interfaces and along the layers of resin between adjacent fibres. The main features observed on the crack surface are exposed fibre surfaces and broken resin layers between the fibres. The latter exhibit a serrated shear fracture pattern, designated as "hackles" [3, 4], as in Fig. 6.

Figure 6 The surface of a crack in a compression test in the fibre direction. Letters A indicate uncovered fibres and B the hackles.

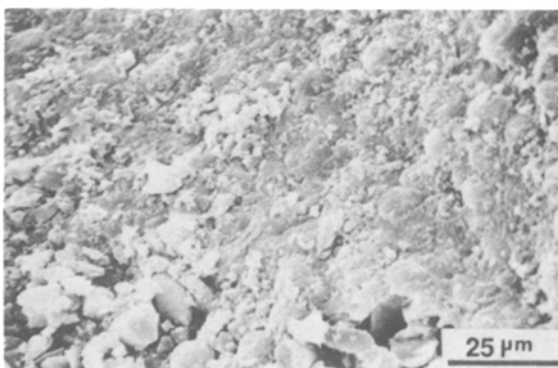
Large areas of such surfaces are covered with debris composed of fibres and resin, such as shown in Fig. 5. Such debris was not removed by conventional ultrasonic cleaning.

Figure 5 Debris on a mutually rubbed compressive fracture surface.

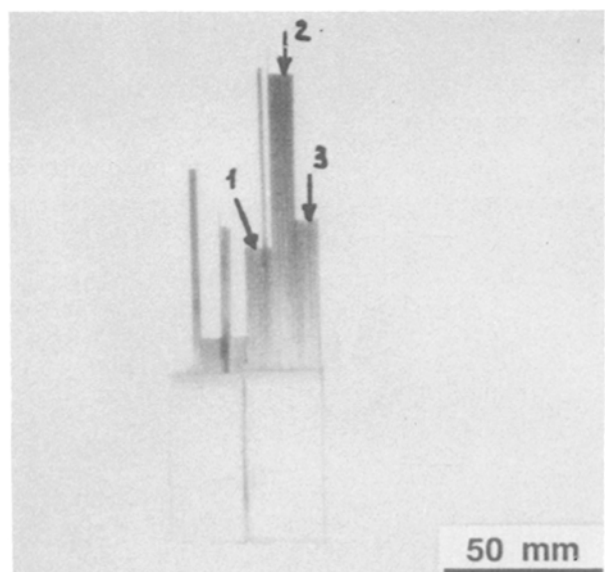
separate segments such as those numbered 1 to 3 in Fig. 7. Such a fracture shape indicates several origins.

Figure 7 Two fractured tensile specimens. The numbers 1 to 3 mark separate segments of the fracture of the right-hand sample.

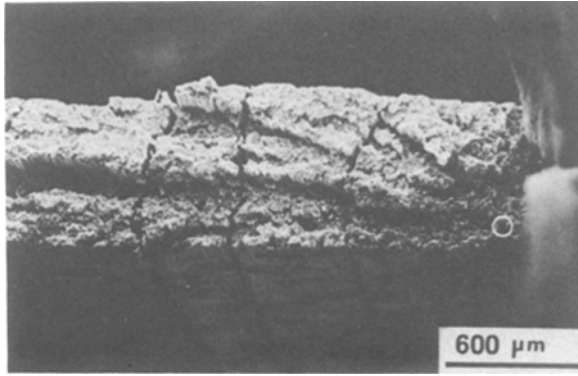
SEM examination of a typical segment reveals radial lines, as in Fig. 8, that emanate from a point on the surface, the crack origin, marked O. The failure clearly occurs by the merging of such surface cracks. According to Purslow [1], such radial lines are a characteristic of brittle fracture.

Figure 8 The segment of the fracture surface marked 2 in Fig. 7. The local crack origin is marked O.

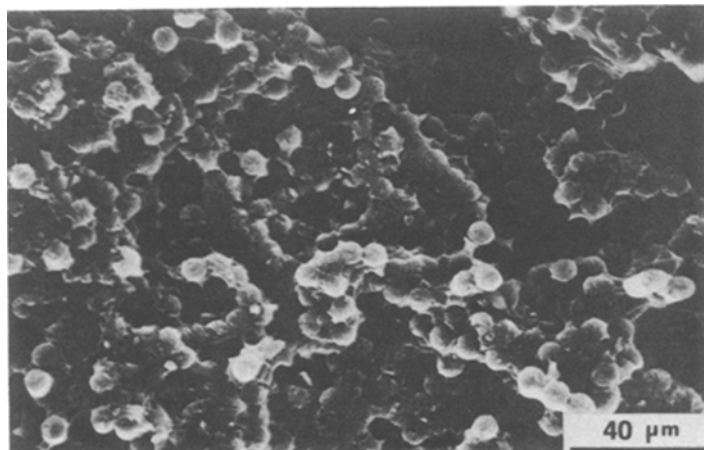
A typical area of the fracture is shown at higher magnification in Fig. 9. It can be seen that the fracture propagates through the fibres in regions of different height. Each region consists of a few dozens of fibres. Closer examination reveals microscopic radial lines on the fracture surface of the individual fibres, as shown in Fig. 10. The centres of these lines are marked by an arrow on each fibre. These lines start from a point on the fibre-matrix interface, indicating the origin of the failure of the individual fibre. This implies that the fibres fail in a sequence, the fracture propagating from Fibre A in the figure to Fibre B, then to C and so on, the direction indicated by the larger arrow. Accordingly the radial lines on the fracture of the individual fibres allow one to locate the fracture origin and follow its direction.

Figure 9 An area of a tensile fracture surface at higher magnification.

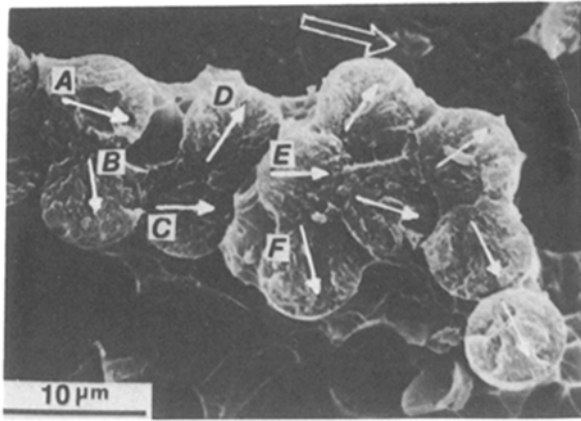
Figure 10 Propagation of a tensile fracture through individual fibres. The large arrow indicates the general direction of propagation of the fracture in the specific area selected.

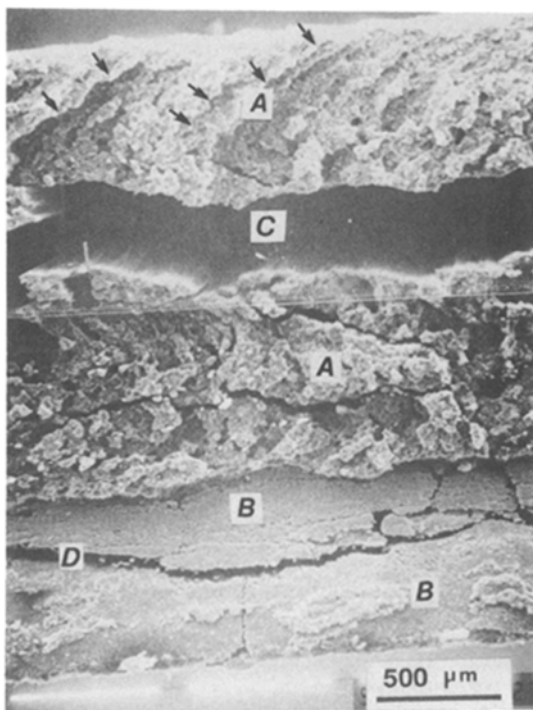
The failure in the three-point bending test occurred at that point in the specimen opposite the central roller. Fig. 11 shows an area of the bend fracture surface. It

will be seen that the transverse fracture surface consists of two morphologically different areas with a distinct boundary between them. A closer examination reveals that the morphologies of these fracture areas are identical to those of axial compressive and tensile fractures as described in Sections 3.1 and 3.2, respectively. In Fig. 11 the letters A and B indicate the tensile compressive fracture areas, respectively.

The fact that the tensile fracture region is considerably larger than the compressive one indicates that the failure started from the tensile surface [1]. The fracture flow lines visible on the tensile fracture area, and arrowed in Fig. 11, indicate that the crack started from the full width of the external tensile surface and propagated into the specimen. The tensile propagation results in an increase of the flexural deformation and of the interlaminar shear stresses, the latter resulting in a large delamination crack, marked C in Fig. 11. After delamination the failure of the specimen is completed by partially tensile and partially compressive fracture of the remaining intact thickness. The new tensile failure initiates at the surface of the delamination and the compressive fracture initiates at the outside surface of the specimen. These two different fracture areas extend over approximately the same thickness of material and the boundary between them is clearly seen in Fig. 11. Some longitudinal cracks, marked D, can also be observed in the compressive fracture area.

Figure 11 An area of the bend fracture surface. The letters A and B mark the tensile and the compressive fracture regions, respectively. The letter C marks a delamination crack in the tensile fracture region and the letter D marks a longitudinal crack in the compressive fracture region. The arrows indicate the fracture flow lines.

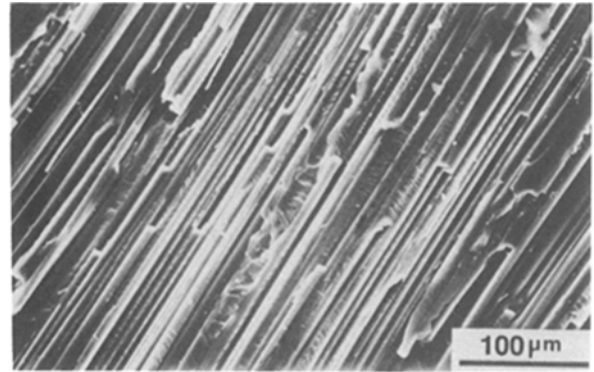
The microscopic morphology of the fracture surface for the two types of failure is very similar. In both cases the failure occurs either at the fibre–matrix interface or in the matrix itself with some additional fracture in the fibres. Accordingly, the following features are observed on the fracture surfaces: (a) exposed fibres free of resin, or imprints of the fibres in the matrix; (b) cleavage of the epoxy matrix; (c) hackles, indicative of shear fracture of the matrix; and (d) some fractured fibres. The fracture surface is similar to those observed by Liechti *et al.* [4]. Fig. 12 shows a fracture surface in transverse tension. The surface consists mostly of fibres free of all matrix. A few fractured fibres are visible.

Figure 12 A fracture surface in transverse tension.

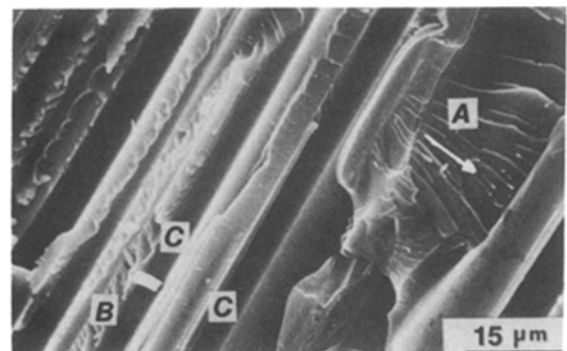
Fig. 13 shows a detail of Fig. 12 at higher magnification. An area of cleavage in the matrix is shown at A. The cleavage is characterized by a relatively smooth fracture surface and shows river markings which indicate the local direction of propagation of the fracture. These river markings are arrowed. The local directions vary from region to region. At magnifications above $\times 5000$ fine flow lines can be seen between these river marks. B in Fig. 13 indicates the hackles formed

by shear fracture of the matrix. The river markings, mentioned above, can be observed only in those regions of failure in the matrix which were wider than the diameter of a fibre, and they are more frequent on the tensile fracture surface. On the compressive failure surface the matrix cleavage regions usually show finely spaced, parallel flow lines. This difference tends to support a hypothesis that the failure in transverse tension originates at several internal sources, while the failure in transverse compression is due to propagation of macrocracks formed perpendicular to the fibre direction and to the loading direction.

Figure 13 A detail of Fig. 12. Letter A indicates a region of matrix cleavage, B of hackles and C of imprints of the fibres in the matrix. The arrow indicates the local direction of cleavage in the matrix.

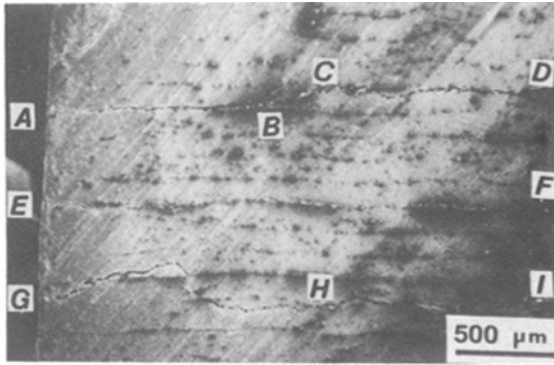
Figure 14 The LT-ST edge of a failed specimen in a short-beam interlaminar shear test. ABCD, EF and GHI indicate the paths of three cracks. LT = long transverse, ST = short transverse directions.

specimen. Usually they tend to develop and propagate between the plies as a delamination crack and sometimes inside a ply. Fig. 14 shows the LT-ST edge of a failed specimen. Three equally spaced cracks are seen on the specimen surface. For the greater part the cracks propagate between the plies, such as crack paths AB, CD, EF and HI. There are also crack paths that do not follow the boundary between the plies but penetrate the plies and propagate there, such as crack paths BC and GH.
