Mechanical sputtering of structural stainless steels

T. NENADOVIĆ*, N. POPOVIĆ*, J. FINE†

**Boris Kidrič Institute of Nuclear Sciences, PO Box 522, 11001 Belgrade, Yugoslavia*

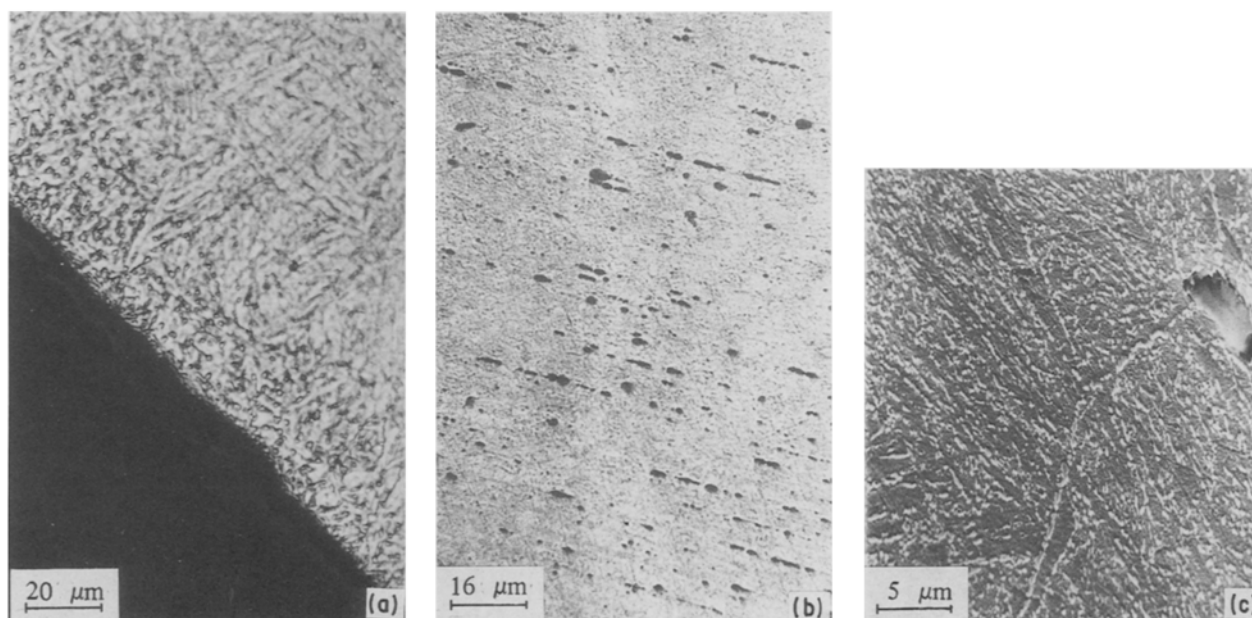
The results of investigating the structural characteristics of blades (longitudinal specimen cut) are shown on micrographs in Figs 1a to c and Figs 2a to c. The material of a new blade is essentially both martensitic crystal structure (Fig. 1) corresponding to wrought heat-resisting steel. Along the edge of the blade (Fig. 1a) and in the middle of it (Fig. 1b) the structure is uniformly distributed. Higher magnification shows the fine substructure of crystals (Fig. 1c). The same investigation of the material of an old blade (Fig. 2) show initial changes on the surface (Fig. 2a) and in some areas of its middle part (Fig. 2b) resulting from working conditions. At higher magnification, fine structure of the material (Fig. 2c) with unaltered austenitic boundaries can be observed.

Figure 1 Optical micrographs and scanning electron micrograph showing martensitic crystal structure of a new steam turbine blade at the top (a) and in the middle of it (b) and (c). Elongated sulphide inclusions in longitudinal section are also visible.

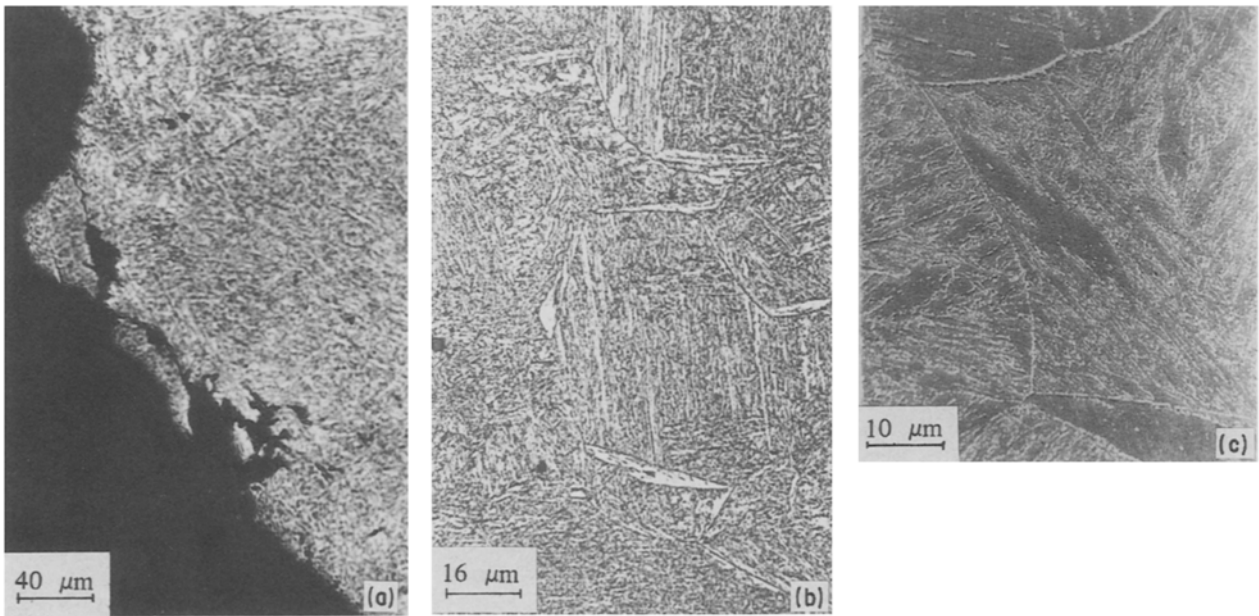
Figure 2 Changes of steam turbine blade (MP) removed from an engine after 52 000 working hours, showing surface degradation (a) and crystal structure (b) and (c) resulting from surface conditions.

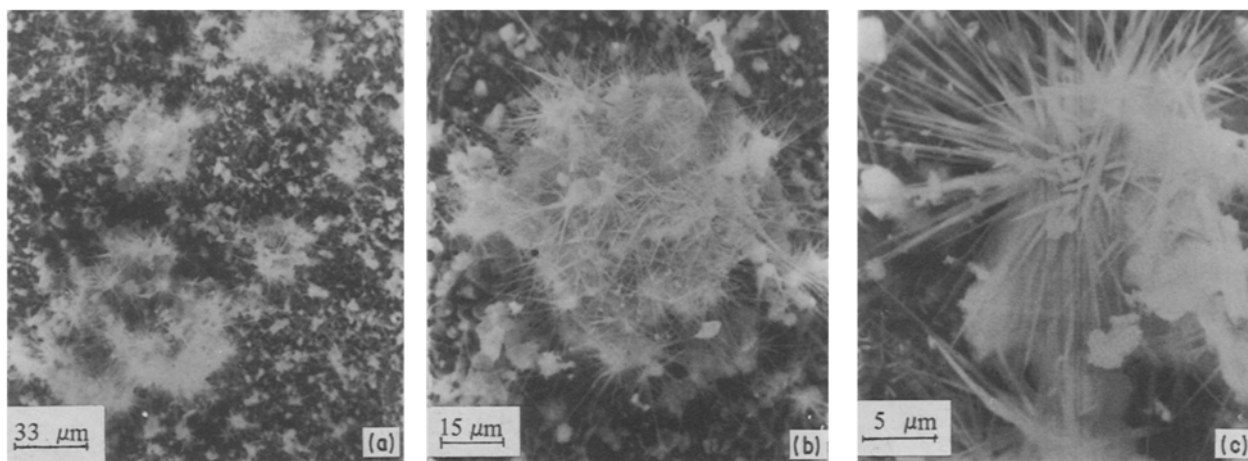
The results of the investigation of deposit properties on new and old steam-turbine rotating blades are shown in Figs 3 and 4. On the new blade Figs 3a to c the localized white and black deposits are structurally and compositionally inhomogeneous. Rounded crystals with spongy structure (Fig. 3a) characterize (or typify) the morphology of the deposit. At higher magnification it is observed that the porousness comes from white needle-shaped crystals, characteristic of the steam-phase deposition (Figs 3b and c). By means of chemical analysis it has been found that the deposit consists of salts (NaCl , Na_2CO_3 and SiO_2) caused by the low quality of steam (improper operating conditions). Other components on the surface of the material are iron oxides (Fe_2O_3 and Fe_3O_4), the major constituent in the black deposits. The distribution of the deposits on the old blade shown in Figs 4a and c is also inhomogeneous. Morphological characteristics of the deposits show spheroidization effects. The concentration of needle-shaped crystals has decreased (Fig. 4a). The distribution of components as well as their thickness is inhomogeneous (Fig. 4b). Qualitative chemical analysis has shown that the basic deposit components are iron, copper and silicon oxides.

Figure 3 Spongy structure of the deposit on the surface of a new turbine blade (a). White deposit consists of needle-shaped crystals formed as a result of condensation of salts dissolved in steam (b) and (c).

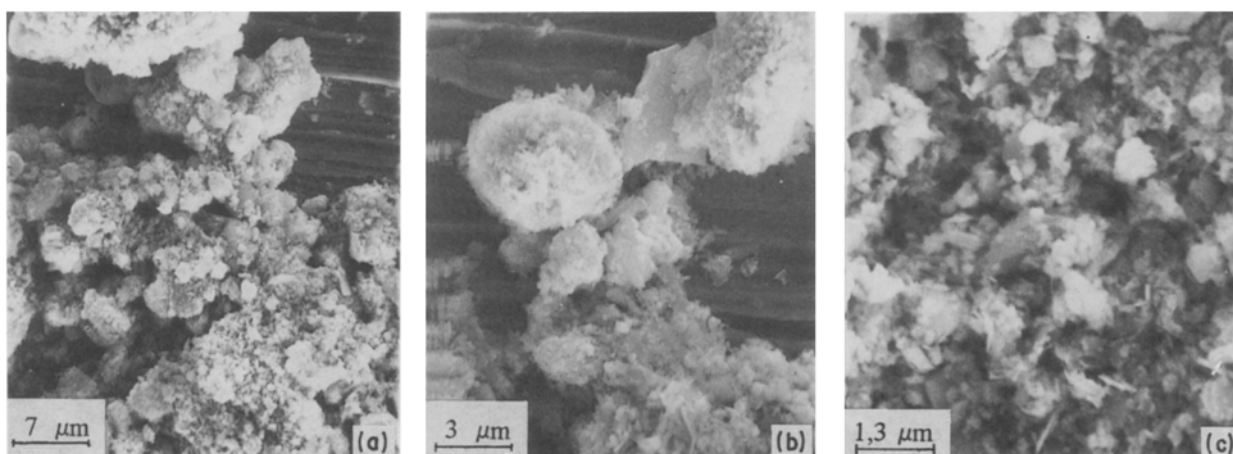
Figure 4 Morphological characteristics of the deposit on the surface of an old rotating blade (12 row). Black deposits area: spheroidization (a) and (b) and non-uniformly distribution of components (b) and (c).

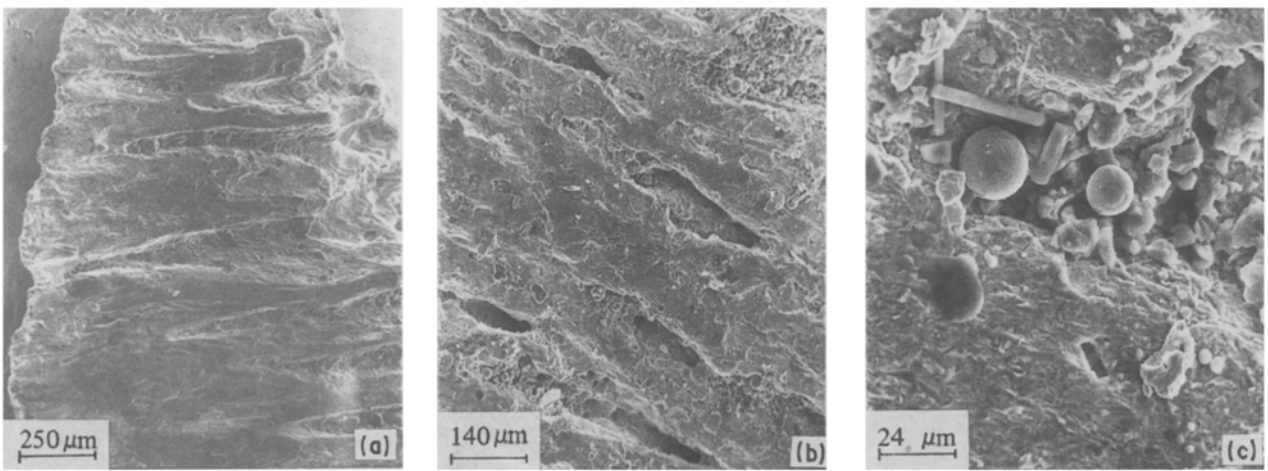
The results of the investigation of erosion on the top of the blade are shown on micrographs in Figs 5a to

c. The top of the blade is severely damaged (Fig. 5a). Morphological changes in the damaged zone have shown that the mechanism of erosion is mechanical sputtering. Its direction is from the bottom of the blade to the top (marked by an arrow). Individual collisions with beam particles occurred at glancing angles (high angle is the normal to the surface) and the energy transferred during interaction is dissipated within the surface area. Depth of damage in this zone is small. In zones not directly bordering on the edge of the blade (2 to 5 mm far from the top), two different mechanisms of damage are observed. In the first closer to the top of the blade, craters are formed during the interaction containing irregular oxide species of high hardness. A beam of very fast oxide particles, in this case, strikes the target (rotating blade) at oblique angles (Fig. 5b). The incident angle of beam particles is about 60° and greater. The particle beam path within the working fluid is short and damage due to individual impacts is clearly visible. The last type of damage in this zone (a large width of the erosion spot) occurred during the interaction with spheroidized fast moisture droplets containing oxygen, salts, and oxide particles (Fig. 5c). The initial damage is liquid-impingement erosion. The cavity shape and area depend on the surface conditions and material properties. On the wall of the cavity are trapped oxides and

Figure 5 Mechanical sputtering on the top of a steam-turbine rotary blade: mechanical sputtering at glancing angle (a), individual impact damage (b) and fast moisture droplets interaction (c).

inclusion particles which can drastically accelerate corrosion-erosion attack.

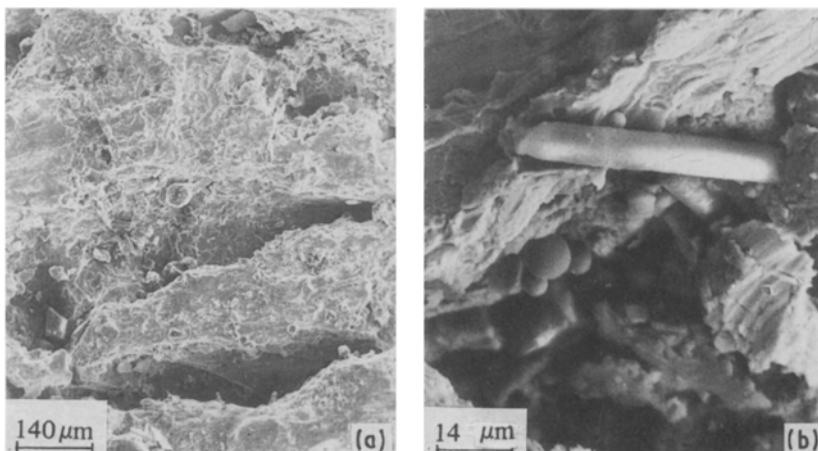
The results of investigation in the zone extending 10 cm below the top of the blade are shown on the micrograph in Figs 6a and b. The type of damage appearing in this zone can be classified into two groups. The first group of damage is caused by fast oxide species (particles) together with the working fluid at low angle (normal) striking the target surface (Fig. 6a). The shape of the individual spots corresponds to the shape of individual irregular and polygonal incoming particles. The penetration depth is greater than at the top of the blade. The second group of damage is liquid-impingement erosion caused by liquid droplet collisions and is related to the chemical composition of the steel and its heat treatment (Fig. 6b).

Figure 6 Scanning electron micrographs of the blade surface in the zone extending about 10 cm from the top. Damage is due to fast individual (irregular and polygonal) oxide particles at low incoming angle (a) and to liquid droplets collisions.

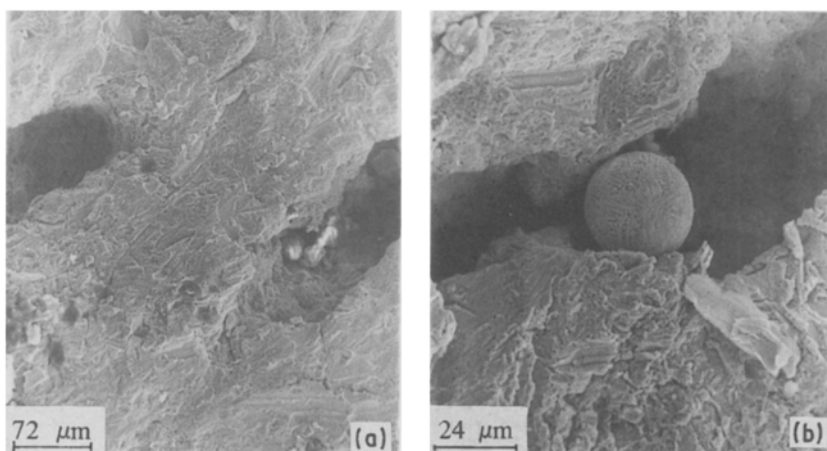
Finally, Figs 7a and b shows damages that took place in the middle of the foil of the blade. The erosion was caused by individual polygonal and spheroidized oxides species going along with overheated steam; it can be observed that oxide particles are of the same order of magnitude at places of corrosion-erosion damages (Fig. 7b). The beam incident angle is not constant but is more at right angles than at oblique angles. The depth of the damages is variable but the impact velocity of incoming particles is always very high. The second group of damage (large area erosion

spot) corresponds as before to droplet collisions and to the electrochemical inhomogeneity of the material.

Figure 7 Scanning electron micrographs taken in the middle on the concave side of steam-turbine blade: spots correspond to the shape of individual polygonal and spheroidized fast incoming particles (a) and captured spheroidized beam particle (b).

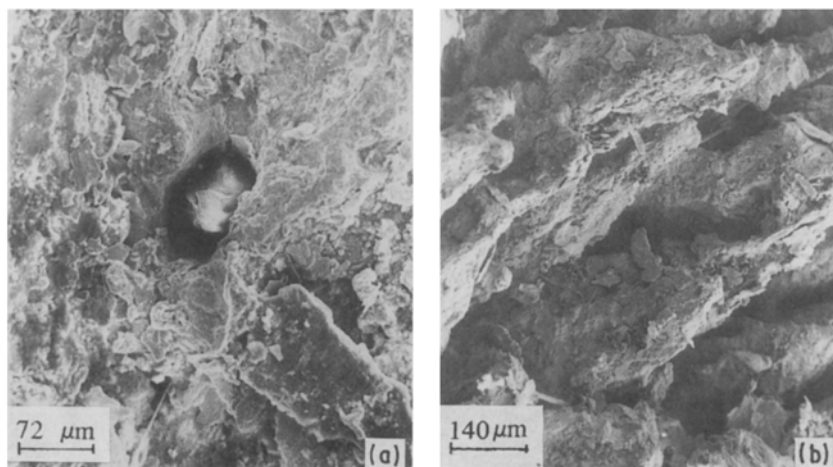
The erosion of the leading edge of a steam-turbine rotating blade is less pronounced than that of the base material, although the transferred energy in this zone is the highest and the incident angle of the particles is primarily at right angles rather than at oblique angles. The types of damage appearing in this case are shown in Figs 8a and b. A part of the treated surface is covered by oxide species deposited from the working fluid. Polygonal oxide grains which have been implanted into the substrate (Fig. 8a) can be observed at some places. On regions from which the protection has been removed, erosion damage is the same as in the base material (Fig. 8b) and consists of individual impact craters and liquid-impingement erosion damage with the capture of incident beam material. The reduction of the effect of the hydrodynamic intensity in this zone is obtained by local hardening of the leading edge which provides this zone with a highly erosion-resistant surface layer. The microhardness measurements confirm this hypothesis.

Figure 8 Surface morphology at the leading edge: implanted polygonal oxide particle (a) and a number of individual impact craters in an unprotected region where the hydrodynamic intensity was very light.

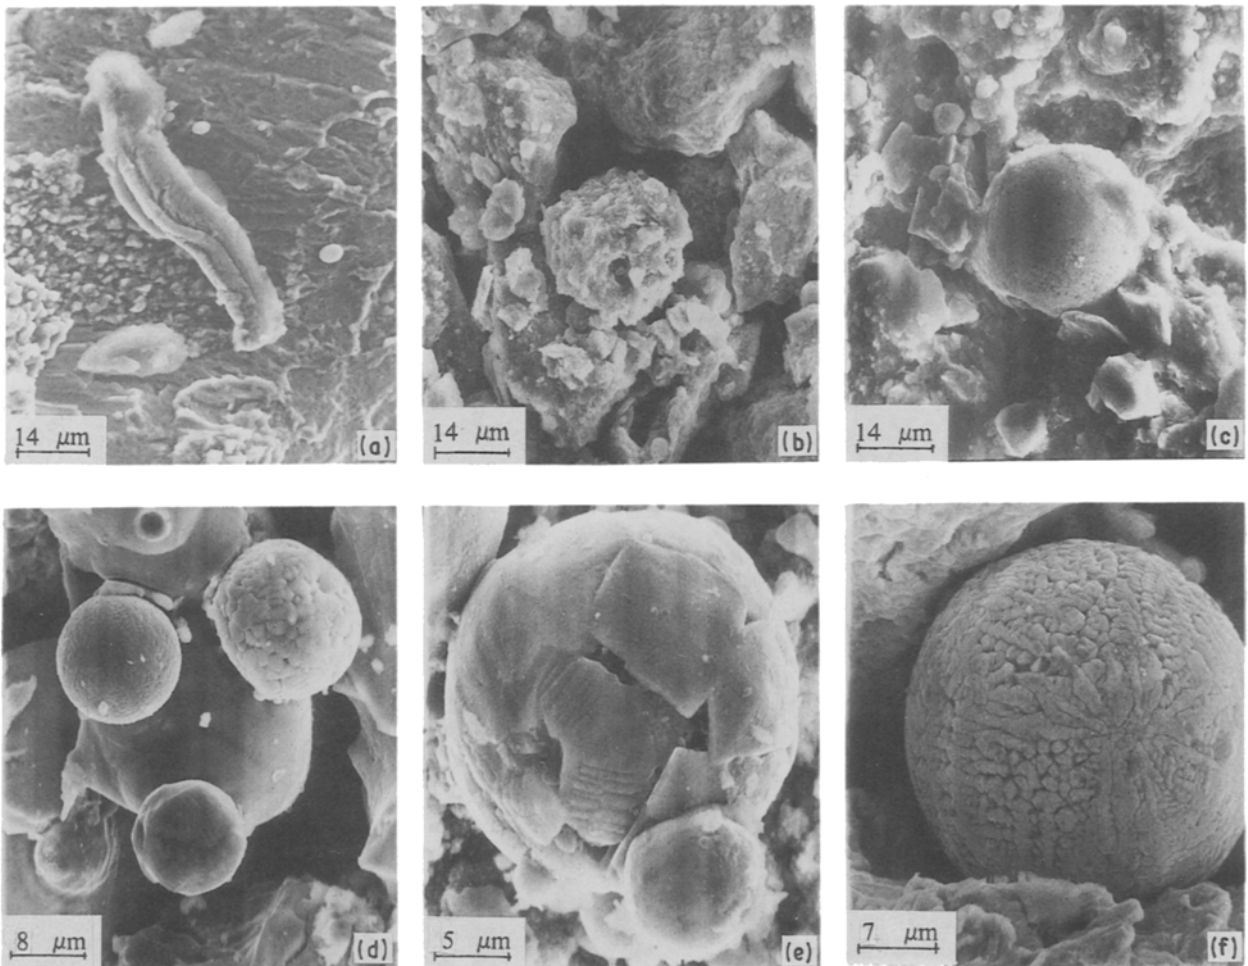
The shape and size changes of 'beam particles' in some rows of medium pressure turbine blades are shown on micrographs in Figs 9a to f. Samples for the investigation have been taken at about 10 cm from the top of the blade. Species removed from the basic material have an irregular shape initially (Fig. 9a). This species is mostly seen in the second row of the medium pressure blades. The total concentration of this species in the row is low. During the interaction with the rotating blades (and other parts) species have been broken due to great brittleness of the

material forming smaller polygonal grains; the shape of the polygonal grains in row 4 is shown in (Fig. 9b), polygonal grains may be combined by further collisions; rounded particles are formed mostly in row 6 of the blade (Fig. 9c). Finally, in row 8, a great number of species are spherical in shape (Fig. 9d). This shape is a result of a rather large number of collisions the 'particle' had on its long path. The observations regarding the last rows are also of interest. There a great number of 'particles' (10 at the investigated sample) with a pronounced interval structure have been found. Spherical eroded 'particles' of this type have been found in rows 11 (Fig. 9e) and 12 (Fig. 9f) of the medium pressure turbine blades. Beginnings of perlite structure (Fig. 9e) point to nucleation under conditions of continual cooling; this structure (Fig. 9f) was formed by separating austenite into ferrite and cementite. The question as to whether conditions for this formation were satisfied during the production of blades (probable), during species separation due to thermomechanical stress, or on its way through the turbine (less probable) remain open.

Figure 9 Changes of a beam particle shape: hard irregular oxide species (a), polygonal species-grains (b), rounded polygonal particles (c), spherical particles (d), pronounced internal structure (e) and perlitic structure of particle (f).
