# *In situ* observation of electrode melting in multilayer ceramic capacitors

H. C. LING, D. D. CHANG

*A T & T Bell Laboratories, Princeton, New Jersey 08540, USA*

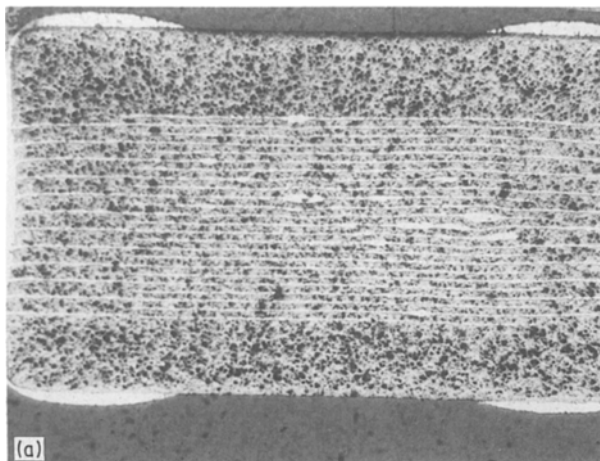
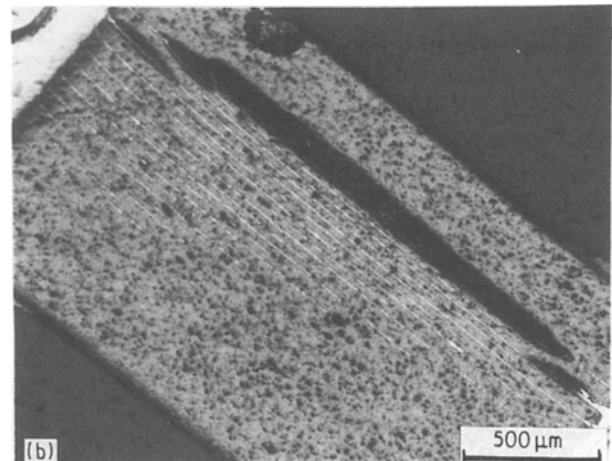
A general observation from this study is that the initial microstructure in the polished plane of the sample did not indicate whether the sample was more prone to surge-test failure. Fig. 2 contrasts two samples from lot  $\gamma$ : (a) shows a normal mlc cross-section, except for several pockets of thick internal electrode, while (b) shows a large delamination near the cover layers. The latter sample also had seen more polishing such that several electrode layers had disappeared completely. Both samples passed the current surge test at the maximum applied current of 1 A.

Figure 2 Cross-sections of two different samples in lot  $\gamma$ .

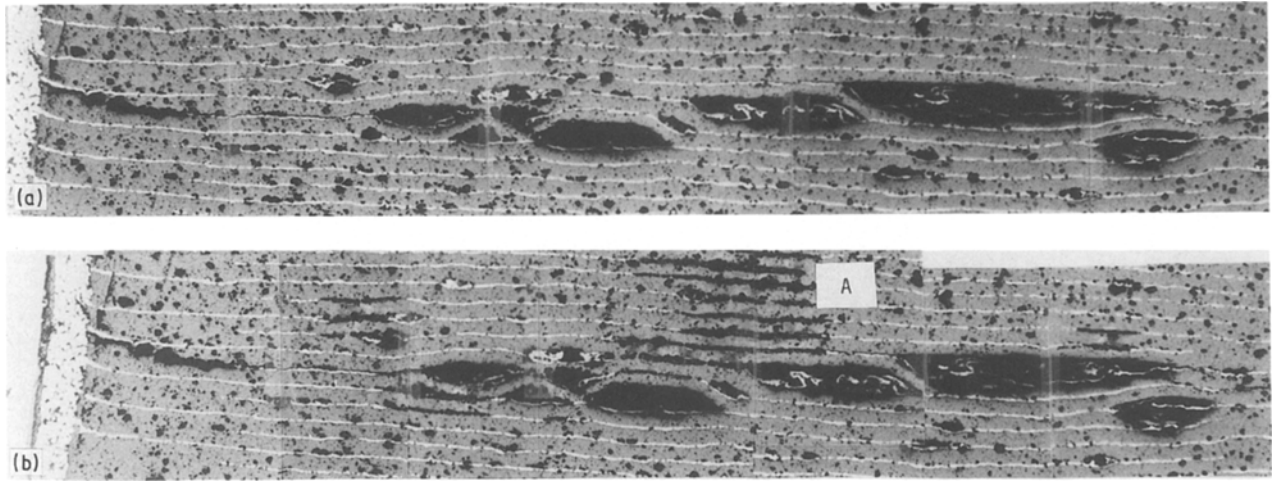
Fig. 3a shows the initial microstructure prior to the surge test. The mlc contained many internal distortions, including large delaminations, distorted and bent electrodes as well as microcracks. Such defects were not observed in the first two samples. After a few shots of current pulses at  $I_{\text{max}} = 40\ \text{mA}$  were applied, we began to notice localized electrode lines turning black in the optical microscope. As more shots at the same current level were delivered to the sample, the darkened electrode lines propagated in length and new regions of darkened electrodes appeared. Fig. 3b shows the microstructure after the test. There were four areas where the electrode lines had turned black. While the darkened lines occurred near the large delaminations, they did not extend to the full length of the delaminations. Furthermore, the largest area (marked A) extended away from the delamination and covered nine electrode layers. It was not clear whether the delaminations in this sample in some way induced the electrode-darkening phenomenon.

Figure 3 Optical micrographs of lot  $\alpha$ , sample 3: (a) before surge test, and (b) after surge test.

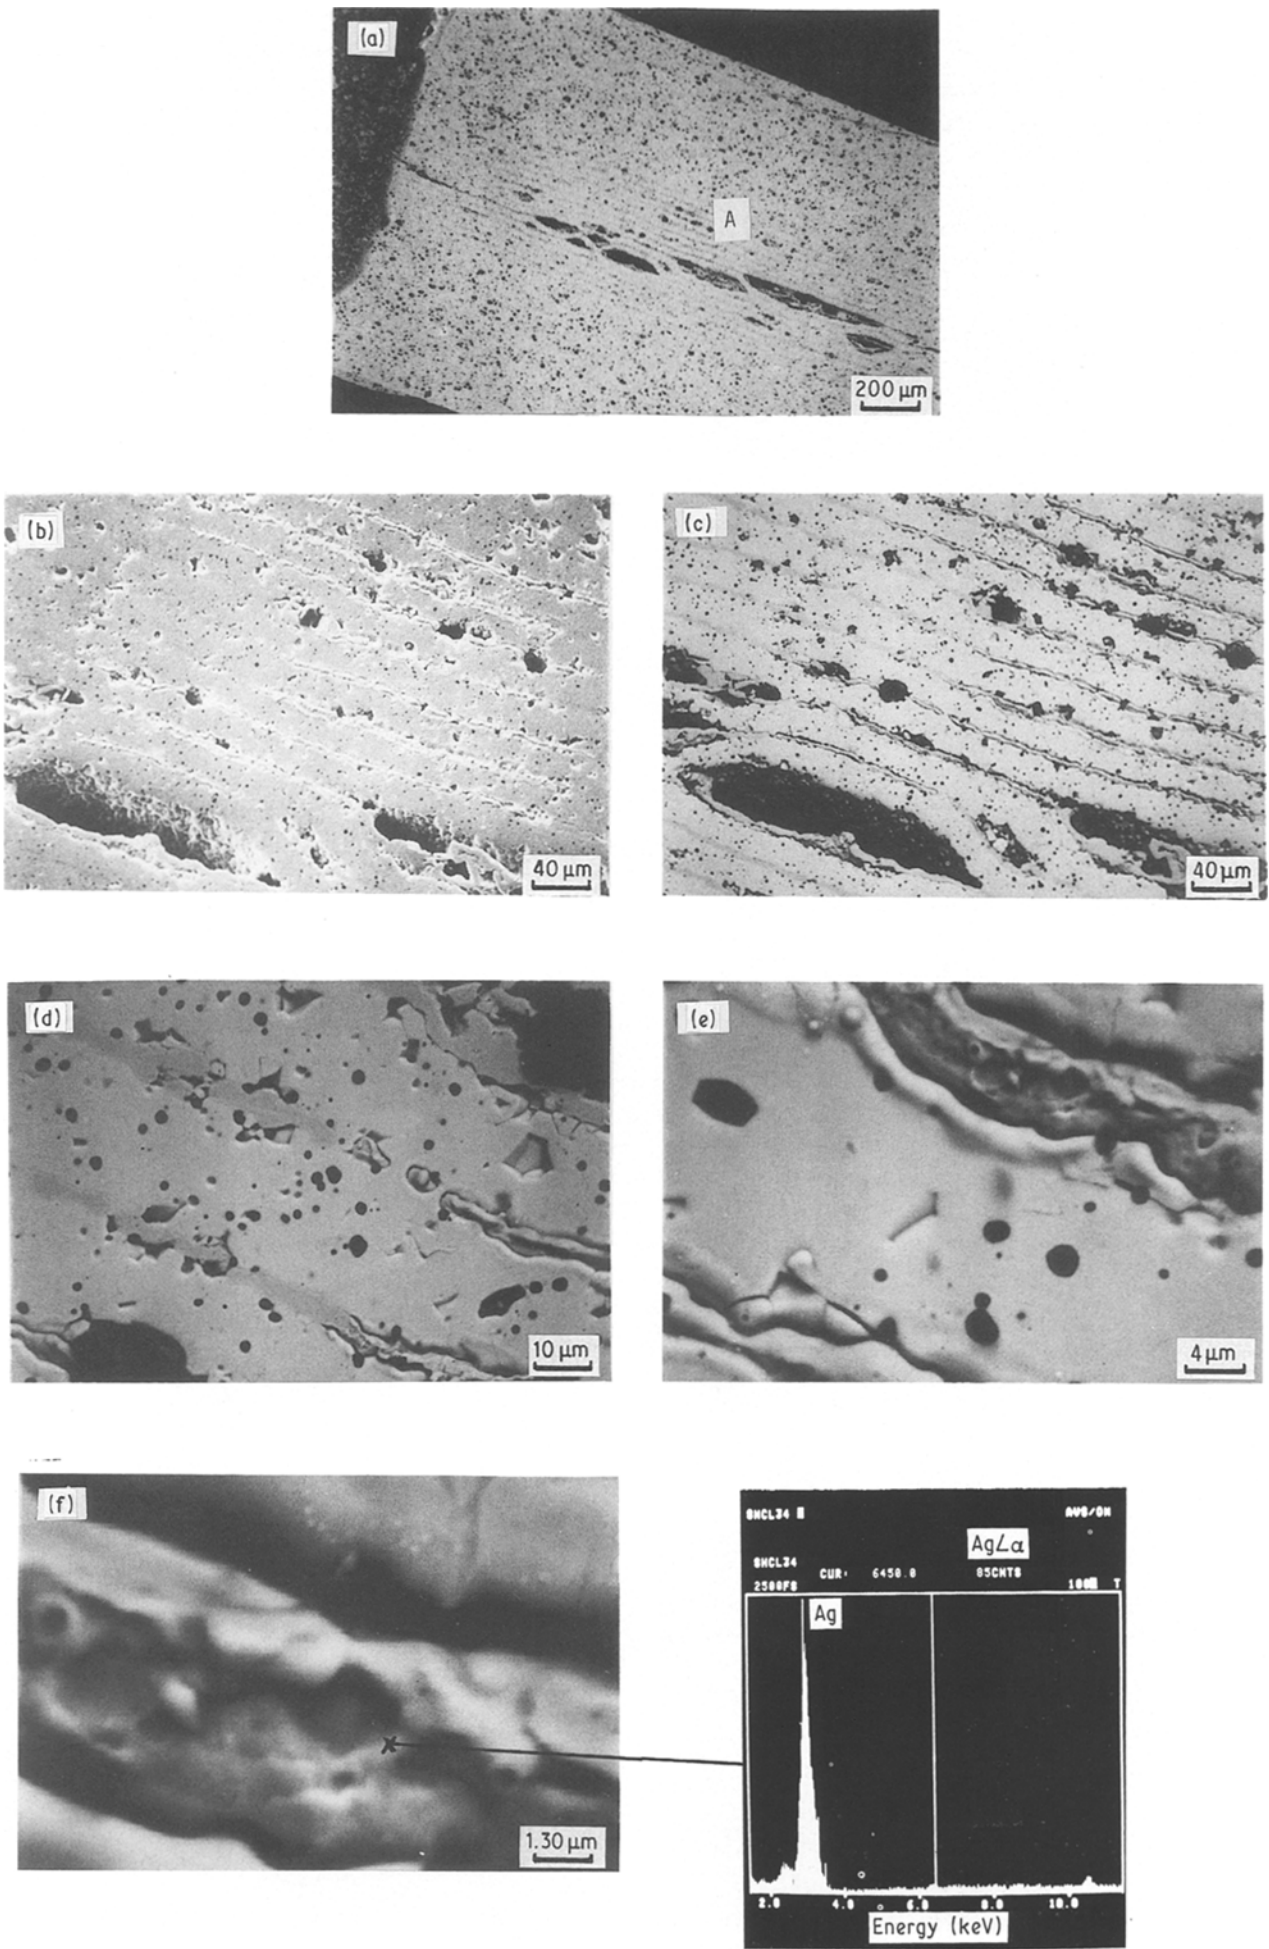
Scanning electron micrographs of this sample are shown in Fig. 4. Both Figs 4a and b were taken in the back-scattered electron mode of the SEM while Figs 4c to f were taken in the secondary electron mode to give a better contrast in the images.

Figs 4b and c focus on the same area, A, previously shown in Fig. 3b. The as-polished electrode lines were flat and smooth while the appearance of the darkened electrode lines indicated that melting and re-solidification of the electrodes had taken place. This region is shown in higher magnifications in Figs 4d to f. Energy dispersive X-ray (EDX) analysis of the electrode area

in Fig. 4f revealed silver (Ag) and palladium (Pd) peaks. No other peak with significant intensity was detected. This suggested that very little, if any, interdiffusion between the ceramic and metal electrode took place during the brief high-temperature event. Oxygen was most likely present together with the metals, because the Ag/Pd were probably oxidized to give the dark appearance in the optical microscope. However, our SEM was not able to detect elements with an atomic number as low as oxygen. In Fig. 4e, the shape of the ceramic bordering the electrode also pointed to a melting and re-forming of the ceramic in that area.

Figure 4 Scanning electron micrographs of the sample in Fig. 3b showing melted and re-solidified electrodes.

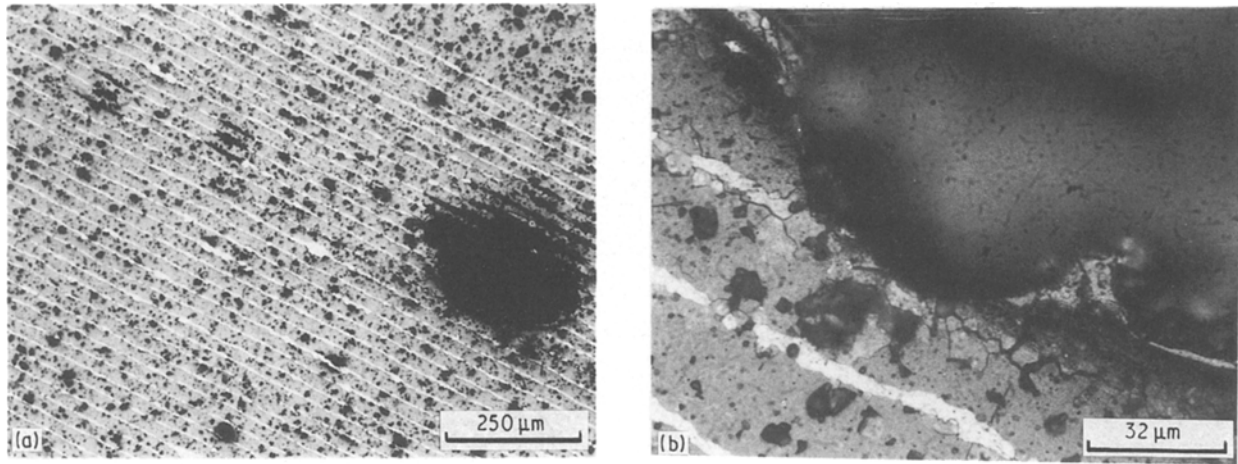
Two samples were subjected to current pulses increasing up to 500 mA without any observable damage optically or electrically. For the next two samples,  $I_{\max}$  was further increased to 1 A. Both failed and charred at that current level. For the fifth sample, small regions of darkened electrodes appeared when  $I_{\max}$  was increased to 500 mA. Simultaneously, a bluish flash was observed in the optical microscope whereby a dark void covering eight electrode layers were formed. These features are shown in Fig. 5a. A higher magnification of the void border (Fig. 5b) shows some large cracks induced by the void formation. The capacitor also became electrically shorted.

Figure 5 Optical micrographs of lot  $\beta$ , sample 5, after surge test showing (a) a large void and several regions of darkened electrodes, and (b) cracks near the void.

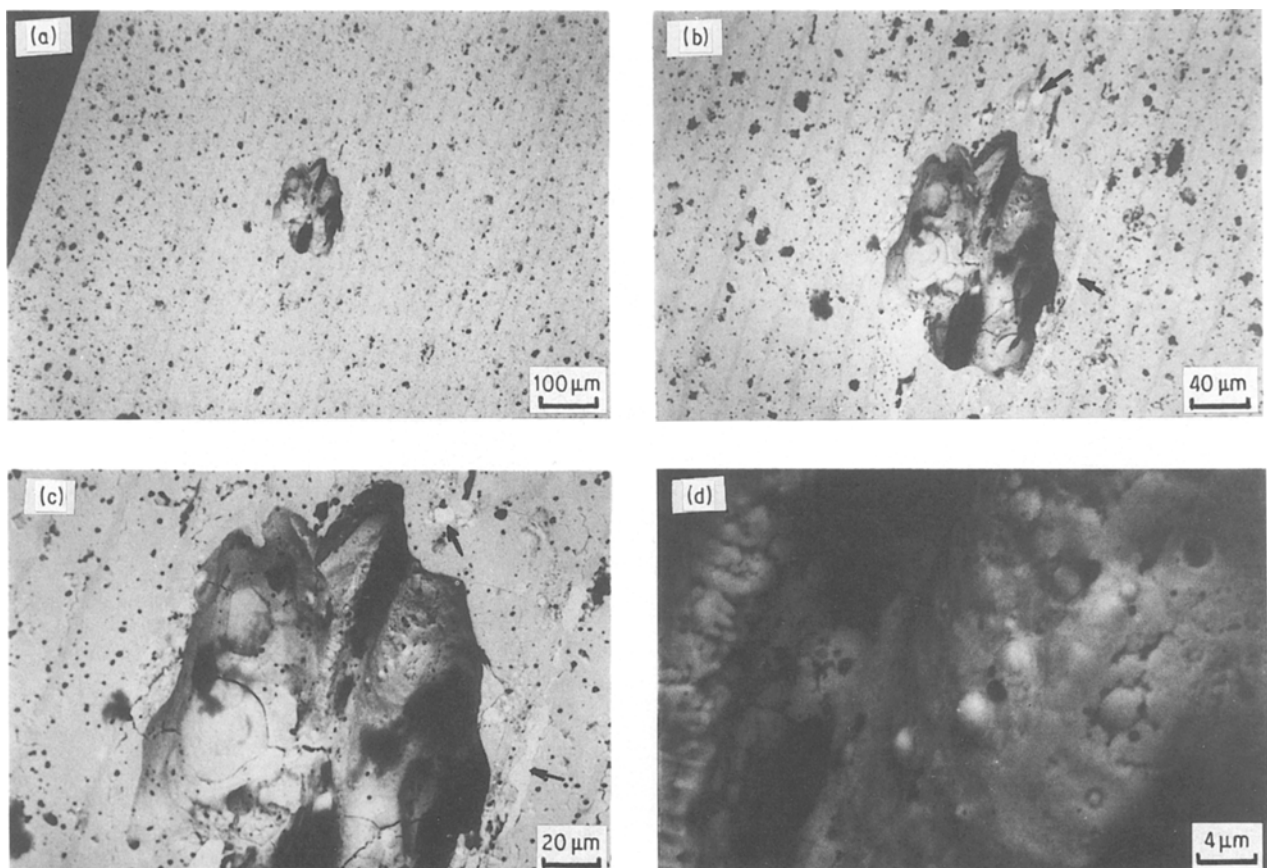
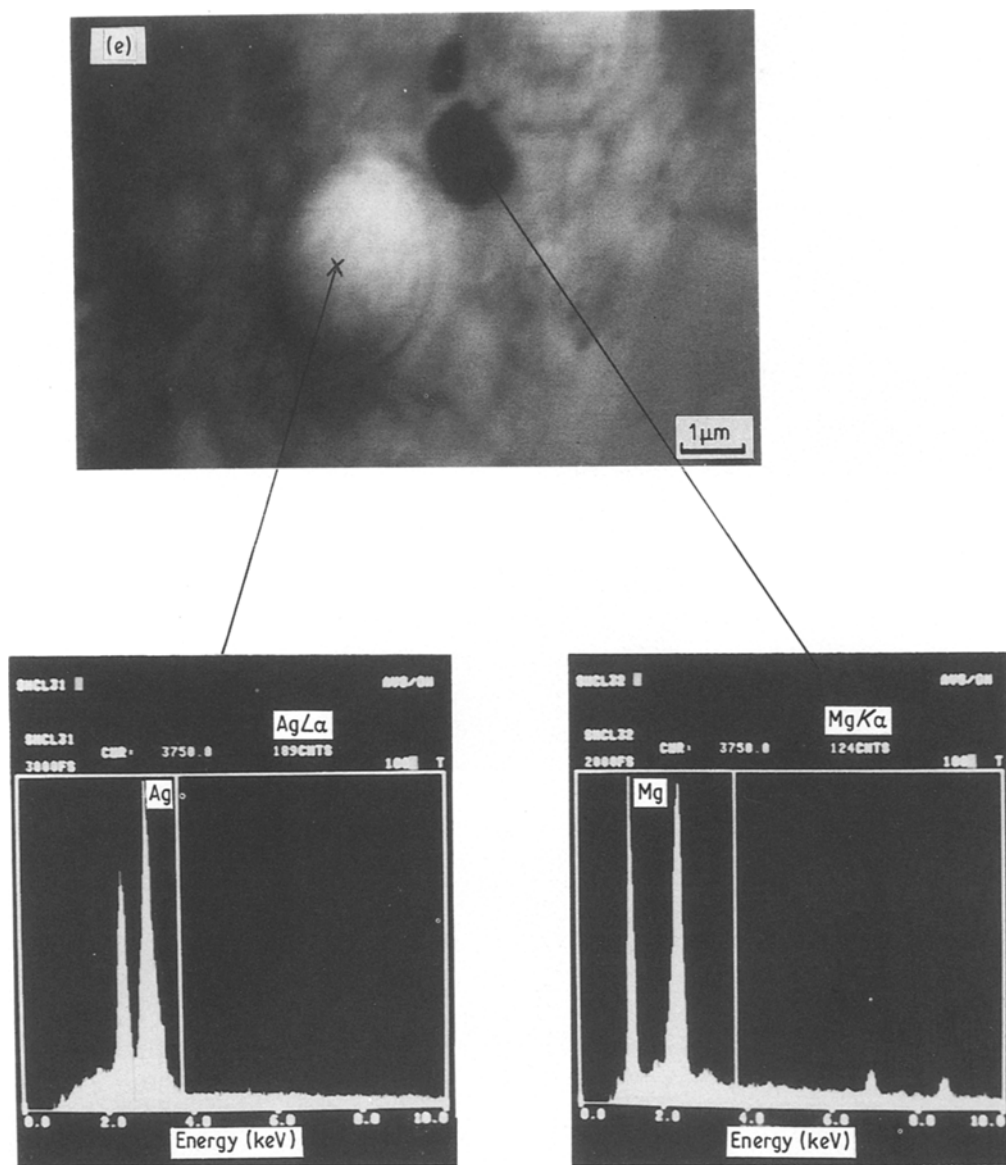
in the SEM. Figs 6a to e show increasingly higher magnifications of the void area. The slightly whitish areas bordering the void (marked by arrows in Figs 6b and c) indicated melted and re-solidified electrodes. On the inner wall of the void, we found hemispherical particles which were identified by EDX to be droplets of Ag/Pd (Fig. 6e). In this sample, we unambiguously observed electrode melting due to the current-surge test, which eventually led to a minor blow-out in the capacitor.

Figure 6 Scanning electron micrographs of the void in Fig. 5, showing (a) the void, (b) melted electrodes, (c) cracks, (d) hemispherical droplets of Ag/Pd and (e) a hemispherical particle of Ag/Pd and magnesium-rich inclusions together with the EDX analysis.

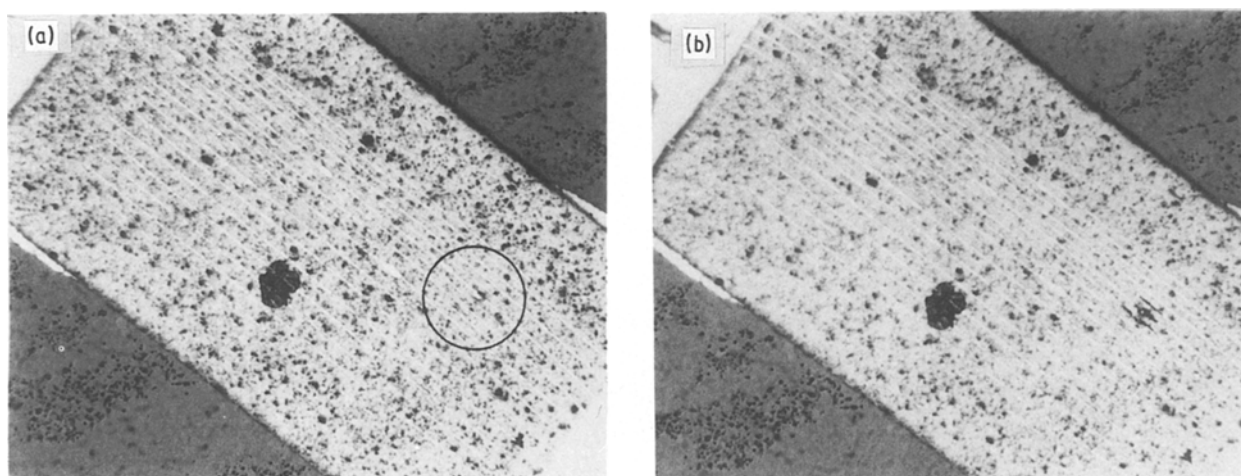
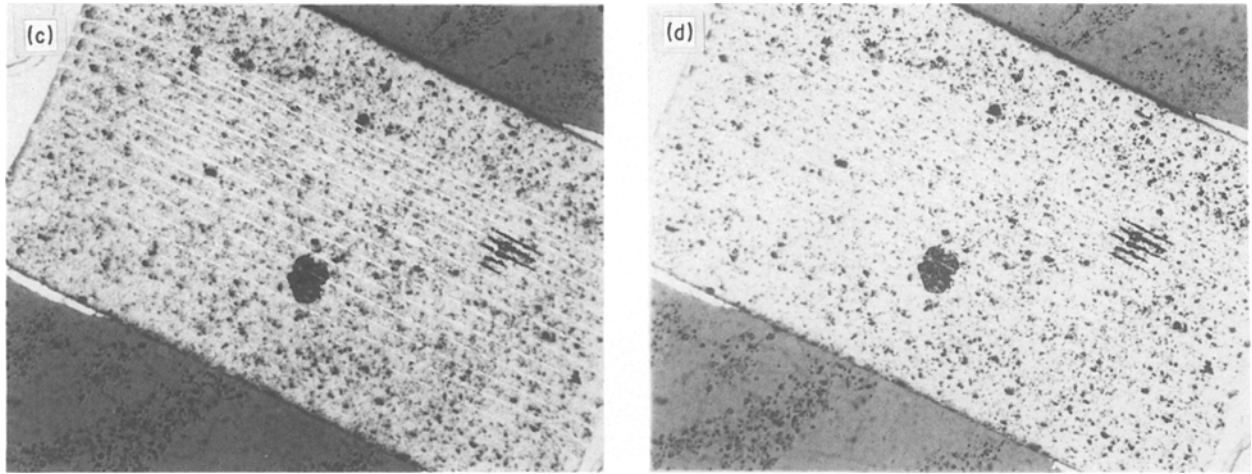
In two out of the three samples we examined in this lot, we did not detect surge-test failure up to  $I_{\max} = 1$  A. On sample 3, an  $I_{\max}$  of 40 mA caused the appearance of three darkened electrode lines (Fig. 7b) in an area where none was observed initially (Fig. 7a). As more shots of 40 mA were delivered to the sample, the dark lines grew in length and two additional neighbouring lines were affected (Figs 7c and d). The capacitor still maintained good DF and insulation resistance (IR) values.

Figure 7 Optical micrographs of lot  $\gamma$ , sample 3: (a) before surge test, (b) after one shot of 40 mA current, (c) after further shots of 40 mA current, and (d) after additional shots of 40 mA current.

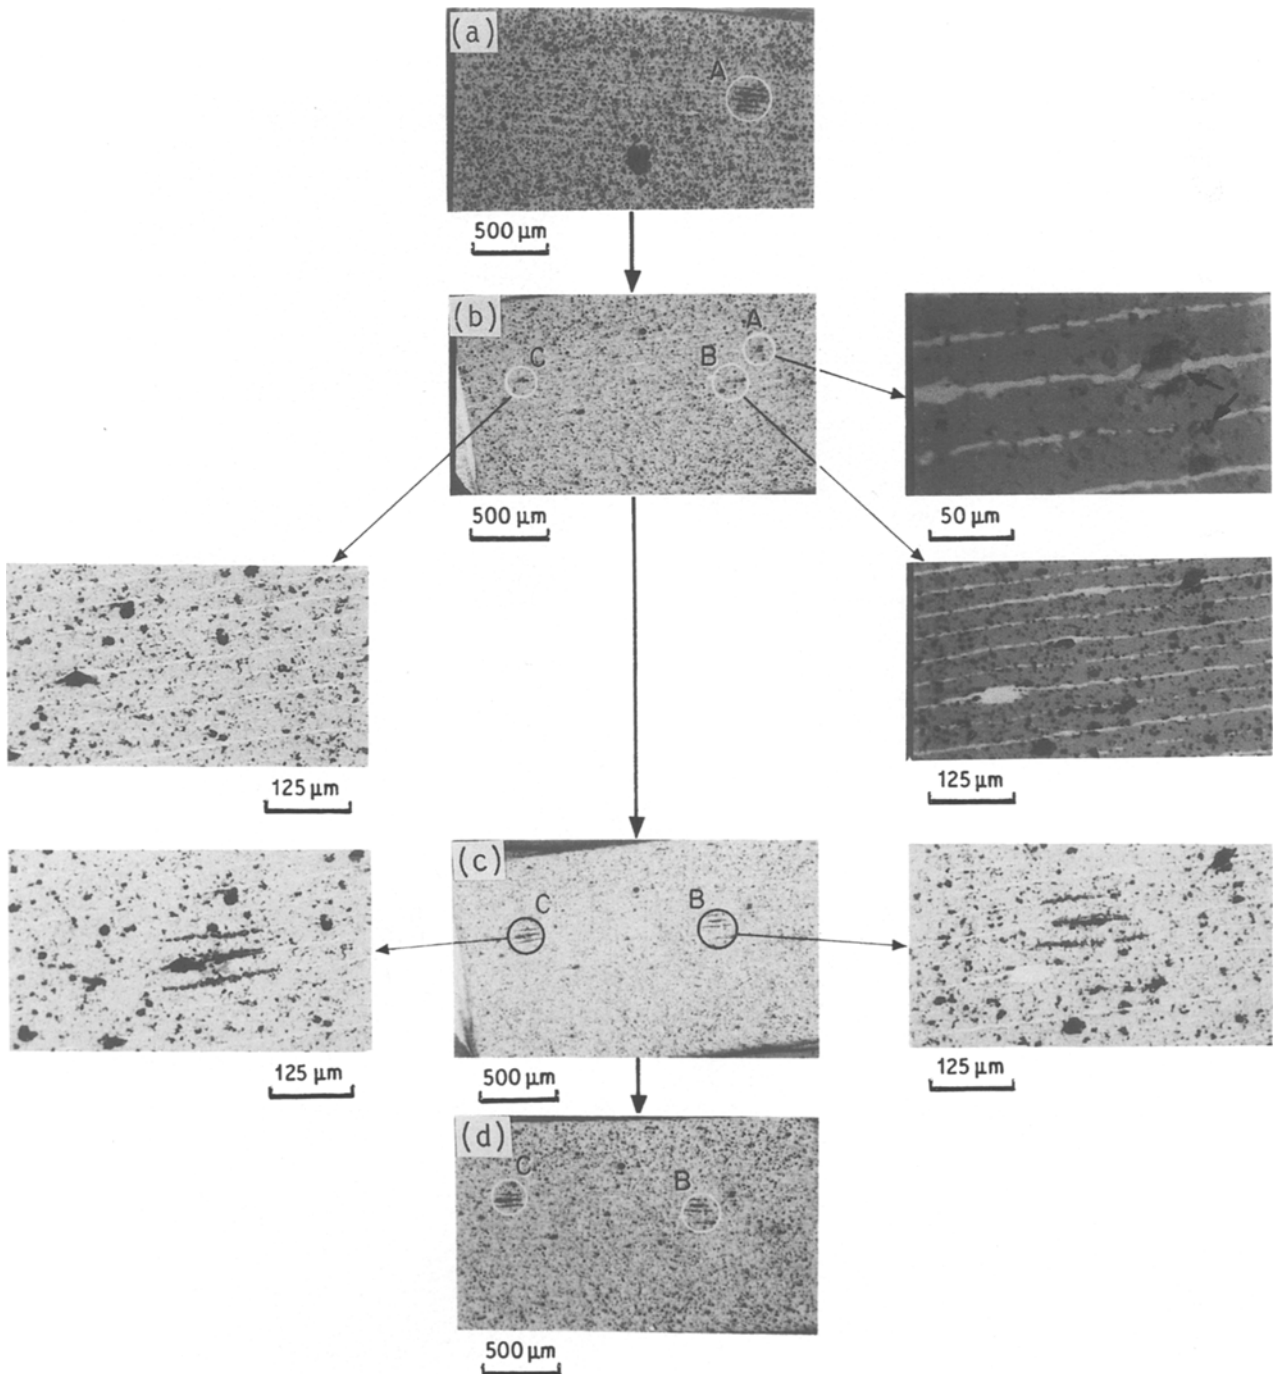
We decided to re-polish the sample to determine the extent of damage. Fig. 8a shows area A before re-polishing. After removing about 0.001 in. (25  $\mu\text{m}$ ) of the surface, an expanded view of area A is shown in Fig. 8b. The damaged electrode layers were mostly removed except for a deep hole and a small stretch of

melted electrode (marked by an arrow). However, two additional areas, B and C, were found to contain some damage not seen prior to the re-polishing. The capacitor still maintained its initial values of capacitance of  $0.0784 \mu\text{F}$ , a DF of 1.36% and an IR of  $2.5 \times 10^{10} \Omega$ .

When one more shot of 40 mA was applied to the re-polished sample, darkened electrodes appeared in areas B and C (Fig. 8c). The surrounding ceramic also showed bluish coloured burnt mark, as indicated in Fig. 9. The capacitance increased to  $0.0837 \mu\text{F}$ , DF to 1.75% while the IR decreased to  $1.7 \times 10^9 \Omega$ .

Subsequently, another six shots of 40 mA and six shots of 125 mA current pulses were delivered to the sample with no further visual changes. The properties remained the same, with a capacitance of  $0.0839 \mu\text{F}$ , a DF of 1.70% and an IR of  $2.5 \times 10^9 \Omega$ . After the sample was left overnight, both the capacitance ( $0.0796 \mu\text{F}$ ) and the DF (1.28%) returned to the initial values prior to testing, but the IR remained at the degraded value of  $1.5 \times 10^9 \Omega$ . Thus the temporary change in capacitance and DF appears to have been caused by the heat generated during the surge test, but the degradation in IR is permanent. When the IR

Figure 8 Optical micrographs of lot  $\gamma$ , sample 3: (a) after the test described in Fig. 7, (b) re-polished to remove 0.001 in. (25  $\mu\text{m}$ ) from the surface, (c) after one more shot of 40 mA current, and (d) after six shots of 40 mA and six shots of 125 mA current.

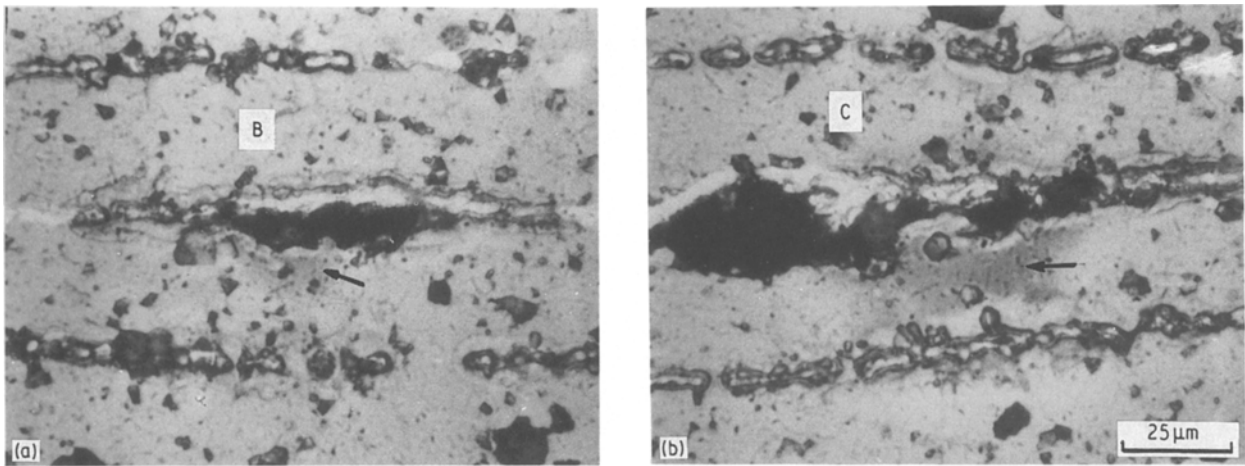
Figure 9 Higher magnifications of areas B and C in Fig. 8d to show the burnt marks in the ceramic.

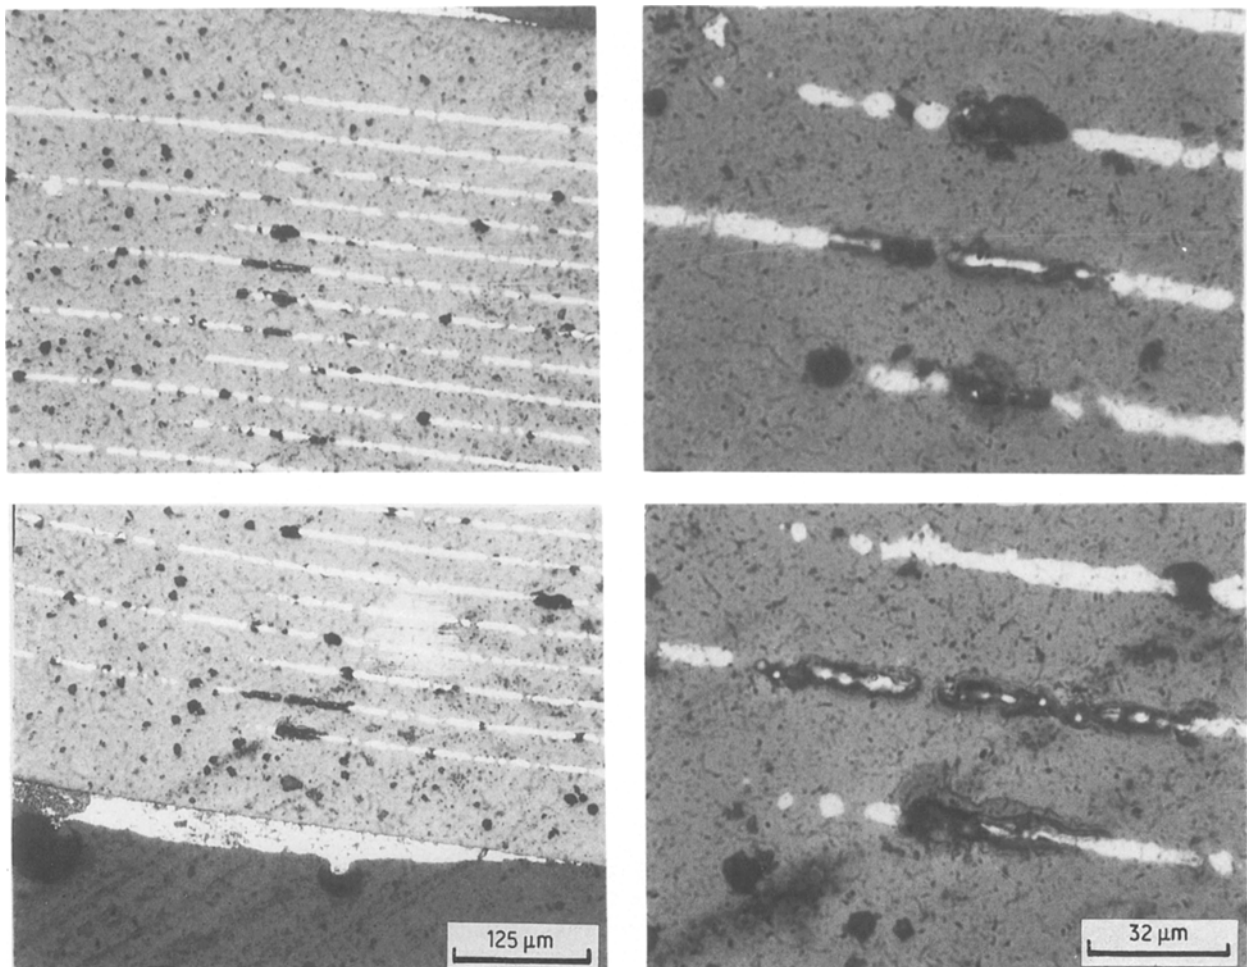
In this lot, one out of three samples tested suffered damage as a result of the current-surge test. After polishing, the sample had a capacitance of  $0.0633 \mu\text{F}$ , a DF of 0.93% and an IR of  $1.7 \times 10^{10} \Omega$ . After five shots of 40 mA current, two separate areas of darkened electrodes were observed, with some burnt

marks in the neighbouring ceramic. This is shown in Fig. 10. As in the case of lot  $\gamma$ , the capacitance increased to  $0.070 \mu\text{F}$ , DF to 2.06% while the IR dropped to  $1.7 \times 10^9 \Omega$ . After waiting for 24 h, both the capacitance and the DF were restored to the initial values, but the IR degradation remained.

Figure 10 Optical micrographs of capacitor from lot  $\delta$  after surge test, showing two areas of darkened electrodes.
