Stress corrosion cracking of pyrotherm reformer tube for steam-reforming hydrogen production

T. C. CHOU, W. HUANG, R. PACIEJ

BOC Group Technical Centre, 100 Mountain Ave., Murray Hill, NJ 07974 USA

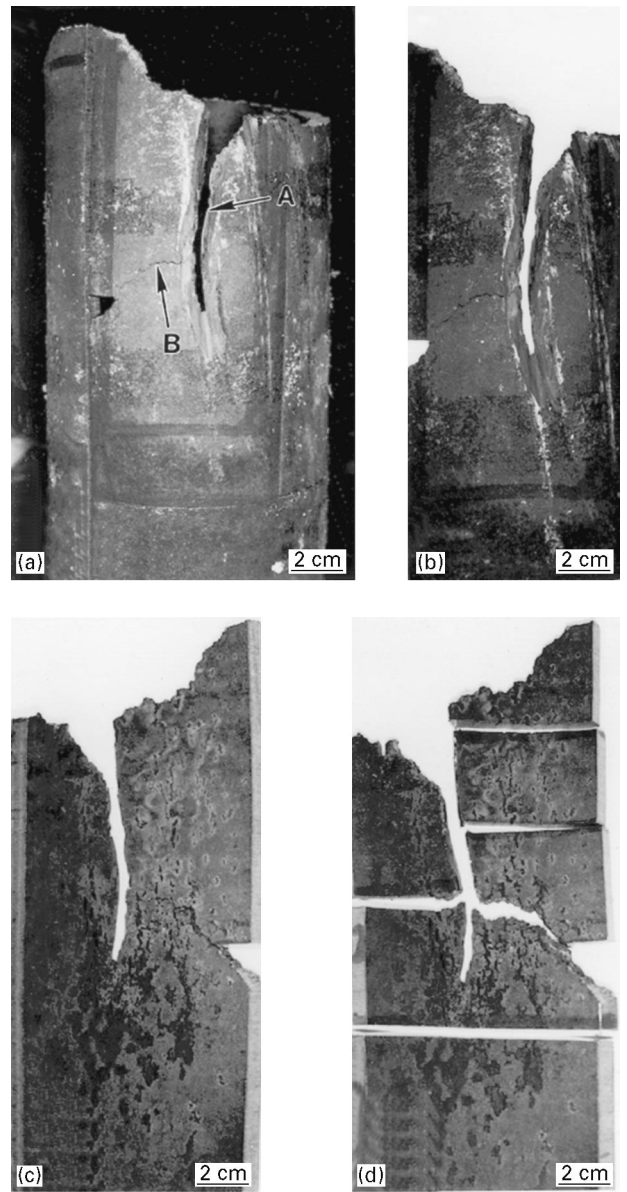
The ruptured section was separated from the whole pipe and photographed as shown in Fig. 1(a). The primary evidence of rupture, the formation of longitudinal cracks of about a 4 mm width and 15 cm in length, was destroyed by grinding in an attempted welding repair. As a result, the primary cracks featured like an open slot which was denoted by arrow A in Fig. 1(a). During the repair, a new crack [denoted

Figure 1 Optical photographs showing the characteristics of (a) the sectional ruptured pipe and (b) the external and (c) the internal surface of the rectangular sample piece. The locations of various samples dissected from the rectangular piece are indicated in (d).

by arrow B in Fig. 1(a)] was formed as a result of heating at 1100 °C.

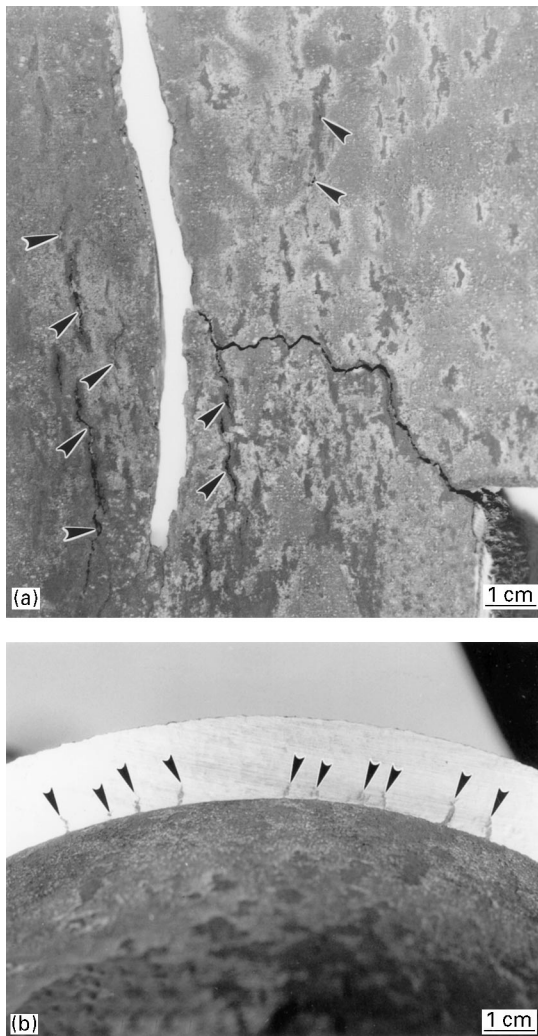
On the internal pipe surface, numerous areas were noted to exhibit signs of heterogeneous corrosion attack in the neighbourhood of the primary crack site. These areas exhibited a brownish colour with some of them associated with either continuous or discontinuous fissures, denoted by arrows in Fig. 2(a). By contrast, signs of heterogeneous corrosion attacks were not observed either in the remote areas of the internal surface or on the external surface. The external pipe surface was covered by an oxide scale and exhibited a blackish colour.

Cross-sectional views (along the transverse/radial direction) of the dissected pipe in areas containing the fissures revealed the presence of a few radial cracks [Fig. 2(b)], originating from the internal surface and propagating towards the external surface. These

fissures have not yet evolved into through-wall-thickness cracks. They developed along both the longitudinal and radial directions of the pipe with a tendency to bridge together forming continuous cracks. Given enough time, these cracks are expected to go through the wall thickness and rupture the pipe.

Figure 2 Optical photographs showing (a) the signs of heterogeneous corrosion attack and (b) the presence of radial cracks. The presence of fissures is evident in areas denoted by arrows in (a).

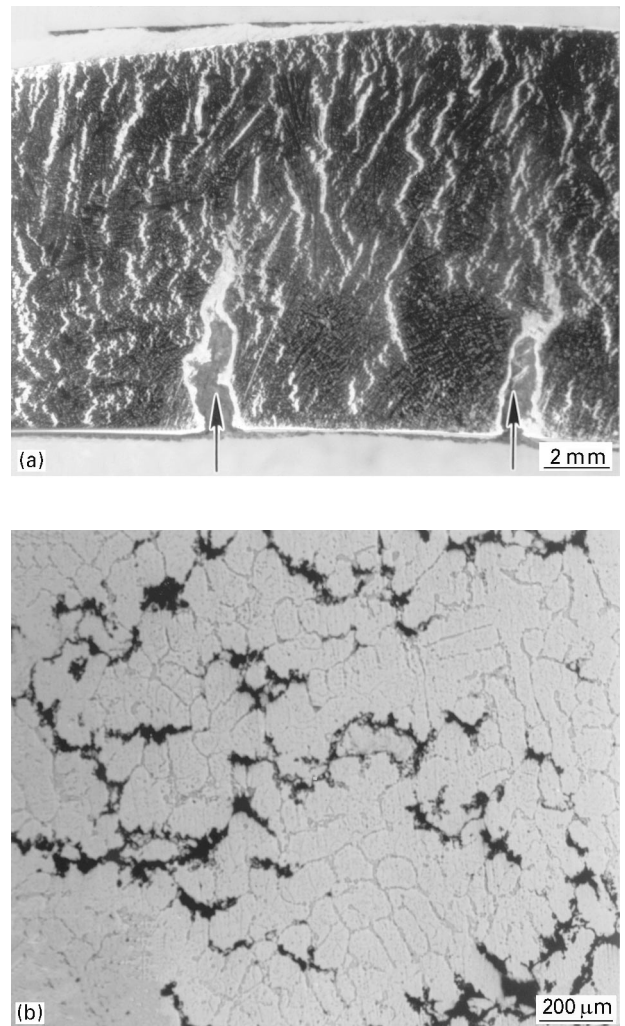
Metallographic examination of the pipe, along the transverse direction, in areas near to the primary crack site revealed the presence of numerous internal microcracks. Fig. 3(a and b) show optical photographs featuring the characteristics of microcrack-bearing

Figure 3 Optical photographs showing the characteristics of internal microcracking at (a) low and (b) high magnifications. Indicated in (a) by arrows are radial macrocracks originated from the pipe internal surface.

surfaces. As is shown in Fig. 3(b), cellular grain boundaries resulting from the spin casting are clearly visible in the microstructure. The microcracks were formed primarily along the grain boundaries. In all the samples examined, creep voids that are characteristic of most creep rupture failures were not observed. Typical photomicrographs showing the features of an originating surface macrocrack as well as branching-out internal microcracks are presented in Fig. 4. Close examination of the macrocracked surfaces revealed the presence of a granular microstructure [Fig. 5(a)], indicative of a brittle failure mode. By contrast, the microstructure of *ex-situ* fractured surfaces in areas remote from the cracks revealed a transgranular failure mode showing primarily cleavage facets [Fig. 5(b)].

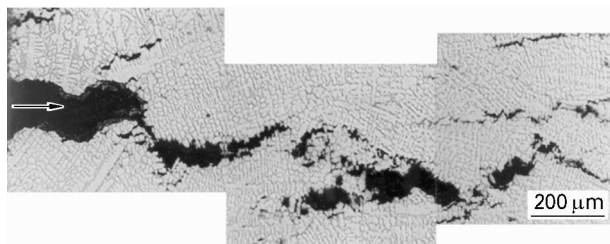
Figure 4 Optical photographs showing the presence of an originating surface macrocrack (denoted by an arrow on left) and internal microcracks.

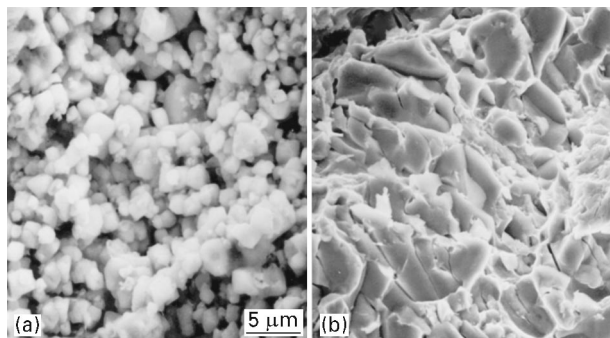
Figure 5 SEM photomicrographs showing (a) the typical granular microstructure observed on macrocracked surfaces and (b) the typical microstructure of cleavage fracture on *ex-situ* fractured surfaces.

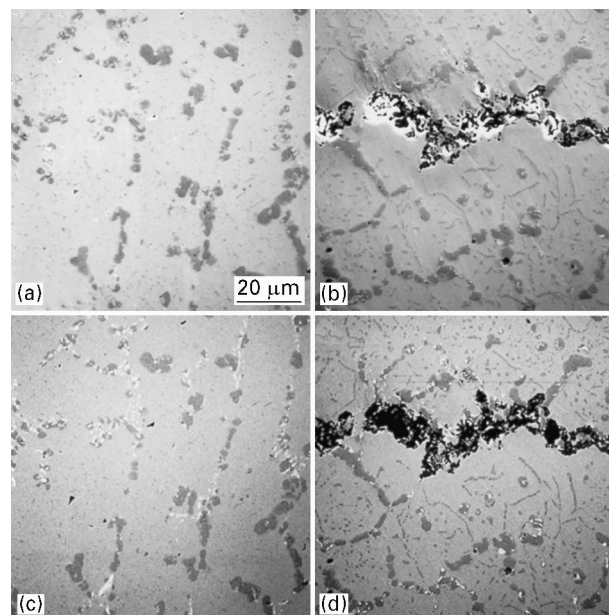
Figure 6 Electron photomicrographs showing the secondary electron images, (a) and (b), and backscattered electron images, (c) and (d), of the microstructure in areas remote from and nearby the primary crack site, respectively. Cr-enriched regions are featured by the dark-grey areas in (a), (b), (c) and (d); Nb-enriched regions are characterized by the white dotted areas in (c) and (d).

primary crack site. Typical SEM photomicrographs showing the microstructures in areas remote from and nearby the primary crack sites are presented in Fig. 6(a and b), respectively. The cellular microstructure observed in the remote areas appears to be similar to that of the as-cast pipe [12]. This suggests that the thermal energy infused into the reformer tube by the steam-reforming process was not significant enough to induce appreciable grain growth. According to the EDX microanalysis, the cellular boundaries were strongly enriched with chromium (Cr) and niobium (Nb), as compared to the grain matrix. The Cr content in segregated boundaries could reach 85 wt %, as compared to a nominal composition of 25.5–27 wt %; the Nb content reached 75 wt %, as compared to a nominal composition of 1.3–1.7 wt %. Although a quantitative WDS (wavelength dispersive spectrometry) analysis is yet to be performed, the segregation of Cr and Nb to the grain boundaries is attributed to the formation of carbides due to their highly negative Gibbs free energy of formation [16, 17]. It is important to note that Cr and Nb segregated to different regimes of the grain boundaries. The differential segregation behaviour is better contrasted in the backscattered electron photomicrographs shown in Fig. 6(c and d), and best illustrated using X-ray mapping as is shown in Fig. 7.

Segregation of Cr to grain boundaries, *in lieu* of uniform dissolution in the solid solution matrix, poses two deleterious effects to the material. From the standpoint of creep strength, the formation of Cr-carbide limits the availability of carbon to Nb for the formation of the creep strengthening phase NbC. From a corrosion standpoint the grain boundary segregation of Cr gives rise to the formation of a Cr-depletion zone nearby the boundary due to diffusion kinetics. This is highly undesirable because the low-

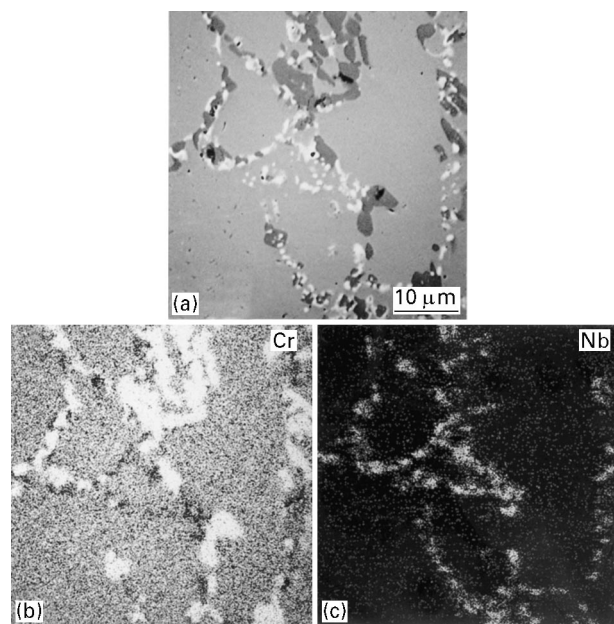
Figure 7 (a) A backscattered electron photomicrograph of X-ray maps of the corresponding area showing the differential segregation behaviour of (b) Cr and (c) Nb in the grain boundary regimes.

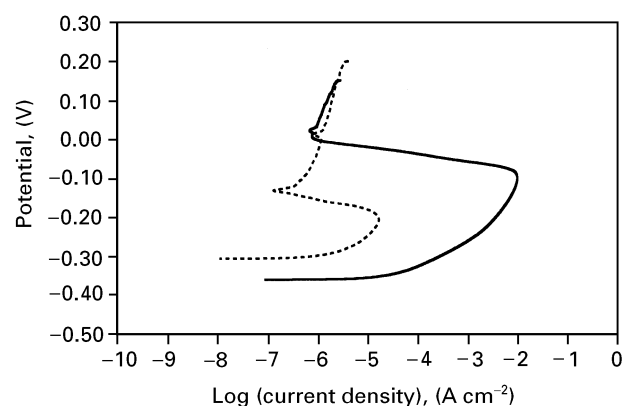
Figure 8 Electrochemical reactivation curves measured from (—) Pyrotherm G 25/35 Nb alloy and (- - -) 304 SS.

Cr-content regime is anodic to the rest of the grain [18], which in turn renders the material susceptible to SCC (or intergranular corrosion) in a corrosive environment when under stress. The mechanism for SCC in the present case is similar to that for the sensitization of stainless steel, which is effected by the segregation of Cr to the grain boundaries [18, 19]. The susceptibility of the subject pipe material of SCC was further verified by electrochemical reactivation (EPR) tests conducted (at 30 °C) in compliance with ASTM G-108. A typical EPR curve measured from the pyrotherm G alloy is displayed in Fig. 8. As a comparison, the EPR curve of a solutionized AISI 304 stainless steel which is not susceptible to intergranular corrosion is also shown in Fig. 8. It is clearly observed that the anodic current density measured from the Pyrotherm alloy was about 3 orders of magnitude higher than that from the 304 SS. The test results indicate that the Pyrotherm alloy is highly susceptible to intergranular corrosion and/or intergranular stress corrosion cracking [13].
