Material damage in space from microparticle impact

L. BERTHOUD

J.C. MANDEVILLE

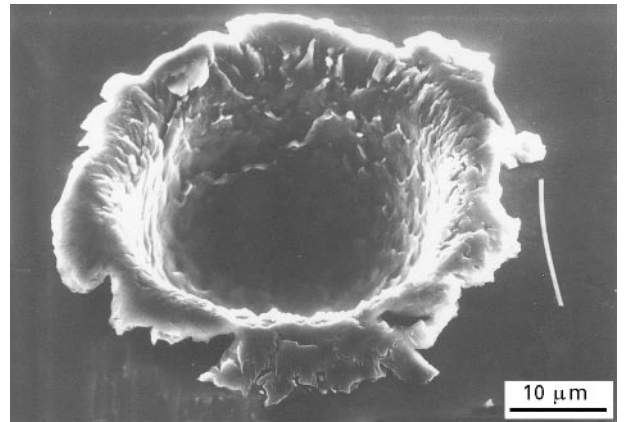
Figure 4 SEM image of the impact crater in an LDEF aluminium sample (diameter is 120 µm).

A typical impact crater found in aluminium is shown in Fig. 4. Craters on ductile surfaces are characterized by a radial symmetry, a raised lip and a dark central cavity or pit. Perforations look similar to craters except on the very thinnest of targets, where the hole usually has little lip and takes on the same shape as the impacting particle. Most of the work on particle-target interaction models has been done with aluminium as a target [6], although glass has been the subject of some investigations [7]. Very little is known about the relative sizes of damage to materials such as Mylar, Kapton and tefloned glass fibre.

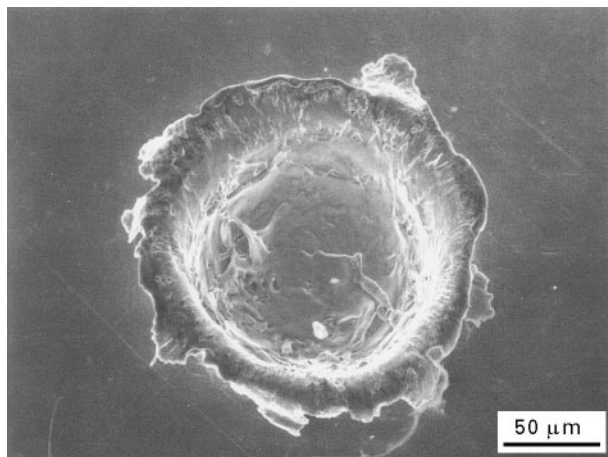
Figure 5 SEM image of crater on LDEF copper sample A3-2 (diameter is 110 μm).

Only one 110 μm-sized impact feature was found on the copper sample, which is shown in Fig. 5. The morphology of the impact was very similar to those found on aluminium; namely a radial symmetry, a raised lip and melt 'walking' up the crater walls. The depth to diameter ratio of the crater was measured to be 0.43 which is shallower than the average value of 0.55 in aluminium. This difference is possibly due to the higher density of copper.

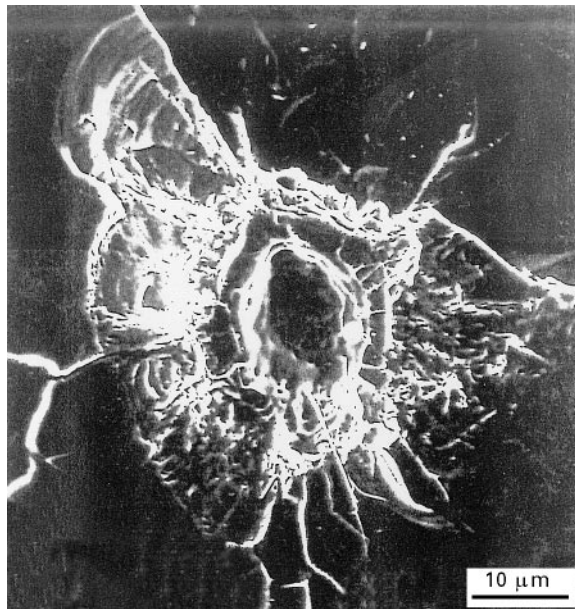
Figure 6 SEM image of the impact in a glass sample from LDEF (central pit diameter = 48 × 34 μm).

Fig. 6 shows an example of an impact on a quartz glass sample on LDEF. An asymmetrical area is visible around the central pit, where material has been ejected by the rarefaction shock wave returning to the surface (a process called 'spallation'). The central pit measures 34 × 48 μm and has a thin lip. The rounded

contours inside the pit indicate that the glass has softened (glass softens around 1100–1400 °C). For comparison, Fig. 7 shows a crater formed in a lunar rock, as the Moon is also pitted by craters from a continual rain of meteoroids. The crater formed on the glassy material of the rock shows a similar morphology to those on the space samples.

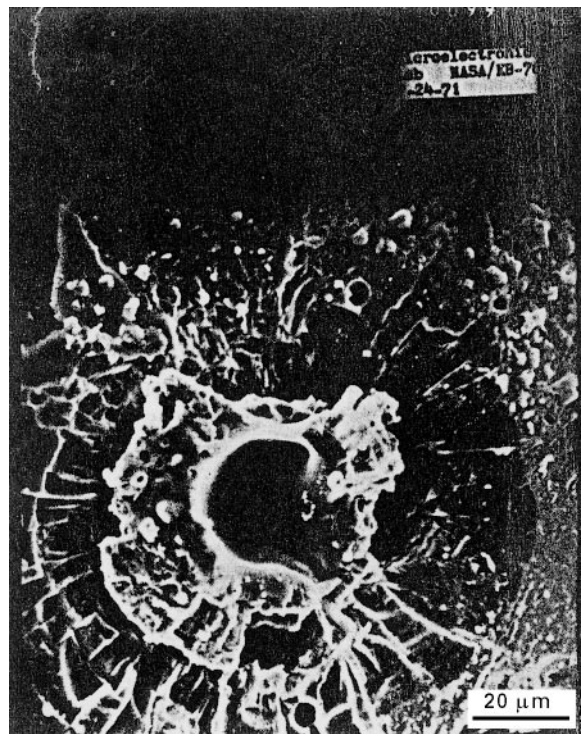
Figure 7 SEM image of the crater formed by the impact of micro-meteoroids on a glassy sphere from the Moon's surface brought back by Luna 16 (photo from NASA JSC, Houston).

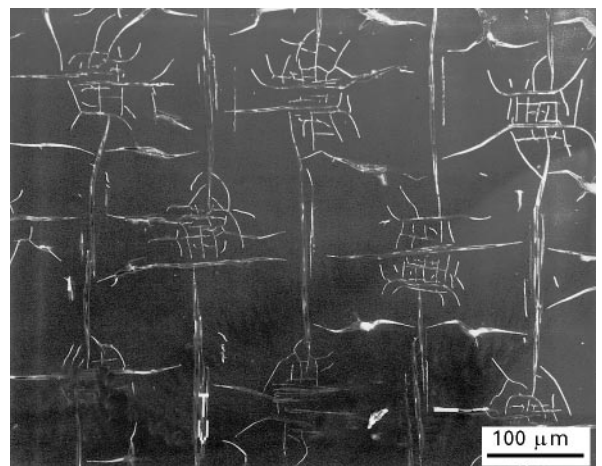
Figure 8 The regular pattern of microcracks covering LDEF thermal blankets.

Protective thermal covers consisting of tefloned glass fibre with aluminized mylar for the FRECOPA power supply were examined. A regular pattern of microcracks was found, which was not present on reference samples (shown in Fig. 8). The teflon matrix seems to have been eroded away by radiation and atomic

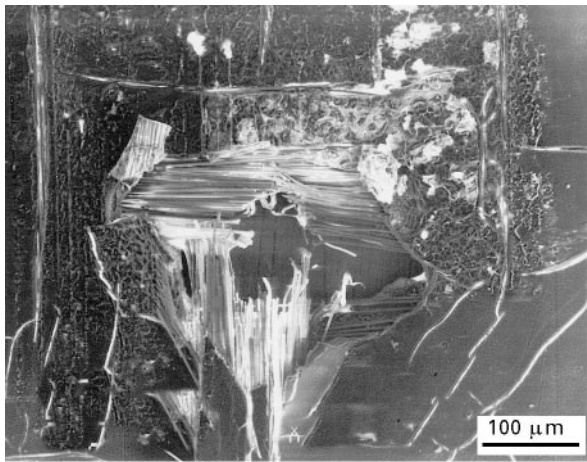
Figure 9 Impact found on the LDEF thermal blanket (perforation diameter = 200 μm).

oxygen to a point well beneath the substrate surface. Wider fissures occurred in parts of the matrix unsupported by glass fibre tissue, sometimes perforating the matrix completely. Fig. 9 shows a perforation of 200 μm diameter in the tefloned glass. The damage was limited on the left side and above and below by neighbouring bunches of fibres. An area of 500 μm diameter of the top layer of teflon was fractured along microcracks present before impact. Fig. 10 – a detail of Fig. 9 – shows evidence of fibre fracture and melting (rounded fusion products).

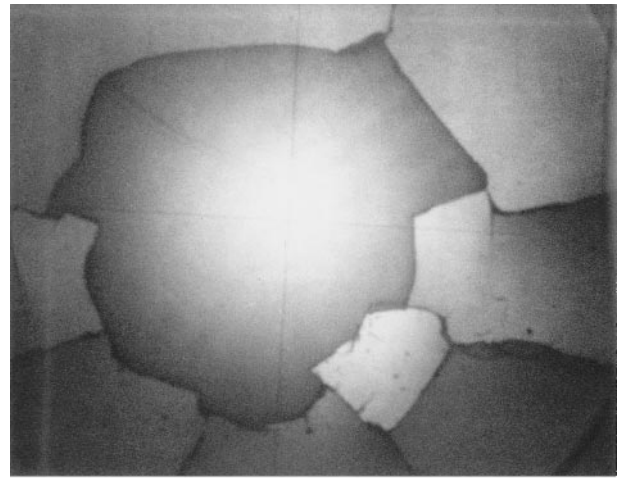
Figure 11 Angular fracture produced in mylar (Diameter = $1.8 \times 1.5 \text{ mm}$).

The aluminized mylar was degraded in two ways by space exposure. Firstly the aluminium coating turned a goldish colour on the side exposed to the sun, due to contamination. And secondly, the mylar became brittle and tore easily with handling. This is a known effect of radiation on certain polymers; the radiation causes crosslinking of the chains and embrittlement ensues. A perforation was left by the passage of the same microparticle which caused the above impact. The perforation was significantly larger than that produced in the tefloned glass fibre. Fig. 11 shows the angular fracture. Cracks radiate outward from the impact point.

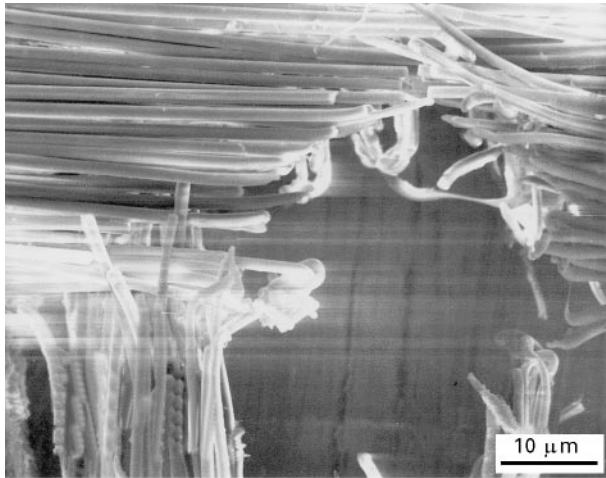
Figure 10 Detail of the LDEF thermal cover impact showing fusion products on fibre ends.

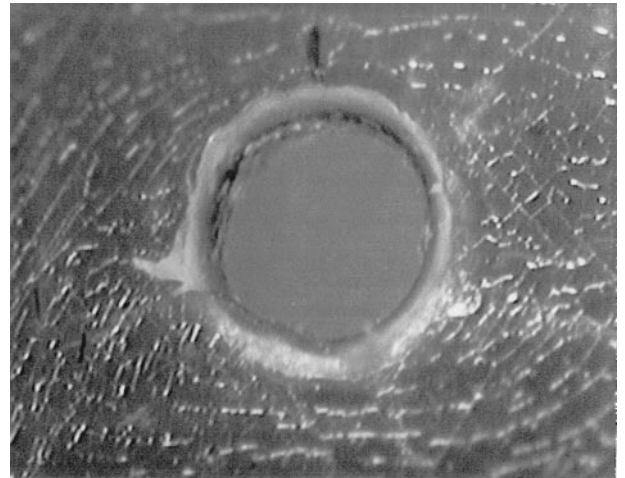
Figure 12 Perforation of Kapton tape on MIR (Diameter = 180 μm).

As is shown in Fig. 12 an impact measuring 180 μm in diameter was found in a sample of Kapton tape 50 μm thick. The tape was perforated and showed signs of fusion on the lip. Black markings were found on the surface behind the tape. These were thought to have been caused by carbonization of the tape upon impact. Charring of Kapton occurs at temperatures above 800 $^{\circ}\text{C}$.

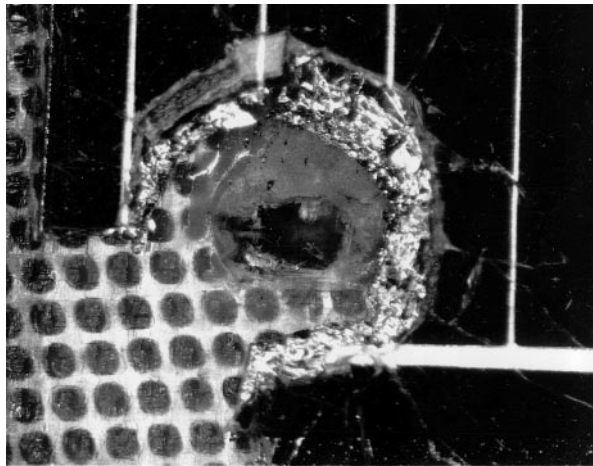
Figure 14 Optical microscope image of perforated HST cell (diameter of outer damage is 3.1 mm).

(the area of each side was approx. 20 m^2). An optical microscope image of one of these perforations is shown in Fig. 14.
