An investigation of spalling of case-hardened Nitralloy

T. DOGGART, H. GUPTA

Center for Grinding Research and Development, University of Connecticut, Storrs, CT 06269, USA

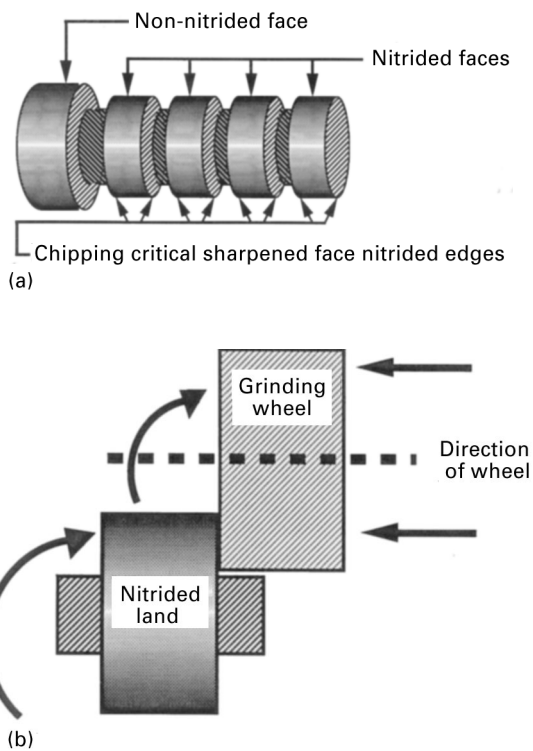
A test part was designed to model an average nitrided valve spool (Fig. 1). The part had eight, sharp, nitrided edges, which are the specific areas in the production parts where the spalling occurred and caused the valves to fail inspection.

Figure 1 (a) Manufacturing the test part. (b) An isolated land, and spalling critical land grinding.

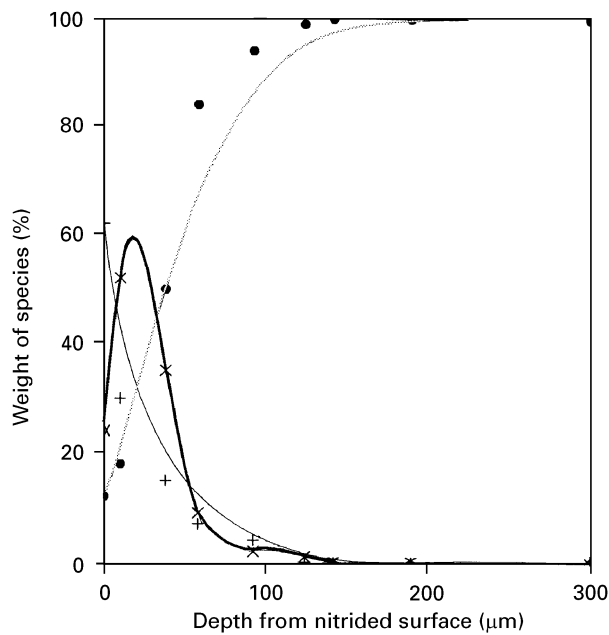
Inspection of the test parts after final grinding revealed that the two specimens that were vacuum-annealed after nitriding did not spall at all; all other specimens badly chipped during the final grinding. Surface analysis of the parts immediately after nitriding and annealing indicated higher concentrations of nitrides in nitrided parts than in annealed parts (Figs 2 and 3)

Figure 2 Phase versus depth profiles: aggressive nitrided parts. (x) Austenite (—), (+) Fe₄N (—), (●) ferrite, (·····).

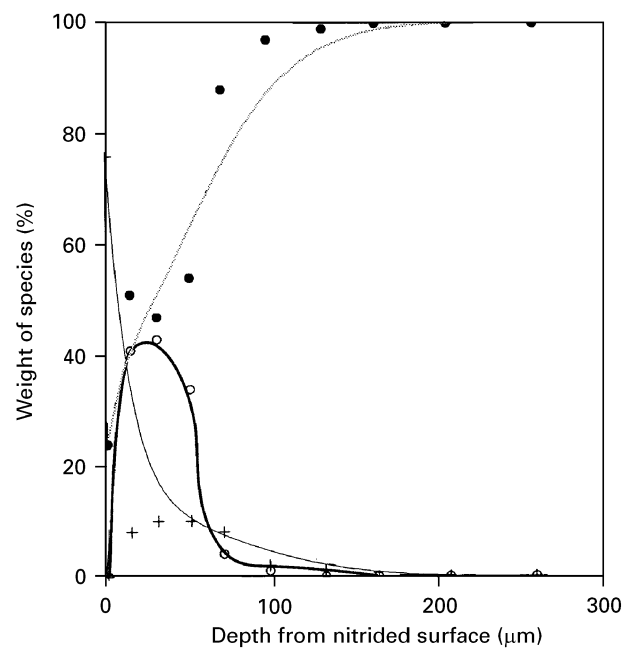
Figure 4 Phase versus depth profiles: less aggressive nitrided parts. (●) Ferrite, (·····), (+) Fe₄N iron nitride (—), (○) Fe₂₋₃N iron nitride (—).

- (ii) similar near-surface compressive residual stresses;
- (iii) similar case depths;
- (iv) identical microstructures;
- (v) no apparent correlation between phases present (α -Fe, γ -Fe, γ' -iron nitride and ϵ -iron nitride) and chipping (Figs 2–4).

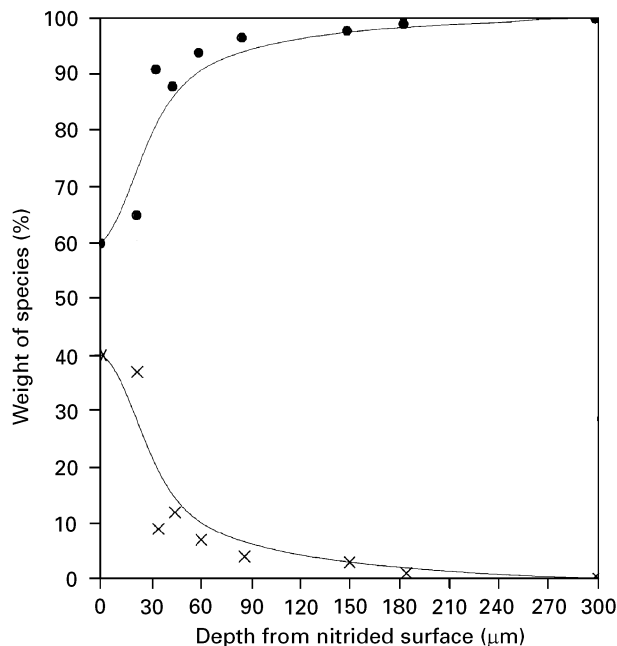
Figure 3 Phase versus depth profiles: aggressive nitrided and annealed parts. (●) Ferrite, (x) austenite.

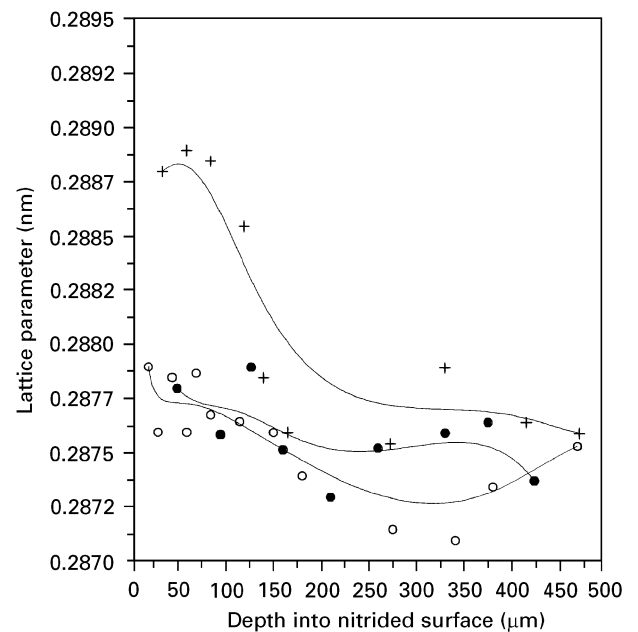
Figure 5 α -Fe lattice parameter profiles. (+) Pre-anneal a -spacing, serious chipping; (○) post-anneal a -spacing, no chipping; (●) good nitride a -spacing, no chipping.

The only conclusive differences were in their chipping characteristics and their α -Fe lattice parameters, which represents a measure of nitrogen dissolved in solid solution within the α -Fe (Fig. 5).

All of the chipped samples displayed a near-surface lattice parameter of nearly 0.289 nm, which indicates a super-saturated α -Fe solid solution. Alternatively, this parameter indicates that significantly more nitrogen is present in the α -Fe host lattice than α -Fe can usually dissolve under equilibrium conditions. This unusually large amount of dissolved nitrogen had considerably distorted the α -Fe lattice, the effect of

The annealed and less aggressively nitrided parts have near-surface lattice parameters in the range of 0.2875–0.2880 nm, nearly a full 1000th of a nanometer below that of the chipped parts. This indicates that significantly less nitrogen exists in solid solution near the surface of the unchipped parts than in the chipped parts. This reduced nitrogen dissolution results in reduced lattice distortion, and hence reduced embrittlement, which consequently leads to a greatly reduced likelihood of spalling.

1. Spalling of sharpened nitrided corners is not inherent to the nitriding process. The current investigation found that sharp corners with radii $< 25 \mu\text{m}$ can be produced without spalling.
2. The use of a less aggressive nitriding process eliminates the spalling problem.
3. The use of a post-nitride anneal can render even seriously embrittled parts usable again.
4. The chipping seems to be caused by an excessive amount of nitrogen dissolved in the α -Fe lattice, causing the α -Fe solid solution to embrittle and making the steel susceptible to spalling.
5. The concentrations of various nitride phases or austenite in the nitrided layer do not seem to have any noticeable effect on embrittlement of steel and hence on chipping or spalling.

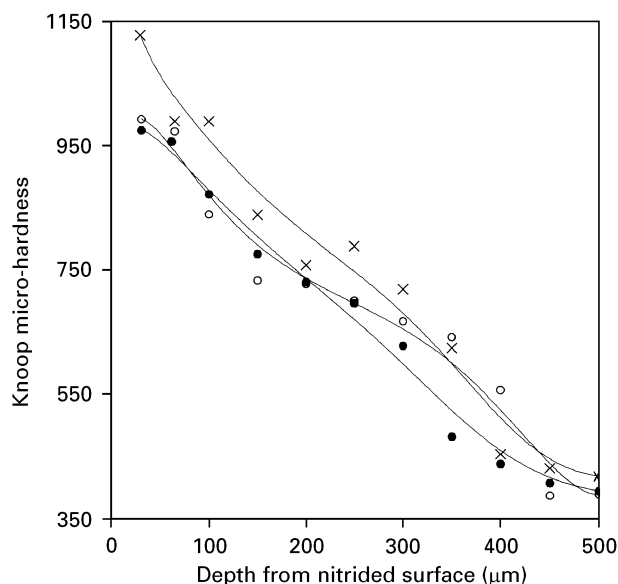
(i) similar bulk hardness and micro-hardness versus depth characteristics (Fig. 6);

Figure 6 Hardness versus depth profiles. (●) Less-aggressive nitride, (×) aggressive nitride, (○) aggressive nitride and anneal. Bulk hardness: aggressive nitride, 31.9 Rc; aggressive nitride with anneal, 29.9 Rc.

Finally, it can be concluded from Fig. 6 that nitriding with a less aggressive nitriding cycle or annealing of aggressively nitrided parts does not result in significant hardness loss. These parts still remain within the hardness specification for the intended use.
