# Microstructure characterization of fractured steel beam-to-column connections

C. P. OSTERTAG

*Civil and Environmental Engineering Department, University of California, Berkeley, CA 94720-1710*

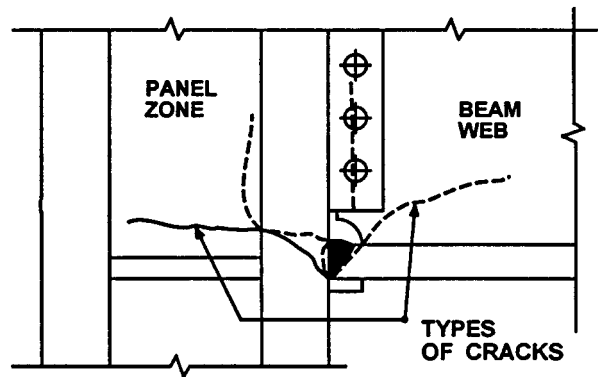
Figure 2 Common crack formations in welded beam-to-column connections [3].

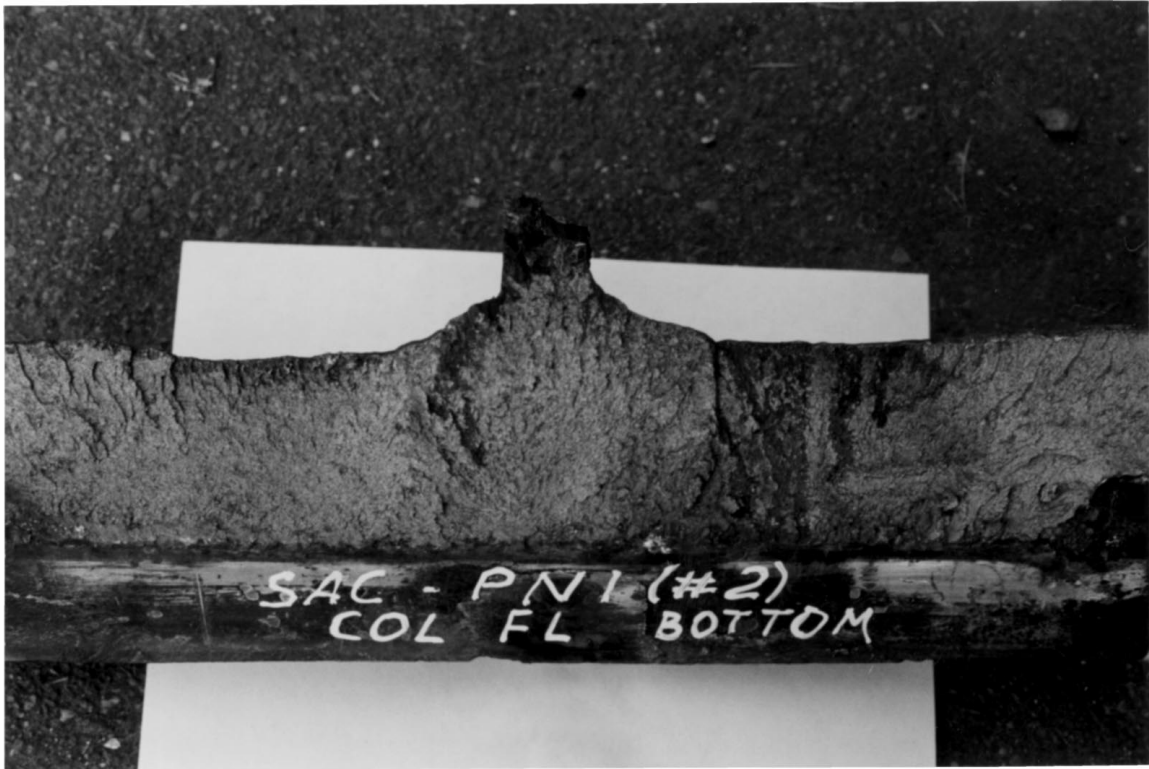
Fig. 3 shows the fracture surface. The appearance of the fracture surface reveals the overall character of the brittle fracture. The crack initiated in the center of the bottom beam flange to column welded joint at the weld root and propagated across the column flange. The location of the fracture origin is clearly indicated marked by the Chevron pattern visible in Fig. 3b, which is an enlarged view of the fracture surface close to the fracture origin.

Figure 3 (a) Fracture surface of failed welded beam-to-column connection (b) Fracture surface close to the fracture origin at higher magnification.

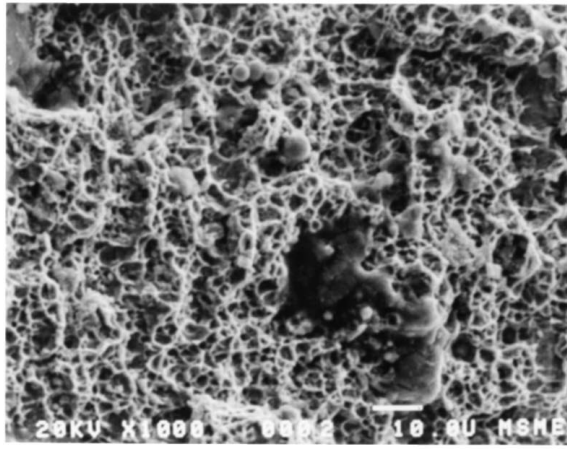
The dominant brittle fracture was preceded by a ductile crack of 2 mm length. Fig. 4a is a SEM picture of the ductile fracture surface. The ductile fracture surface has a characteristic dimpled appearance in marked contrast to the faceted appearance of the cleavage fracture surface (Fig. 4b and c). Each dimple corresponds to a fracture nucleation site and these link up by microvoid coalescence. Fig. 4b is a SEM picture of the cleavage fracture surface corresponding to area A (fine-grained heat affected zone) of Fig. 3b. The cleavage fracture surface in Fig. 4c corresponds to area B (outside of the heat affected zone) of Fig. 3b.

Figure 4 Scanning electron microscope (SEM) picture of (a) ductile fracture surface, (b) cleavage fracture surface corresponding to area A of Fig. 3b, and (c) cleavage fracture surface corresponding to area C of Fig. 3b.

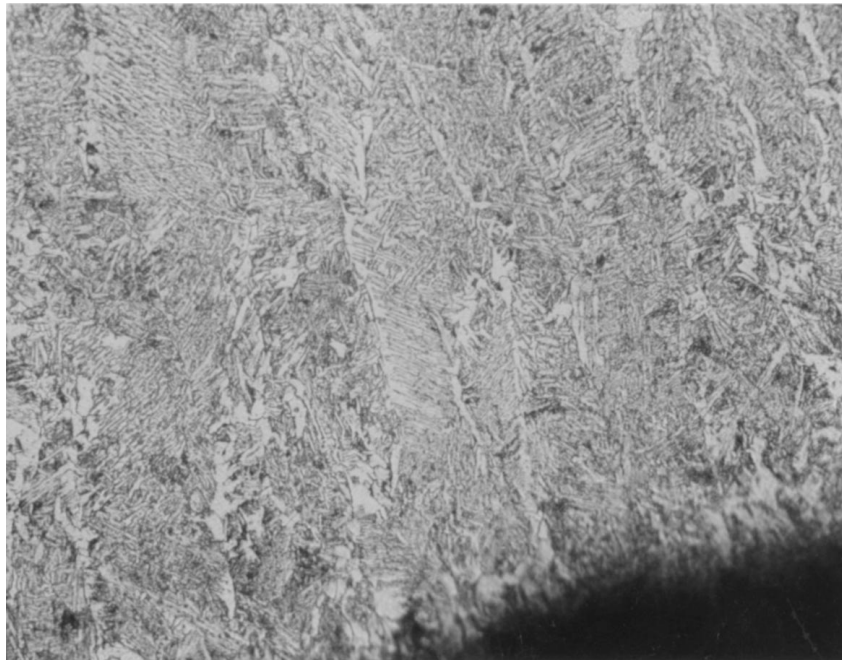
The crack initiates at the weld root adjacent to the backup bar in the coarse grained region close to the fusion line. The microstructure associated with crack initiation is shown in Fig. 5. TEM analyses were re-

quired to identify each of the constituents due to its complex microstructure. The analysis revealed ferrite, martensite, retained austenite and carbides. The ferrite phase was present as grain boundary ferrite, small traces of a circular ferrite, and parallel aligned ferrite laths. Carbides were present in the form of  $\text{Fe}_3\text{C}$ . The morphology of martensite is dislocated lath type. The inter-lath boundaries of the ferrite laths contain martensite, austenite and carbides. This microstructure will be denoted as MAC microstructure in this paper. This MAC microstructure is associated with poor toughness as will be illustrated later. Optical micrographs taken from the weld root in sections 2 and 10 cm away from the center revealed the same coarse grained microstructure that was associated with the MAC in the center of the joint.

Figure 5 Optical micrograph of microstructure associated with crack initiation (magnification 200 $\times$ ).

The brittle microstructure in the vicinity of the weld root adjacent to the unfused backup bar undoubtedly contributes to brittle fracture. In order to reduce the probability of brittle failure of welded steel beam column connections the brittle microstructure needs to be avoided specifically in the vicinity of the weld root adjacent to the local stress concentration present in beam-column joints. However, at this stage, it is not known if the formation of a ductile microstructure could have prevented brittle failure. The large change in cross section of the beam column joint which acts like a notch (with or without unfused backing bar) may cause sufficiently high triaxial stresses to develop, that even a ductile microstructure in its vicinity may not be sufficient in preventing brittle fracture in these connections, unless the notch effect in steel beam column connections is being reduced considerably.

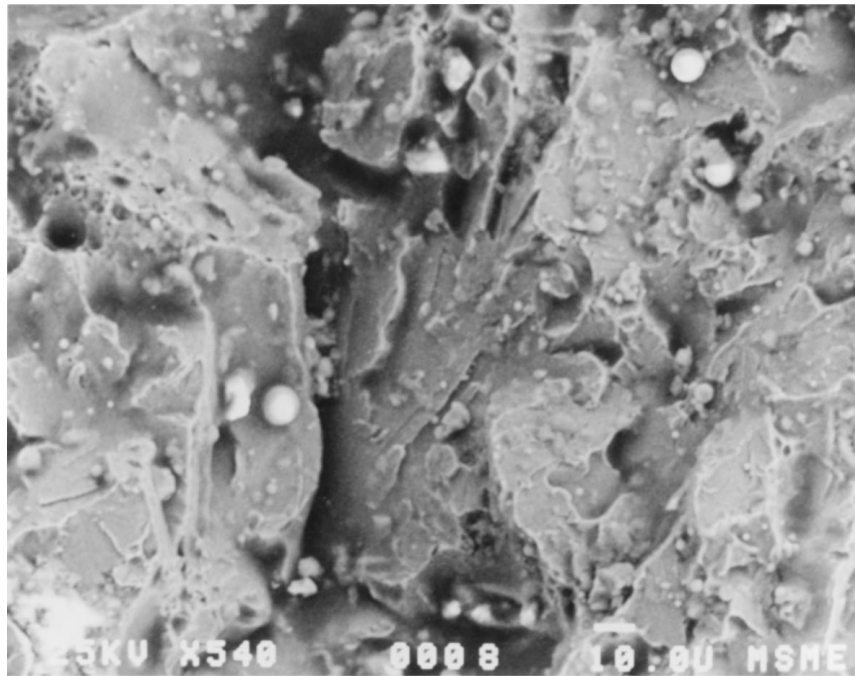
The change in fracture mode from ductile to cleavage did not coincide with a change in microstructure, but occurred within the same MAC microstructure. The brittle cleavage crack within the MAC structure is shown in Fig. 6. After reaching a length of 4 mm (2 mm ductile crack and 2 mm cleavage crack), the crack changed direction and propagated into the heat-affected zone of the column flange, encountering a refined microstructure (Fig. 7). This refined microstructure forms, when the column parent metal is heated above the transformation temperature ( $A_{c3}$ ) into the austenitic regime but low enough in temperature to suppress grain growth in the austenitic phase. The cleavage fracture surface associated with the refined microstructure is shown in Fig. 4b. Note the smaller cleavage facets associated with the fine grained microstructure compared with the coarse grained MAC structure (Fig. 6). When the fracture mode is cleavage fracture, the measured cleavage facet sizes in the coarse grained region correlate with the measured grain sizes of prior austenite [4]. The average cleavage facet size in the coarse grained region is 100  $\mu\text{m}$ , which would correspond to prior austenite grains of that size range. In comparison, the average grain size of the ferrite grains in the column material is 70  $\mu\text{m}$ . The prior austenite grain size of 100  $\mu\text{m}$  indicates grain growth during the welding process, indicating that the peak temperature of the weld pass was far above the transformation temperature  $A_{c3}$ .

Figure 6 Cleavage fracture surface associated with brittle coarse grained MAC microstructure.

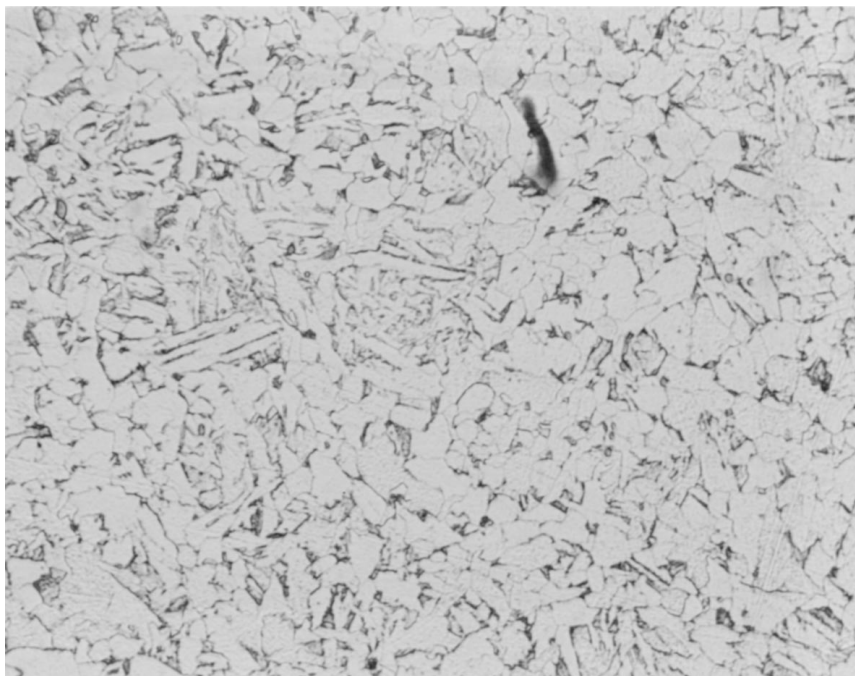
Figure 7 Optical micrograph of refined microstructure of heat affected zone in column flange (magnification 400×).

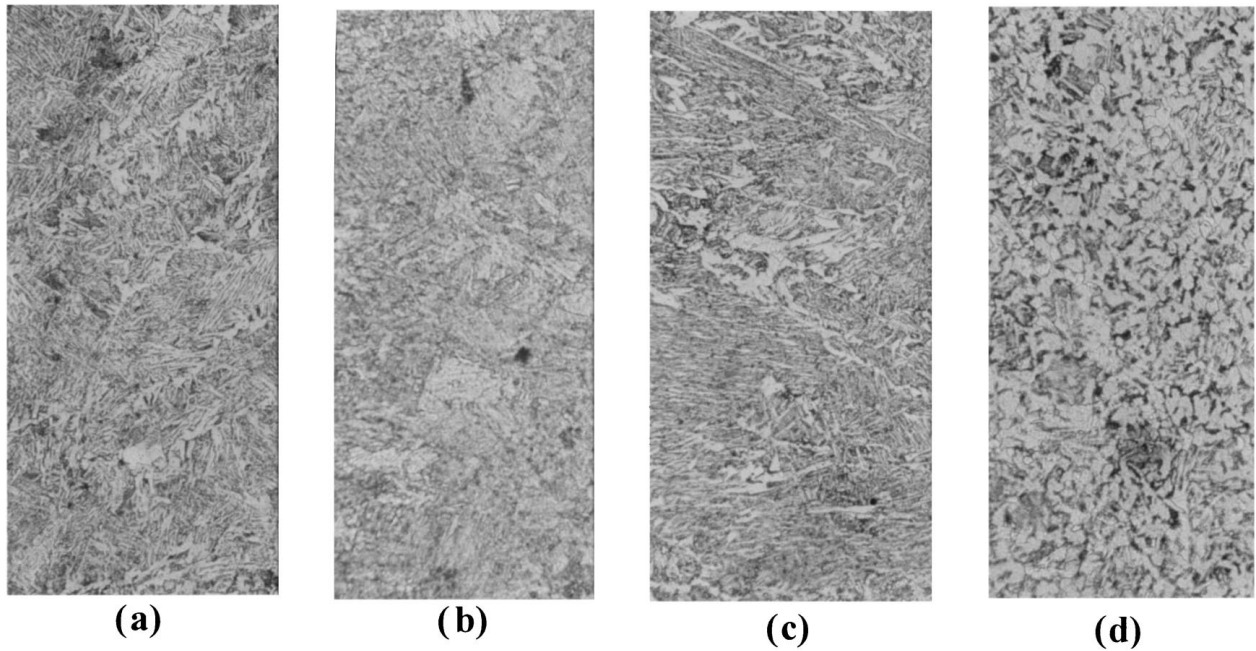
The weld metal in the beam column connections is deposited in multiple paths, therefore, the microstructure (and hence the properties) of the early runs can be completely altered by the heat from subsequent weld passes. The variation in microstructures within the weld is revealed in Fig. 8. The optical micrograph in Fig. 8a was taken from the first weld pass. The microstructure is caused by a coarse prior austenite grain size indicating that the peak temperature of the first weld pass must have been far above  $A_{c3}$  to cause coarsening of the austenite grains. Coarse grained microstructures were observed besides the first weld bead at various locations within the weld region (Fig. 8b) and in the last weld pass (Fig. 8c). The coarse grained regions varied with

respect to their hardness which may indicate that either the volume fraction of martensite or the carbon content in the martensite was different within the various coarse grained regions. Fine grained microstructures, an example of which is shown in Fig. 8d, were also observed at various locations within the weld region. Weld

Figure 8 Optical micrographs of microstructural variation in weld due to multiple pass welding (magnification 200 $\times$ ); (a–c) coarse grained regions within the weld, (d) refined microstructure between weld passes.
