Stress corrosion cracking fracture mechanisms in rock bolts

E. GAMBOA, A. ATRENS

Division of Materials, The University of Queensland, Brisbane, QLD 4072, Australia

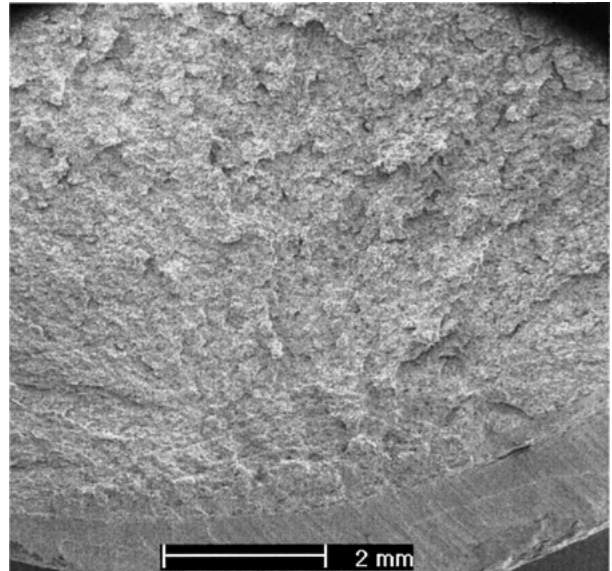
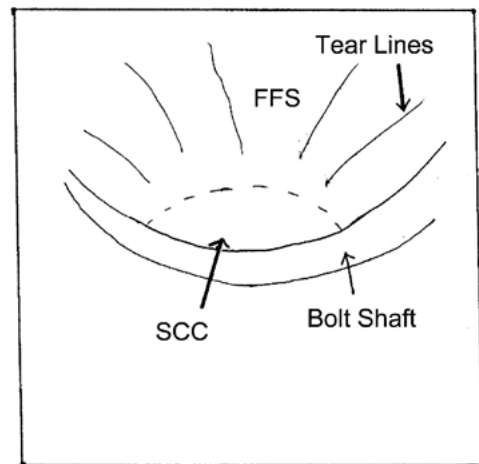
Figure 2 SCC region overview.

(a) SCC region overview

(b) Schematic view showing different fracture regions (FFS = Fast Fracture Surface)

Fig. 2 illustrates a typical fracture surface of a bolt failed by SCC. The typical features were the thumbnail

shaped slow crack growth region (SCC), surrounded by the fast brittle fracture region (Fast Fracture Surface (FFS) displaying cleavage fracture) marked by tear lines radiating out from the subcritical crack growth region. Crack branching was not evident on the slow crack growth region. On closer examination, SCC consisted of three distinct fracture morphologies: Tearing Topography Surface (TTS), Corrugated Irregular surface (CIS) and Micro Void Coalescence (MVC). TTS occurred close to the free surface whereas MVC was located mainly at the SCC-FFS transition. Most of the SCC region consisted of CIS.

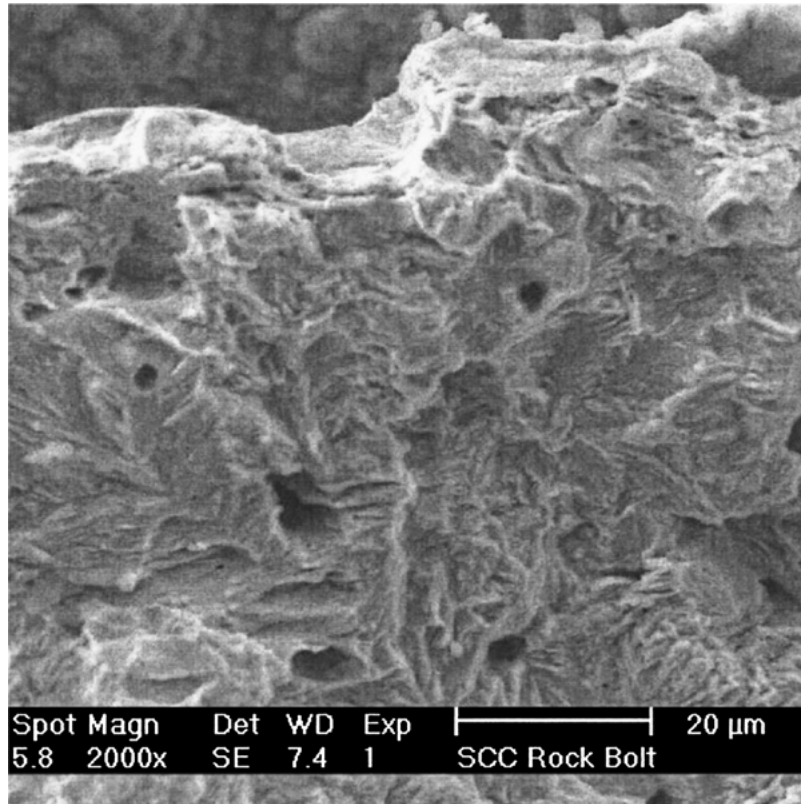
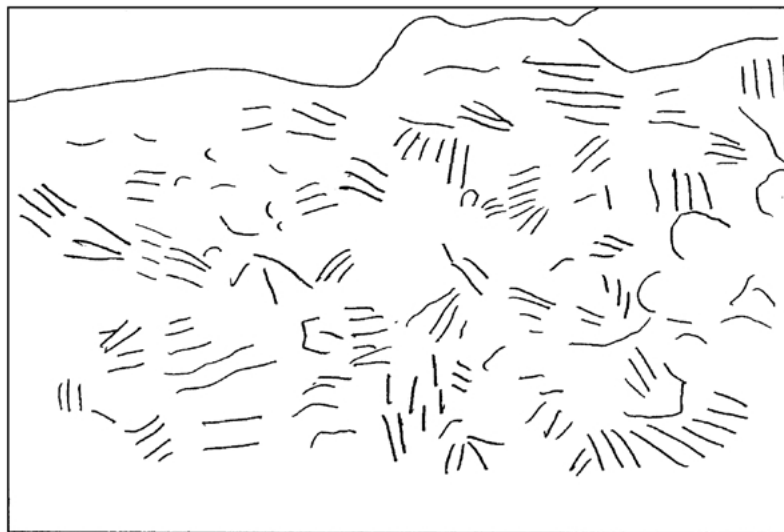
Figure 4 Rock bolt TTS region.

TTS occurred in rock bolt samples as shown in Figs 4 and 5. TTS in the rock bolts had a lower degree of orientation. Figs 4 and 5 illustrate the range

of appearance for the TTS. These figures show the main features of TTS that were observed in rock bolts. These features are the flat ridged areas and the secondary cracks. The ridges sometimes seemed to radiate from one point within a flat area. At other places the ridges were parallel to each other. The flat regions within TTS did not correspond to a single pearlite grain as shown in Fig. 6. Fig. 6 shows also that the TTS ridged structure did not follow pearlite colony orientation nor pearlite colony boundaries, as pearlite colonies were aligned differently to the ridges. The flat region

(a) Rock bolt TTS region.

(b) Schematic view showing rock bolt TTS ridge orientation

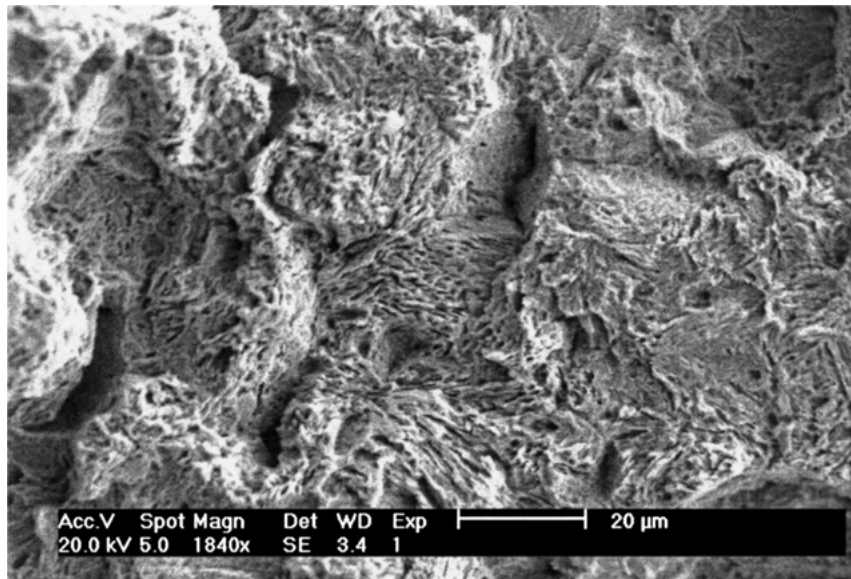
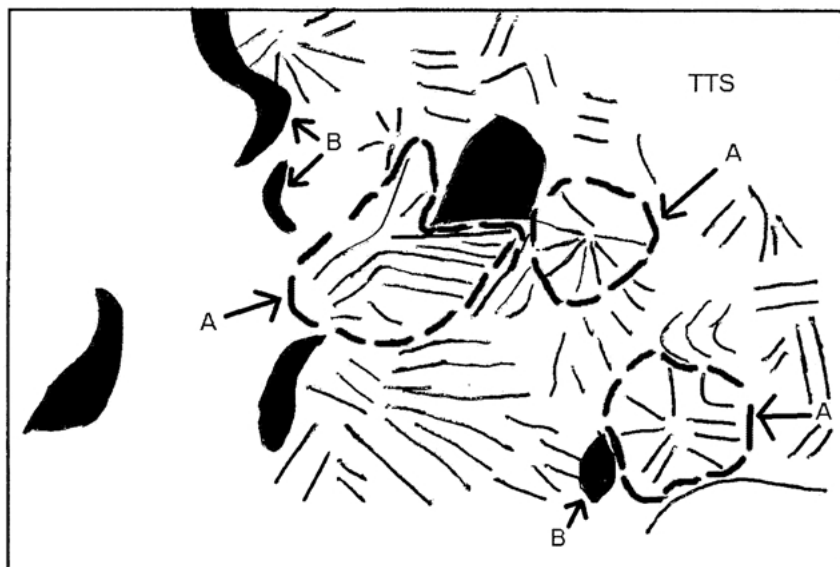
Figure 5 Typical TTS.

(a) Typical SCC close to free edge of sample (TTS)

(b) Schematic view showing TTS. A: Flat region (bounded by dashed line) B: Chasm or secondary crack

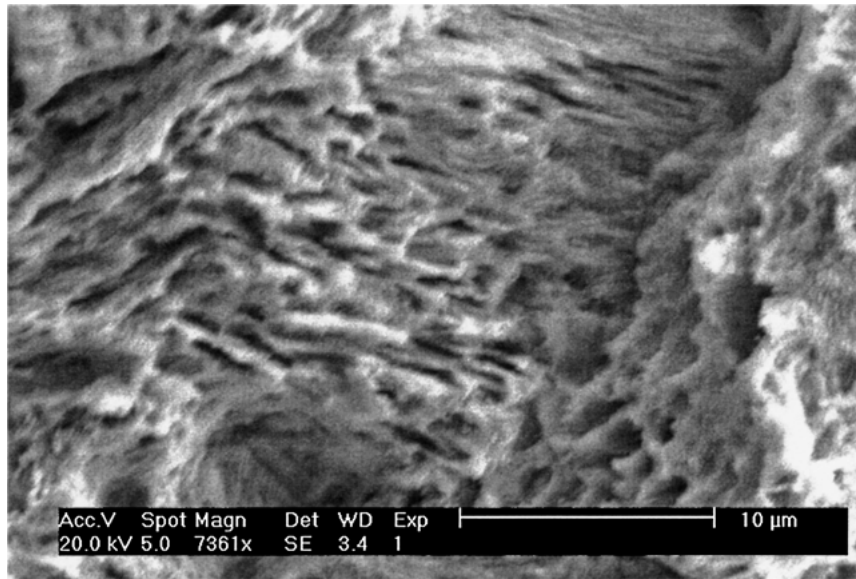
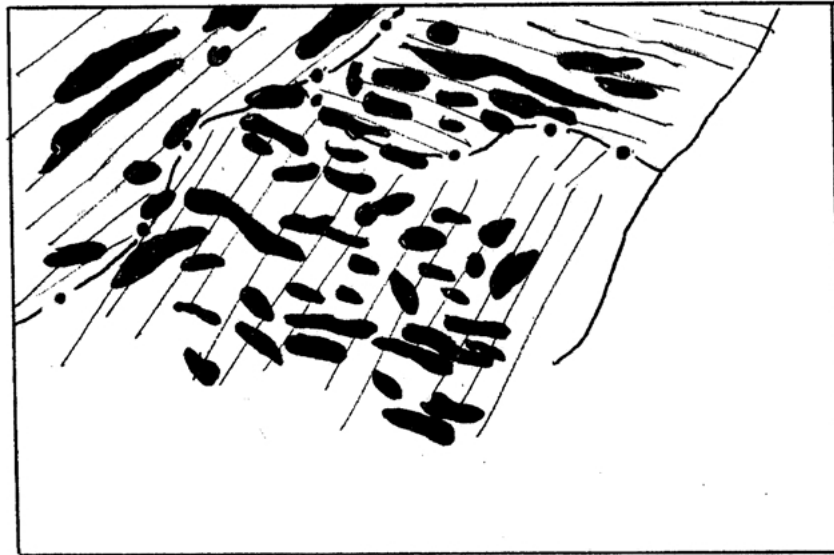
Figure 6 Higher magnification of Fig. 5.

shown by the figure was made up by at least 3 different pearlite colonies of different orientations (the dot-dash lines show the pearlite colony boundaries). Only the top colony followed the direction of the ridges, whereas the other two colonies were aligned perpendicularly to the ridge direction. The ridges of the top part of the figure had a spacing similar to the pearlite lamella, but the deep ridges apparent throughout the surface were not dependent on pearlite colony orientation; sometimes the pearlite colony lay perpendicular to these deep ridges. The perpendicular orientation of the ridges to the pearlite colony suggested that the fracture mechanism was independent of the pearlite.

(a) Ridged structure of TTS

(b) Schematic view showing the ridge direction and pearlite colony orientation indicated by the fine parallel lines indicative of the direction of the plates of ferrite and carbide that make up the pearlite.

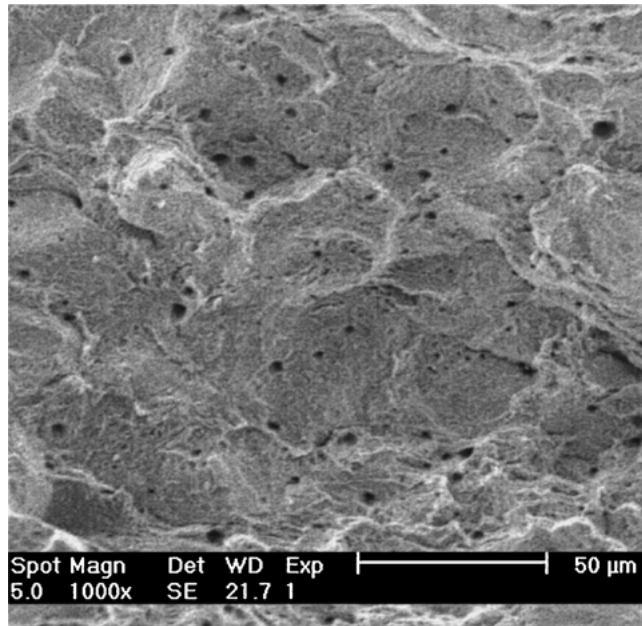
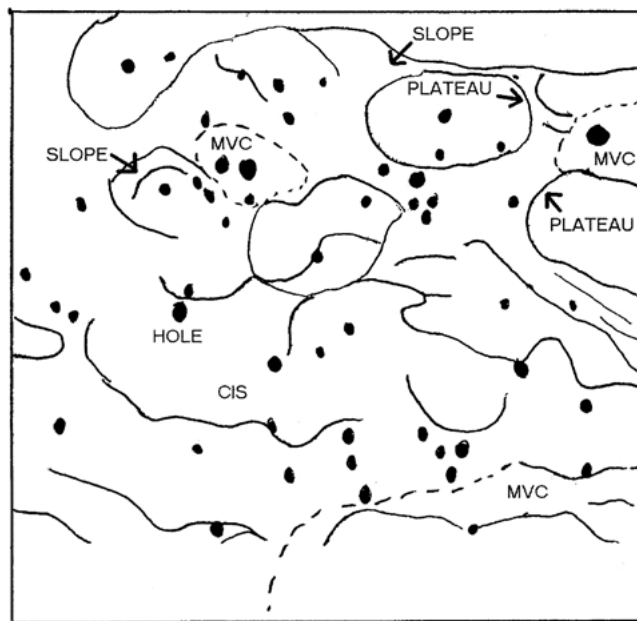
Figure 7 Typical SCC (CIS).

Fig. 7 shows typical CIS regions. Fig. 7 also contains a diagram identifying the characteristic plateaus, slopes and isolated regions of Micro Void Coalescence (MVC). The holes in the surfaces of this figure were due to the cleaning process. This surface was cleaned with the EDTA solution for 15 min, before it was discovered that such a long immersion time introduced holes in the fracture surfaces although it produced no other discernible change. Subsequent

(a) Typical SCC (CIS)

(b) Schematic view showing major features of SCC (CIS), including slopes and plateaus

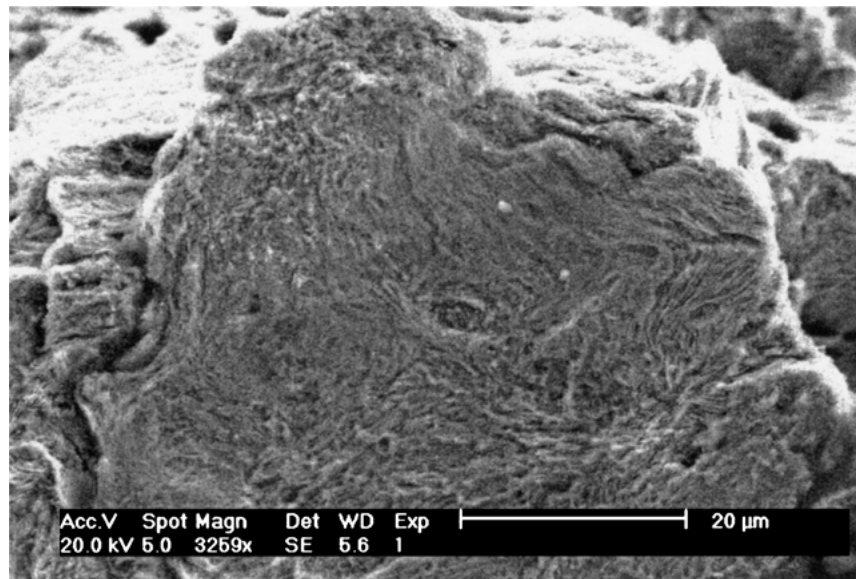
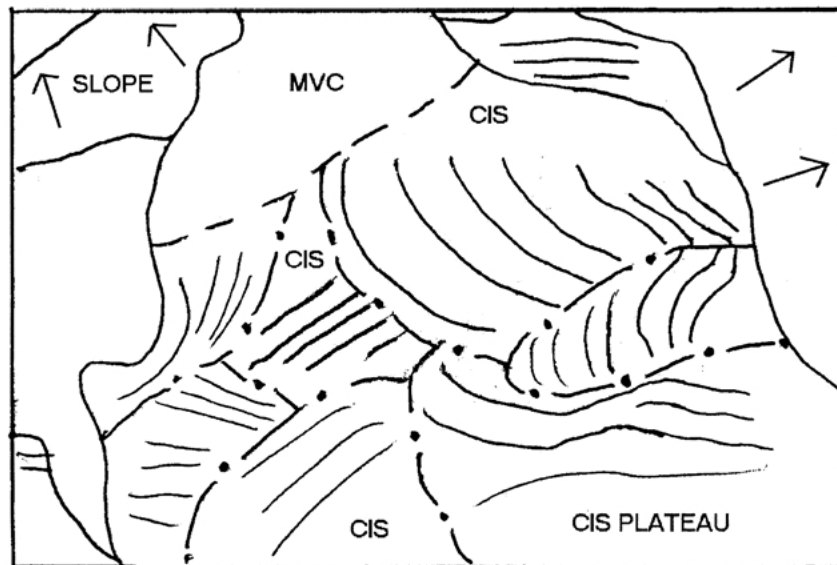
Figure 8 High magnification view of a plateau within CIS.

Fig. 8 illustrates a plateau and the irregular corrugated slopes. In the foreground there was a plateau, with slopes leading down from the mesa in an irregular fashion. The mean change in depth between flat regions was of the order of 30 microns. Fig. 8 also shows the plateau at high magnification revealing the pearlite colonies and their orientation. The mean depth of features on these plateaus was of the order of a micron. The diagram depicts the different fracture regions, as well as the pearlite colony orientation.

The flat plateau regions within CIS were not individual pearlite grains. Fig. 8 shows that there were several pearlite colonies in each flat area, and that the boundary of such regions did not follow the orientation or the boundary of pearlite colonies.

(a) CIS plateau showing pearlite colony orientation

(b) Schematic view showing SCC (CIS) and MVC regions. Parallel lines show pearlite colony orientation. Arrows show down slopes.

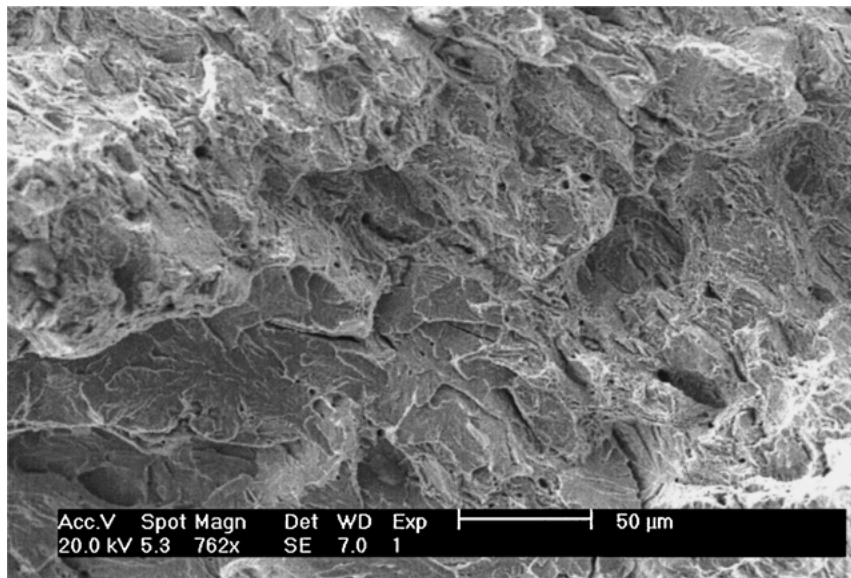
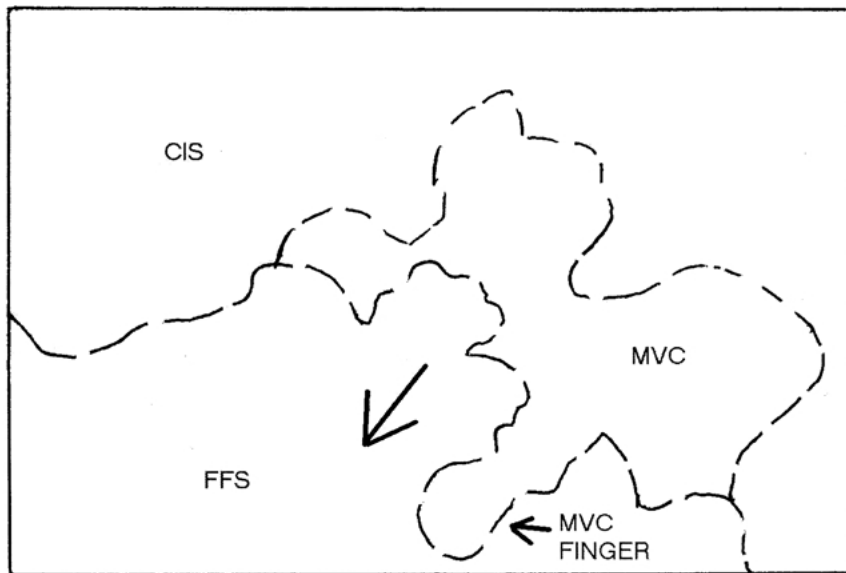
Figure 9 Typical SCC-MVC-FFS interface.

The CIS-MVC interface was common. Fig. 9 shows one such interface. The MVC region was nestled between CIS and FFS. The topographical height difference between CIS and MVC could vary. At times MVC continued at the same height as CIS, with the interface line being difficult to identify. The sudden abundance of small microvoids was one way of identifying the

change in these cases. This was the case in Fig. 9. The region in the MVC finger and in the lower right portion of the figure shows several small holes which were not readily found in the upper right portion (in the CIS region) of the figure. Fig. 14 shows one such hole in greater detail.

On the left side of Fig. 9 was a typical CIS-FFS interface. The two surfaces were separated by a difference in height, joined by a steep corrugated slope. Cases have also been found where the fracture mechanism changed in the middle of a flat region.

(a) SCC-MVC-FFS interface

(b) Schematic view showing a MVC "finger" extending into the FFS. Large arrow shows crack growth direction.

Fig. 9 shows a MVC region that has grown as a “finger” into the FFS region, while the rest of the MVC-FFS interface was a relatively straight line. These fingers could extend into the FFS region by a much greater amount than the 50 microns mentioned previously.

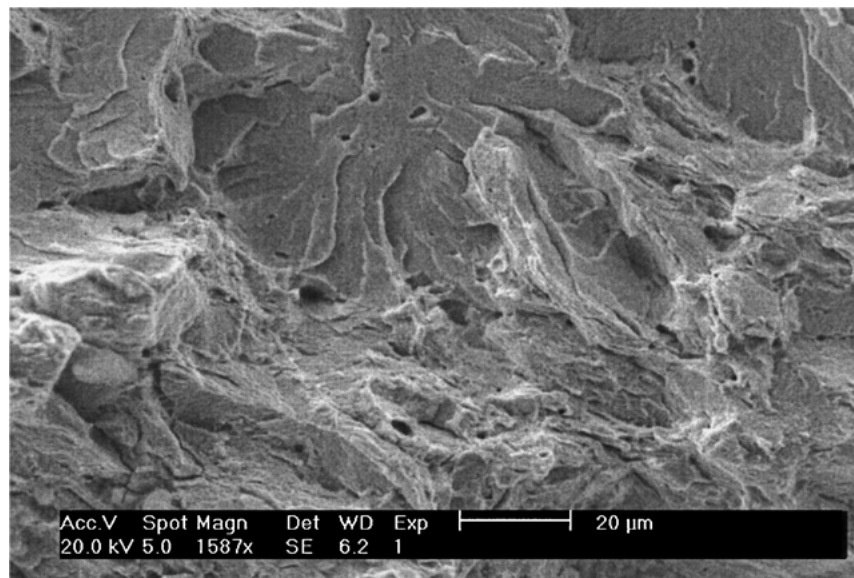
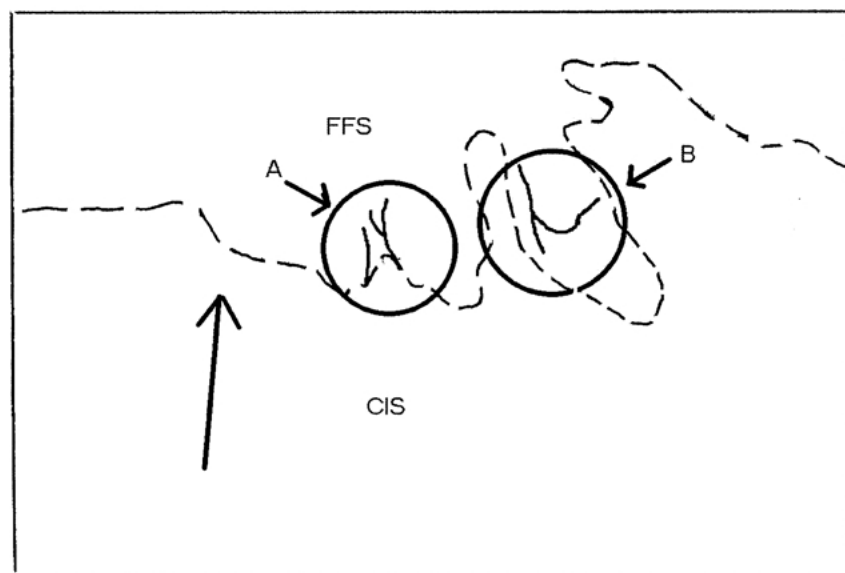
Figure 10 Typical SCC(CIS)-FFS interface (x1587).

Figs 10–12 show another case of the CIS-FFS interface. Fig. 10 shows CIS on the bottom part of the figure, with a slope leading down to the FFS region. The actual interface line was distinctive and has been indicated in the diagram. On one side of the line the surface was corrugated and irregular, while on the other side of the line the surface was flat and smooth. An interesting feature of this CIS-FFS interface illustrated in Fig. 10 were the "fingers" of CIS pointing inside the FFS. These "CIS" fingers were similar to the MVC fingers and are attributed to a similar mechanism.

(a) CIS-FFS interface

(b) Schematic view showing SCC(CIS) and FFS regions. Large arrow shows crack growth direction. A: Figure 11, B: Figure 12

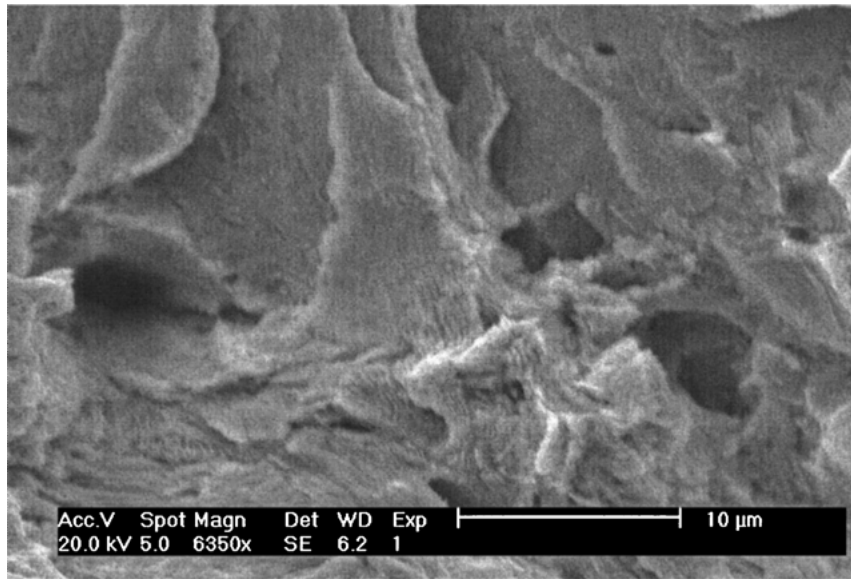
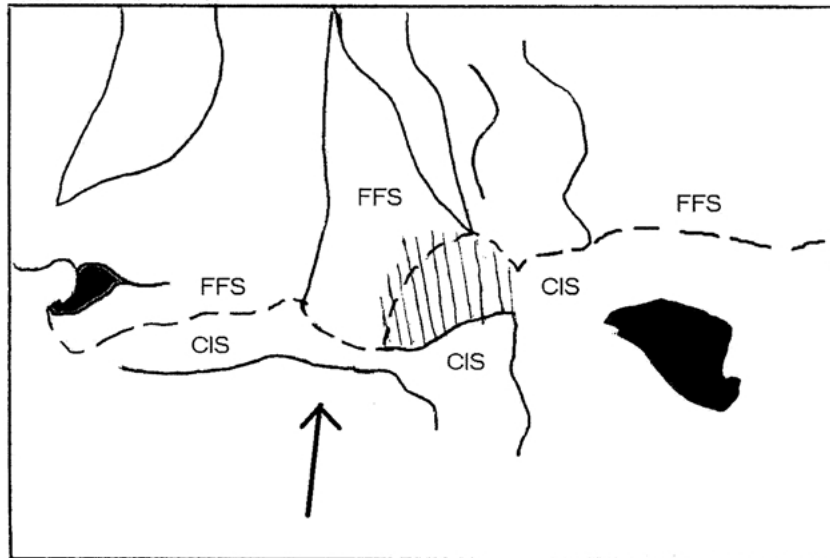
Figure 11 Higher magnification view of region A of Fig. 10 ($\times 6350$).

Fig. 11 shows the pearlite colony orientation across the interface line. The diagram shows that the pearlite colony in the centre of the figure was aligned with the direction of the crack propagation. There was a clear imaginary line separating the coarse ridged area of the CIS and the smoother FFS. The pearlite colony lamella

appeared coarser (grooves were more marked) in the CIS region, with the lamella of the same colony appearing smoother in the FFS region. This indicated that the fracture mechanism changed from CIS to cleavage in the middle of a pearlite colony in a very abrupt manner, indicating no third mechanism. At first sight it appeared that this coarser appearance of the lamella within the CIS region was due to preferential corrosion of one of the phases. This hypothesis was discarded as lamella near the free fracture surface would then be more markedly ridged as they would have been exposed to the electrolyte for longer periods of time, but this was not the case. The similarity of ridge depth at the interface and the free surface suggested that the coarseness was due to the fracture mechanism itself.

(a) SCC-FFS interface showing pearlite colony direction

(b) Schematic view showing SCC(CIS) and FFS regions. Parallel lines show pearlite colony orientation. Large arrow shows crack growth direction.

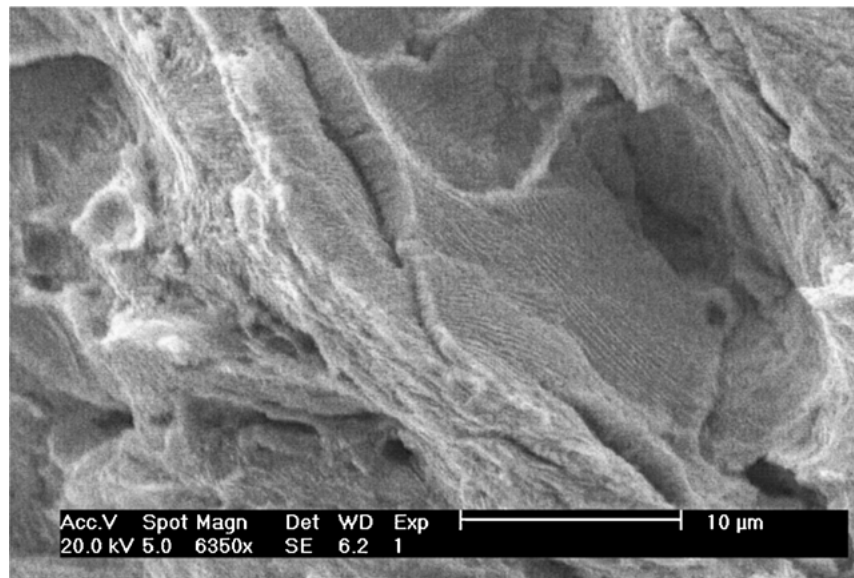
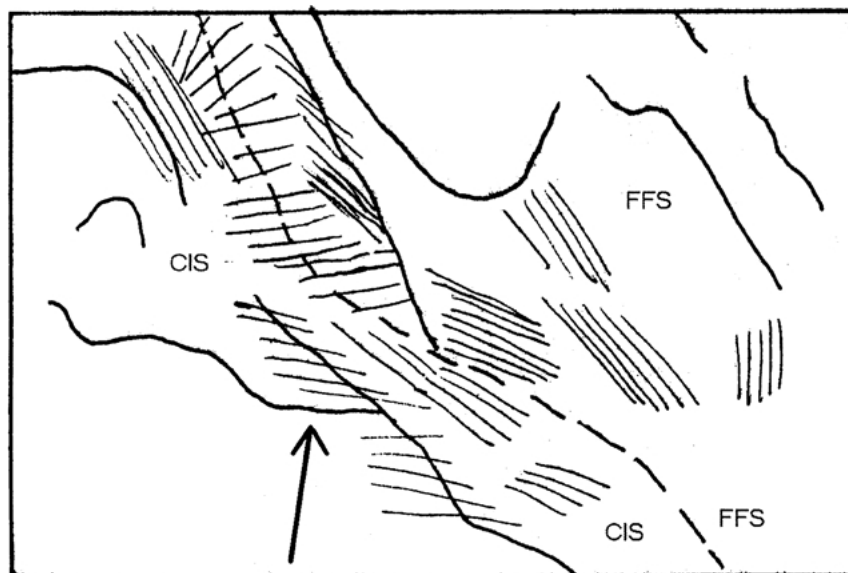
Figure 12 Higher magnification view of region B of Fig. 10 ($\times 6350$).

Fig. 12 shows the opposite. The diagram indicated that the pearlite colony direction towards the top of the

figure was perpendicular to the crack propagation direction. Towards the bottom of the figure the pearlite colony direction was not quite perpendicular to the crack propagation direction, but nevertheless it was at a high angle. The fracture mechanism changed from CIS to cleavage while the crack propagated perpendicular (or close to perpendicular) to pearlite lamella direction. Again a smooth transition suggested that there was no third fracture mechanism involved in the change over. Moreover, there was a change from CIS to FFS in the middle of a pearlite colony.

(a) SCC-FFS interface showing pearlite colony direction

(b) Schematic view showing SCC(CIS) and MVC regions. Dashed line shows interface. Parallel lines show pearlite colony orientation.

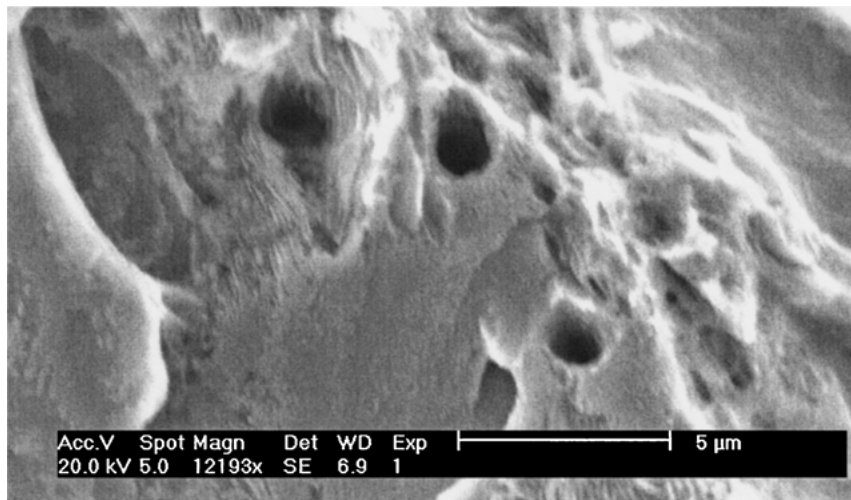
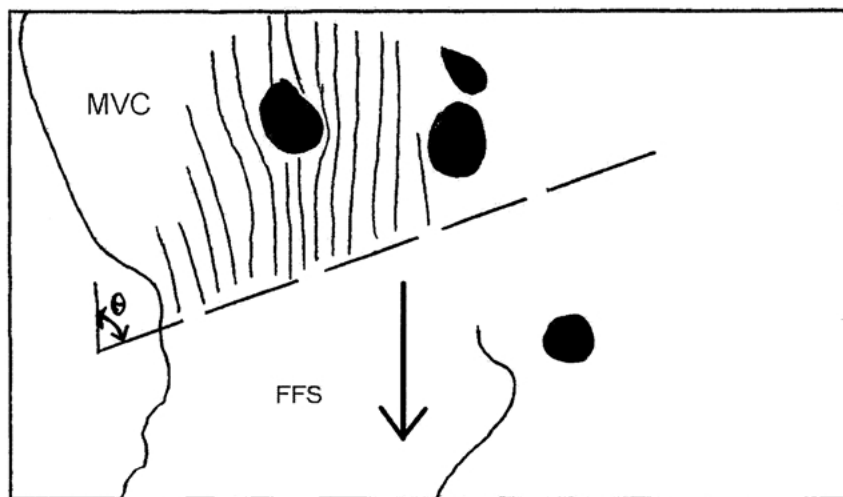
Figure 13 Typical MVC-FFS interface ($\times 12193$).

Fig. 13 shows the pearlite colony orientation across the interface. Fig. 13 also shows that the pearlite lamella was oriented parallel to the crack propagation direction and the interface was at an angle θ to that direction. The transition of MVC to FFS was smooth without a third mechanism. Fig. 14 shows an interface where the MVC side showed shallow dimples on a flat surface. There were several different pearlite colonies within this flat region, with different orientations. Fig. 15 shows another interface. This time pearlite

(a) MVC-FFS interface

(b) Schematic view showing MVC and FFS regions. Parallel lines show pearlite colony orientation. Large arrow shows crack growth direction.

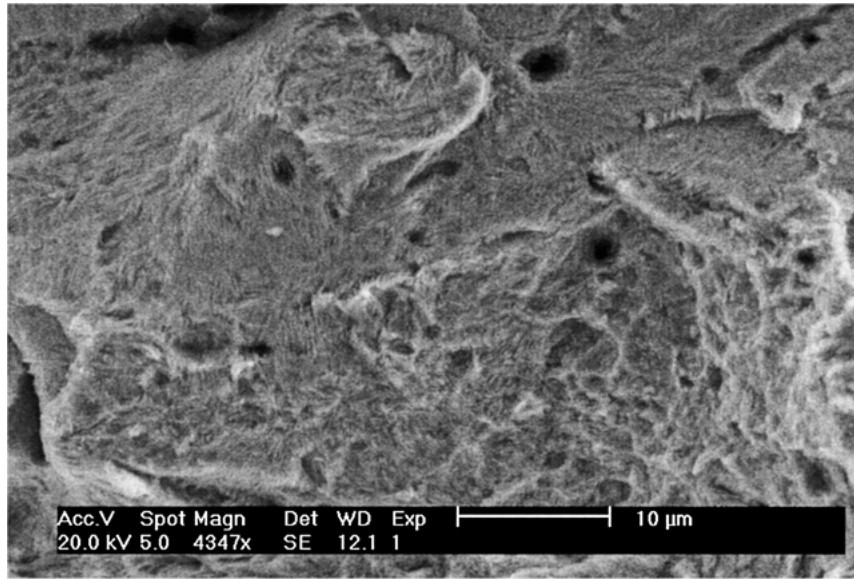
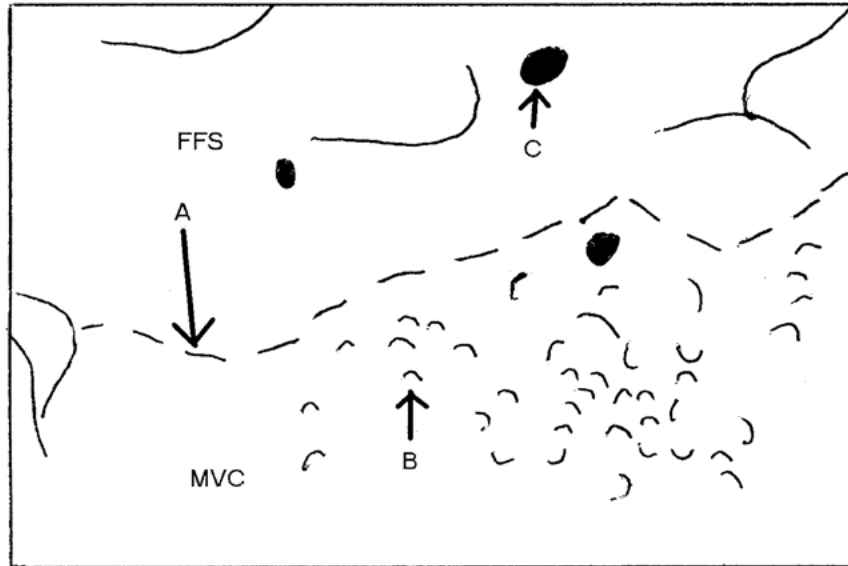
Figure 14 Flat region within the SCC-FFS interface ($\times 4347$).

(a) High magnification image showing pearlite structure

(b) A: Dashed line showing MVC-FFS interface, B: MVC dimples, C: Holes

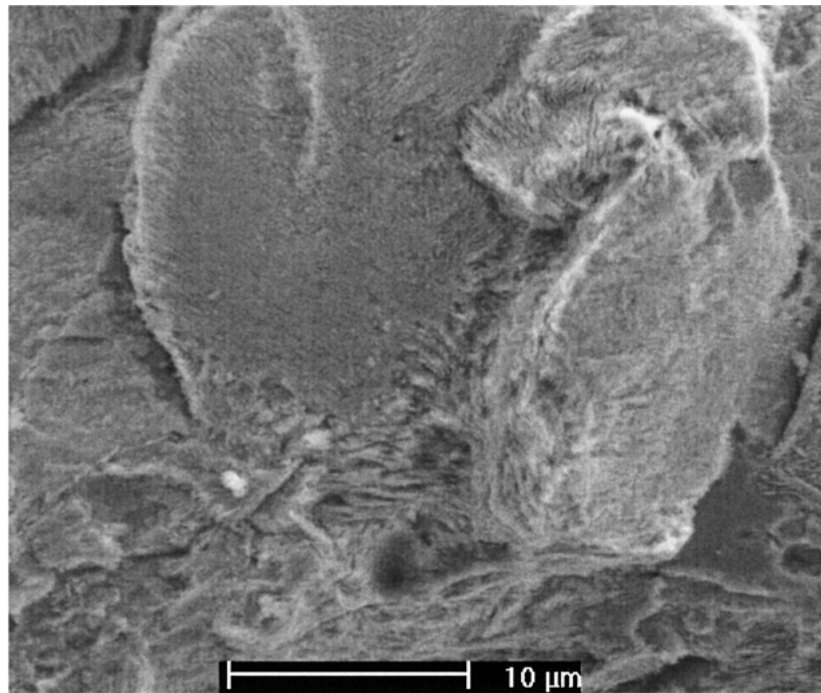
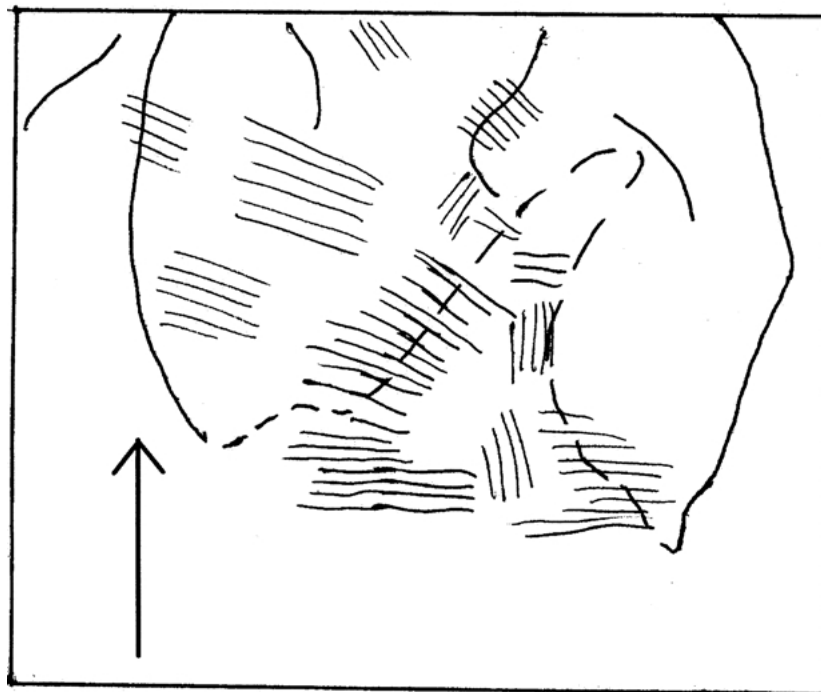
Figure 15 SCC—fast fracture interface.

colonies were aligned perpendicular to the crack direction, and the fracture mechanism changed within these perpendicular colonies. The change over was again smooth. Another point of note was that fast fracture tear lines were in close proximity to the interface line (as in Fig. 15). At times, these tear lines occurred within the same pearlite colony that displayed a change in fracture mechanism. Hence, the same colony with a single lamellar orientation could display a mechanism change as well as tear lines regardless of the pearlite orientation.

(a) High magnification image showing pearlite structure

(b) Dotted line is the SCC-FFS interface. Parallel lines are pearlite colony orientations. Large arrow is crack growth direction.

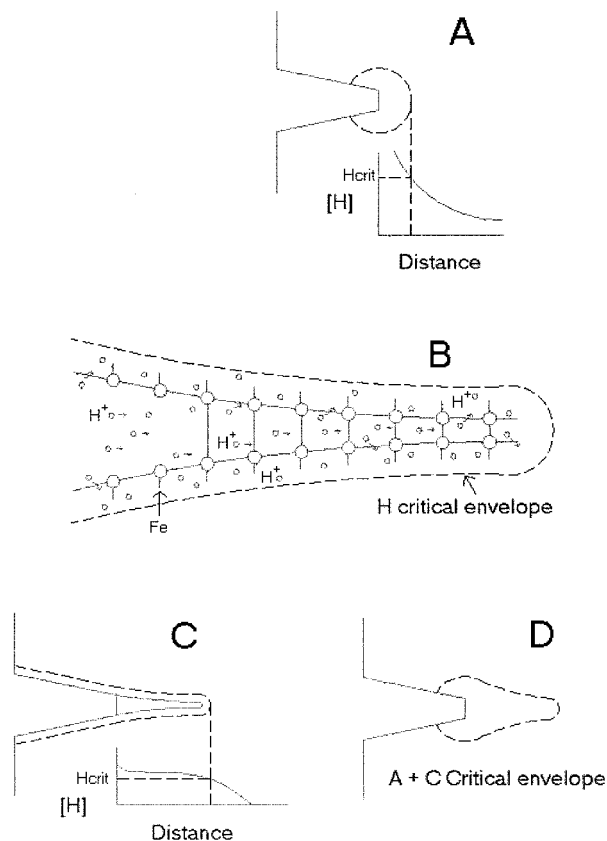
Figure 16 Critical hydrogen envelope.

The resulting region of critical hydrogen concentration resembled the shape of a flame, as illustrated in Fig. 16. This shape was the result of two effects. The first effect was the diffusion of hydrogen into the material, driven by the concentration gradient and the triaxial stress at the crack tip. The region of hydrogen concentration due to the concentration gradient was a sphere around the crack tip, as shown in A. The second effect was due to the tensile stress present. The tensile stress (lower than the yield stress) caused the atomic bonds to

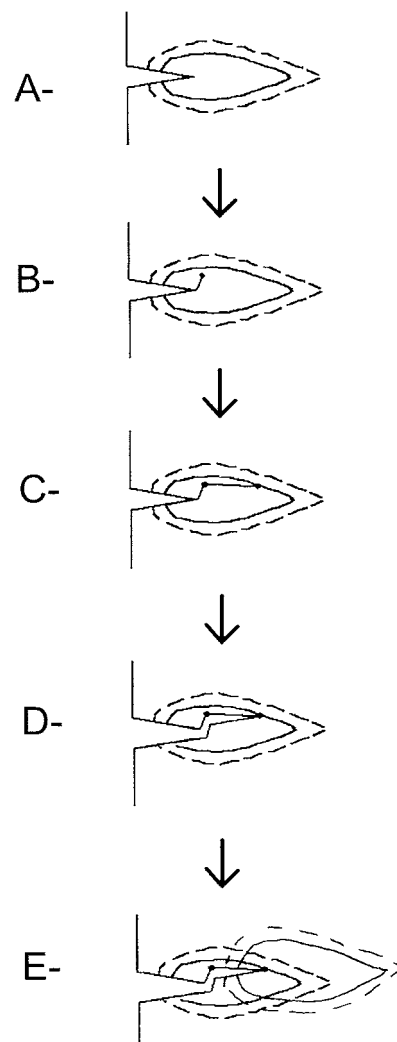
Figure 17 Slow crack growth propagation.

Fig. 17 presents the suggested mechanism for crack propagation within the embrittled region:

(b) The crack propagated in a random direction with the tendency of staying within the brittle region. Crack propagation at a high angle away from the perpendicular corresponded to a CIS slope on the fracture surface. Overall the fracture surface was perpendicular to the applied stress. The CIS slopes made significant

(c) The crack turned and grew directly into the material due to the tensile stress, aided by the larger embrittled region directly in front of the crack. The crack was arrested when it extended beyond the brittle region. This phase corresponded to a long flat region, hence a plateau. Due to the nature of the SEM it was difficult to determine the angle the plateau made to the

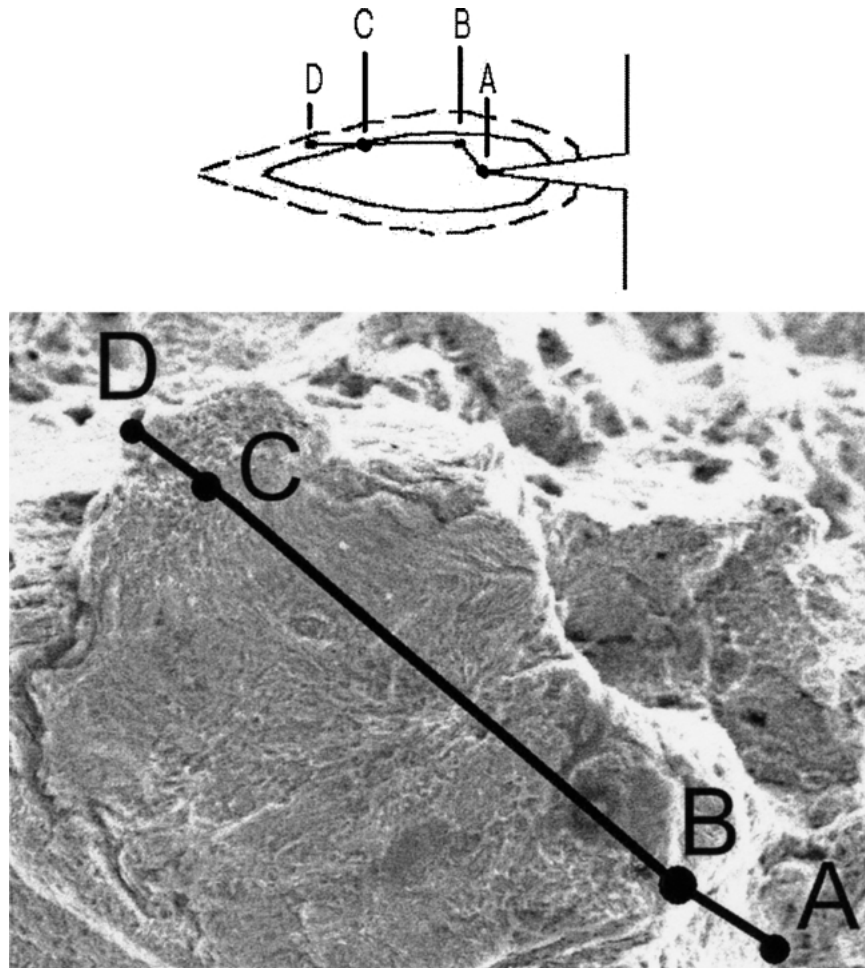
Figure 18 Crack path related to microstructure.

Fig. 18 relates the fractography to the proposed mechanism. Point A corresponds to prior crack arrest. The hydrogen brittle envelope was developed around point A. Once the hydrogen concentration became critical, the crack grew from point A to point B at a random angle, producing a CIS slope. Subsequent crack propagation was across a region of high hydrogen concentration towards point C in a straight line. As the crack travelled it cuts across pearlite colonies indiscriminately, following the region of highest hydrogen concentration. At point C the hydrogen concentration fell below the critical level. As the crack propagated beyond point C it started to be arrested, coming to a stop at point D. The resulting fractography from point B to D was the flat plateau (mildly corrugated due to the pearlite colonies) from B to C, and the shallow dimpled MVC region between points C and D.
