## Investigation of blade failure in a gas turbine<sup>†</sup>

Yeon-Sun Choi<sup>1,\*</sup> and Kyu-Hwa Lee<sup>2</sup>

### Abstract

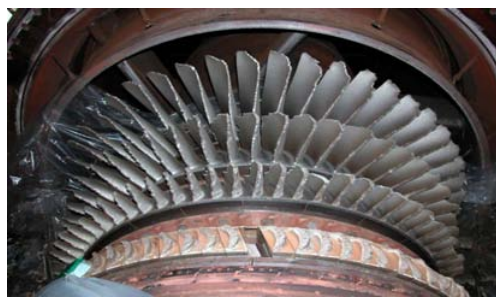
morning start-up period. Out of a total of 81 blades in the first row, only one blade was broken at its root area, and the freed upper platform part was found in the bottom of the exhaust section. Almost all the blades and vanes of the subsequent rows and other areas of the machine also suffered extensive damages by the shock and flying fragments of the blades as shown in Fig. 1(a). The heart of the damage was easily traced to the blade, which was the only blade that was broken at the root as shown in Fig. 1(b). Within a fraction of a second after the blade broke away, the neighboring blades and vanes were subjects to breakage. The debris from the blades and vanes flew in all directions, causing a chain reaction of damage.

(a) Broken rotor from the first to the fourth row blades

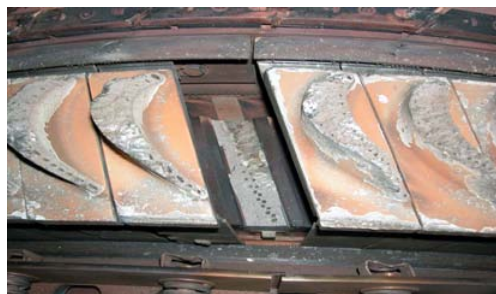
(b) Broken blade in the first row

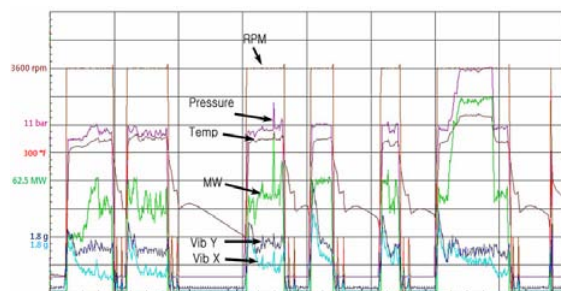
Fig. 2. Operational data during breakage.

Fig. 2 shows recorded operational data such as the pressure and the temperature of combustion gas, the rotational speed of rotor, the generated electric power and the vibrations of the turbine. The start-up operation of the turbine in the morning of the failure was not particularly different from those of the prior week. However, the day before the failure, the amount of electricity produced was at 100% of turbine capacity, where roughly 50% capacity was produced on other days. The vibration level was slightly higher than on the previous day.

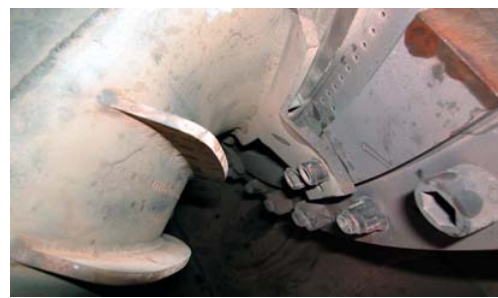
Fig. 3. Transition piece and bracket.

In this case, the damage to the transition pieces was relatively minor compared to other parts as shown in Fig. 3. All 14 transition pieces and their holding bolts were intact with bent brackets and thin gaps between the transition piece and the turbine body after the accident. These findings are the greatest difference from the two other recent turbine failure cases, where the transition piece bolts were found broken after the respective accidents. The only reasonable explanation for the bending of these brackets is the powerful reverse flow of gas due to the abrupt explosion inside of the turbine.

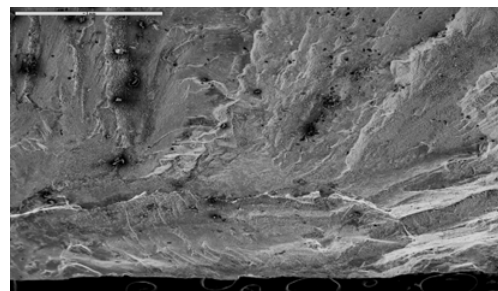
(a) Crack origins at fracture surface

The fracture surface of the failed blade root was examined by a scanning electron microscope (SEM). Fig. 4(a) shows the areas where the crack began. The primary crack was branched laterally, and numerous secondary cracks appeared to have developed simultaneously. It is considered that multiple origins of cracks nucleated independently on the top serration surface that was in contact with the disc.

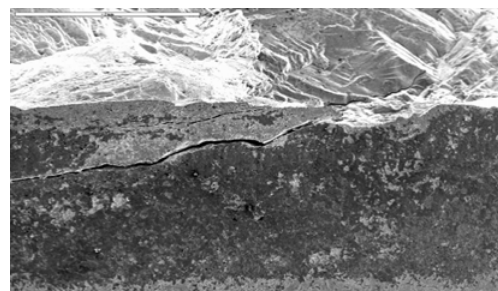
(b) Crack initiations at top serration surface

Fig. 4(b) shows the midpoint of the crack from start to final rupture demonstrating representative morphology of crack propagation. Most of the fracture surface prior to the final rupture shows granular cleavage, or faceted fractures with river lines and ratchet marks. Occasionally beach marks and fatigue striations were also visible indicating that non-ductile fatigue cracking was the means of crack propagation. The location of fatigue crack initiation is generally related with the stress concentration; however, it is hard to explain where the stress concentration originated. Stresses were calculated to determine the location where the maximum stress occurred.

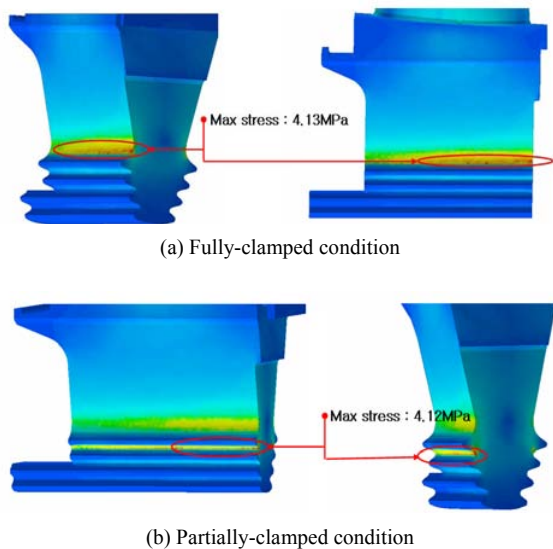
Fig. 5. Maximum stress distribution depending on clamp conditions.

Pressure profiles were developed for nozzle wakes, transition piece wakes and flow distortion. Stresses were calculated for a fully-clamped condition, and for the case which the upper portion of the blade was not clamped, based on the assumption of the existence of a small clearance between the blade and the rotor clamp. It means that if the location of the crack initiation coincides with that of maximum stress at the condition of partial clamp, we can conclude that the looseness between the blade and the rotor clamp was the source of the crack initiation. The bending stress due to the pressure profile on the airfoil and the tensile stress due to the centrifugal force during rotation were calculated and combined using SAMCEF software [10]. The pressure was given as 13.7 psi according to the specification of the turbine. The results show that the maximum stress of the fully clamped case is marginally greater than that of the partially clamped case as shown in Fig. 5(a) and Fig. 5(b). And the location of the crack initiation coincides with the position where the maximum stress was occurred in the case of fully clamped in Fig. 5(a). It means that the blade was fully clamped until the breakage. This stress concentration could lead to the initiation of crack and the dynamic situation during operation would tend to enlarge the size of the crack over time.

As the stress analysis shows, the primary cracks at the blade started from the top serration surface, and initially propagated into the blades perpendicular to the exterior surface, and then changed direction horizontally. In addition to the primary crack that eventually led the blade to final rupture, a few secondary cracks were also visible at the top serration surface as illustrated in Fig. 6. When minute elastic deflections or slight motion actually occurs, the cyclic motion of extremely small amplitude is enough to cause micro welding on both surfaces. Fretting wear occurs on mating surfaces that are essentially stationary with respect to each other. Fatigue crack can be initiated on these contacting surfaces. Fretting wear took place

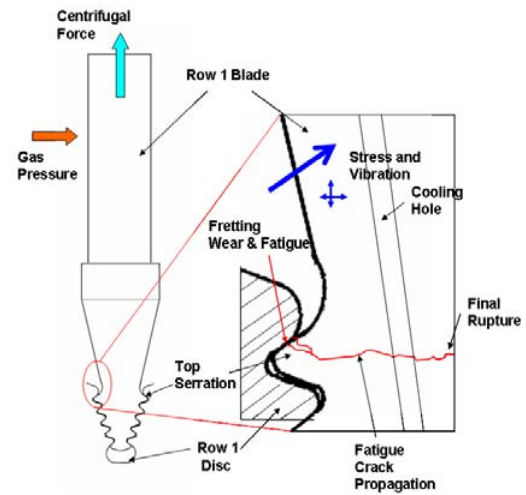
Fig. 6. Illustration of fretting fatigue crack initiation and propagation.

on both the pressure (concave) side and the suction (convex) side of the blades. The crack from the current accident initiated on the pressure side, but blades in the two previous cases were actually cracked at the suction side top serration contact borderline.

- (1) Excessive fretting wear occurred on the mating surfaces of the blade root serration and the disc. The contacts were essentially stationary with respect to each other but when slight movement occurred, the cyclic motion of extremely small amplitude was enough to cause micro welding on both surfaces. Fatigue cracking was initiated on the contacting surfaces.

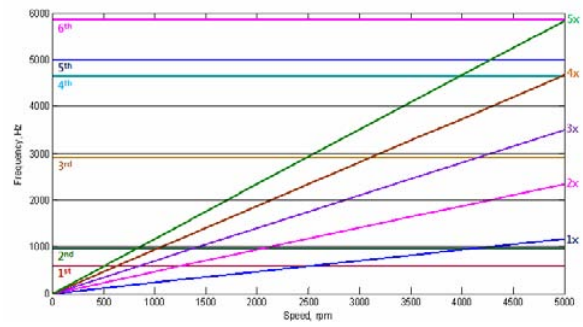
Fig. 8. Campbell diagram.

possible. The results show that there are too many natural frequencies compared to those of one blade. There are various types of mode shape depending on the natural frequencies; some of mode shapes show large deflection, some are in the same direction and others are in the opposite direction of the neighboring blades. Interference diagram [13, 14] can be used to avoid the potential excitation of a particular mode of vibration for turbine blades, thus reducing the risk of fatigue failures. Such diagrams are an excellent tool with which to combine information on blade natural frequencies and mode shapes, excitation sources and the operating speed of the machine on the same graph. In interference diagrams, the condition of resonance for the bladed disk is that the natural frequency of the bladed disk must be equal to the frequency of the exciting force and the number of nodal diameters must coincide with the harmonic of the force  $n$ . Nodal diameter is a sinusoidal diametric pattern of the displacement of the tip of each blade when plotted with angular position. Each nodal diameter mode shape occurs in a pair. The maximum number of nodal diameters in a bladed disk assembly is half of the number of blades for an even number of blades. For a disk having an odd number of blades, the maximum nodal diameter is half of the total number of blades minus one. Our turbine has maximum 40 nodal diameters as shown in Fig. 9. It shows that the natural frequencies of the first, fourth and sixth nodal diameters produce the frequency close to those when it runs 3600 rpm with the consideration of 14 nozzles. This is the crucial conjecture of this accident. However, if this conjecture is correct, this gas turbine could not sustain for longer period

- (2) To avoid resonance, excitation frequencies during normal operation condition should be far from the natural frequencies of the structure which can be checked by using Campbell diagram and Interference diagram. The Campbell diagram for one fixed blade shows that the closest intersections of frequencies and significant integral order excitation components were not found. The Interference diagram shows that some modes of the blade assembly are close to a resonance condition. However, this alone is not sufficient since the blade natural frequencies can be affected by operating load and firing temperature.

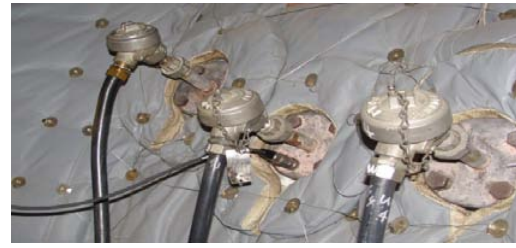
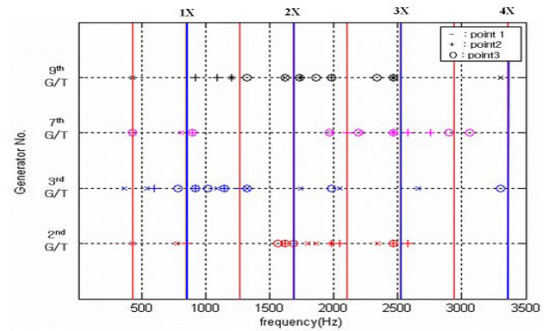
Fig. 10. Vibrations of the gas turbine during operation.

The gas turbine has 14 transition pieces, and each transition piece has one nozzle. The gas turbine runs at 3600 rpm in normal operation. Therefore, the possible fundamental frequency of the vibration can be 840 Hz. The Fourier coefficient of the impulse-like vibration signal can have multiple order of the fundamental frequency.  $1/2x$ ,  $1x$ ,  $2x$ ,  $3x$ ... components can appear. The frequency of the measured vibration should be the same since the gas turbines are the same specification and the measured points were the same. In this respect, the vibrations of the four different gas turbines (G/T 2nd, 3rd, 7th, and 9th) at the site, which have the same specifications, were measured using 3 accelerometers at the surface of the turbine casing in operation as shown in Fig. 10(a). However, Fig. 10(b) shows different frequency components depending on the measured position even in normal operation condition. And the multiple order of the fundamental frequency is hard to find in its frequency component. This implies that there are factors affecting the operation condition inside the combustion chambers of the gas turbine, and the operation condition, especially the combustion process inside the chamber, is completely different though the gas turbines have the same specification.

The combustion process can easily be unstable and show different spectra depending on burning conditions. Considering that the blades were in operation for more than 6 years, the fatigue fracture of the blade originated probably during transient events and not during continuous stable operation under vibratory stresses. As shown in Fig. 2 of the monitored signals, the gas turbine was operated with full capacity on the previous day just before the breakage. That was the final test after the overhauling. It is believed that the full operation on the previous day led to more unstable combustion process. Nevertheless the monitored vibration signals at the designated bearings do not show any special indication as the operation condition changes. These monitored signals represent the operation condition of the rotor only, not the combustion chamber. Therefore, it is recommended that the condition monitoring should include a larger variety of signals.

- (3) The vibrations measured on four different gas turbines of the same specifications during stable operation show different frequency components. Considering that the real blades were in operation for more than 6 years it may be concluded that the dynamic characteristics of the blades such as mechanical resonance did not contribute to blade failure. The fatigue fracture of the blade was probably originated during transient events and not during continuous stable operation under vibratory stresses. The combustion process can easily be unstable and show different spectra depending on burning conditions. As a result, high vibratory stresses could be developed in the blades structure. It is believed that the full

(4) Considering the extent of damage of current blade failure, it is difficult to think that the operators had no means of detecting and preventing the failure before it actually happened. It is noted that a more precise turbine rotor vibration monitoring technique must be developed and used for safer operation.
