Investigation of plasma facing components and vacuum vessel in RFX

P. Sonato ^{*}, V. Antoni, M. Bagatin, W.R. Baker, S. Peruzzo, L. Tramontin, P. Zaccaria, G. Zollino

Padova Fusion Research Group (EURATOM–ENEA–CNR–Università di Padova) Istituto Gas Ionizzati – CNR, Corso Stati Uniti 4, 35127 Padua, Italy

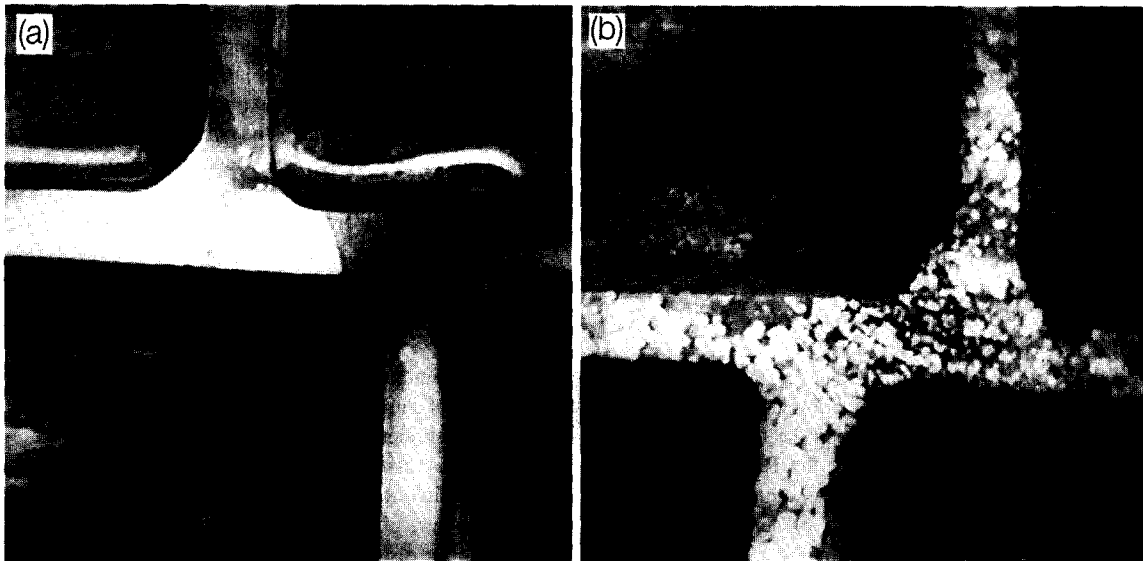
Localized erosions are evident at the edges of some tiles and graphite caps exposed to the superthermal electron flow along the poloidal direction [6,8] (Figs. 1 and 2). This erosion preferentially takes place on the graphite tiles located in the lower part of the vessel (Fig. 2a) at the two poloidal gaps.

In the upper part of the vessel (Fig. 2b) erosion from unipolar arcs and redeposition appear to combine in such a way that it is difficult to discern the original graphite surface and the direction of the arc tracks.

The vacuum vessel surface that is not protected by the tiles shows damage correlated to those of the graphite tiles: In correspondence to the localized erosion in the lower part of the vessel, ‘grooves’ in the metal surface along the poloidal direction, consistent with the flow of superthermal electrons, are observed (Fig. 2a) with a maximum depth of 0.2 mm, measured with a potentiometric transducer installed on the RHS.

In correspondence with the uniform erosion of the graphite, in the upper region of the vessel, the metallic surface is so rough (Fig. 2b) that it has not been possible to measure the depth by the potentiometric transducer. This phenomenon extends in both the poloidal and toroidal interspacings between the tiles.

Fig. 2. Damage on the vessel surface and graphite tile edges in the poloidal gap region observed by means of the CCD camera installed on the RHS. The horizontal and vertical directions correspond to the toroidal and poloidal directions, respectively. (a) Lower part of the vessel. (b) Upper part of the vessel.

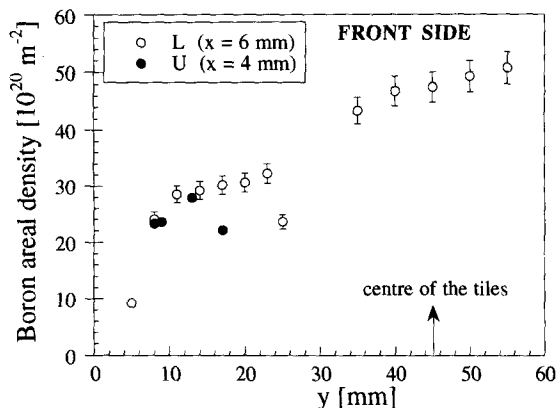
A local coordinate system was chosen with the x axis in the toroidal direction, the y axis in the poloidal one and with the origin at the corner of the graphite tiles exposed to the superthermal electron flow. The boron concentration on the front side along the poloidal direction (Fig. 3) increases by a factor of 5 going from the edge of the tile to its centre, confirming a severe erosion at the edge of the graphite exposed to the superthermal electrons [6,8]. It is worth noting that the areal density in the centre of the tile is in agreement with the quantity expected after 4 boronizations. The boron redeposition measured on the rear of the tiles varies along the poloidal direction and it is maximum near the most eroded areas. The redeposition thickness along the toroidal direction shows a decay length of about 9 mm independent on the poloidal coordinate.

Fig. 3. Boron areal density measured on the front side of the tiles along the poloidal direction y .

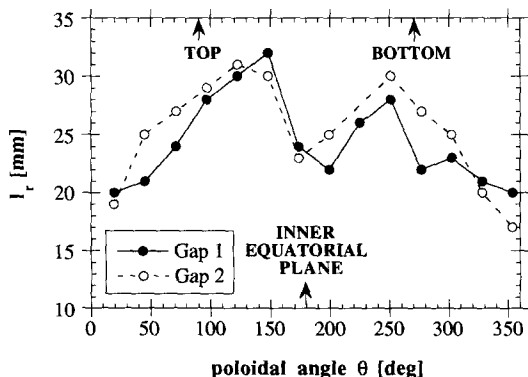
The inspection of the rear side of the 112 graphite tiles has revealed a non uniform redeposition of carbon and boron with a clear asymmetry in the toroidal direction with a maximum on the edge facing the ion diamagnetic drift. The toroidal extension of the redeposition, l_r , evidences a poloidal dependence for the tiles around the two poloidal gaps not affected by localized erosion (Fig. 4). The surface analysis of long term stainless steel samples exposed in the RFX scrape-off-layer has shown that the redeposited layer mainly consists of carbon. With this assumption, the analysis of the interference colours [10] indicates thickness values higher than 800 nm depending on the angle θ along the poloidal direction. The comparison with the local erosion of the tile edge confirms that most of the particles released by thermal erosion are redeposited locally [8].

Fig. 4. Toroidal extension of the redeposition, l_r , as a function of the poloidal angle θ , on the rear side of the tiles along the two poloidal gaps.

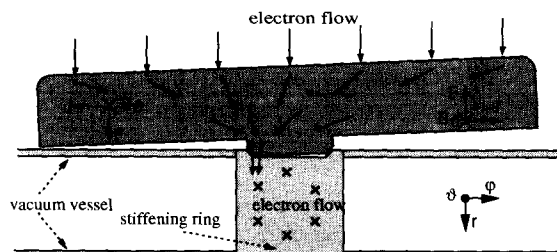
Fig. 5. Tilting force on the tiles due to halo currents.

A rough estimate can be made of the minimum current required to flow through a tile in order to tilt it as described in Fig. 5. With the maximum value of the poloidal component of the magnetic field (0.32 T), a minimum current of 2 kA has been deduced.

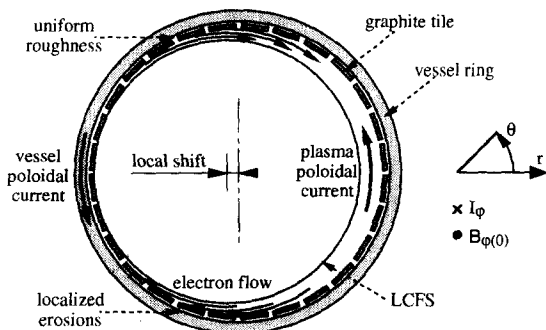
The origin of halo currents in RFX can be ascribed to the effect of a radial displacement of the plasma column due to the magnetic field deformation induced by mode locking. The phenomenon is toroidally localized with an extension of approximately 1/10 of the major circumference, as derived by CCD camera images and magnetic measurements [7,15]. Unlike tokamak devices, where the poloidal component of a halo current is due to disruptive events [16], in RFX a large poloidal current in the outer part of the plasma column is always present, being necessary for the maintenance of the RFP configuration. Because of a radial deformation of the column, a particle flow can collide with the first wall and the current follows the path of the least electrical resistance in the structure, reasonably coming back into the plasma after about half a poloidal circumference in the vessel (Fig. 6).

Fig. 6. Hypothetical halo current path in RFX.

extension of the plasma-wall interaction observed with the CCD cameras in the mode locking region. Assuming a current of 3 kA flowing in the vessel through 3 ÷ 4 tiles per stiffening ring and 5 rings, invested by the locked modes, a total halo current of approximately 50 kA is estimated. This value corresponds to about 10% of the toroidal current. Considering the electric resistance of the assumed path of the current in the structures, a total power dissipation of about 1.5 MW can be estimated, as a minimum reference value.
