Damages of hot-pressed boron carbide during solid target boronization in Uragan-3M torsatron

Abstract

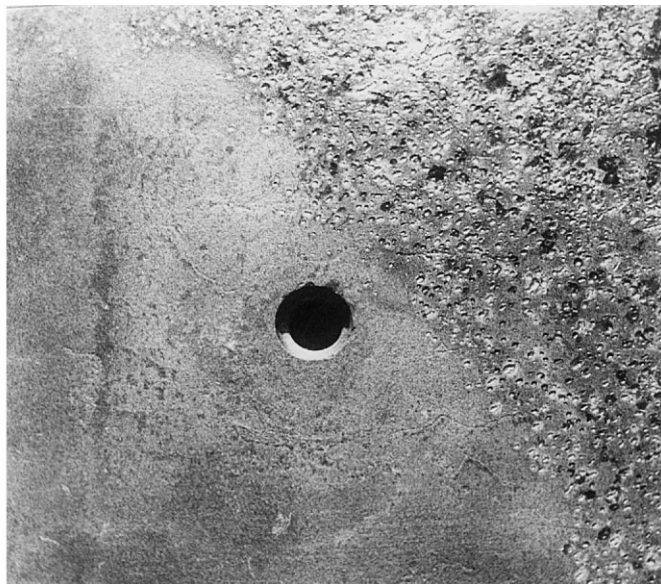
Fig. 1 shows the total view of this B_4C -plate. Many craters and spallings of different sizes on that part of the sample surface which have had the direct contact with an edge plasma are seen. Damages of similar kind but with lower intensity and density are present also on the sides and even on the back surface of the plate.

Fig. 1. The boron carbide head plate of the movable limiter exposed to the arc-regime of STB.

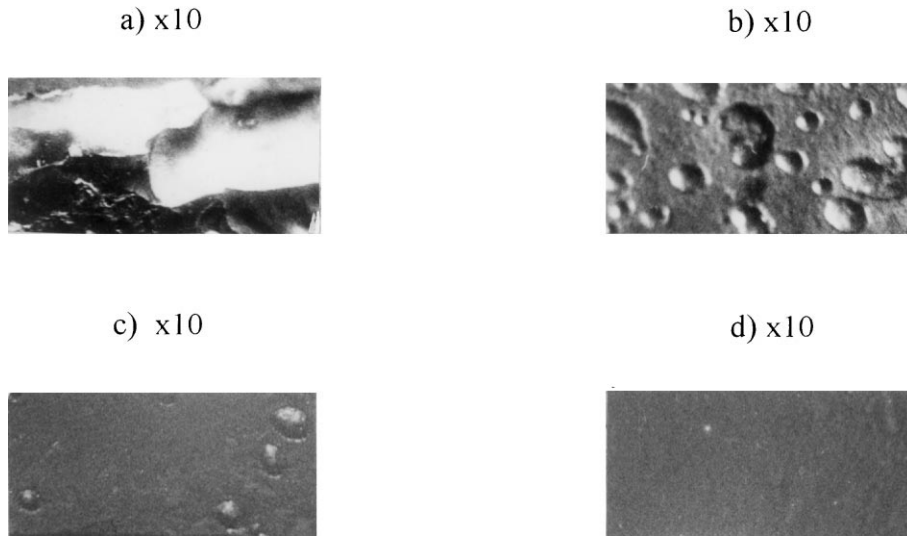
The most damaged are those plate edges which were located during the experiment at the nearest distance from the plasma axis (Fig. 2(a)). There are observed not only craters but also partially melted spallings. In contrast, there are only craters on the sample surface located far away from the plasma axis (Fig. 2(c)). The total number of craters (without spallings) on the sample surface as a function of their average diameters is presented in Fig. 3. As it is seen, the size of the majority of craters ranges between 0.1 and 0.5 mm. Smaller sizes of craters than those observed in work [2] can be explained by a difference in boron carbide surface temperatures during the tests. Fig. 4 shows the crater density distribution on the damaged surface. The decrease of the crater density value at the nearest dis-

tances from the plasma column axis is explained by appearing the numerous spallings which demolish the craters.

Fig. 2. The character of B_4C -plate surface damages for different distances r from the plasma column axis: (a) $r = 10.5$ cm; (b) $r = 11.5$ cm; (c) $r = 13.5$ cm; (d) $r = 14$ cm.

The arc causes a local abrupt overheating that, taking into account the rather low thermal conductivity of the boron carbide, can lead to a thermoshock and, as a result, can give rise the thermal stress cracking and spalling. It should be noted that earlier [3] we have observed the “spalling” kind erosion for the hot-pressed boron carbide after its exposure to high power pulsed fluxes of a hydrogen plasma when the whole irradiated surface became to be coated with a shelling layer as a result of spallings. In the case of the arc-regime of boronization, when we have a local heating in the regions of cathode spots, the spallings are most probable at the points of
