Journal of Nuclear Materials 273 (1999) 334–337

Letter to the Editors

# Modification of microstructure and the alligatoring damage in a modified 9Cr–1Mo steel

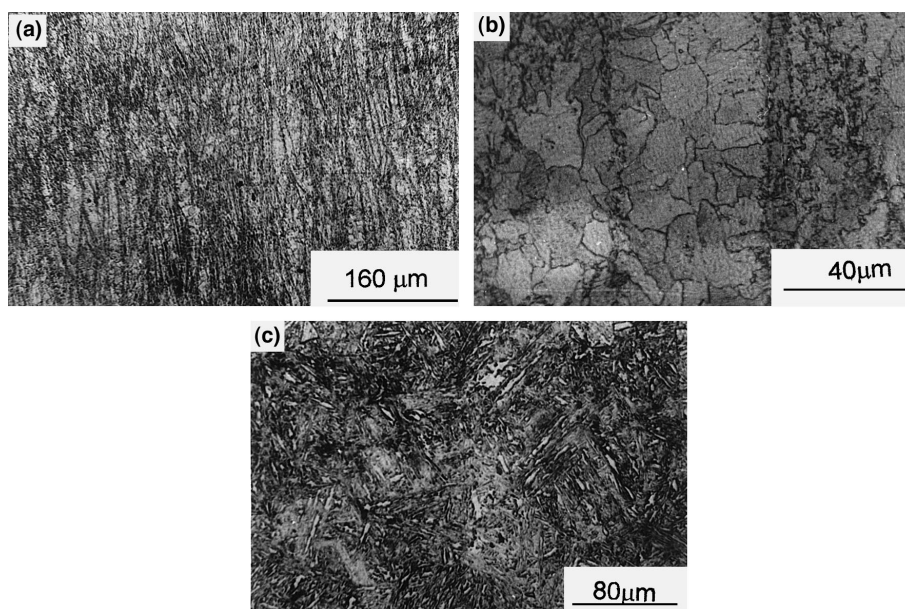
The modified 9Cr–1Mo steel was received as a hot rolled billet with square cross section of  $120 \times 120$  and 240 mm long, the chemical composition for which is given in Table 1. The as-received (designated as AR) microstructure shows severe banding along the transverse direction of the billet (Fig. 1(a)). These bands under higher magnification could be resolved to be rows of segregated globular carbides (Fig. 1(b)). Plates of  $120 \times 120$  and 20 mm thick sliced from this billet along the transverse plane were used in this investigation. One lot of the plates were given a  $1100^\circ\text{C}$  (1 h) normalising and a tempering treatment at  $710^\circ\text{C}$  (1 h) (designated as 710T). The normalising treatment results in complete dissolution of the carbides and the 710T microstructure

Fig. 1. Microstructure of the 9Cr–1Mo steel billet in transverse direction. (a) AR condition at lower magnification; (b) AR microstructure at higher magnification; (c) in 710T condition.

is typical tempered martensite, with no evidence of banding (Fig. 1(c)).

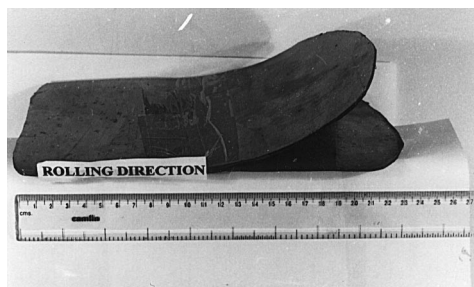
The phenomenon of alligating in this steel can be attributed to the presence of carbides lying as bands

parallel to the sheet rolling direction. The carbides in the centre plane of the plate are under tensile loading during the initial stages of rolling [2] and the voids nucleate at the carbide–matrix interface. The voids subsequently join up to form small cracks. As more voids accumulate, the crack extends in length, in the direction of rolling, with increasing strain (Fig. 3). The stresses in the plate are expected to reverse as the plates become thin [1]. This should cause tensile stresses away from the centre plane and the cracks should form in these planes as well at the carbide–matrix interface. Fig. 4 shows stable cracks in the planes away from the centre plane. The cracks are not expected to ‘heal’ in the course of rolling because of the carbide particles within them. The final failure is further assisted by the concavity developed at the front end of the sheet which can act as stress riser [2]. This acts as the initiation site for the alligating failure. The normal stresses that exist at the front end of the plate at the exit from the rolls, is sufficient to spilt the slab along the centre plane, which is already weakened by small cracks. Thus the failure is invariably along the centre plane of the sheet even if cracks are present in other planes as well.

Fig. 2. Failure of AR material by alligatoring after about 40% reduction at room temperature rolling.

It should be noted that the same material under identical rolling condition did not fail by alligatoring when the banded microstructure was eliminated by the 710T treatment. The precipitates formed by this heat treatment are much finer ( $0.1\ \mu\text{m}$ ) [6] than those in the AR condition ( $\sim 3\ \mu\text{m}$ , Fig. 3) and are distributed uniformly. These fine precipitates will not decohere easily and nucleating a void at the carbide–matrix interface is made difficult. Even when the voids form at the carbide–matrix interface, their chance of getting interconnected in to a crack is less because of uniform distribution of carbides. However, the alligatoring was reported in the 1090 plain carbon steel even when the spheroidised carbides were distributed uniformly. One probable reason for this difference in behaviour between the present and the reported work [2] appears to be the fairly large size of the carbides in the latter, which is susceptible to decohesion. It is difficult to comment at this stage on the influence of the carbide types on the strain to nucleate interfacial voids.

1. Alligatoring damage was found to occur in a modified 9Cr–1Mo steel if the microstructure was banded, due to segregated carbides and could be alleviated if the banded structure was destroyed through a conventional normalising and tempering treatment.
2. When the microstructure is banded by the segregated coarse carbides, the alligatoring damage is facilitated by the cracks formed by the inter connection of the voids at the carbides. The concavity at the front end can help in the final failure of the sheet. Trimming of the front end could not prevent the alligatoring failure.

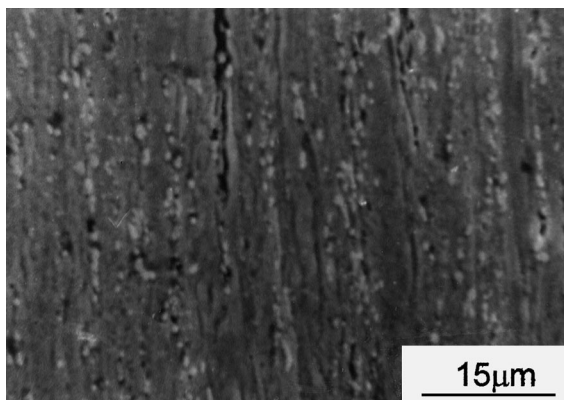
Fig. 3. Micrograph showing cracks associated with carbides.

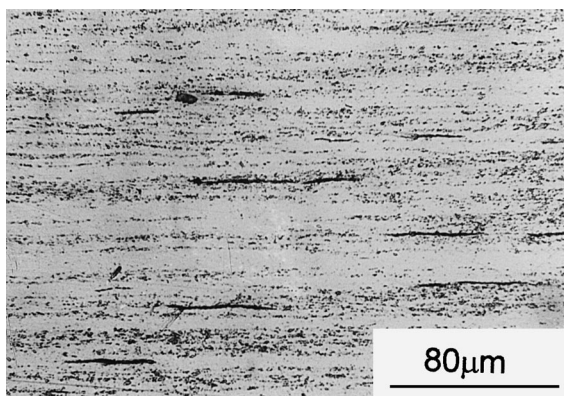
Fig. 4. Multiple cracks at planes away from centre in the sheet failed by alligatoring. These cracks remain stable and do not take part in final failure.
