Journal of Nuclear Materials 296 (2001) 139-144

The mechanical properties of an Alloy 718 window after irradiation in a spallation environment

M.R. James ^{a,*}, S.A. Maloy ^a, F.D. Gac ^a, W.F. Sommer ^a, J. Chen ^b, H. Ullmaier ^b

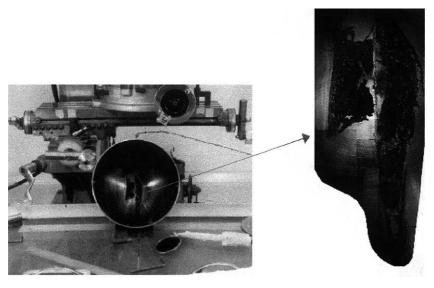
Disassembly of the window immediately revealed a scale adhering to the surfaces between the two shells in the vicinity of the beam center (see Fig. 2). The deposit was later determined to be copper in the form of a copper oxide (tenorite, CuO). The presence of copper in the cooling water was not unexpected as the same water loop is used to cool the copper beam stop. The deposition, in conjunction with other evidence including thermal-hydraulic analysis of the window [3], strongly suggests that boiling was occurring at this point in the window. Another feature of interest was the degradation of the spacer wire that separated the two shells. The wire that ran across the window center (and therefore the beam center) showed a reduction of cross-sectional area and a fracture near the window center. Disruption of the coolant flow by the serpentine arrangement of the wires, tack welds that held the wires and possible cross-flow conditions all served to exacerbate the hot spot and lead to boiling of the water and poor cooling in the window

Fig. 2. Images of deposit seen on interior cooling channel.
