# SNS target tests at the LANSCE-WNR in 2001 – Part II

J.D. Hunn <sup>\*</sup>, B.W. Riemer, C.C. Tsai

## Abstract

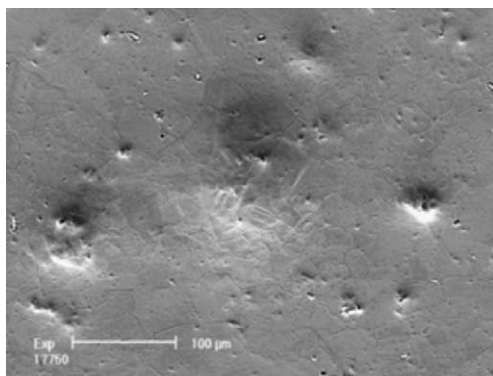
Evidence for the initiation of cavitation-induced erosion was found in the form of pits in the polished surfaces. These pits showed two distinct features, dishes and craters. Dishes were formed by inelastic deformation of the flat, polished surface. Fig. 1 shows a typical dish. Shadowing of the electrons collected by the secondary electron detector which sits at about a  $45^\circ$  angle

Fig. 1. Central pit shows typical dished depression. Deformation slip lines are evident. Material: annealed stainless steel.

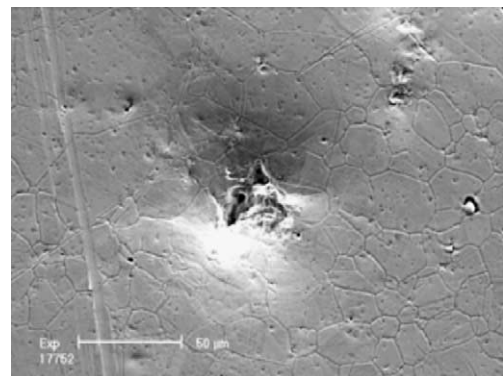
Fig. 2. Typical crater at the bottom of a pit. Material: annealed stainless steel.

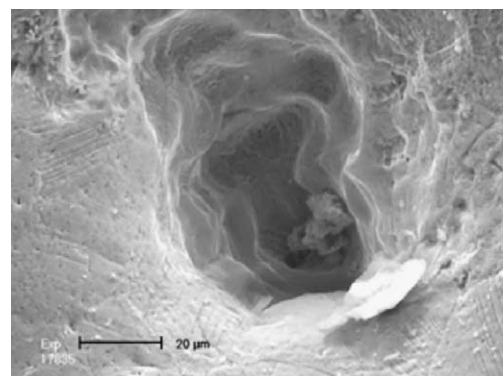
to the surface produces the light/dark shading that makes the pit topography visible. The parallel striations within each crystal grain are 'slip lines' formed by adjacent planes of atoms sliding over one another. This is evidence that mechanical deformation has occurred. Where the pits did not overlap, the dishes were typically round and symmetric, suggesting that they were formed by the collapse of a single bubble. The dark spots are relatively deep, sharp-walled craters out of which few, if any, secondary electrons reach the detector. Craters were formed by the forceful removal of material from the surface. These craters were found near the bottom of many of the dishes, especially the larger ones (Fig. 2). The shapes of the craters were very irregular and the side walls had a high aspect ratio. Fig. 3 shows a close-up image of a crater.

Fig. 3. Close-up of a typical crater exhibiting steep sidewalls. Material: annealed stainless steel.

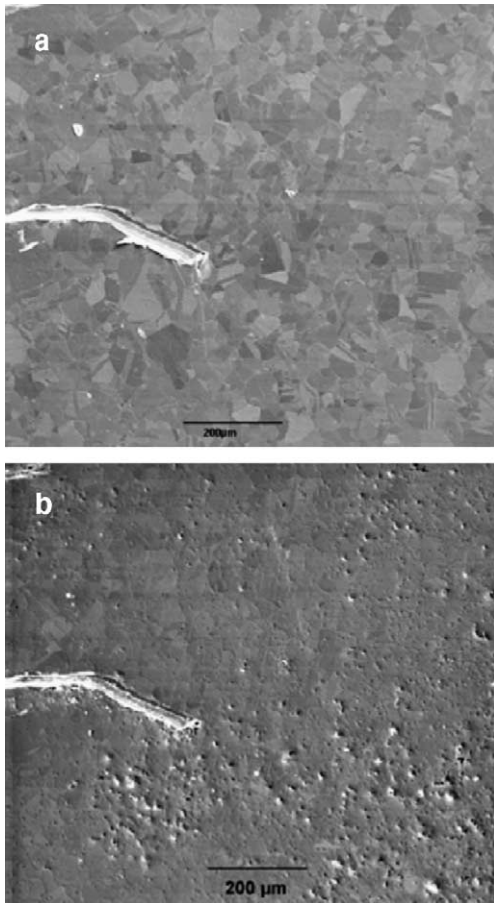
The two targets tested in July 2001, LE3 and LE4, were essentially identical, as described in Part I. Fig. 4 shows an area near the center of the front flange of LE3, a 1.5-mm-thick annealed 316LN stainless steel window.

Fig. 4. Just off center of LE3 front flange (a) before and (b) after 200 pulses. Material: annealed stainless steel.

Comparison of the pre- and post-irradiation images clearly shows evidence for surface pitting during the test. The 5–20  $\mu\text{m}$  pits in the upper half of Fig. 4(b) were typical of what were seen scattered over the entire surface. In the lower half of the figure can be seen a higher density cluster of slightly larger pits. This clustering was observed in several regions on the flange. One big cluster of especially large pits, up to 200  $\mu\text{m}$  diameter, could be seen even with the unaided eye. Part of this cluster is shown in Fig. 5. Laser profilometry showed some of these pits to be up to 70  $\mu\text{m}$  deep. Figs. 1 and 2 show some of these pits at higher magnification. This one area of heavy damage on the specimen, visible with the unaided eye, was a common observation in our tests. As discussed in Part I, we believe this heavy damage is a focusing effect related to the cylindrical shape of the target volume. This hypothesis is being tested in some ongoing experiments.

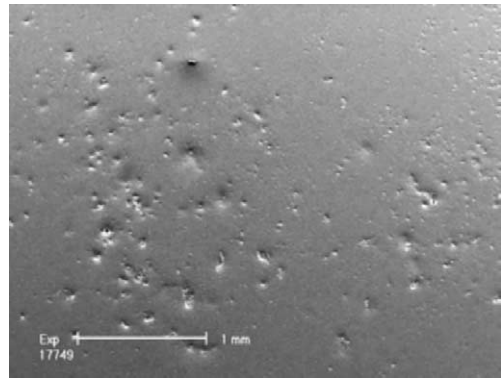
Fig. 5. LE3 front flange after 200 pulses, heavily damaged region. Material: annealed stainless steel.

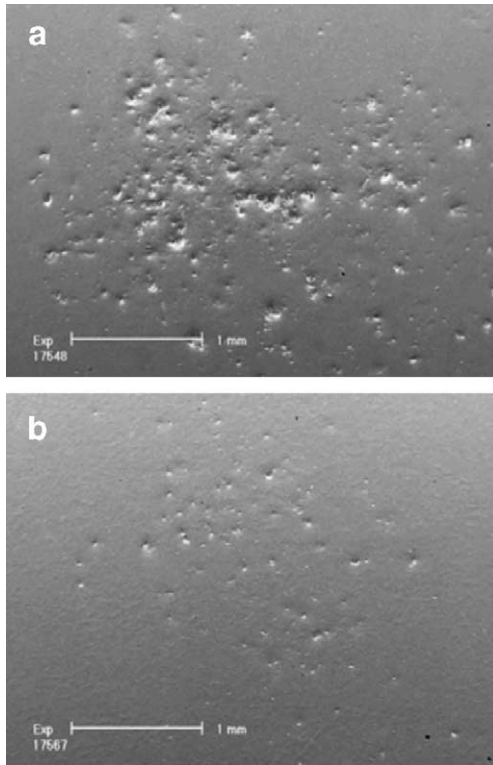
the LE3 front flange. The rear window of LE4 was surface hardened by the Kolsterization<sup>1</sup> process described in Part I. Small pits were not as obvious on the Kolsterized surface because there were more than a factor of 10 fewer of them (none in clusters), and partly due to the fact that the Kolsterizing treatment roughened the polished surface making inspection more difficult. In addition to a few isolated small pits, a cluster of larger pits was also seen on this specimen. Fig. 6 shows the heavily damaged area from the two rear flanges. Again, the flange from LE4 was not as heavily damaged as its counterpart due to the Kolsterizing surface treatment that increased the surface hardness by about a factor of 8. Qualitatively, the pits were the same on the Kolsterized flange, but they appeared smaller and at a lower density.

Fig. 6. (a) LE3 rear flange and (b) LE4 rear Kolsterized flange, heavily damaged region.

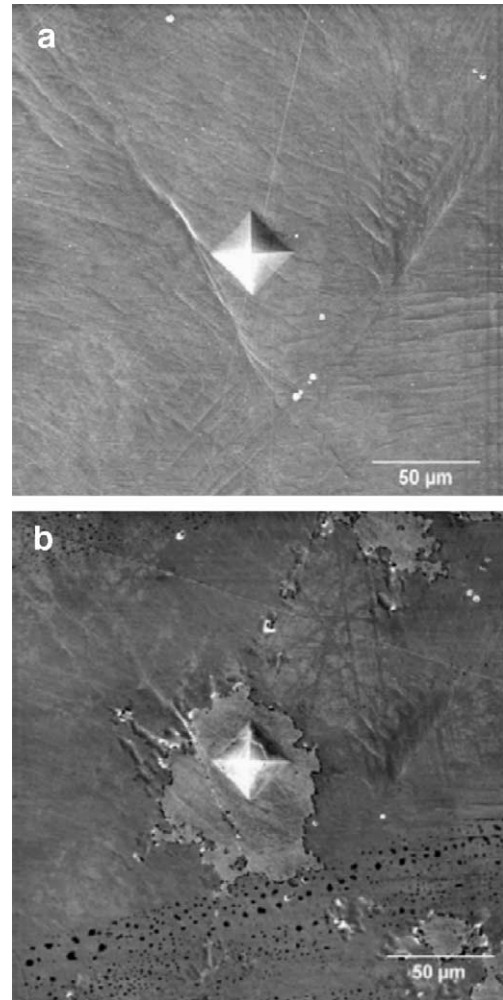
The front flange of LE5, a 10-mm-thick Kolsterized 50% cold-worked 316LN plate, showed little to no pitting in the SEM inspection, which was capable of identifying pit features larger than 1  $\mu\text{m}$ . Fig. 7 shows the Kolsterized surface before and after irradiation. The high density of deformation slip lines in the pre-inspection image was typical of the Kolsterizing process which injects a high concentration of carbon into the surface. In the post-irradiation image, it was evident that a surface film had blistered and partially exfoliated. The surface in the exfoliated area was still as hard as the original Kolsterized surface and there was still no evidence of pitting in these areas. Laser profiling showed that the exfoliated film was 3–5  $\mu\text{m}$  thick, about 10% of the Kolsterized layer. X-ray diffraction analysis showed the presence of an iron carbide phase on the surface of the Kolsterized layer which may be what was flaking off.

Fig. 7. Front flange of LE5 (a) before and (b) after irradiation.

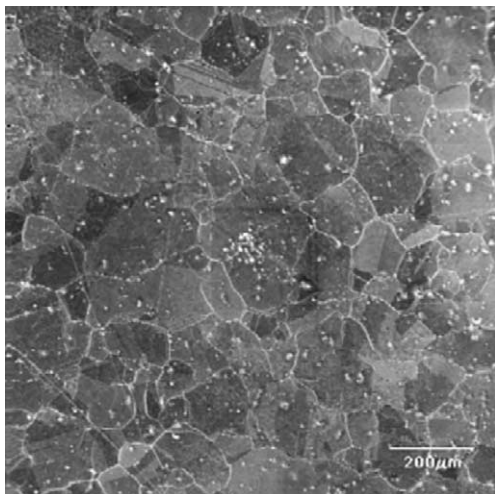
The rear flange of LE5, 10-mm-thick annealed 316LN, had an area of damage that was visible with the unaided eye. This area was centered on the flange and was approximately 40 mm diameter. These visible spots of damage were actually 100–200  $\mu\text{m}$  diameter clusters of smaller pits. One such cluster is shown in the center of Fig. 8. This differed significantly from what was observed in LE3 and LE4, and in general on all the 1–2-mm-thick windows. There the visual damage consisted of larger, isolated, 100–200  $\mu\text{m}$  diameter pits in a 1–5 mm diameter cluster. Presumably, the change was due to the difference in window thickness, which would change the acoustics, the local strain, and the amount of motion in the window. In addition to the visible clusters on the rear flange of LE5, there were also isolated pits up to 50  $\mu\text{m}$  diameter scattered over the entire specimen surface (Fig. 8).

Fig. 8. Rear flange of LE5 after 200 pulses. Material: annealed stainless steel.

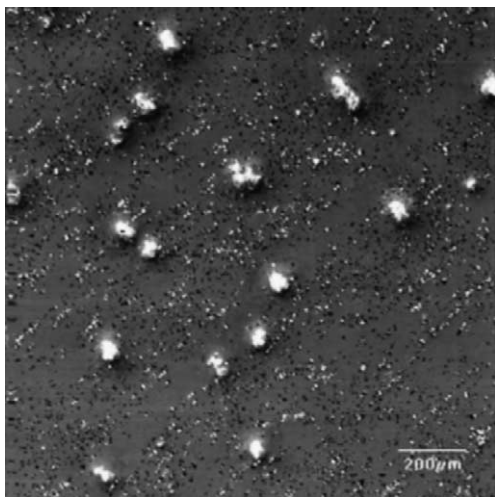
the Kolsterized steel. This material's response was distinctly different from the others tested. A 3 mm diameter cluster of pits in the area where the proton beam had passed through could be seen with the unaided eye. This was different from the position of the large pit clusters observed on the thin windows, as discussed in Part I. The pit cluster was also characteristically different in that it consisted almost entirely of large pits, 150–200  $\mu\text{m}$  diameter (Fig. 9), as opposed to the continuous size distribution observed on other specimens. The unusual size distribution in the pit cluster suggests that the Stellite material was able to resist all but the most violent impacts. There was also no indication of the small generalized pitting that was observed on the other flanges (with the exception of the Kolsterized surface).

Fig. 9. Front flange of LE5 after 200 pulses. Material: Stellite-6B. The small black and white specks are pre-existing features (carbides and polishing defects).

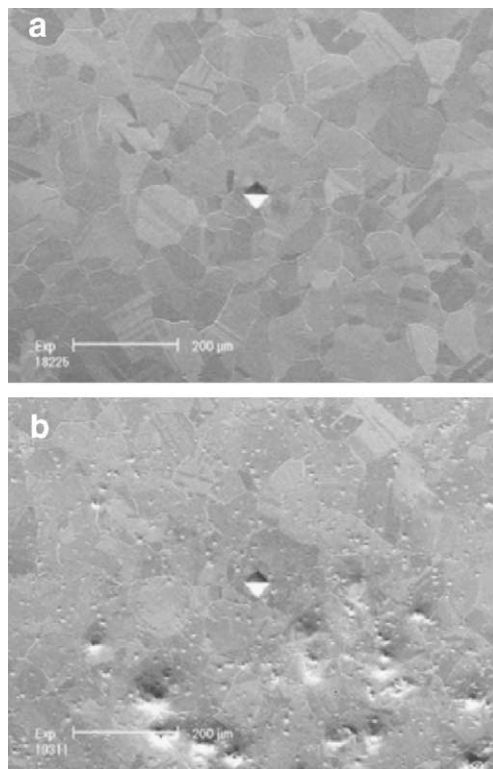
reduced the window diameter from 10 to 3.8 cm. There was a 2 mm diameter cluster of pits up to 100  $\mu\text{m}$  diameter in the center of the specimen which could be seen with the unaided eye. In addition to this damage, there were smaller, randomly distributed pits over the entire surface. Fig. 10 shows these small pits as well as a few of the larger pits in the center cluster. The size and density of the general pitting dropped off sharply as a function of distance from the center, suggesting that the conical section may have acted to concentrate the pressure pulse toward the center of the front flange.

Fig. 10. Front flange of LE7 with conical offset (a) before and (b) after 100 pulses. Material: annealed stainless steel.

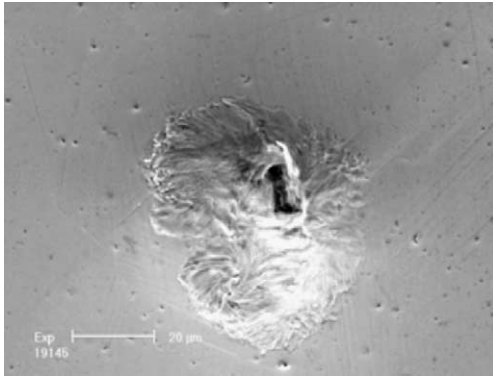
Fig. 11. Pit in surface 2 of the rectangular target after 200 pulses. Material: 20% cold-worked Nitronic-60.

The characteristics of the pits on the insert (surfaces 2 and 3) was different from that observed on other specimens. Fig. 11 shows a pit in surface 2. In addition to the dished depression and the sharp-walled crater, there is an intermediate area where material has been removed or smeared at an oblique angle. These scooped out areas tended to show a spiral character as can be seen in Fig. 12.

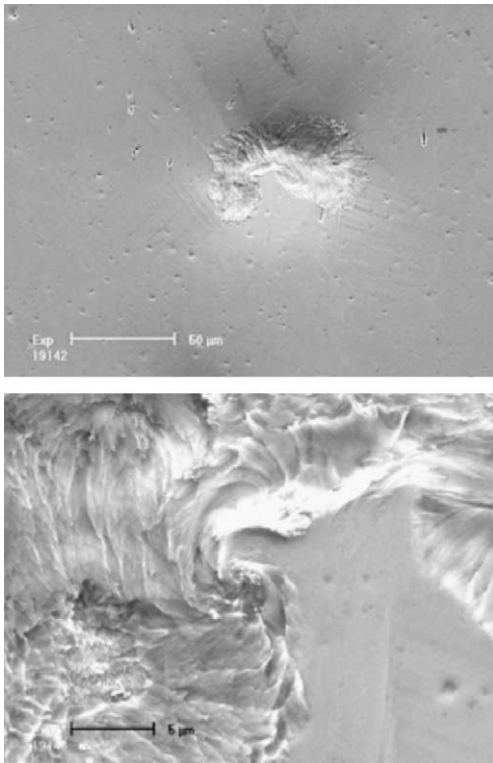
Fig. 12. Pit (at two magnifications) in surface 2 of rectangular target after 200 pulses. Material: 20% cold-worked Nitronic-60.
