Rupture analysis of CuCrZr plasma facing component during a loss of flow accident in Tore-Supra

Abstract

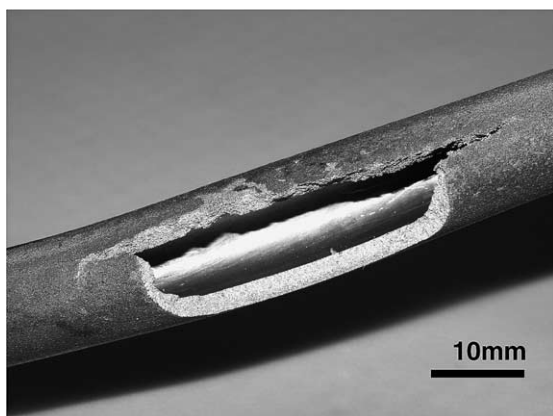
Fig. 2. Rupture morphology of ripple tube structure.

to a re-resolution treating of material. The hardening of material dropped because the chromium precipitates growth and become incoherent with the copper matrix. X-Ray Radiography of tube structure did not show secondary cracks around the failure, proving that the tube was exempt of cracks before explosion. At the fracture level a low thickness reduction of 2.7% has been measured.

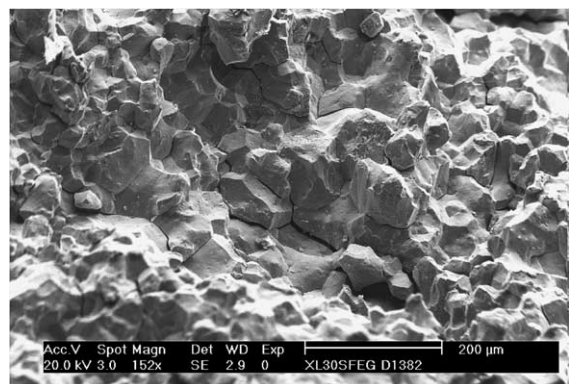
As shown Scanning Electron Micrograph (SEM) in Fig. 3, the fracture of tube is completely brittle without visible signs of ductility like dimples and cavities. The failure area shows clearly intergranular zones with crack separation of many grains, which typically occurred during elevated service temperature. The fracture morphology reveals no fatigue striations neither trace of fusion. The observed faces do not indicate secondary recrystallisation phase. Optical micrographs point out equiaxed grains; the average size of grain is about 80 μm . As for creep-fracture behaviour, it can be stated that the fracture surface appears with very little elongation due probably to intergranular microvoids formation. Even so separation of the grains could be the result of brittle behaviour of grain boundaries attributed to either local modification of kinetic precipitation or the microvoids diffusion [3,4].

Fig. 3. SEM of rupture surface: brittle intercrystalline zones and cracks.

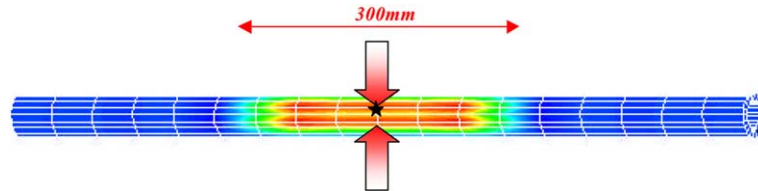
Fig. 4. 3D finite element calculation with exponential decay length of 0.5 mm.

account of the Larmor radius of λ and the nominal flux Φ_0 (Fig. 4). The deposited power can be considered as concentrated on only one of the tubes because the installation accuracy of the protection is in the millimetre range. During the formation of plugging, the ripple protection kept its role of heat exchanger. The water heated up to the saturation point (242 °C at 3.5 MPa) involving a change of phase. The change of phase delay for 100 mm of tube has been calculated at 2 s. The curved shape of structure tube did not allow the formed vapour bulk to go away; the heat transfer to the cooling fluid therefore abruptly decreased. The rupture occurred immediately because the ripple tube structure could not evacuate the deposited heat. The main finding indicates that the rupture occurred after the plugging from a flow rate drop of 35%. The rupture delay has been calculated by mean of CAST3M Finite Elements code following different plugging rate. In the more probable case, the rupture appeared between 17 and 24 s after the beginning of the plasma discharge (40 °C s⁻¹). The evolution of hardness and simulated surface temperature show a good correlation. Just before the explosion, 300 mm of tube structure indicated an overheated zone. With some uncertainties, our study indicates that the rupture surface temperature exceeded 800 °C (Fig. 5).

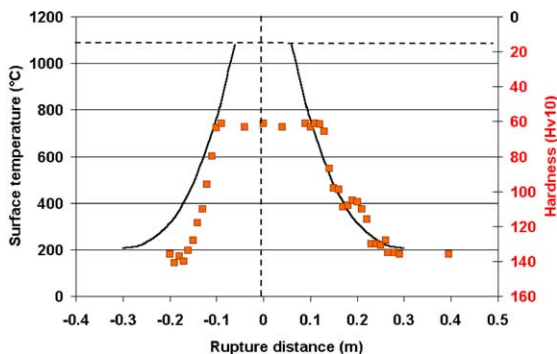
Fig. 5. Surface temperature evolution for a 100% plugging correlated to hardness measurements showing an unsymmetrical evolution.
