Surface modification of thick SiC gradient coatings on doped graphite under long pulse plasma irradiation

C.Y. Xie ^{a,*}, J.L. Chen ^a, J.G. Li ^a, Q.F. Fang ^b

^a Institute of Plasma Physics, Chinese Academy of Sciences, P.O. Box 1126, Hefei 230031, PR China

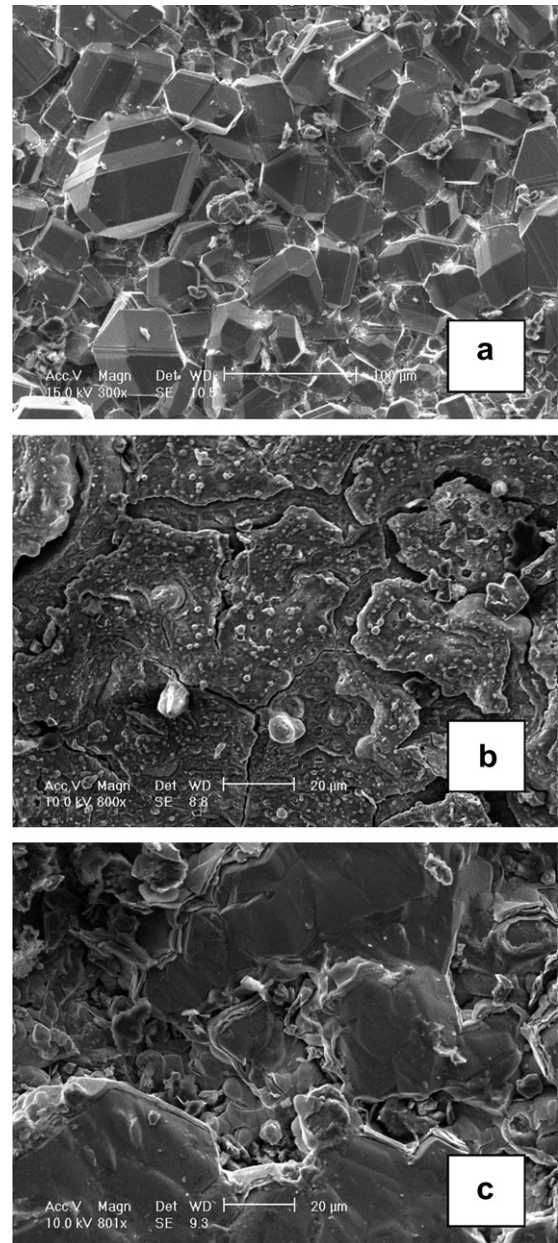
The SEM results as Fig. 1 clearly showed that the surface morphologies and structure of the eroded tile and deposited tile were quite distinct from the new one. Surface morphology of the new tile is a regular SiC crystal as Fig. 1(a), the lamellar struc-

Fig. 1. SEM surface morphologies of the new, eroded and deposited carbon tiles with thick SiC coatings.

ture with little spots and cracks on the surface of eroded tile was shown as Fig. 1(b), while the profile of SiC crystal with thin film was seen on the surface of deposited tile as Fig. 1(c). Thus it can be seen that the structure of SiC crystal on the graphite tile was damaged clearly different and the coating morphology was changed in various degrees under long pulse plasma irradiation.

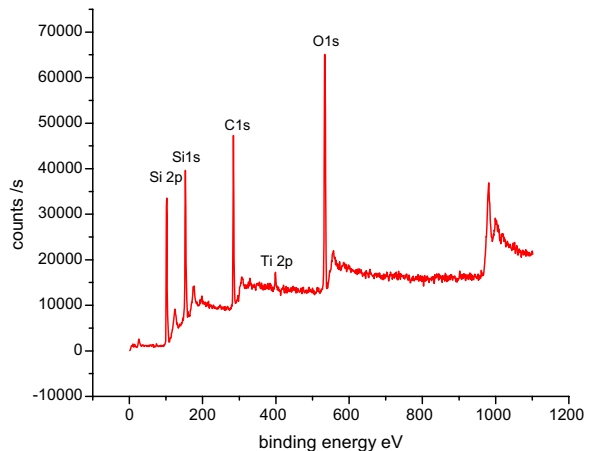
Survey of the surface from new limiter tile by XPS as Fig. 2 showed that oxygen beside the carbon and silicon existed. The surface composition of new tile was: 34.51%C, 36.19%O and 29.30%Si. Analysis of the binding energy subdivision showed that 29.86%C was from SiC or graphite, 4.65%C was from carbon oxide; 22.41%O was from O₂, 13.78%O was from carbon oxide or silicon oxide; 20.67%Si was from SiC, 8.63%Si was from silicon oxide. The composition changed obviously after Ar⁺ bombardment. Survey as Fig. 3 showed that oxygen percent was reduced to 10.42% and the peak

Fig. 2. XPS survey of the new carbon tiles with thick SiC coatings.

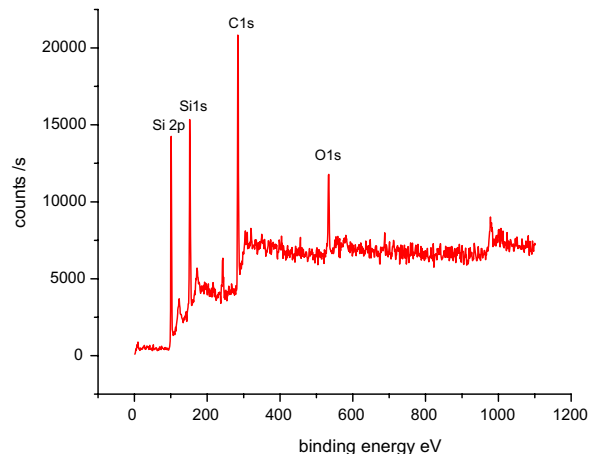
Fig. 3. XPS survey of the new carbon tile with thick SiC coatings after Ar⁺ bombardment.

binding energy was 533.5 eV which was mainly from SiO₂; silicon percent was 33.53% and the peak binding energy was 100.6 eV which was from SiC or SiO₂; carbon percent was 50.05% and the peak binding energy was 283.9 eV, from SiC or graphite.

Ar⁺ bombardment of 12 nm reduced the oxygen percent obviously, so we considered that oxygen

percent was gradient distributing from surface, and that most of the oxygen in surface of new tile is O₂ adsorbed. The residual oxygen percent after Ar⁺ bombardment possibly came from the oxygenation in course of siliconization.

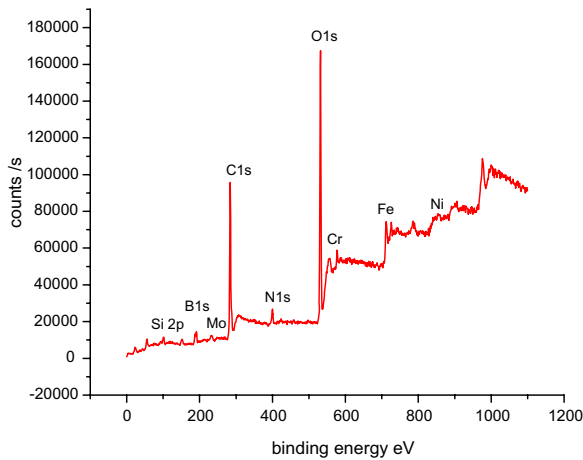
Survey of the surface from eroded limiter tile by XPS as Fig. 4 showed the surface composition of new tile: 26.29%C, 49.03%O, 15.05%B, 3.46%Fe, 1.25%Cr, 0.51%Ni 0.29%Mo, and 4.11%N. According to the binding energy subdivision, 11.73%C was from graphite, 14.56%C was from carbon oxide or B₄C; 35.33%O was from O₂, 13.70%O was from carbon oxide or metal oxide; boron was from B₄C or BN; all the metal existed as metal oxide. Survey after Ar⁺ bombardment as Fig. 5 showed that the composition had changed from original surface

Fig. 4. XPS survey of the eroded carbon tile with thick SiC coatings.

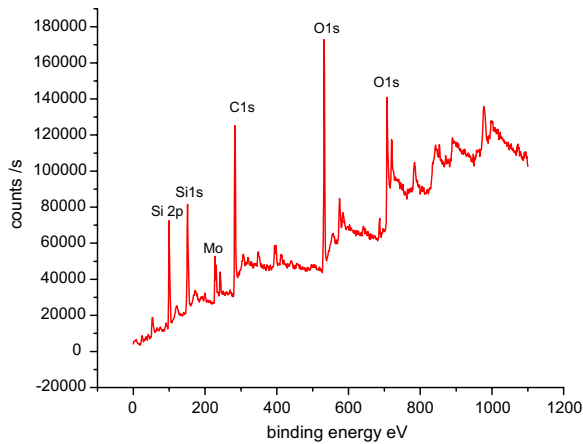
and oxygen percent reduced to 25.43%. So the large part of oxygen in the surface of eroded tile was O₂ adsorbed and the residual oxygen percent after Ar⁺ bombardment possibly came from the oxygen gettering in this campaign.

Fig. 5. XPS survey of the eroded carbon tile with thick SiC coatings after Ar⁺ bombardment.

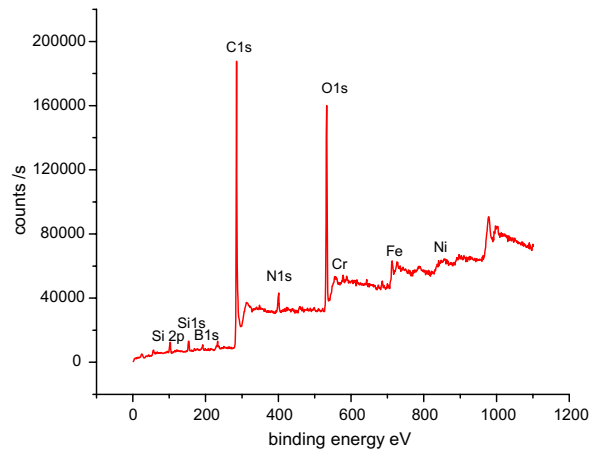
The composition of deposited tile tested by XPS as Fig. 6 was: 63.76%C, 25.54%O, 2.56%Si, 2.20%B, 1.69%Fe, 0.46%Cr, 0.30%Ni 0.39%Ti, and 3.00%N. In the same way, the binding energy subdivision showed that carbon was from graphite, SiC and carbon oxide; oxygen was from O₂, carbon oxide or metal oxide; boron and nitrogen was BN; all the metal existed as metal oxide. Survey after Ar⁺ bombardment as Fig. 7 showed the oxygen percent reduced to 21.39% and was mainly from carbon

Fig. 6. XPS survey of the deposited carbon tile with thick SiC coatings.

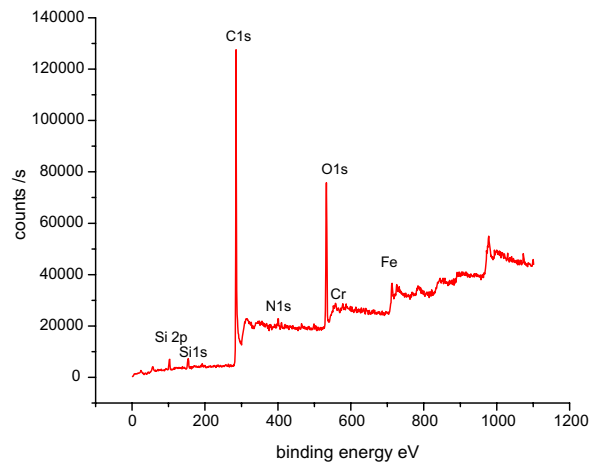
Fig. 7. XPS survey of the deposited tile with thick SiC coatings after Ar⁺ bombardment.

oxide or metal oxide. The other elements remained with a little change of percent and peak binding energy.
