Root causes of intergranular attack in an operating nuclear steam generator tube

This paper reports the secondary side intergranular attack of an Alloy 600 tube, which was located within sludge piles in the hot-leg side of an operating nuclear steam generator. Carbide distribution along the grain boundaries and chromium depletion were analyzed using optical microscopy and transmission electron microscopy. Local crevice chemistry in contact with the defect was also assessed from the hideout return test data and oxide film analysis results using energy dispersive spectroscopy. The main causes of this defect are discussed based on the microstructure, local chemistry and operation temperature.

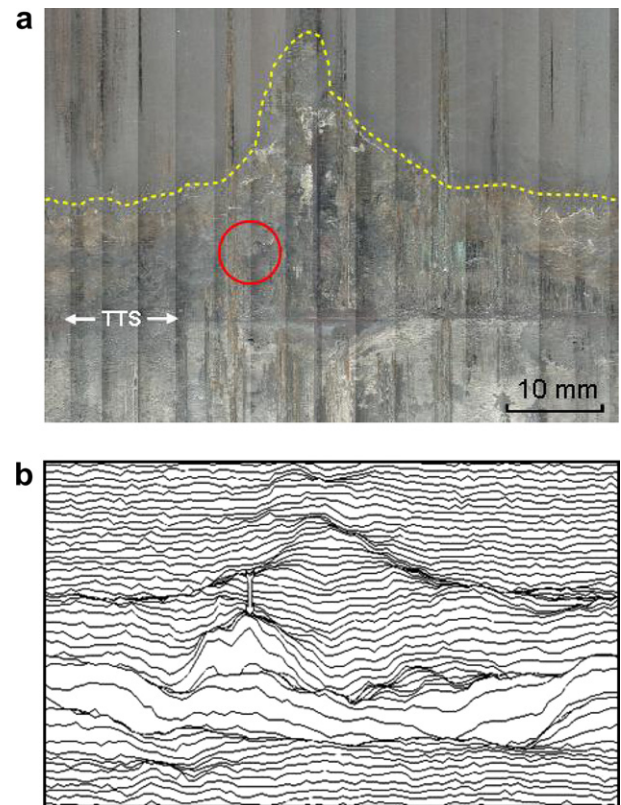
Fig. 1(a) shows a figure of the as-received OD condition of the pulled tube. The TTS line was defined well and the profile of the sludge accumulated around the tube was also clearly identified. The circle corresponds to the location of the defect signal in Fig. 1(b), which was detected by a plus point coil [3] mounted in a motorized eddy current probe at a frequency of 300 kHz. However, no defect was observed from the visual inspection.

Fig. 1. (a) Outer surface of pulled tube and (b) ECT result.

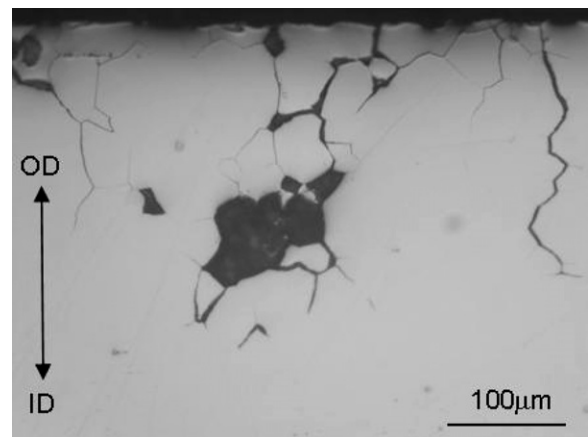
Fig. 2. Cross sectional view showing IGA.

Nevertheless, numerous defects were revealed by metallographic examinations. Fig. 2 shows a cross section at TTS + 8 mm, corresponding to the central location of the defect indication signal. Grain boundaries were attacked and several grains had dropped out. This type of defect was a typical IGA. Similar defects including minor intergranular stress corrosion cracks (IGSCC) were also observed in many other segments.

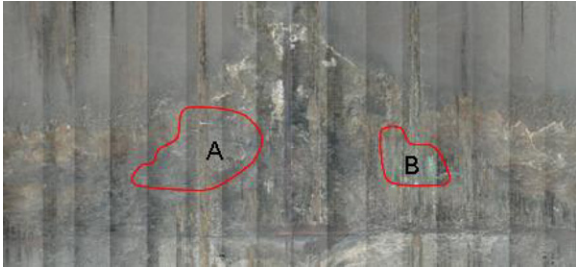
The final result is summarized in Fig. 3. Defects were found in two regions. That is, this type of IGA extended to all over the each region. Defect region A correlated well with the EC defect signal location. In this region, the max-

Fig. 3. Defect regions on the outer surface.

imum depth of the penetration was 28% of the tube wall thickness. Region B indicated no defect signal, but showed IGA/IGSCC with a maximum depth of 16%. This means that it was below a detectable size of the ECT. It should also be noted that these defects were located inside sludge piles and above the expansion transition region.

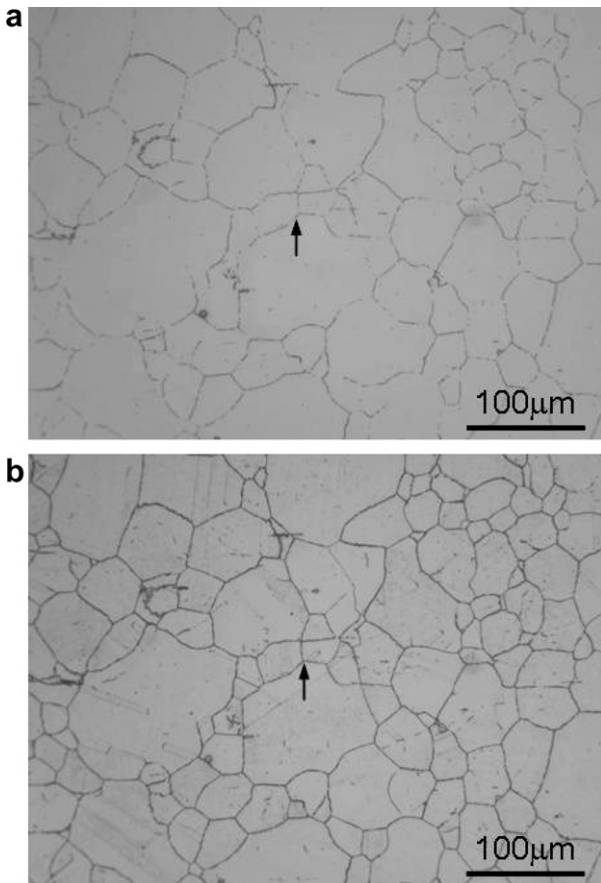
Dual step etch microstructure of a longitudinal section near the defect region is shown in Fig. 4. A discrete decoration of carbides was observed along the grain boundaries with very sparse intragranular carbides. Average grain size determined by a linear intercept method was 68 μm, which was within the specification of a mill-annealed tube.

Fig. 4. Dual step etch micrographs. (a) Phosphoric etch and (b) nital etch.

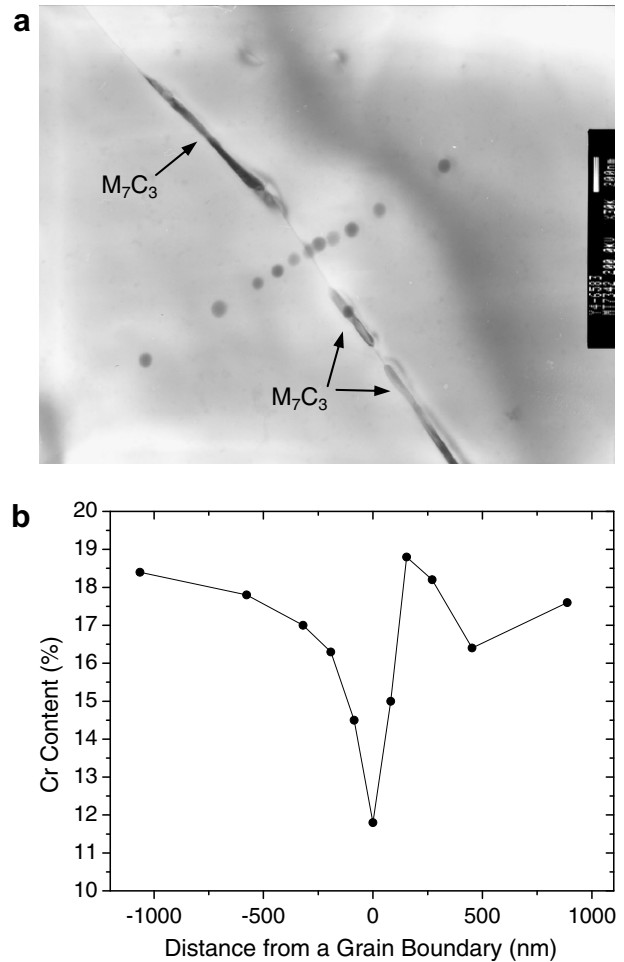
As IGA has been directly correlated with chromium depletion at grain boundaries [8,9], the chromium content at the grain boundaries was measured by TEM-EDS. Fig. 5 shows the morphology of M_7C_3 carbides and the profile of chromium concentration across a grain boundary between two carbides. Chromium content at the grain boundaries was found to decrease to a range of 11.8–13.8 wt%. These values were a maximum of 7 wt% lower than the chromium content of the matrix. This means that the tube was slightly sensitized.

Fig. 5. (a) Carbide morphology and (b) chromium content profile across a grain boundary.

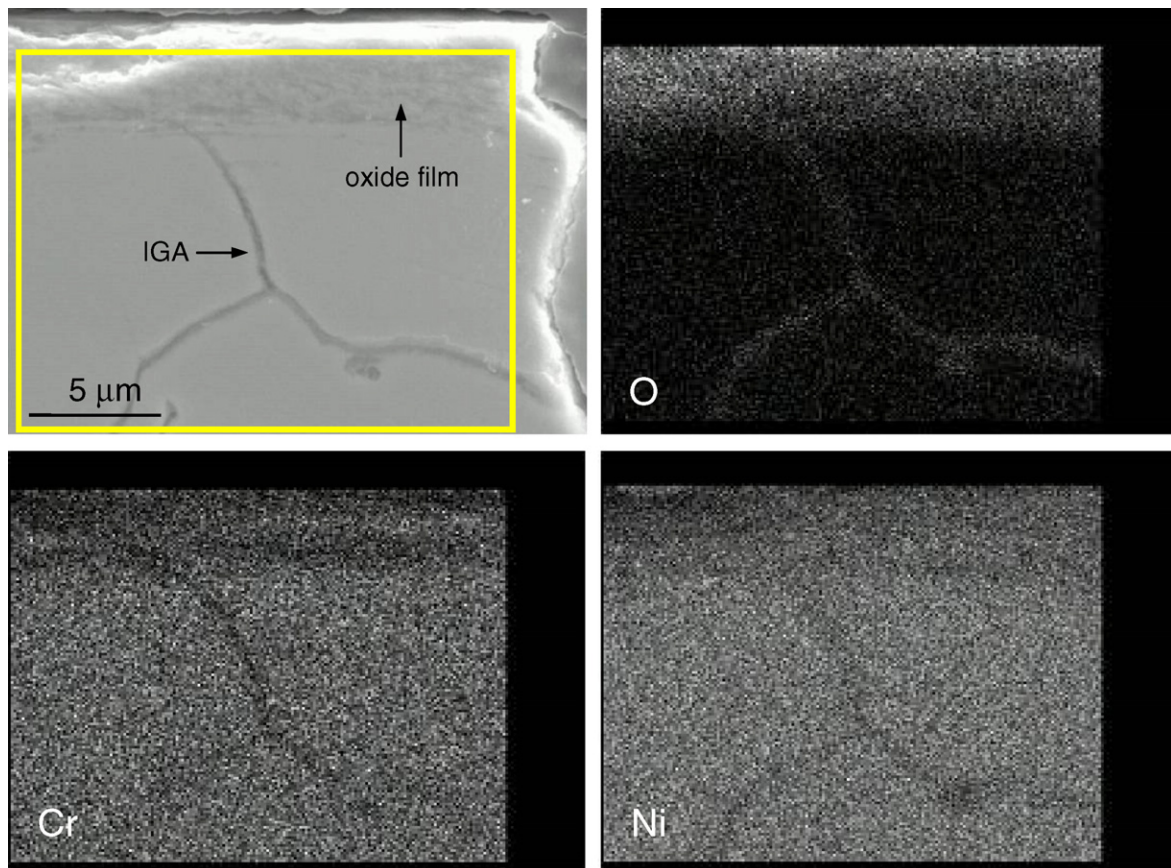
The chemical composition analysis of the oxide film on the defect surface can provide more reliable information of a local crevice pH, because the solubility of chromium and nickel is dependant on the pH. Fig. 6 shows the X-ray mapping result for the oxide film formed on the cross sectional surface of the IGA region. This film was the as-grown

oxide with a thickness of about 3 μm , not the deposits. It was therefore considered that a more reliable interpretation of the local crevice environments could be achieved. This oxide film was found to be depleted in chromium and enriched in nickel. The same trend was also observed at different analysis locations, although there was a small change in the degree of chromium depletion. According to the Pourbaix diagrams of chromium, nickel and iron [11], nickel has the broadest range of solid stability at high pH's with a stable nickel oxide, whereas chromium has the least solid stability. Similarly, it was reported that as the pH increased, the chromium content decreased uniformly and the nickel enriched uniformly in the surface film formed on Alloy 600 [12,13]. Hence, the oxide film composition analysis in Fig. 6 clearly indicates that the local chemistry in contact with the IGA was alkaline.

Fig. 6. Cross section near IGA and X-ray mapping.

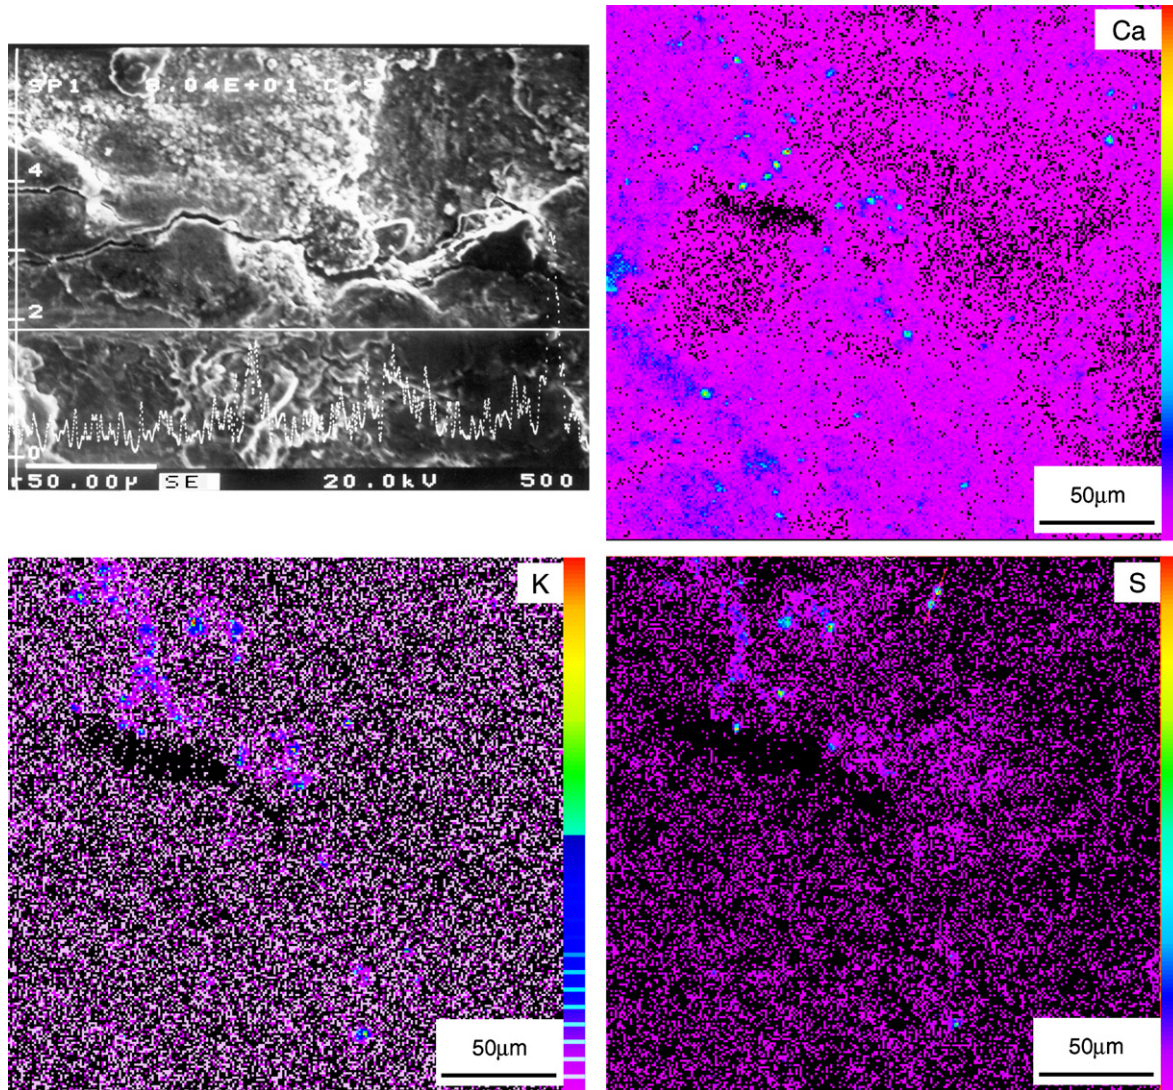
In addition, other impurities such as potassium, calcium and sulfur were detected on the outer surface deposits of the defect area by EDS, as shown in Fig. 7. It should be noted that sulfur compounds have been known to induce a film breakdown and thus accelerate IGA/IGSCC of Alloy 600 [14,15].

Fig. 7. X-ray mapping on the outer surface oxide of the defect area.
