## Post irradiation examination of thermal reactor fuels

### ABSTRACT

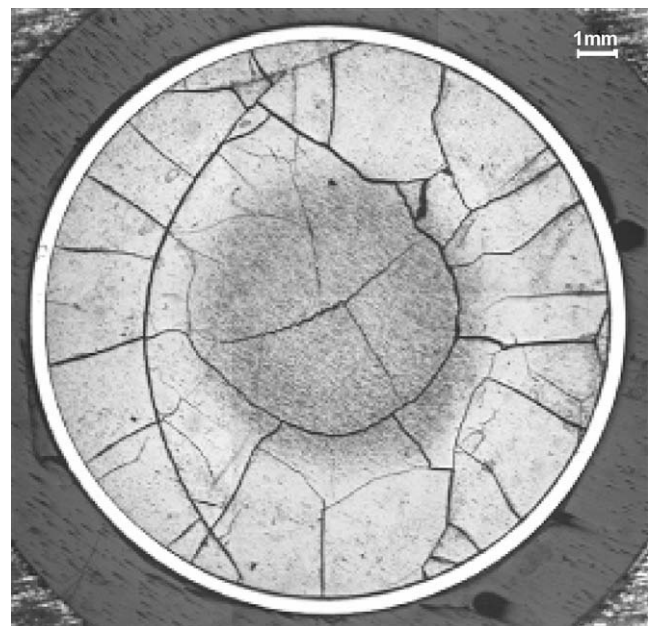
porous region extending up to a fuel fractional radius of about 0.55 was observed in all the sections. A typical macrostructure of one of the samples from the axial location is shown in Fig. 4. A circumferential crack existed adjacent to the boundary of the dark region. Observation of the dark porous region at higher magnification revealed interconnected pores/bubbles on the grain boundaries (Fig. 5). White particles, probably noble fission products, were also observed in the microstructure. The size of dark porous region in the intermediate and central fuel pins was much smaller than the size in the outer fuel pin.

Fig. 4. A typical photomicrograph from the cross-section from the outer pin of the high burnup bundle.

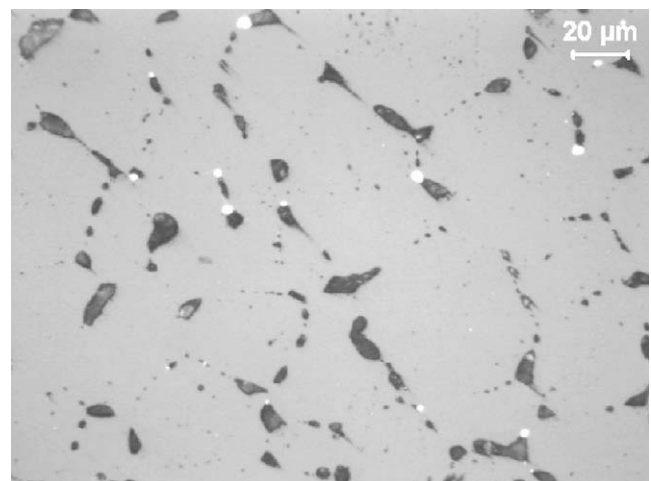
Fig. 5. Grain boundary bubbles at the centre of the fuel section of the outer pin of the high burnup bundle.

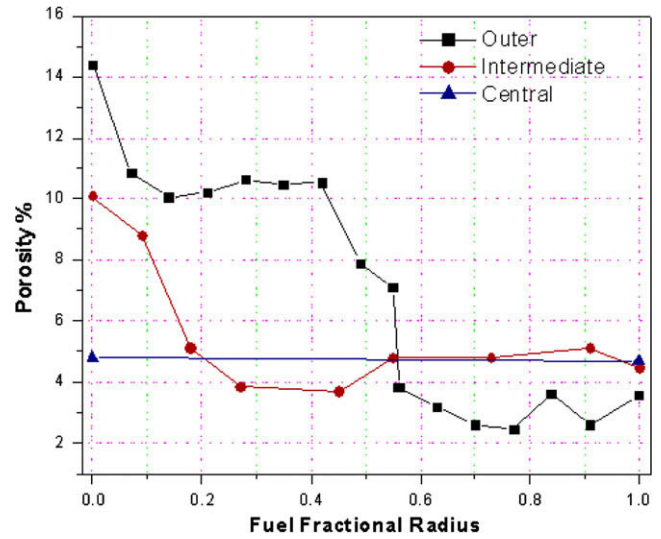
Fig. 8. Radial porosity profile of pellets from the outer, intermediate and the central pins of the high burnup bundle.

**4.2.1.4. Fuel swelling.** The pellet average total porosity volume was estimated from the radial distribution of porosity in the pellet. The porosity measurement was carried out on as-polished metallographic samples using image analysis technique. Measured radial porosity profiles in the pellets are given in Fig. 8. Swelling was taken as the difference between total porosity in the irradiated fuel and the initial porosity. Based on the measured density values of as-fabricated fuel pellets the initial fuel porosity was estimated to be 3.7%. The estimated values of fuel swelling were 1.5%, 1.0% and 1.1%, respectively, in the outer, intermediate and central fuel pins. This shows a volumetric swelling rate of roughly 1% per 10000 MWd/tU.

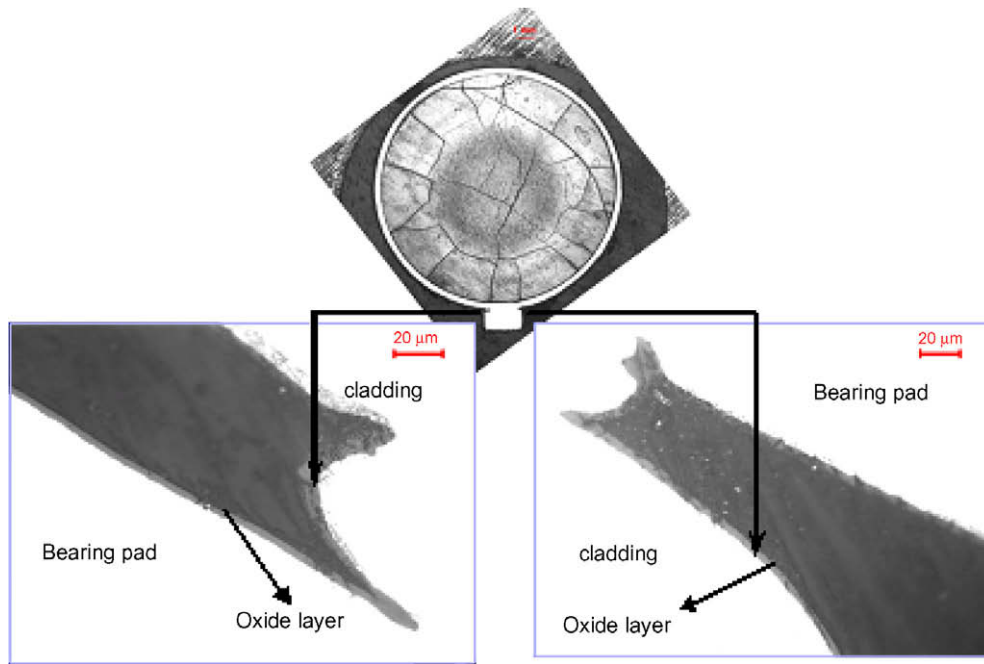
The crevice region around the spot weld between the clad and the bearing pad of the outer pin is shown in Fig. 6. There was no evidence of localized accelerated corrosion at this location. The average oxide layer thickness was 2.7  $\mu\text{m}$ .

Fig. 6. Uniform corrosion at the crevice of the bearing pad of the outer pin of the high burnup bundle.

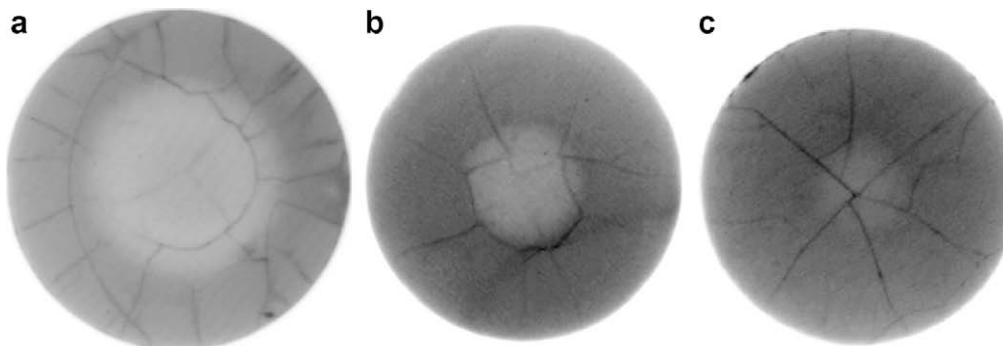
samples. The autoradiographs of samples are shown in Fig. 7(a–c). The central white region in the autoradiograph indicates that the radioactive fission products had migrated from the central region towards the periphery of the fuel section, resulting in lower activity in the central region and a higher activity in the outer region of the fuel cross-section. The radius of the central white region was maximum in case of the outer pin and was minimum for the central pin.

Fig. 7.  $\beta$ - $\gamma$  autoradiographs of (a) outer, (b) intermediate and (c) central pin of the high burnup bundle.

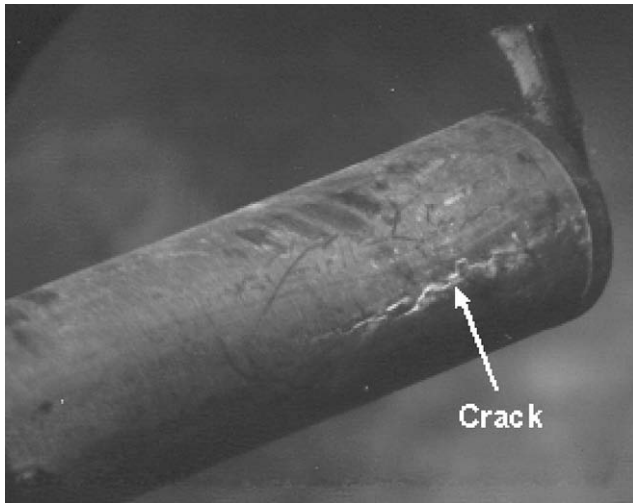
Fig. 9. Crack observed on the cladding of the outer fuel element of the low burnup bundle.

Examination of several failed fuel bundles at low burnups was carried out to identify the causes. Examination has revealed three main reasons for failures namely defect in the end cap weld, hydriding and fretting. An interesting failure was noticed in a fuel bundle at a burnup of 387 MWd/tU within 17 days of residence of the fuel bundle in the reactor. Leak testing of fuel pins after dismantling of the bundle showed that two of the 12 fuel pins in the outer ring had failures in the form of axial cracks slightly away from the end plug weld. The other fuel pins in the bundle were intact. Fig. 9 shows cracks observed in one of the failed fuel pins.

presence of a lack-of-fusion type defect in the end plug weld of the fuel pin. Based on this, the cause of failure has been identified as the lack-of-fusion defect in the end cap weld of this pin, which might have gone undetected during the manufacture of the element. This defect had opened up during the reactor operation leading to the ingress of water in this pin. The presence of steam in the fuel-clad gap would have severely affected the gap-conductance, increasing the central temperature of the fuel. The presence of steam also caused the oxidation of  $\text{UO}_2$  with consequent reduction of fuel thermal conductivity and increase of fuel centre temperature. This led to an increased volume expansion of the fuel, stressing the clad at several places. This could have led to the formation of incipient cracks in the cladding that grew by the delayed hydride cracking.

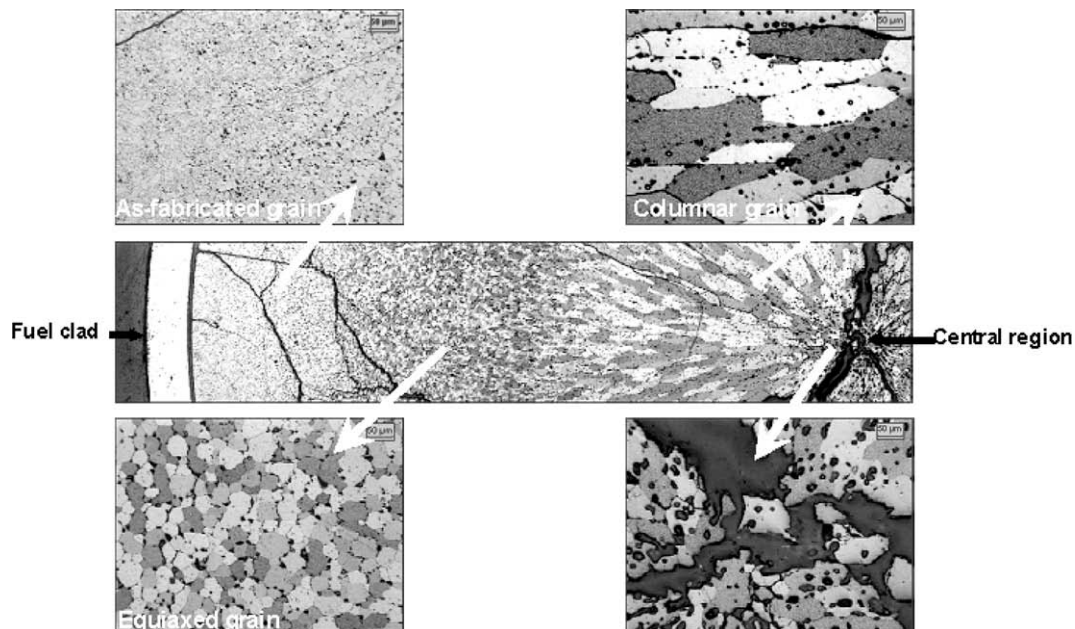
Fig. 10. Restructured zones from periphery to the centre of the fuel pellet in the failed pin at the location of failure of the low burnup bundle.

One of the failed fuel pins was sectioned at several places along the failed region and metallography was carried out. It can be seen from the photomicrograph (Fig. 10) that the fuel had undergone extensive restructuring resulting in the formation of columnar grains in the central region of the fuel pellet section. Based on the restructuring, the fuel centre temperature at the location of failure was estimated to be 2100 °C. Many incipient cracks were observed in the cladding, in addition to through wall cracks. Some of these cracks were in line with the radial cracks in the fuel. Hydride precipitates were found at the tip of the incipient cracks, as shown in Fig. 11. Cracks in the cladding were filled with an interaction product. The fuel was found to be in contact with the clad at several places along the circumference, indicating a strong interac-

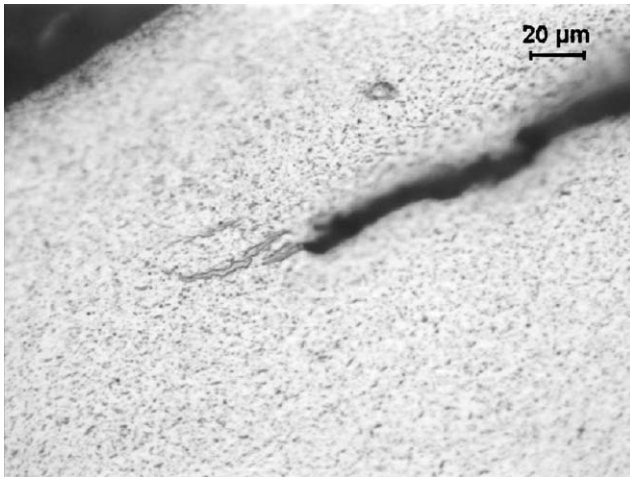
Fig. 11. Hydride platelet at the crack tips in the clad.

tion with each other. Tell-tale features of the pellet-clad interaction/stress corrosion cracking (PCI/SCC) type of failure could be observed at several locations. But the fuel burnup was too low to provide sufficient inventory of iodine to promote SCC. Presence of hydride precipitates at the tip of incipient cracks, (Fig. 11), indicated crack propagation by progressive precipitation and cracking of hydrides at the crack tip.

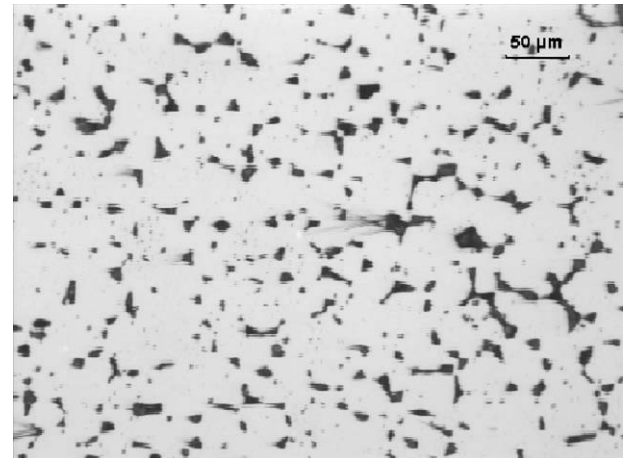
Fig. 13. Microstructure of the fuel cross-section in the un-failed adjacent pin.

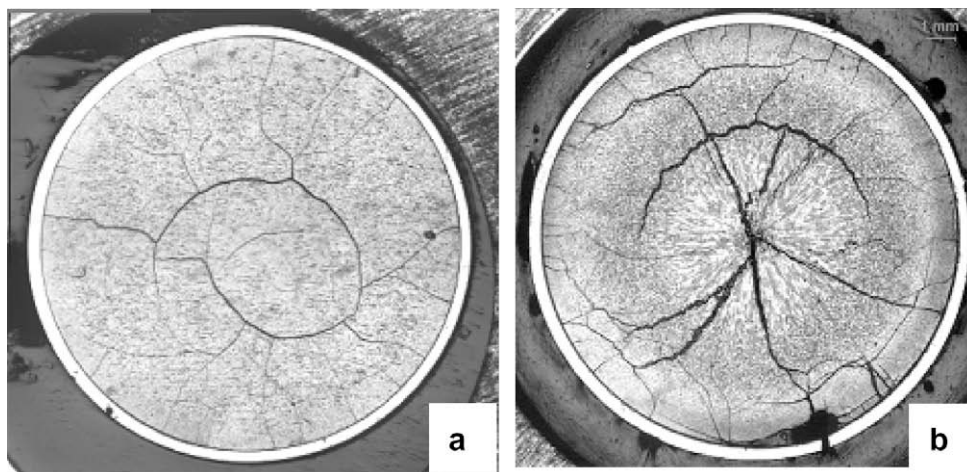
In order to infer the thermal condition of the non-failed fuel pin in the outer ring, sections taken from the intact fuel pins were examined metallographically. A comparison of the photo macrographs of the sections of failed and unfailed fuel pins (Fig. 12) revealed that there was no visible fuel restructuring in the intact fuel pin (Fig. 12(a)), while the failed fuel pin showed extensive restructuring, as shown in Fig. 12(b). An examination of fuel at higher magnification revealed a microstructure of fuel containing intergranular pores at the fuel centre (Fig. 13), but no grain growth. Based on the microstructure, the fuel centre temperature in the intact fuel pin was estimated to be less than 1300 °C. Thus it was clear that the fuel centre temperature in the failed fuel pins was 800 °C higher than the fuel temperature in the intact fuel pins of outer ring during irradiation. As all the outer ring fuel pins experience identical heat ratings during operation, the cause of higher fuel temperature in the failed fuel pin was not clear.

Fig. 12. Photo-macrograph of the fuel cross-section of (a) an un-failed adjacent pin and (b) failed pin.

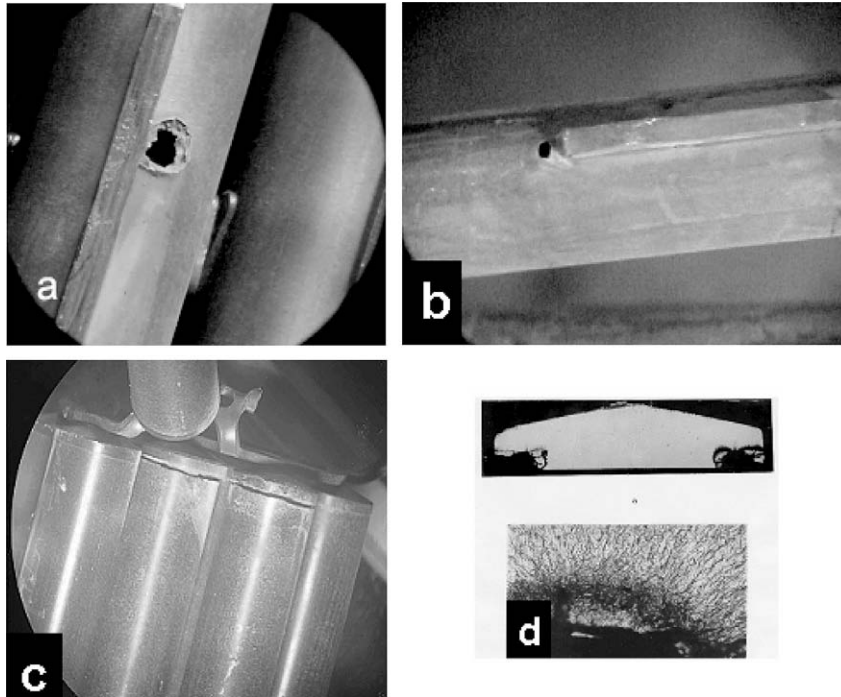
Fig. 14. (a) Pin hole in the clad due to hydride blister, (b) pin hole due to bearing pad damage, (c) cracks at the end plugs and (d) hydridding at the end plug.

Typical failures observed in the other low burnup fuel bundles are shown in Fig. 14(a–d). The pin hole observed in Fig. 14(a) is caused by formation of a hydride blister on the active length of the fuel pin. The failure shown in Fig. 14(b) is caused by the damage to the bearing pad during fuelling operation. A typical hydride failure at the end cap weld is shown in Fig. 14(c–d). Such hydride induced failures have been completely eliminated by strict control of moisture inside the fuel pins.

5. The main causes of failures in the fuel pins of power reactors were identified as weld defects, hydriding and PCI. These failures have been eliminated by stringent quality control of welds,

strict control of moisture and other hydrogenous substances inside fuel pins and graphite lubrication of inside surface of cladding tube.

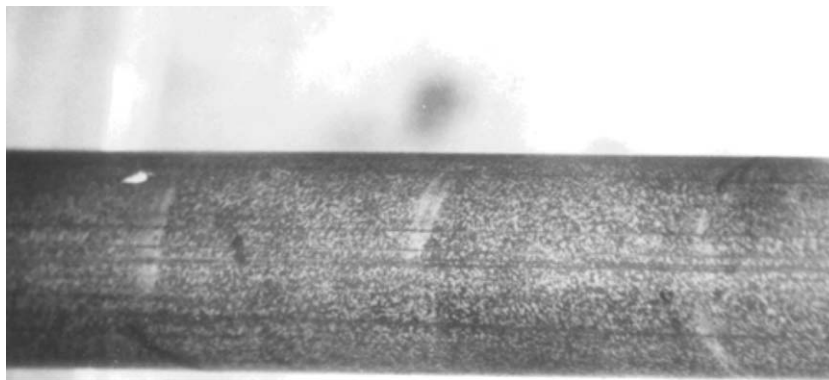
Nodular corrosion was the predominant feature noticed on the fuel clad of TAPS fuel pins as shown in Fig. 16. The concentration of corrosion nodules in the fuel elements followed the burnup profile, the concentration being higher in regions of higher burnup. However, nodular corrosion was limited only to the initial-load-design-fuel and was not observed in the subsequent reload-design-fuel.

Fig. 16. Nodular corrosion observed on a TAPS fuel pin.
