Flow accelerated corrosion and its control measures for the secondary circuit pipelines in Indian nuclear power plants

Vivekanand Kain^{a,*}, S. Roychowdhury^a, Thomas Mathew^b, Atul Bhandakkar^b

^a Materials Science Division, Bhabha Atomic Research Centre, Mumbai 400085, India

A pipe segment in the 10% feed line, immediately downstream of flow element (orifice meter) ruptured releasing steam in boiler room on February 9, 2006, in Kakrapar Atomic Power Station unit-2 (KAPS # 2). The process details and other specifications of the ruptured pipe segment were: process fluid - feed water (liquid), operating temperature - 171 °C, design pressure - 72 kg/cm², flow and velocity - 35 m³/hr (2.33 m/sec), material - A 106 Grade B, size and thickness - 80 NB (7.62 mm). This pipeline carries 10% of the feed water to the steam generator and the failure occurred after approximately 10 years of operation. Fig. 1 gives the schematic of the failed piece of the pipeline showing the location of the fracture with respect to the welds and the location of the orifice meter used for flow measurement. The pipelines are covered with insulation from the OD side. However, there was no indication of any de

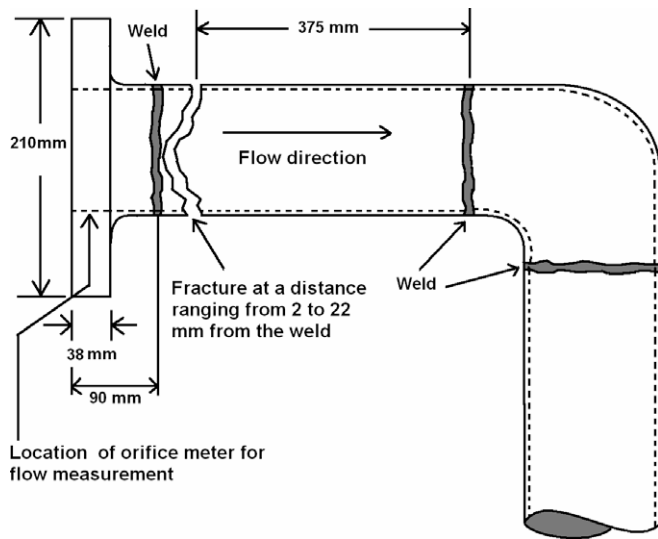
Fig. 1. Schematic of the failed pipeline indicating the location of the fracture surface, welds and the orifice meter for flow measurement.

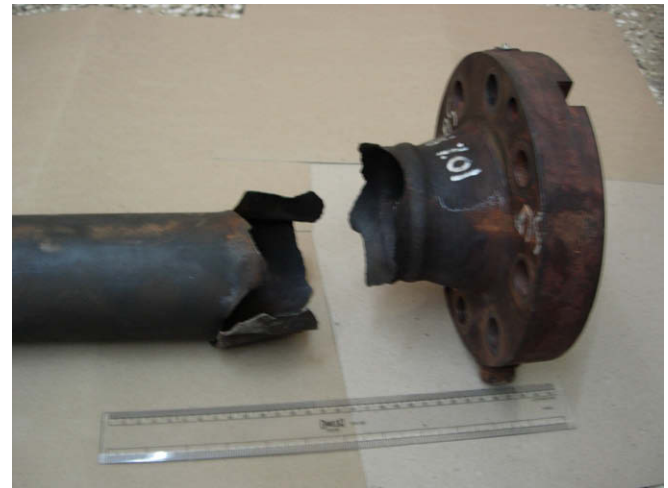
The failure had occurred on the pipeline side of the weld between the flange reducer and the pipeline. The failure was all along the circumference but was not at a uniform distance from the weld as shown in Fig. 2. The observations clearly indicate that the failure is not in the heat-affected zone (HAZ) due to welding. The fracture surface is at varying distances from the weld (at a distance ranging from 2 to 22 mm). Fracture in the HAZ region would approximately be equidistant from the weld all around unlike what is seen here. There is an orifice meter located in the flange for flow measurement and the fracture is downstream the orifice meter. The inner surface that had undergone FAC shows a distinct pattern. This pattern is much finer in the regions severely affected by FAC while it is quite coarse at other locations. The thickness of the pipeline had reduced from the original (measured) value of 7.11 mm to a minimum of 0.4 mm at the location of the failure.

Fig. 2. The failed pipeline showing circumferential fracture and excessive thinning at the location of fracture.

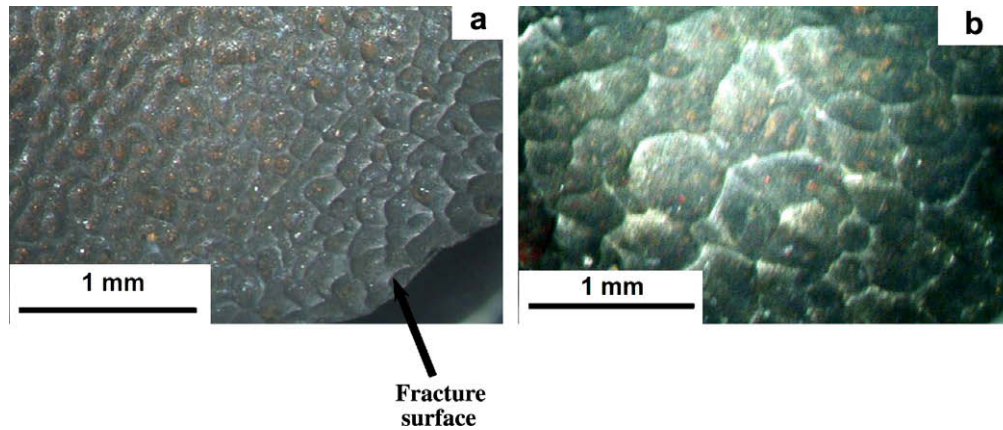
the main features of the ID surfaces near the fracture surfaces. Fig. 3(a) shows the features near the fracture surface, which has a finer pattern, and Fig. 3(b) shows the features away from the fracture surface, which shows a coarser pattern.

Fig. 3. Typical patterns on the ID surfaces as observed by stereomicroscope (a) showing fine pattern near the fracture surfaces (at locations most affected by FAC) and (b) a much coarser pattern at a location that is least affected by FAC.

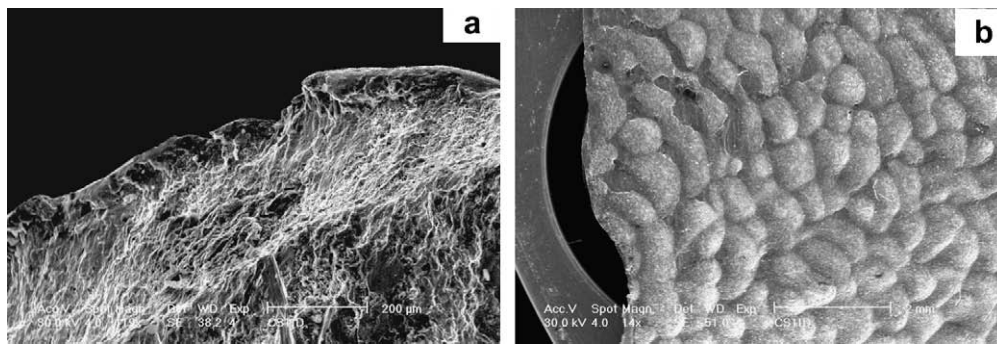
Samples were cut from the pipeline section of the failed component and examined under SEM. The OD, ID and the fracture surfaces were examined. The main results are shown below in Fig. 4. The fracture surface (Fig. 4(a)) shows a clear ductile failure with no indication of cleavage facets. This indicates an overload failure. Since there was excessive thinning observed at this region, the overload failure is due to the pipeline thickness reducing to a level at which it can not withstand the operating load. Similar observations have been reported earlier [1]. The ID surfaces showed features similar to those observed by stereomicroscopy. Fig. 4(b) shows the ID surfaces near the fracture region and removal of material from the ID surfaces can be seen in this figure. The Figs. 3 and 4(b) clearly show the horseshoe-pitting (orange peel) appearance of the ID surfaces in the affected regions as has been reported earlier [2].

Fig. 4. The SEM photomicrographs showing (a) the fracture surface and (b) appearance of the ID surfaces near the fracture establishing horseshoe pits and orange peel appearance.

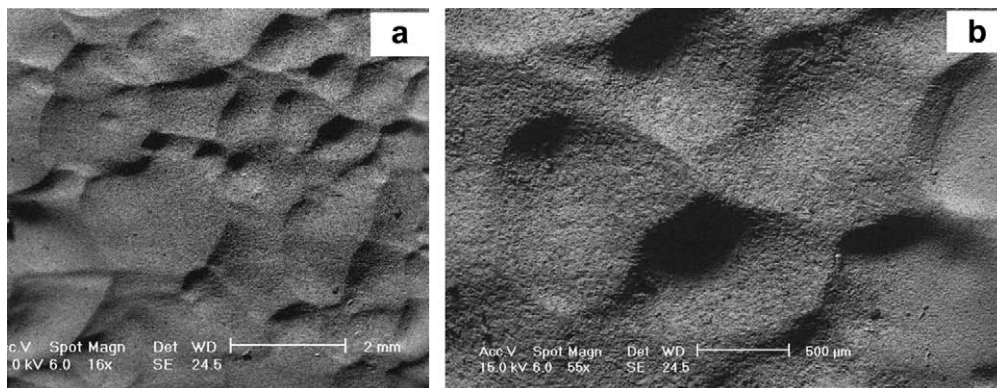
A sample was taken from the other end of the pipeline (after the elbow section) that was not affected by FAC. The thickness at this section was 7.11 mm (design thickness was 7.62 mm). The ID surfaces had a dark brownish appearance. The sample was ultrasonically cleaned to remove any loose products before the examination in SEM. The SEM examination revealed rough surfaces with coarse pattern (Fig. 5(a) and (b)). Compared to this, the pattern (orange peel) in Fig. 4(b) is much finer and that structure also showed horseshoe-pitting type of attack.

Fig. 5. The SEM photomicrographs of ID surfaces at regions far away from FAC affected regions showing (a and b) rough surfaces with coarse pattern compared to that at the FAC affected regions.

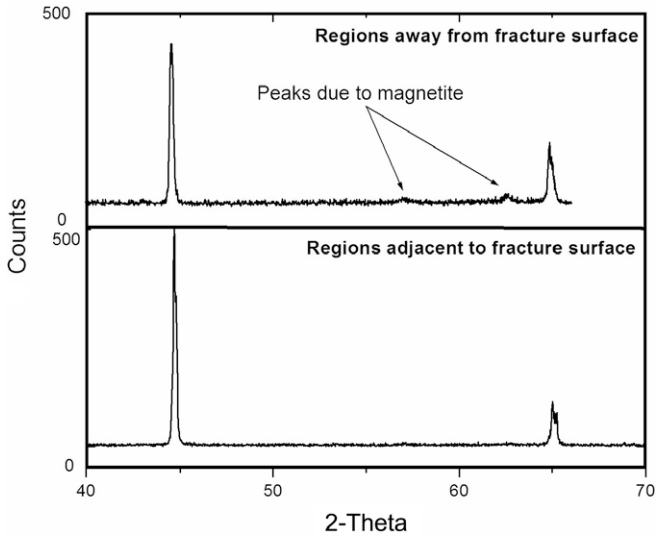
netite at the ID surfaces. Haematite was not detected in this sample. The sample from the failed region showed peaks due to base metal only. The results of the XRD analysis are shown in Fig. 6. The absence of magnetite (or any other oxide) confirmed that the oxide (magnetite) was getting dissolved at the regions of failure.

Fig. 6. XRD analysis showing presence of magnetite on the sample taken at unaffected regions and peaks due to base metal only for the sample taken from the FAC affected regions.

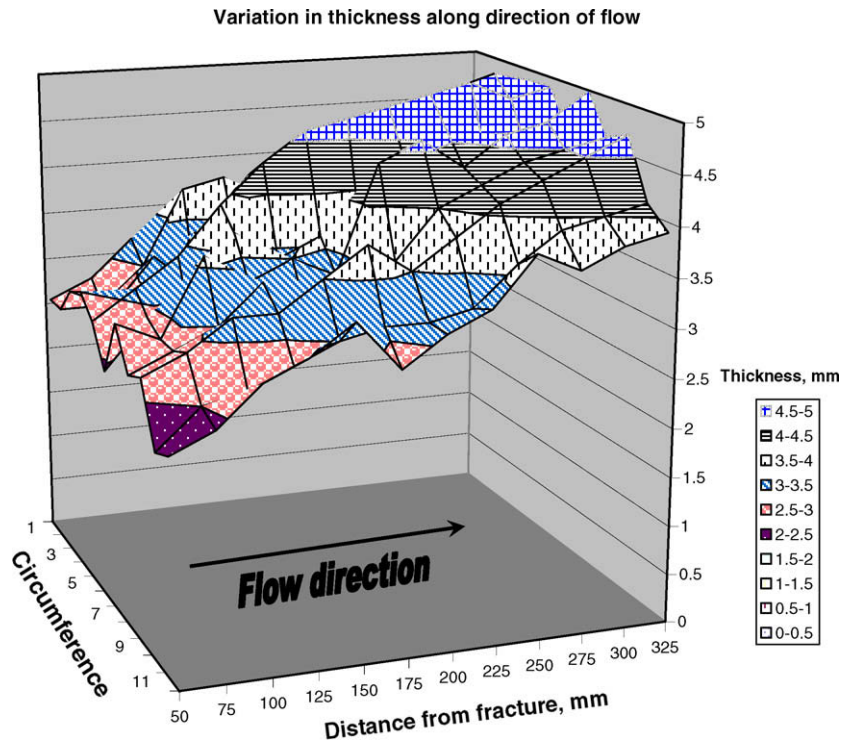
The thickness of the pipe was mapped by ultrasonic method. The thinning was maximum near the flange and it gradually reduced away from it as indicated in the Fig. 7 but the reduction in thickness had occurred over a long distance. The thickness was measured at eleven equidistant locations all along the

circumference and also at one-inch intervals along the length. The region near the fracture was very uneven. Hence, thickness mapping was started at a distance of approximately 50 mm from the fracture surface. The wall thickness at the extrados region was monitored and was found to be around 6.5 mm. This could be attributed to flow disturbance due to the elbow geometry. The maximum thinning took place near the flow disturbance due to orifice meter, as shown in Fig. 7.

Fig. 7. Variation in the thickness of the pipe in the direction of flow.
