## Journal of Nuclear Materials

## Failure behaviors of vacuum plasma sprayed tungsten coatings for plasma facing application

F.L. Chong<sup>a,b,\*</sup>, J.L. Chen<sup>b</sup>, J.G. Li<sup>b</sup>, X.B. Zheng<sup>c</sup>

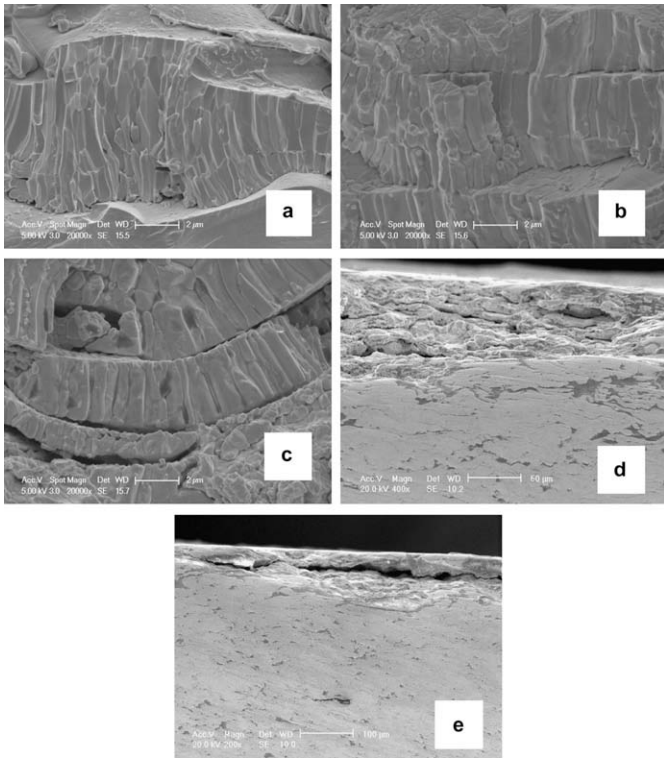
Fig. 1 shows the failure process of VPS-W with the increase of fatigue test cycles. It can be seen that lamellar structure was the typical characteristic of plasma sprayed coatings, and only several pores were scattered in the vicinity of the lamellar layers. The columnar crystals were observed perpendicular to the lamellar direction and the grain boundary was clearly. In the process of fatigue tests, the columnar crystals re-crystallized and grew up, and then micro-cracks between lamellar layers were created due to the repeating heat flux load (see Fig. 1(c)). With the increase of fatigue cycles, the micro-cracks propagated and extended to the macro-cracks or delamination, such as Fig. 1(d) and (e). Finally W coating failed. Of course, during the tests, the cracks also appeared on the surface and propagated with the increase of fatigue. Lamellar

**Fig. 1.** Failure process of VPS-W coating with the increase of fatigue cycles. (a) Original coating, (b) 5 cycles tests, (c) 20 cycles tests, (d) 50 cycles tests, and (e) 100 cycles tests.

structure of VPS-W coating with pore characteristic provides a crack arresting mechanism, and the stresses can be relieved by the limited crack formation, though the laminar structure reduces the thermal conductivity and increases the surface temperature. Columnar crystal structure is favorable to the heat transfer and confines the crack to propagate transversely, so the capability of heat removal was influenced less, even crack appearing along the columnar. No damage was observed at the W/Cu interface.

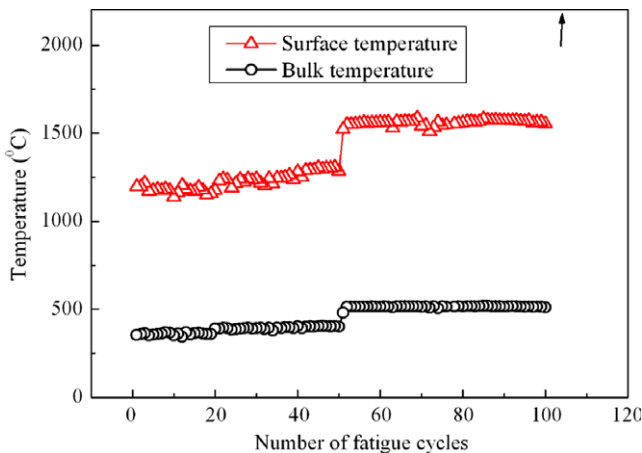
Fig. 2 shows the temperature evolution of VPS-W coatings with the increase of the fatigue tests at 10 MW/m<sup>2</sup> heat flux. Before 50 cycles, the mean surface temperature increased gradually from 1252 to 1307 °C, which indicated that crystals growing up and micro-cracks formation had the less influence on the heat transfer.

**Fig. 2.** The temperature evolution of VPS-W coatings with the increase of fatigue tests at 10 MW/m<sup>2</sup> heat flux.

But when the macro-crack appeared, the surface temperature increased rapidly to 1523 °C, and then it exceeded 2000 °C after 100 cycles. The thermocouple measurement observed that bulk temperature change did not change much. Even when the coating failed, it was only 830 °C.

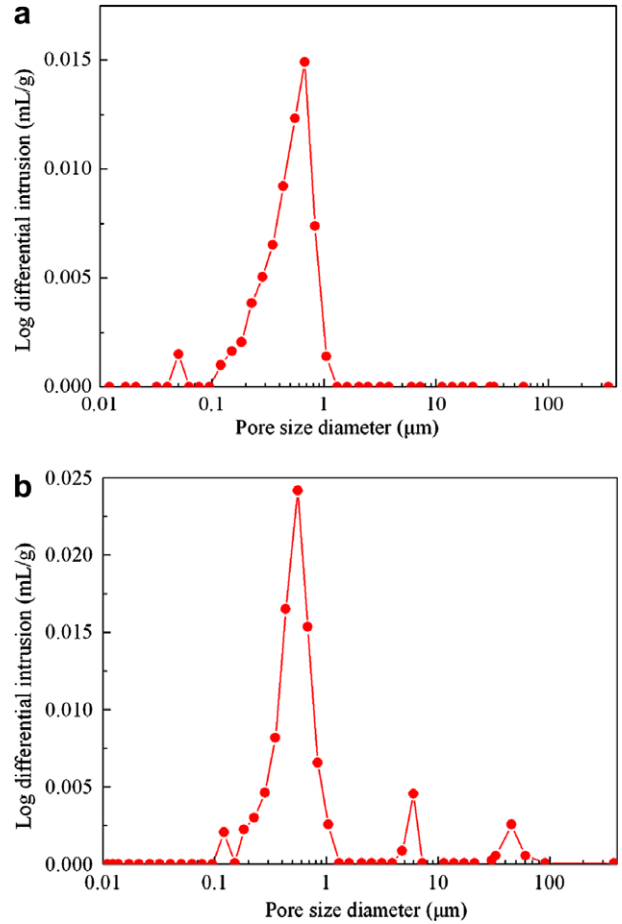
**Fig. 3.** The pore size distribution of VPS-W coatings before (a) and after (b) heat load tests.

distribution of 0.08–1  $\mu\text{m}$  were obtained in the W coating. But after 50 cycles, the porosity showed 14.5% due to the defects formation, such as cracks, delamination. The peak increased to about 0.025 mg/l from 0.015 mg/l of original W coating, and a few pores of about 6.5 and 60  $\mu\text{m}$  were also observed, which is shown in Fig. 3.

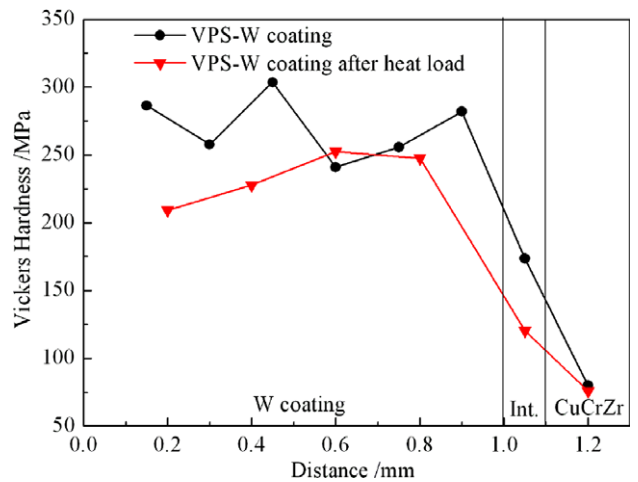
**Fig. 4.** Vickers hardness change of VPS-W coatings before and after heat load tests.

Vickers micro-hardness was measured on the cross section from the coating surface to the substrate with the load of 100 N for 10 s. Due to the effect of porosity and the residual stress, the Vickers micro-hardness reveals significant scattering. The mean hardness is 271 MPa, however, after 50 cycles fatigue tests, the mean hardness changes into 234.1 MPa. Vickers micro-hardness distribution from W coating to CuCrZr substrate is shown in Fig. 4.

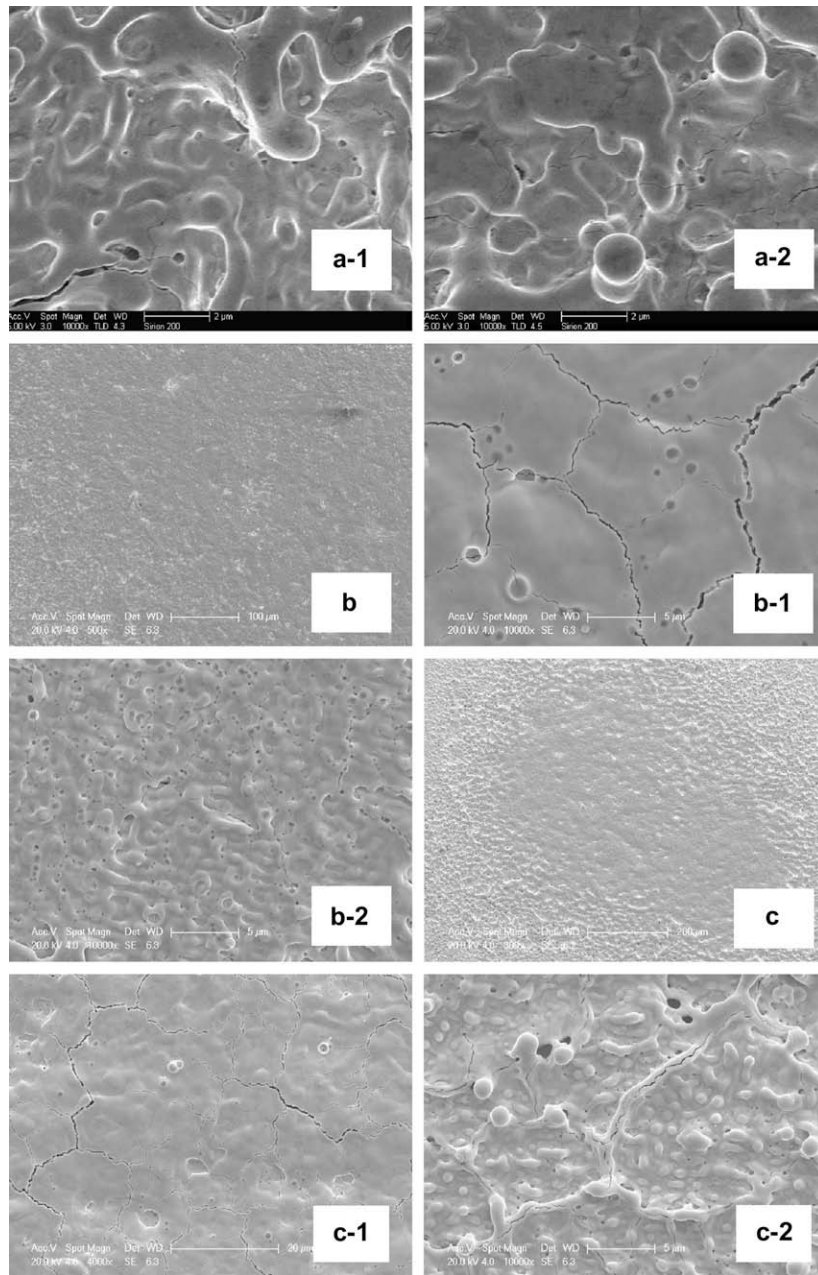
**Fig. 5.** The surface morphology change of VPS-W coatings after laser irradiation. (a-1) 20 pulses, irradiation center, (a-2) 20 pulses, irradiation surrounding, (b) 100 pulses, (b-1) 100 pulses, irradiation center, (b-2) 100 pulses, irradiation surrounding, (c) 300 pulses, (c-1) 300 pulses, irradiation center, (c-2) 300 pulses, irradiation surrounding.

Fig. 5 shows the surface morphology change of VPS-W by laser irradiation. Unfortunately, the surface roughing phenomenon was not observed due to the rough surface characteristic of W coatings by means of stacks of many laminar splats. Fig. 5(a-1) and (a-2) shows the obvious surface homogeneous melting and

micro-cracks, and the surrounding zone cracks were more severe than center. The compressive stresses caused by surface expansion and the tensile stresses caused by the shrinkage after loading would be responsible for the cracks formation. In addition, except the loaded area the whole surface is at room temperature, therefore, at the surrounding zone cracks were also attributed to the temperature gradual stresses. With the increase of pulses, the loaded area was in a state of being melted, and the melting tungsten was ejected around, which were shown in Fig. 5(b-2) and (c-2). The smooth crater can be seen clearly after 100 pulses (see Fig. 5(b)), and the crater enhanced at 300 pulses. From the cross sectional SEM observation it can be seen that the damage such as coating melting, crystals re-crystallized and grew up only appeared at the near surface.

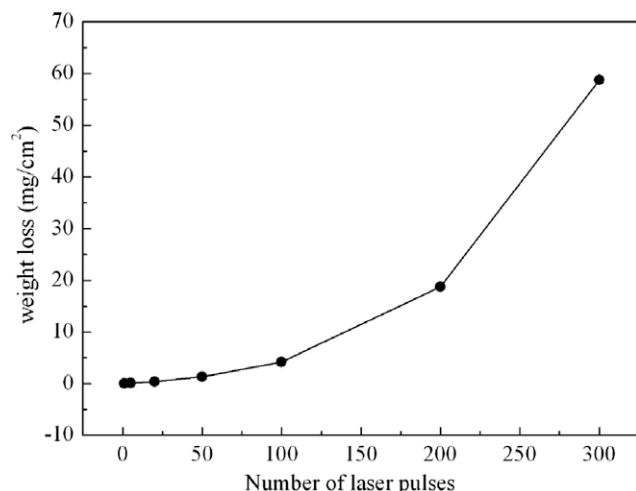
Fig. 6. Weight loss rates evolution of VPS-W under the transient heat load.

Weight loss rates were also examined, which is shown in Fig. 6. Tungsten had the less weight loss rates due to its heavy weigh and high sputtering threshold energy. But the melting of W strongly enhanced the weight loss due to the splash and evaporation.
