## Power operation with reduced heat transmitting tiles at tore supra

R. Mitteau\*, J. Schlosser, M. Lipa, A. Durocher

### A B S T R A C T

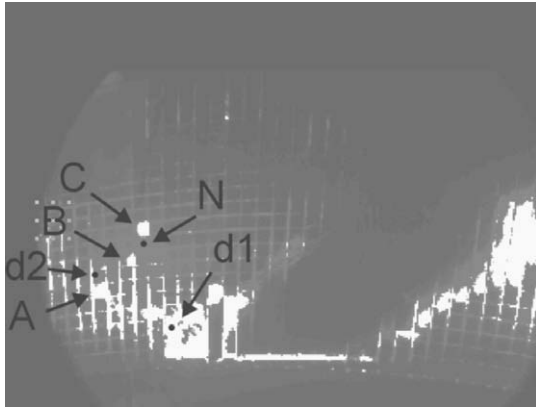
**Fig. 1.** Infrared image of the section PJ6 during cool down after #37047. White areas are hot (1190 K), and black is cold (400 K).

time constant  $\tau$  is then extracted simply by fitting a straight line through the logarithm of the temperature, and taking its slope (Fig. 3). The 5 first points (100 ms) are discarded to reduce the influence of short events like the energy deposited by the disruption and the artificial shortening of  $\tau$  caused by superficial layers. Not all disruptions are however usable: the plateau must be sufficiently steady and the initial temperature sufficiently high to have enough dynamics of the IR signal. The location of the pick-up points is given Fig. 1, along with some other reference points to precise the analysis: N (Normal), d1 (deposit), d2 (another deposit area) – Fig. 1.

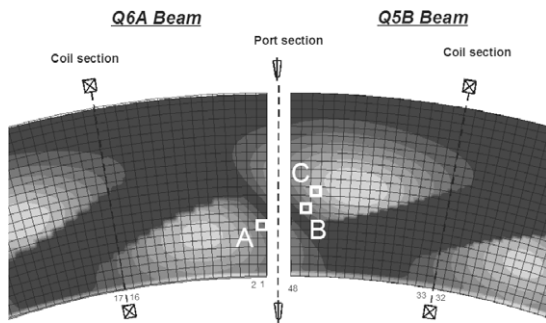
- A is on the first position of Q6A. It is element N° 200, and it is the tile 4 of this element.
- B is on the position 47 of Q5B. It is element N° 610, and it is tile 8 of this element.
- C is on the position 46 of Q5B. It is element N°594, and it is the tile 10 of this element.

The positions are transferred on a heat flux map in Fig. 2. All 3 tiles are localized in a high heat load area, between the two heat flux concentrations. This area is also the one where the cross field heat flux is at its maximum, and is also the location where the ion ripple losses impinge. This can be considered an area where the heat flux is close to the TPL maximum. Investigation in the records of the non destructive examination of the finger elements prior to installation showed that the tiles were defectless at the origin, with a thermal lag  $\Delta T$  smaller than the acceptance criterion of 3° (first line of Table 1).

**Fig. 2.** Location of the defective tiles on the toroidal pump limiter.

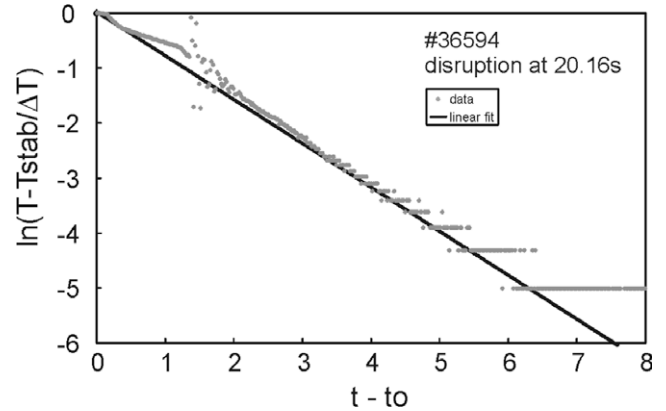
**Fig. 3.** Plot of the relative temperature variation versus time for the extraction of the thermal time constant for defect A (#36594).

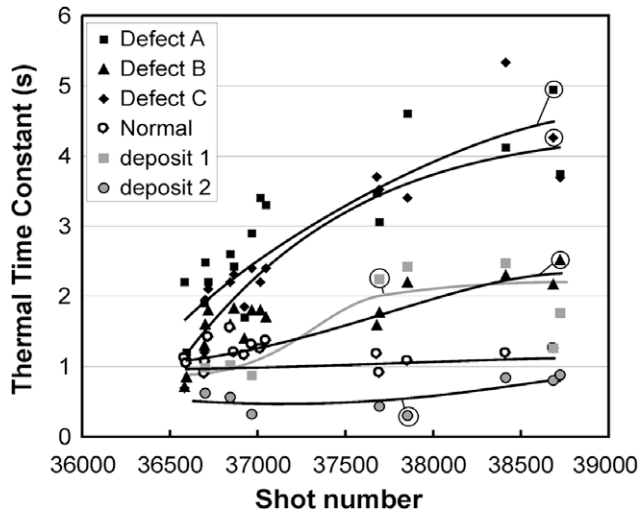
Fig. 5. Evolution of the thermal time constants of defective tiles and reference pick-up points during 2006.

The time constant is plotted against the shot number in Fig. 5. Tile A passes from 1.7 s to 4.4 s, a four fold increase. Tile B increases somewhat less from 1 s to 2.4 s, and tile C from 1 s to 4 s. For the same discharge series, the normal tile undergoes no significant variation. Deposited tiles demonstrate a slow increase, from 0.5 s to 0.8 s for the first pick-up point and from 1 s to 2 s for the second one. These increases are attributed to deposit growth, and are still a factor of 2 smaller than the one apparently caused by bond deterioration. The error margin on  $\tau$  is difficult to establish, still a 20–30% error (the one of the IR measure) is probable. This error bar is also comparable to the reproducibility of the evaluations (Fig. 5). As a result, the  $\tau$  increases are significant and can not be attributed to something else but crack propagation. The slope of the increase is steady, and does not shows sign of saturation: the tiles thermal behavior is expected to tend to the one of a radiation cooled tile.

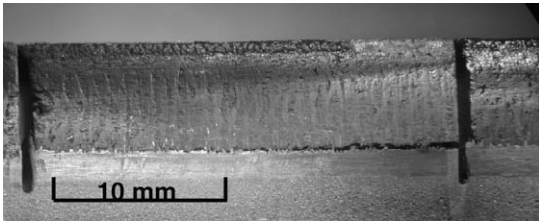
Fig. 6. Photo of the damaged bond (side view of the flat tile bond). The copper heat sink is on the bottom, the carbon tile above it. The heat flux comes on the top of the tile.

During the summer of 2007, Q6A was temporarily removed from the torus, in order to draw 9 element samples (DITS project, aiming at deuterium trapping investigations). The occasion is used to remove the first element of the sector, containing the defect A. Once examined by the side, a crack of 75% of the bond is evidenced (Fig. 6). The crack is seen on both sides, to about the same length. It indicates that the defect is certainly continuous throughout the bond. It is now a transverse band defect, and it is an evolution from the initial estimate that it was a corner defect. A thermal non destructive test is done, using the SATIR test bed (Table 1). The  $\Delta T_{\text{satir}}$  is measured to 21.8°. This is an increase by a factor 15 compared to the initial value, stressing how much the heat transfer has been degraded. It is remarkable to experience that the element is still functional at half its design heat flux with a so large defect: with a 75% defect, the cooling by the heat sink is still highly efficient as the tile is cooled in less than 15 s.

One element with a defective is removed from the vessel during the mid 2007 shut down. The defective tile shows a bond (tile/copper heat sink) cracked to 75%. Tore Supra having been able to operate high power discharges with this defect, this is a demonstration that power operation is possible with a highly damaged tile.
