## Microstructural analysis of MTR fuel plates damaged by a coolant flow blockage

A. Leenaers\*, F. Joppen, S. Van den Berghe

SCK•CEN, Nuclear Materials Science Institute, Boeretang 200, B-2400 Mol, Belgium

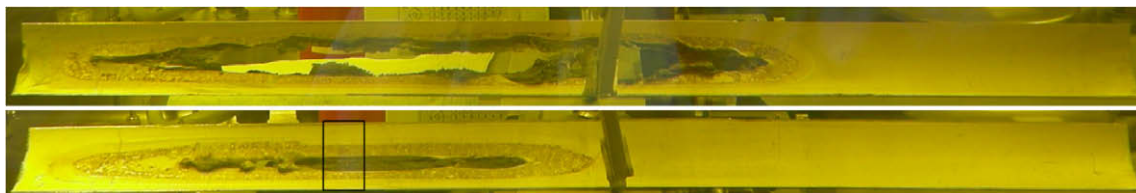
Visual inspection in the hot cell showed that for one of the plates (Fig. 1) almost 50% of the meat zone has melted. In the center of this zone, part of the fuel plate is missing. Most of this material would have been released in the primary circuit but part of it might have been pulled out during transport and handling of the plates.

Fig. 1. Pictures of the two damaged fuel plates.

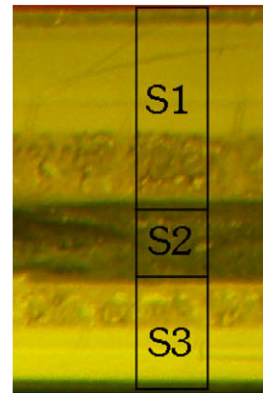
A more detailed image (Fig. 2) of the least damaged fuel plate shows that the affected region consists of 3 areas with different structural aspects:

- the intact cladding;
- an area showing a rough surface structure that might be the result of oxide flakes that peeled off;
- a very dark colored area and at some positions material is missing.

Fig. 2. Optical image of part of the fuel plate.

The totally fractured outer oxide layer observed in zone B could be consistent with the observations on the area in Fig. 2 where the oxide flakes appear to have spalled off from the cladding surface.

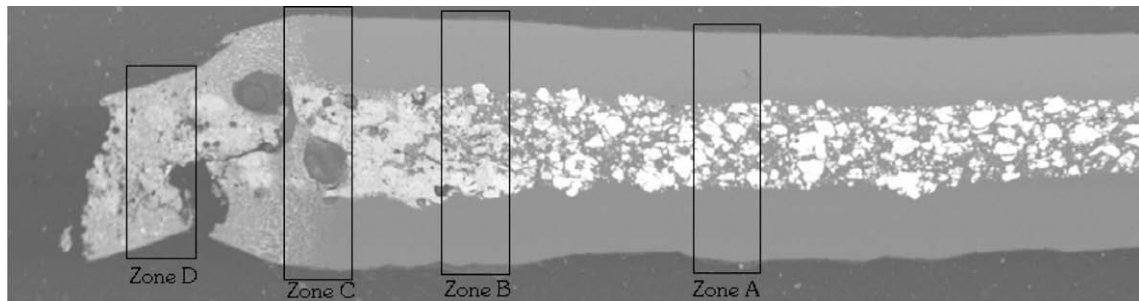
In the backscattered electron image of the cross section of sample S1, shown in Fig. 3, different zones can be identified. The fuel and the cladding in zone A appear to be unaffected by the incident and can be considered to represent the intact fuel plate.

In zone B, one observes a transition in the meat from dense to porous fuel particles. The cladding is still intact but a slight increase in the plate thickness is observed. In zone C, large pores appear in the meat, and in the cladding precipitation is seen at the grain boundaries. In this region, the swelling in the fuel plate has increased even further. In zone D, the meat and the cladding can no longer be distinguished. The severe contraction in the plate thickness and the cracking throughout the cladding indicate that all fission gas was released at this position and the fuel plate was reduced to a melt.

Fig. 3. The backscattered electron image covering the cross section of sample S1.

Further fission gas bubble coalescence has occurred resulting in very large round pores seen in the former meat region of the plate. The swelling of the meat resulting from this is also reflected in the thickness of the fuel plate at this position (Fig. 3).

Increasing fission gas bubble coalescence and mobility results in the formation of larger fission gas bubbles, which in turn cause a substantial increase in plate thickness (Fig. 3).

The transition from Zone C to D is characterized by necking of the fuel plate (Fig. 3). In Zone D, the plate thickness has substantially decreased and large cracks are running through the meat and cladding. No more large fission gas pores are seen as a full release of the fission gas inventory has occurred. The observation of a eutectic microstructure at the cladding grain boundaries points out that the temperature went beyond 660 °C, but, since in the former meat section only  $U_{0.9}Al_4$  precipitates are measured, we should conclude, based on the binary diagram, that the temperature in this zone stayed below 731 °C.

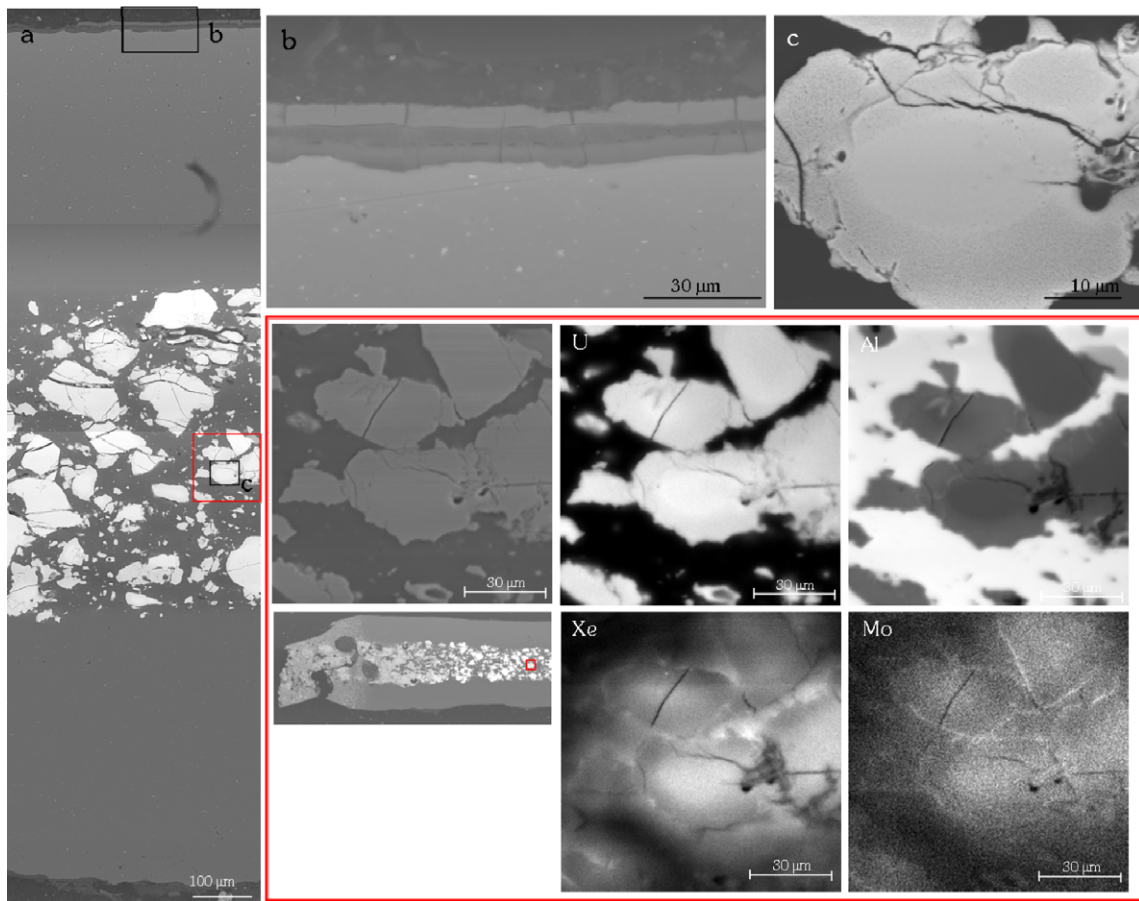
The collage of backscattered electron images (BEI) in Fig. 4a covers the complete plate cross section in zone A. A thick ( $\sim 15\ \mu\text{m}$ ) oxide layer on the outer surface (Fig. 4b) of the cladding can be observed. This oxide layer has cracked both perpendicular and parallel to the surface. The cracks parallel to the surface could indicate that the oxide consists of multiple layers, possibly related to the different reactor cycles. The perpendicular cracks usually result from dehydration of the layer during the drying of the fuel plate in the hot cell [18].

Fig. 4. BEI image across the plate section at zone A (a) and detailed BEI image of the oxide layer (b) and a fuel particle (c). The EPMA X-ray maps are contained within the red frame. (For interpretation of the references to color in this figure legend, the reader is referred to the web version of this article.)

the brittle nature of the fuel. In a more detailed image of a fuel kernel (Fig. 4c), one can observe a layer around the particle, which contains a lot of small bubbles. From the electron microprobe analysis (EPMA), (Fig. 4 within the red frame) it is seen from the X-ray mapping of U and Al that this layer is richer in Al than the particle interior. Local quantitative analysis (Table 1) confirms that it is a  $U_{0.9}Al_4$  layer while the fuel particle is  $UAl_3$ – $UAl_4$ . The  $U_{0.9}Al_4$  layer is the result of the interaction between the  $UAl_x$  and Al matrix. These interaction layers are also found in other types of dispersion fuels. In several studies, this interaction layer is, regardless of the composition of the plate type fuel, characterized as amorphous [19]. This was directly demonstrated for U(Mo) dispersion fuel in [20]. The amorphous nature of these interaction layers is explained as the result of their formation mechanism, which is related to the mixing of fuel material with the matrix by the fission product

In zone A, the fuel plate shows microstructural features typical for fuel operated under normal conditions, that is, the temperature of the fuel would have reached around 200 °C if the reactor was at full power. Even at this low temperature a solid state reaction between the  $UAl_3$  fuel and the Al matrix takes place, resulting in the formation of an  $U_{0.9}Al_4$  interaction layer. This layer shows behavior similar to that noted in other amorphous reaction products in allowing the growth of larger fission gas bubbles. The remaining fission gas is expected to be contained in nanobubbles lying in the  $UAl_3$  kernel. The zone A thus corresponds to the intact fuel plate, in Fig. 2.

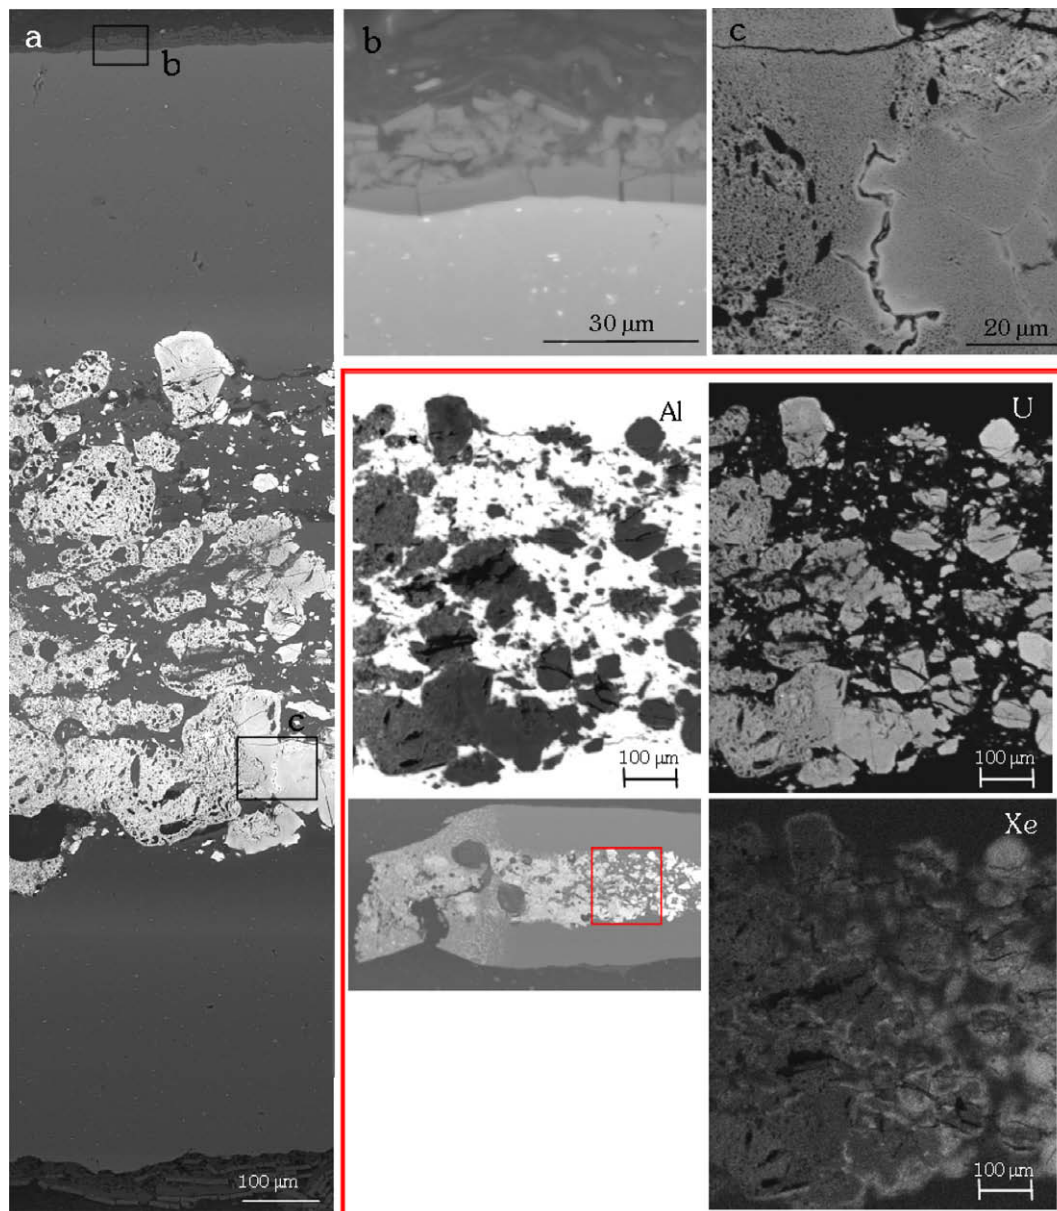
In zone B, we can still distinguish the meat from the cladding (Fig. 5a). Most of the oxide layer on the outer surface of the cladding is spalling off, but a small layer is still attached to the cladding (Fig. 5b).

Inside the meat, a transition in the morphology of the fuel particles is observed. At the right side of Fig. 5a, intact fuel particles are seen, while to the left, the fuel starts to contain large bubbles or pores and the particles become larger and more rounded.

In a more detailed image (Fig. 5c), it is seen that the interiors of the intact particles contain many small (100–300 nm) bubbles. In the interaction layer, the size of the fission gas bubbles has increased, by coalescence with neighboring bubbles. This onset of fission gas release causes the fuel particles to swell and assume a more rounded appearance. Consequently, the plate thickness in Zone B increases (Fig. 3). The solid state reaction rate between the fuel kernel and the aluminum matrix accelerates and consumes the entire kernel.

**Fig. 5.** BEI image across the plate section at zone B (a) and detailed BEI image of the oxide layer (b) and a fuel particle (c). The EPMA X-ray maps are contained within the red frame. (For interpretation of the references to color in this figure legend, the reader is referred to the web version of this article.)

The subsequent zone B, C and D are transition zones in which the microstructure evolves over a very narrow width. In zone B, a clear onset for fission gas release is observed. This means that the fuel temperature was probably increasing to 550 °C. According to literature, fission gas release below 550° is negligible [21], but it does cause the fuel plate to swell.

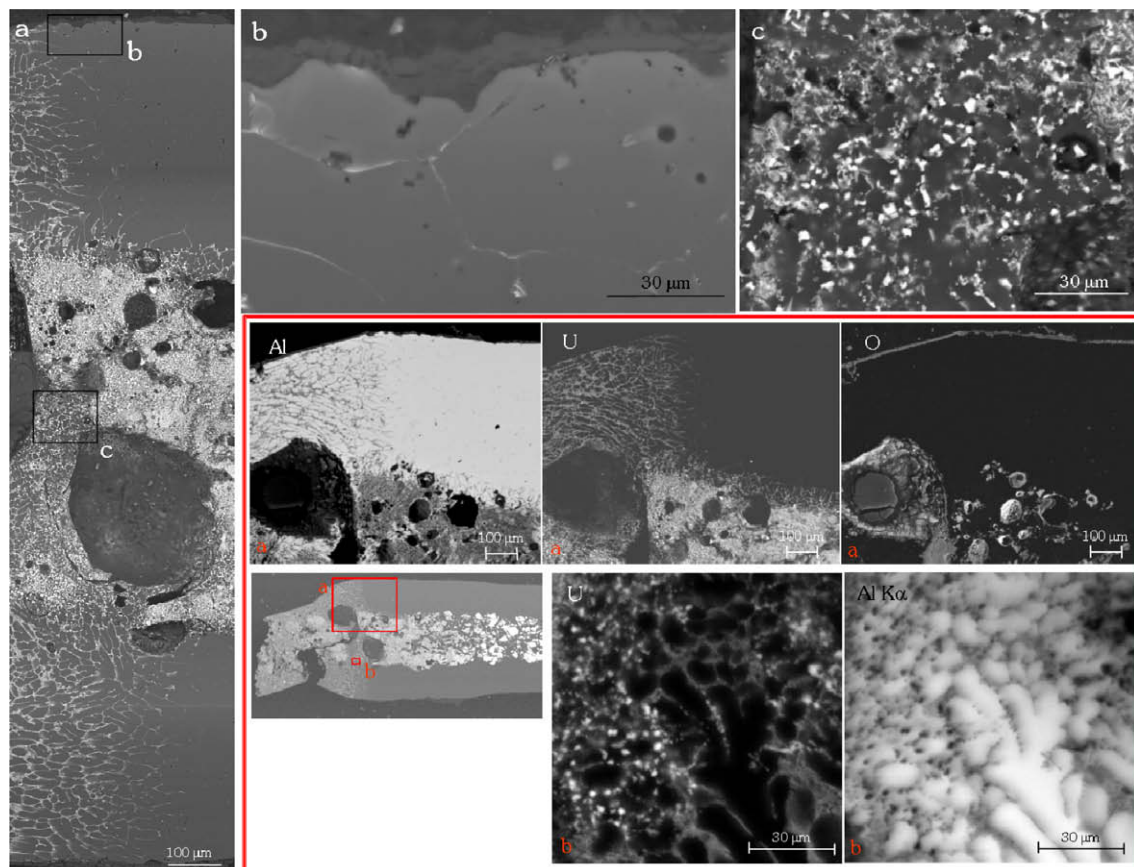
In zone C, the meat can still be distinguished from the cladding (Fig. 6a). Fig. 6b and the O X-ray map (EPMA, top row) clearly show

the presence of an oxide layer (thickness 5  $\mu\text{m}$ ) on the outer surface of the cladding.

In the cladding, a different phase is present at the grain boundaries (Fig. 6b). From the EPMA Al and U maps (top row), it is seen that this feature is associated with uranium aluminide, which has diffused into the cladding via the grain boundaries.

In the meat, it is no longer possible to differentiate the fuel particles from the matrix. Also here, uranium is present on the Al grain boundaries (Fig. 6c and EPMA bottom row), while the observed particles can be identified as  $\text{U}_{0.9}\text{Al}_4$ .

**Fig. 6.** BEI image across the plate section at zone C (a) and detailed BEI image of the oxide layer (b) and a fuel particle (c). The EPMA X-ray maps are contained within the red frame. (For interpretation of the references to color in this figure legend, the reader is referred to the web version of this article.)

The appearance of uranium aluminide on the Al grain boundaries in zone C indicates that incipient melting at the Al grain boundaries is likely to have occurred, giving easy access pathways

for the uranium to diffuse. This means that the temperature in this zone must have been close to 646 °C, the solidus temperature of the cladding.

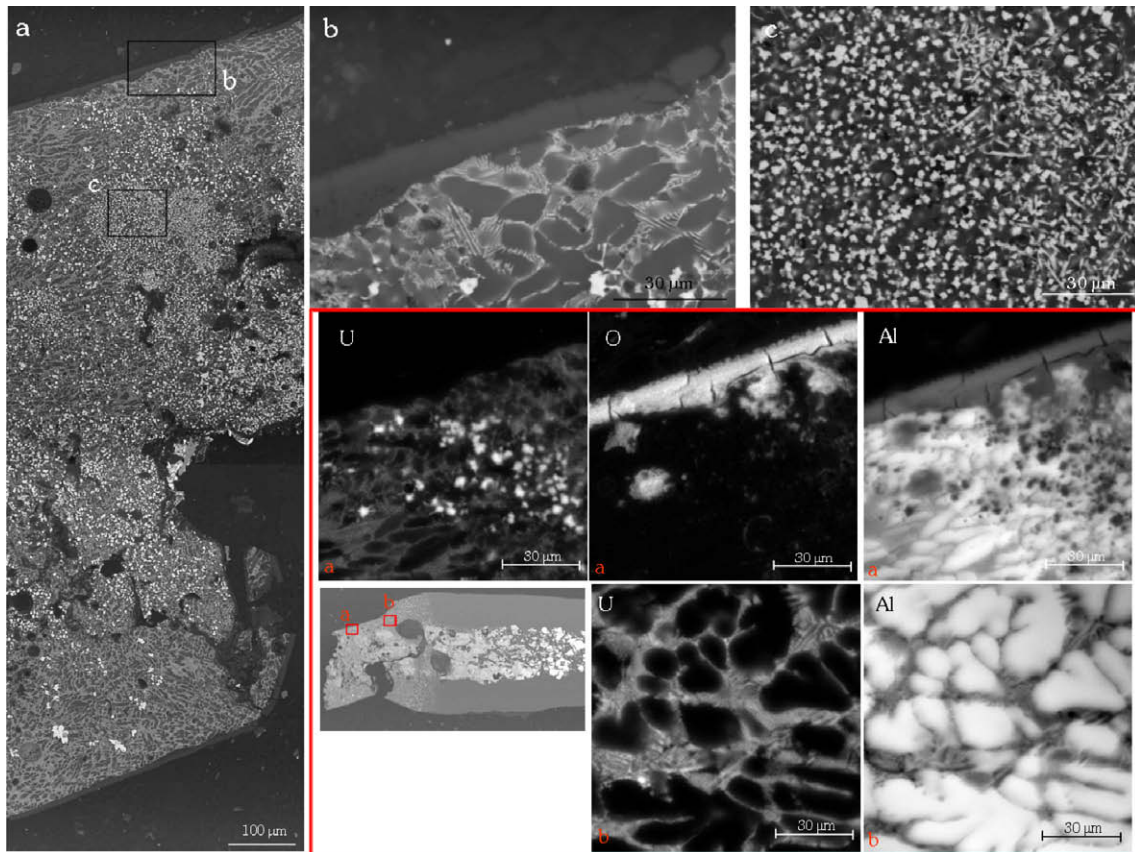
In zone D (Fig. 7a), no clear difference can be made between the meat and the cladding. Pure Al grains are observed, and on the grain boundary the uranium aluminide phase formed a eutectic microstructure. The  $\text{U}_{0.9}\text{Al}_4$  particles can be found at several places but they seem more concentrated in the center of the plate (Fig. 7a and c).

The EPMA measurements confirm these findings. They also show the presence of an approximately 5  $\mu\text{m}$  thick oxide layer remaining on the outer surface (EPMA results, top row and Fig. 7b). This layer contains cracks perpendicular to the surface, indicating dehydration of the oxide sheet. Note that no uranium is measured within this oxide layer, indicating that the layer was formed prior to the incident.

Some smaller rounded pores, related to the fission gas release can still be seen but the thickness of the plate in this zone is severely reduced. Large cracks running through the meat and cladding (Figs. 3 and 7a) also indicate that the complete fission gas

inventory has been released, leaving behind a pool of molten aluminum with small  $\text{U}_{0.9}\text{Al}_4$  particles in it.

**Fig. 7.** BEI image across the plate section at zone D (a) and detailed BEI image of the oxide layer (b) and a fuel particle (c). The EPMA X-ray maps are contained within the red frame. (For interpretation of the references to color in this figure legend, the reader is referred to the web version of this article.)

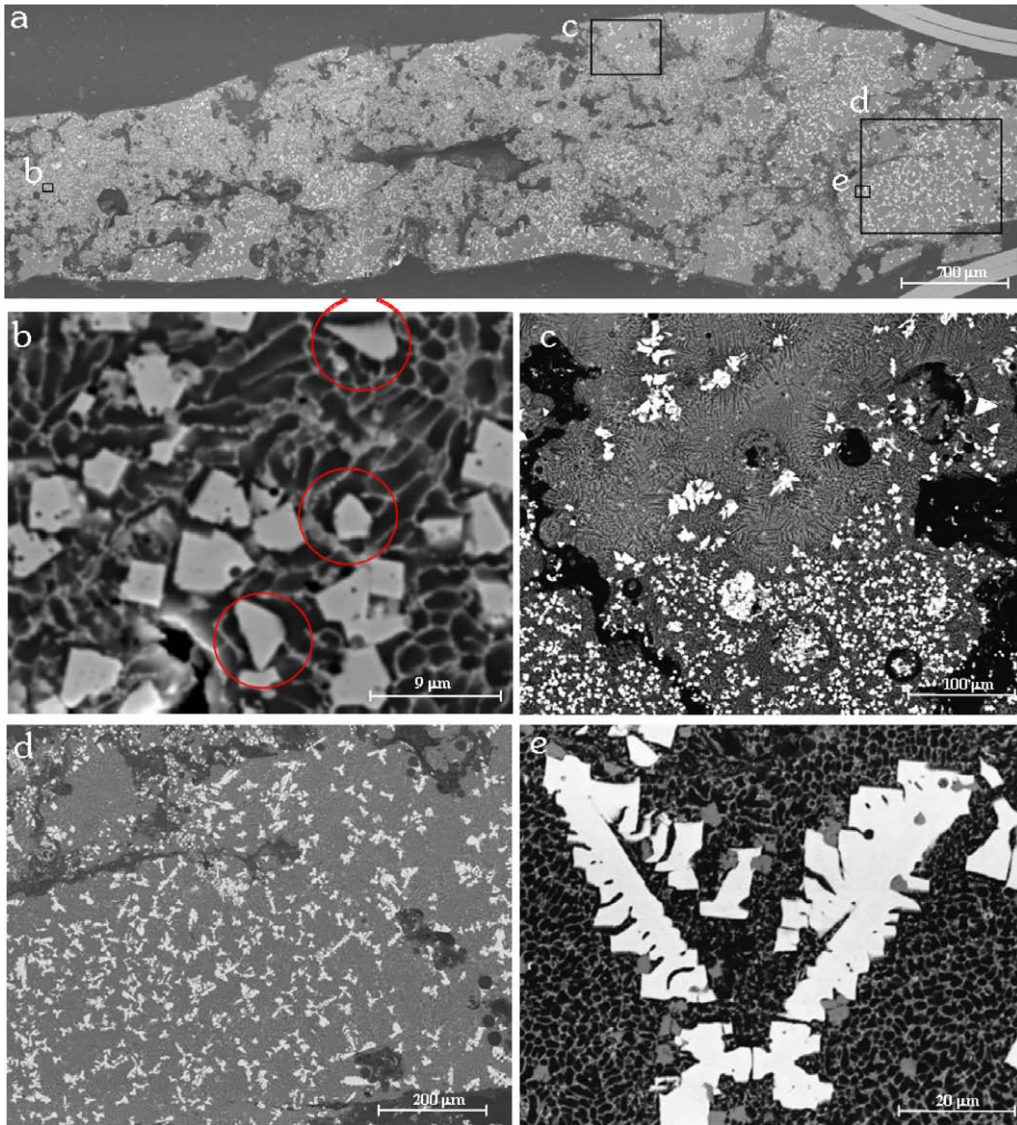
The microstructure of the resolidified material in sample S2 (Fig. 8a) looks nearly identical to zone D in sample S1. However, from more detailed BEI images (Fig. 8b) it is observed that large angular particles have formed, which can be identified as  $\text{UAl}_3$  (Table 1). The smaller, rounder particles (denoted by red circles in Fig. 8b) are the previously observed  $\text{U}_{0.9}\text{Al}_4$  particles (Table 1). More to the right in Fig. 8a (more to the center of the fuel plate), the formation of some dendrites is observed (Fig. 8c). In the area covered by Fig. 8d, almost solely dendrites are observed in the melt. These dendrites shown in Fig. 8d consist of  $\text{UAl}_3$ , while the small particles at the extremities of the branches contain only a few wt% U.

Fig. 8. BEI images covering sample S2 (a). More detailed images reveal the microstructures observed (b–e).

More towards the center of the fuel plate,  $UAl_3$  dendrites are seen. At the extremities of these dendrites, eutectic droplets are observed (gray particles in Fig. 8e). These observations and the assumption that the average composition of the melt is around 72–75 wt% Al (supported by EDX and image analysis), indicate from the binary diagram (Fig. 9) that the temperature in this location must have reached at least 900–950 °C.
