The Erosion of a Cobalt-Chromium Alloy by Liquid Impact [and Discussion]

IX. The erosion of a cobalt–chromium alloy by liquid impact

BY J. B. MARRIOTT AND G. ROWDEN

The English Electric Co., Whetstone, nr Leicester

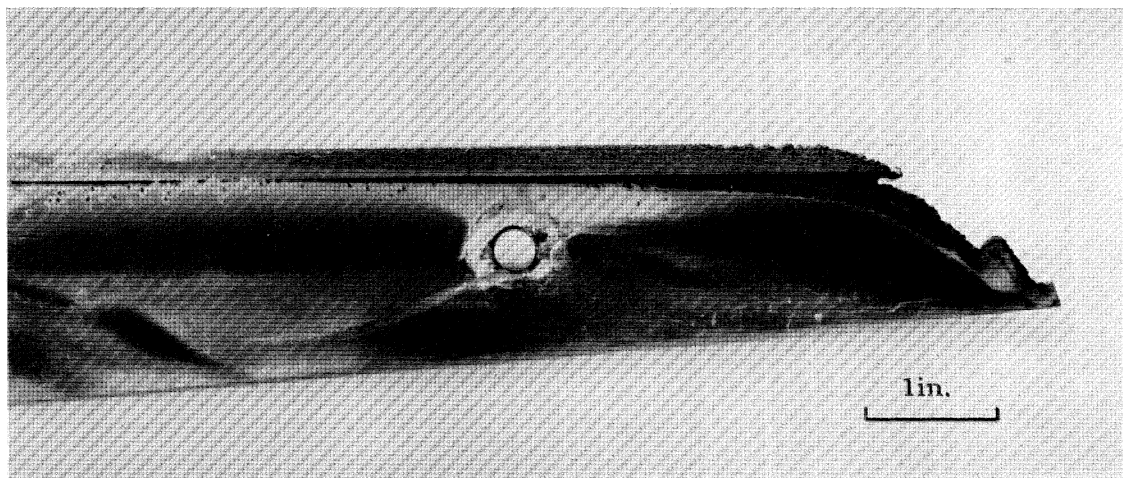
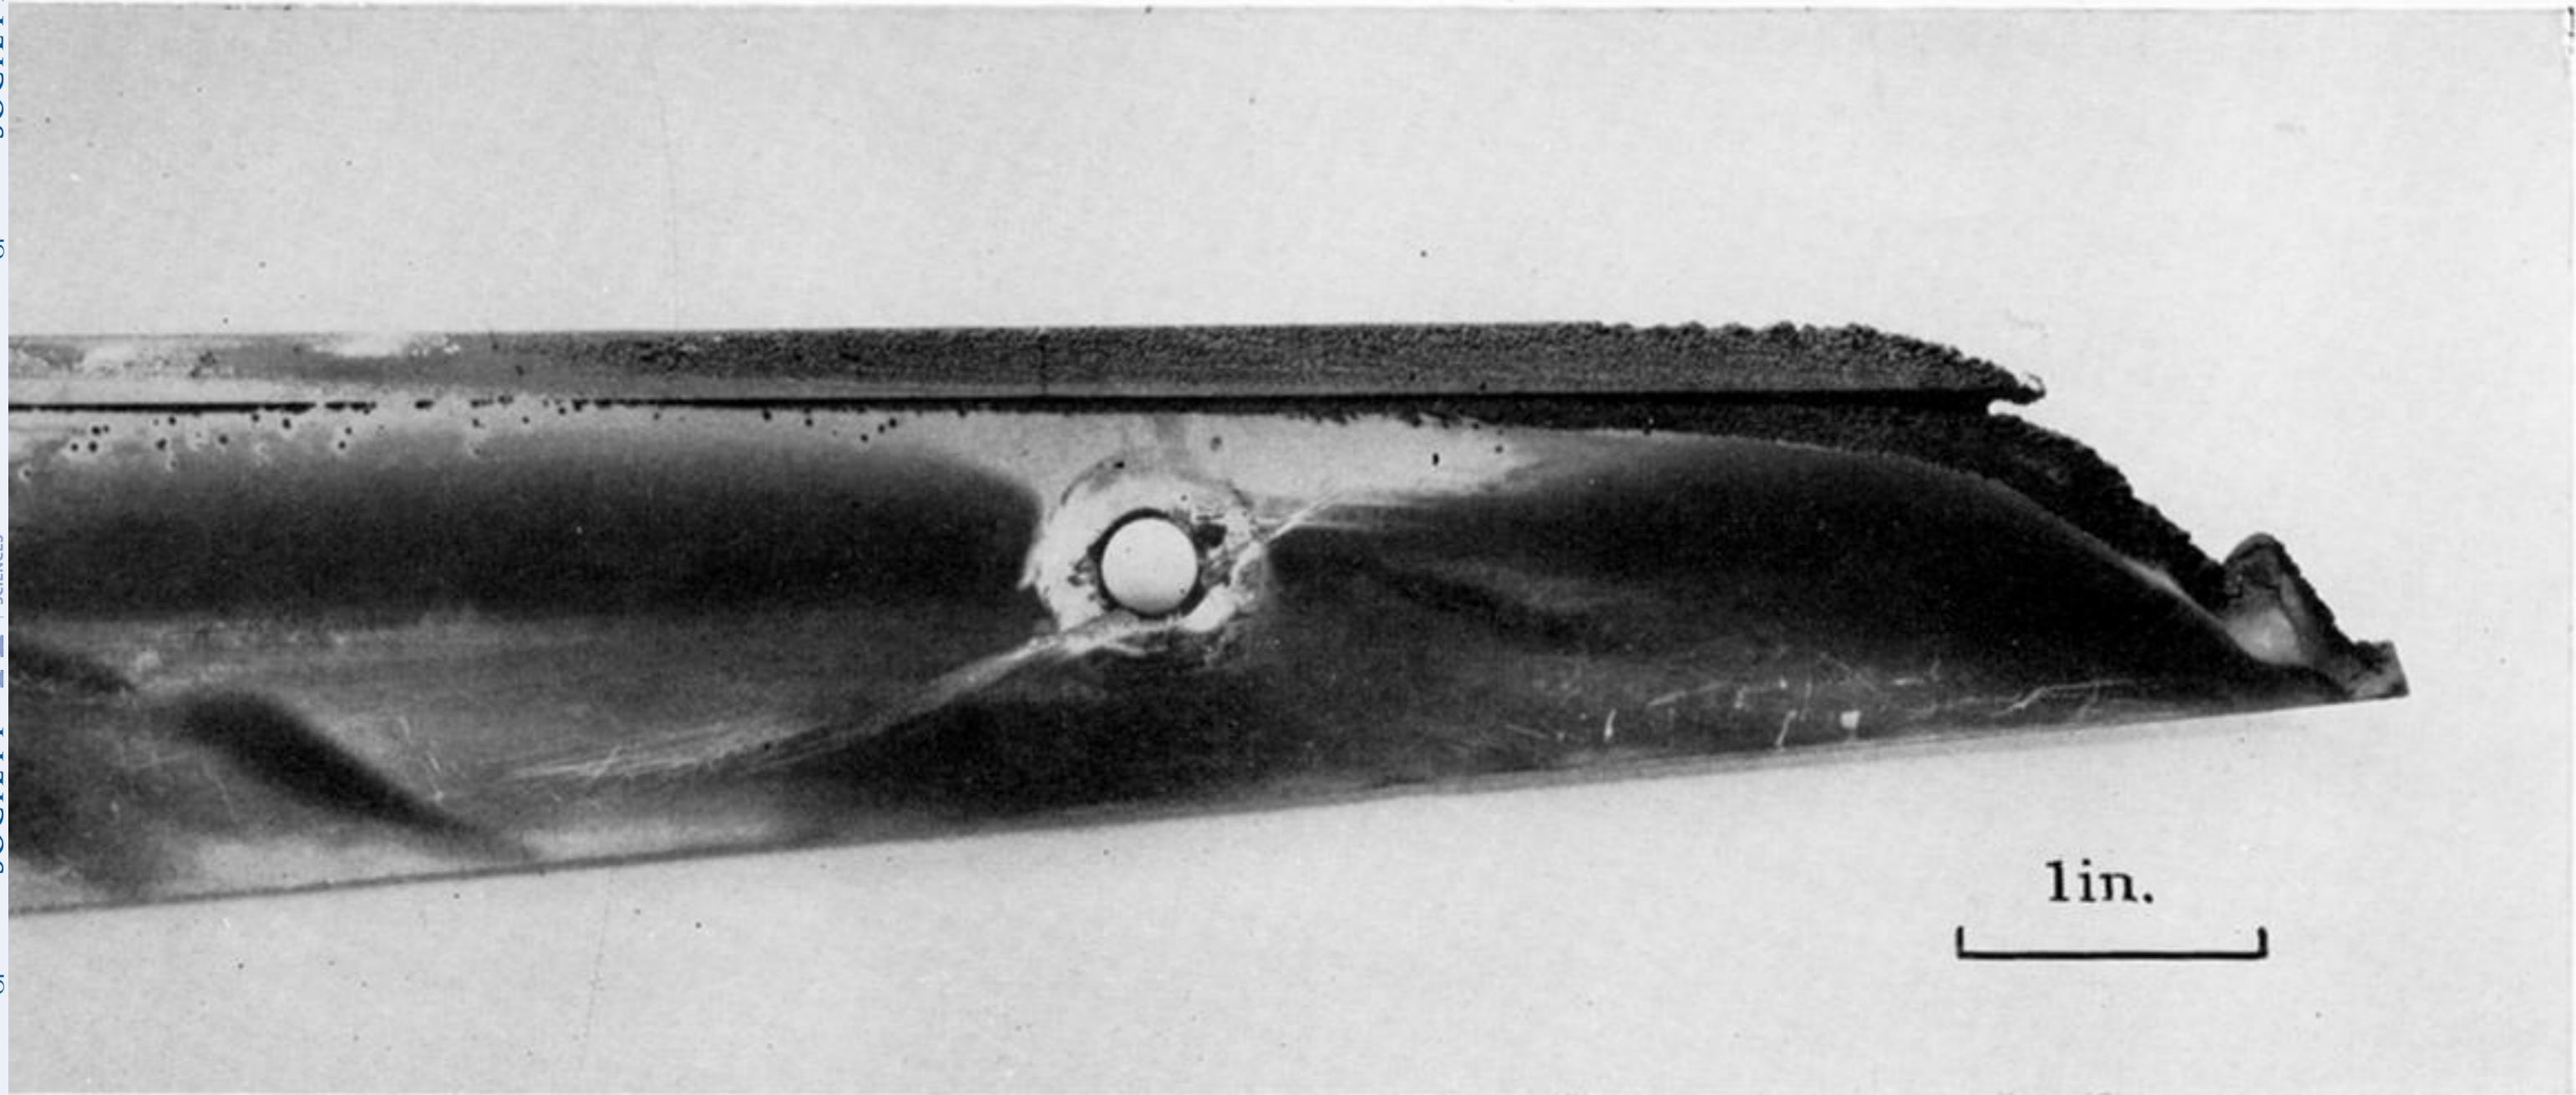
The extent to which damage can occur is shown in figure 1, plate 24. The blade in this figure was removed from service after 30250 h running with a tip velocity of 1400 ft./s. The protection on it was provided by a number of lengths of cast Stellite 6. Examination showed that at the tip the blade and shield had been eroded away. Extensive erosion damage was also observed in the remaining portion of the first shield. Numerous craters were found on the shields lower down the blade.

FIGURE 1. Stellite shielded low pressure blade after 30 250 h service.

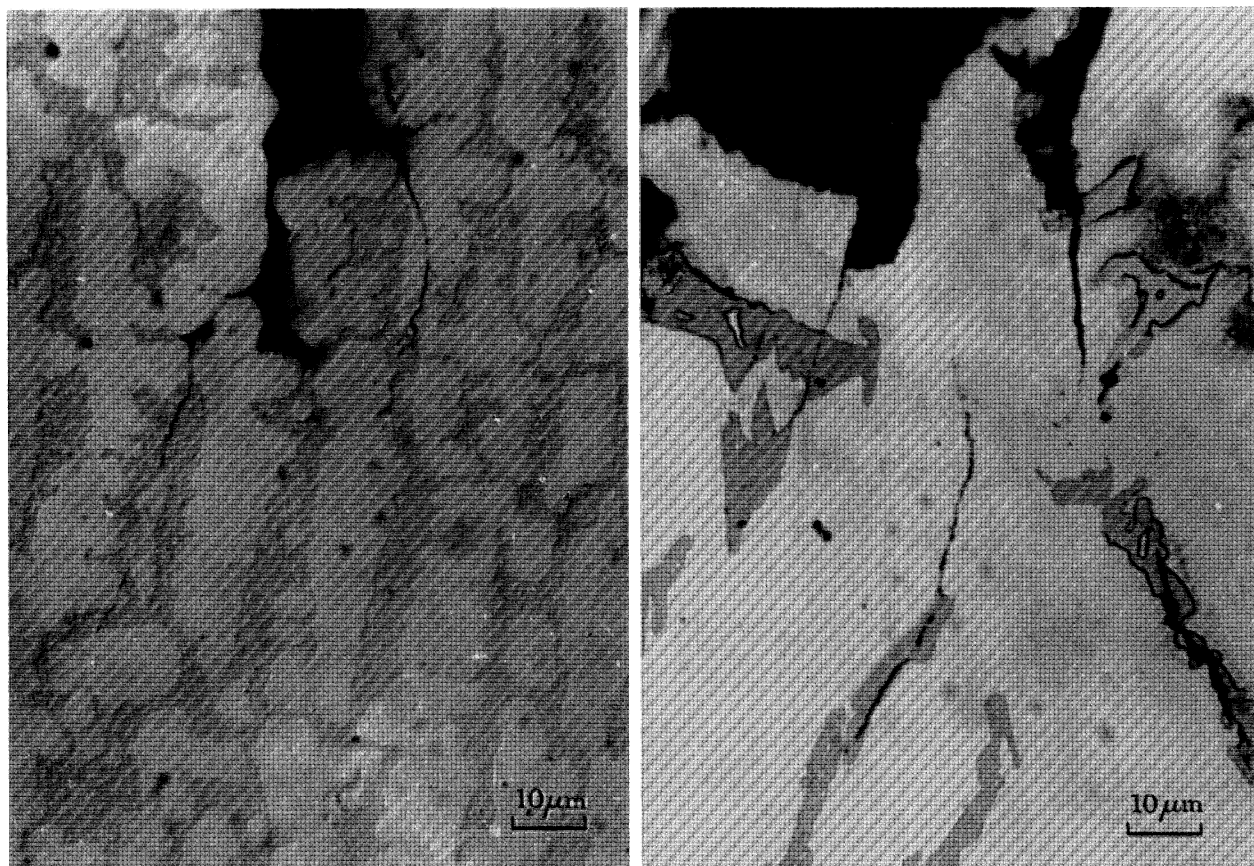
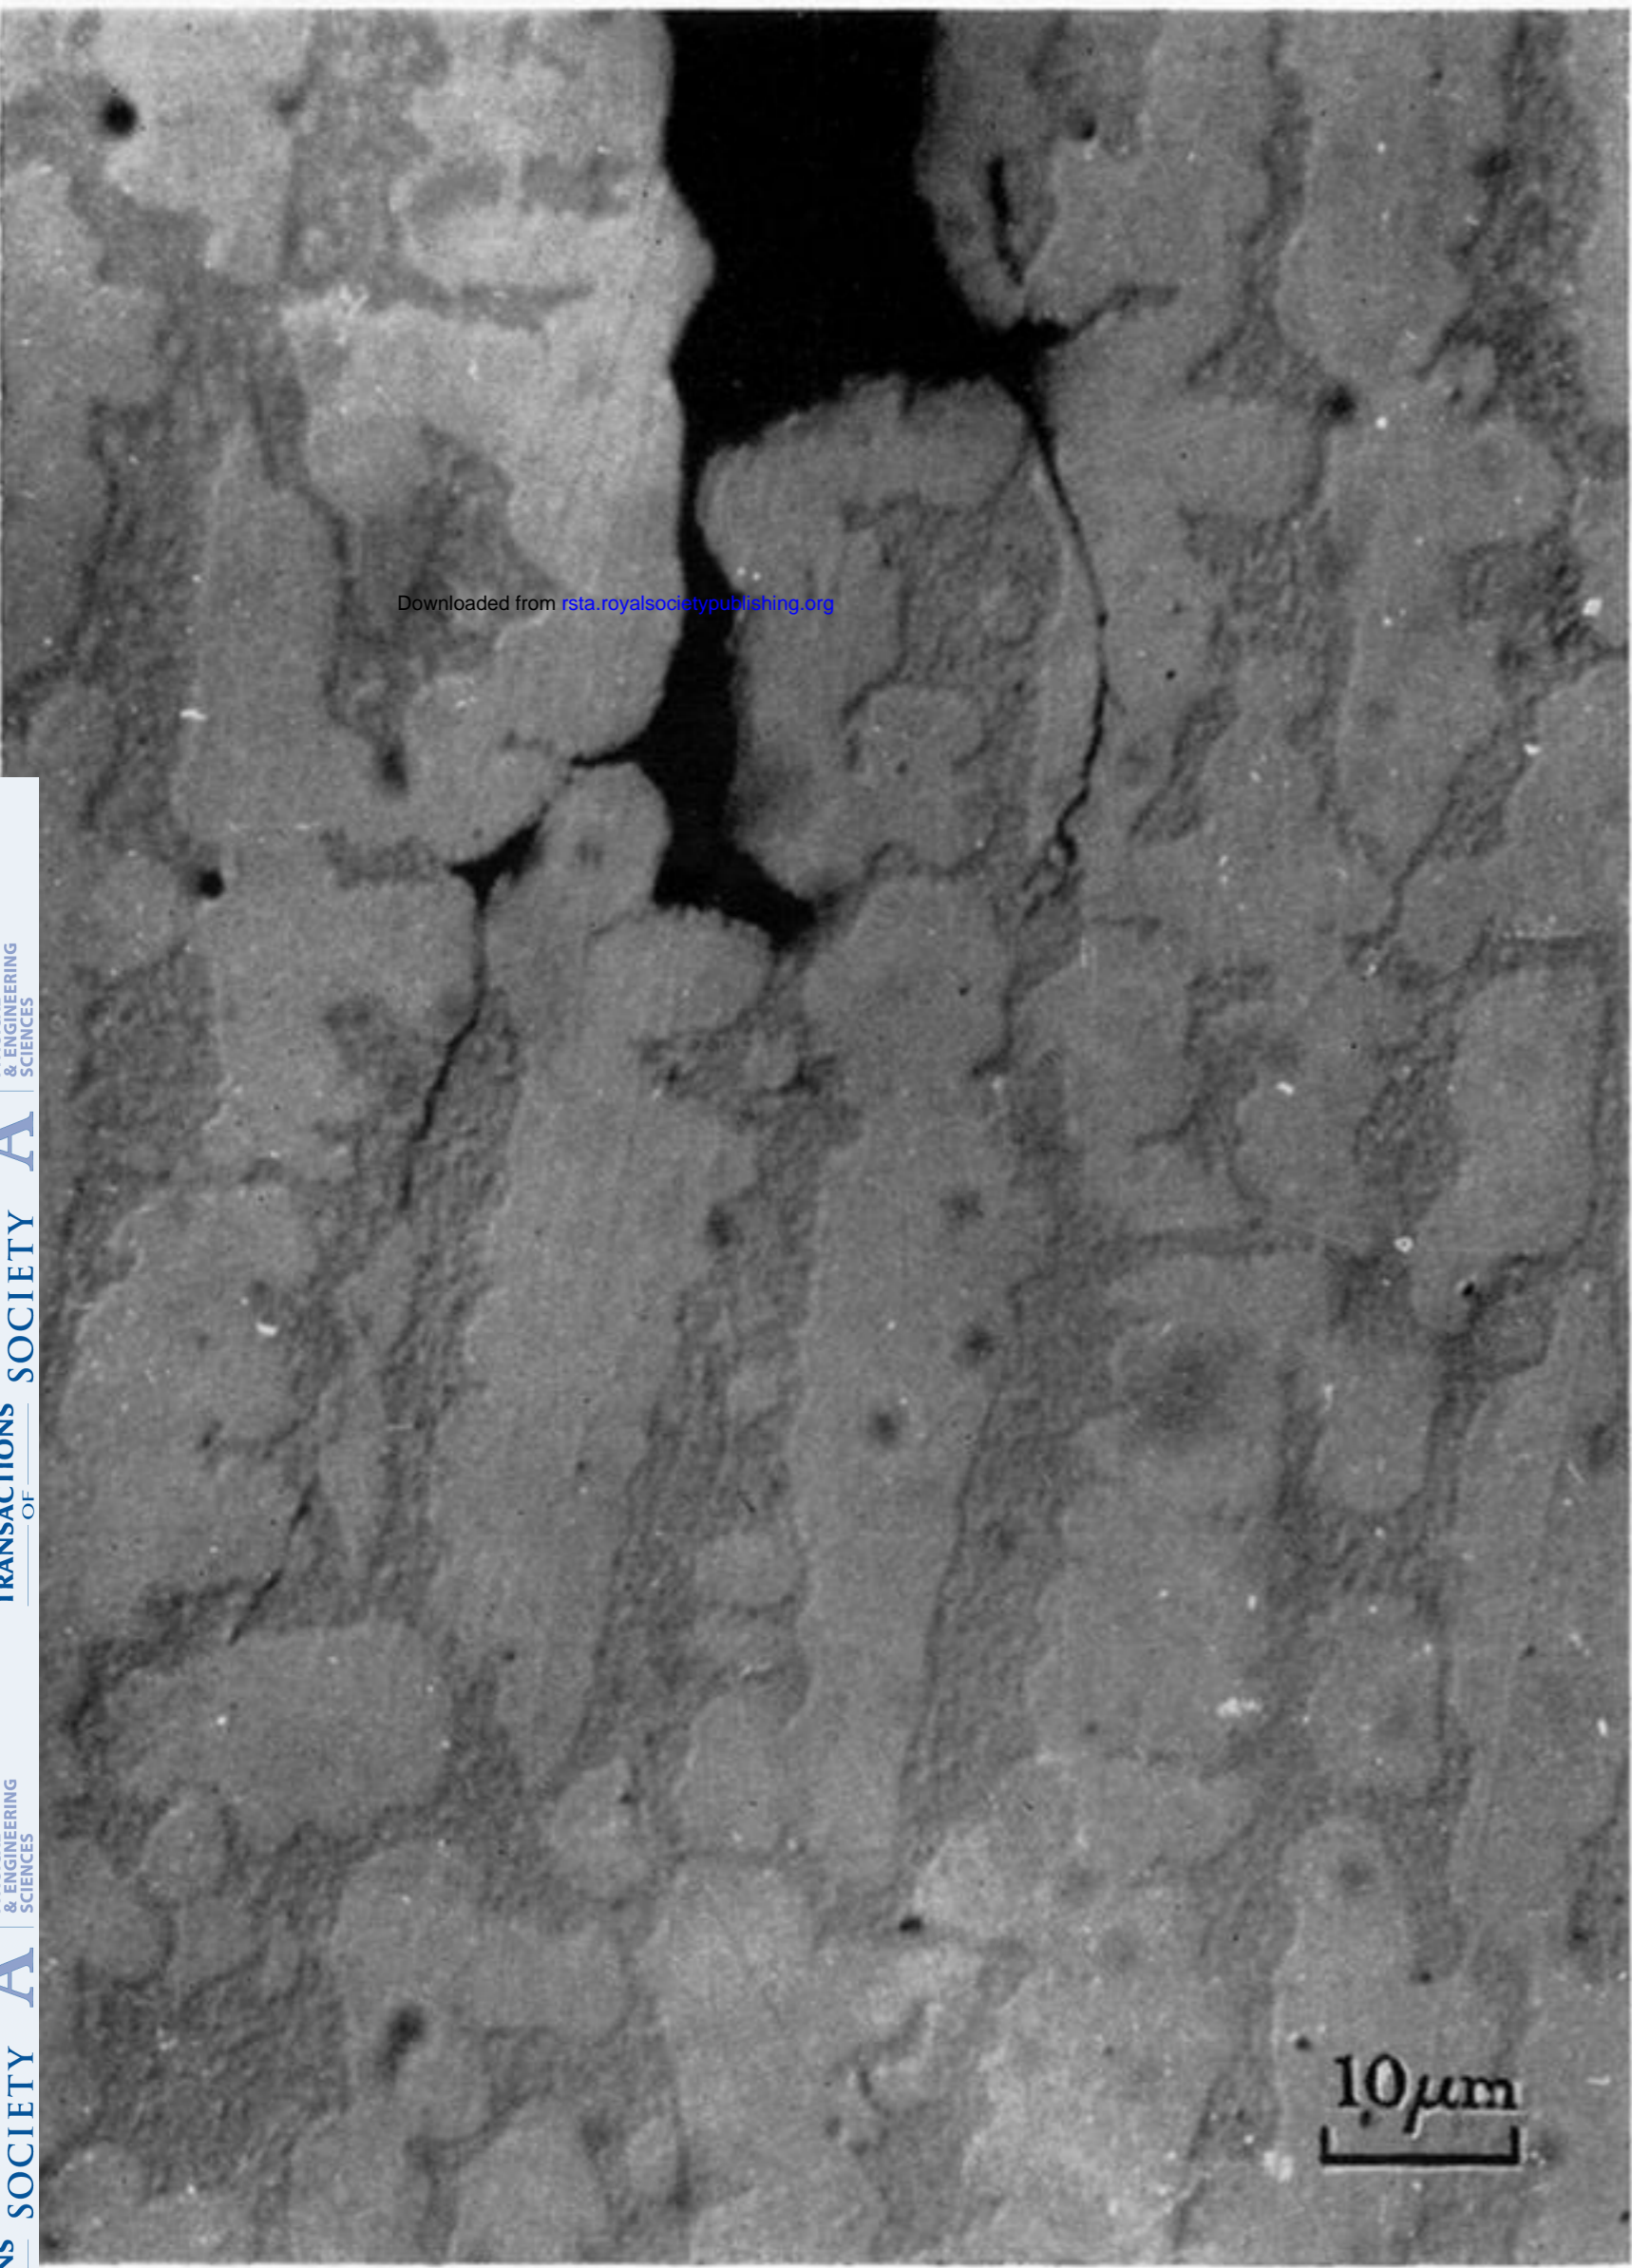
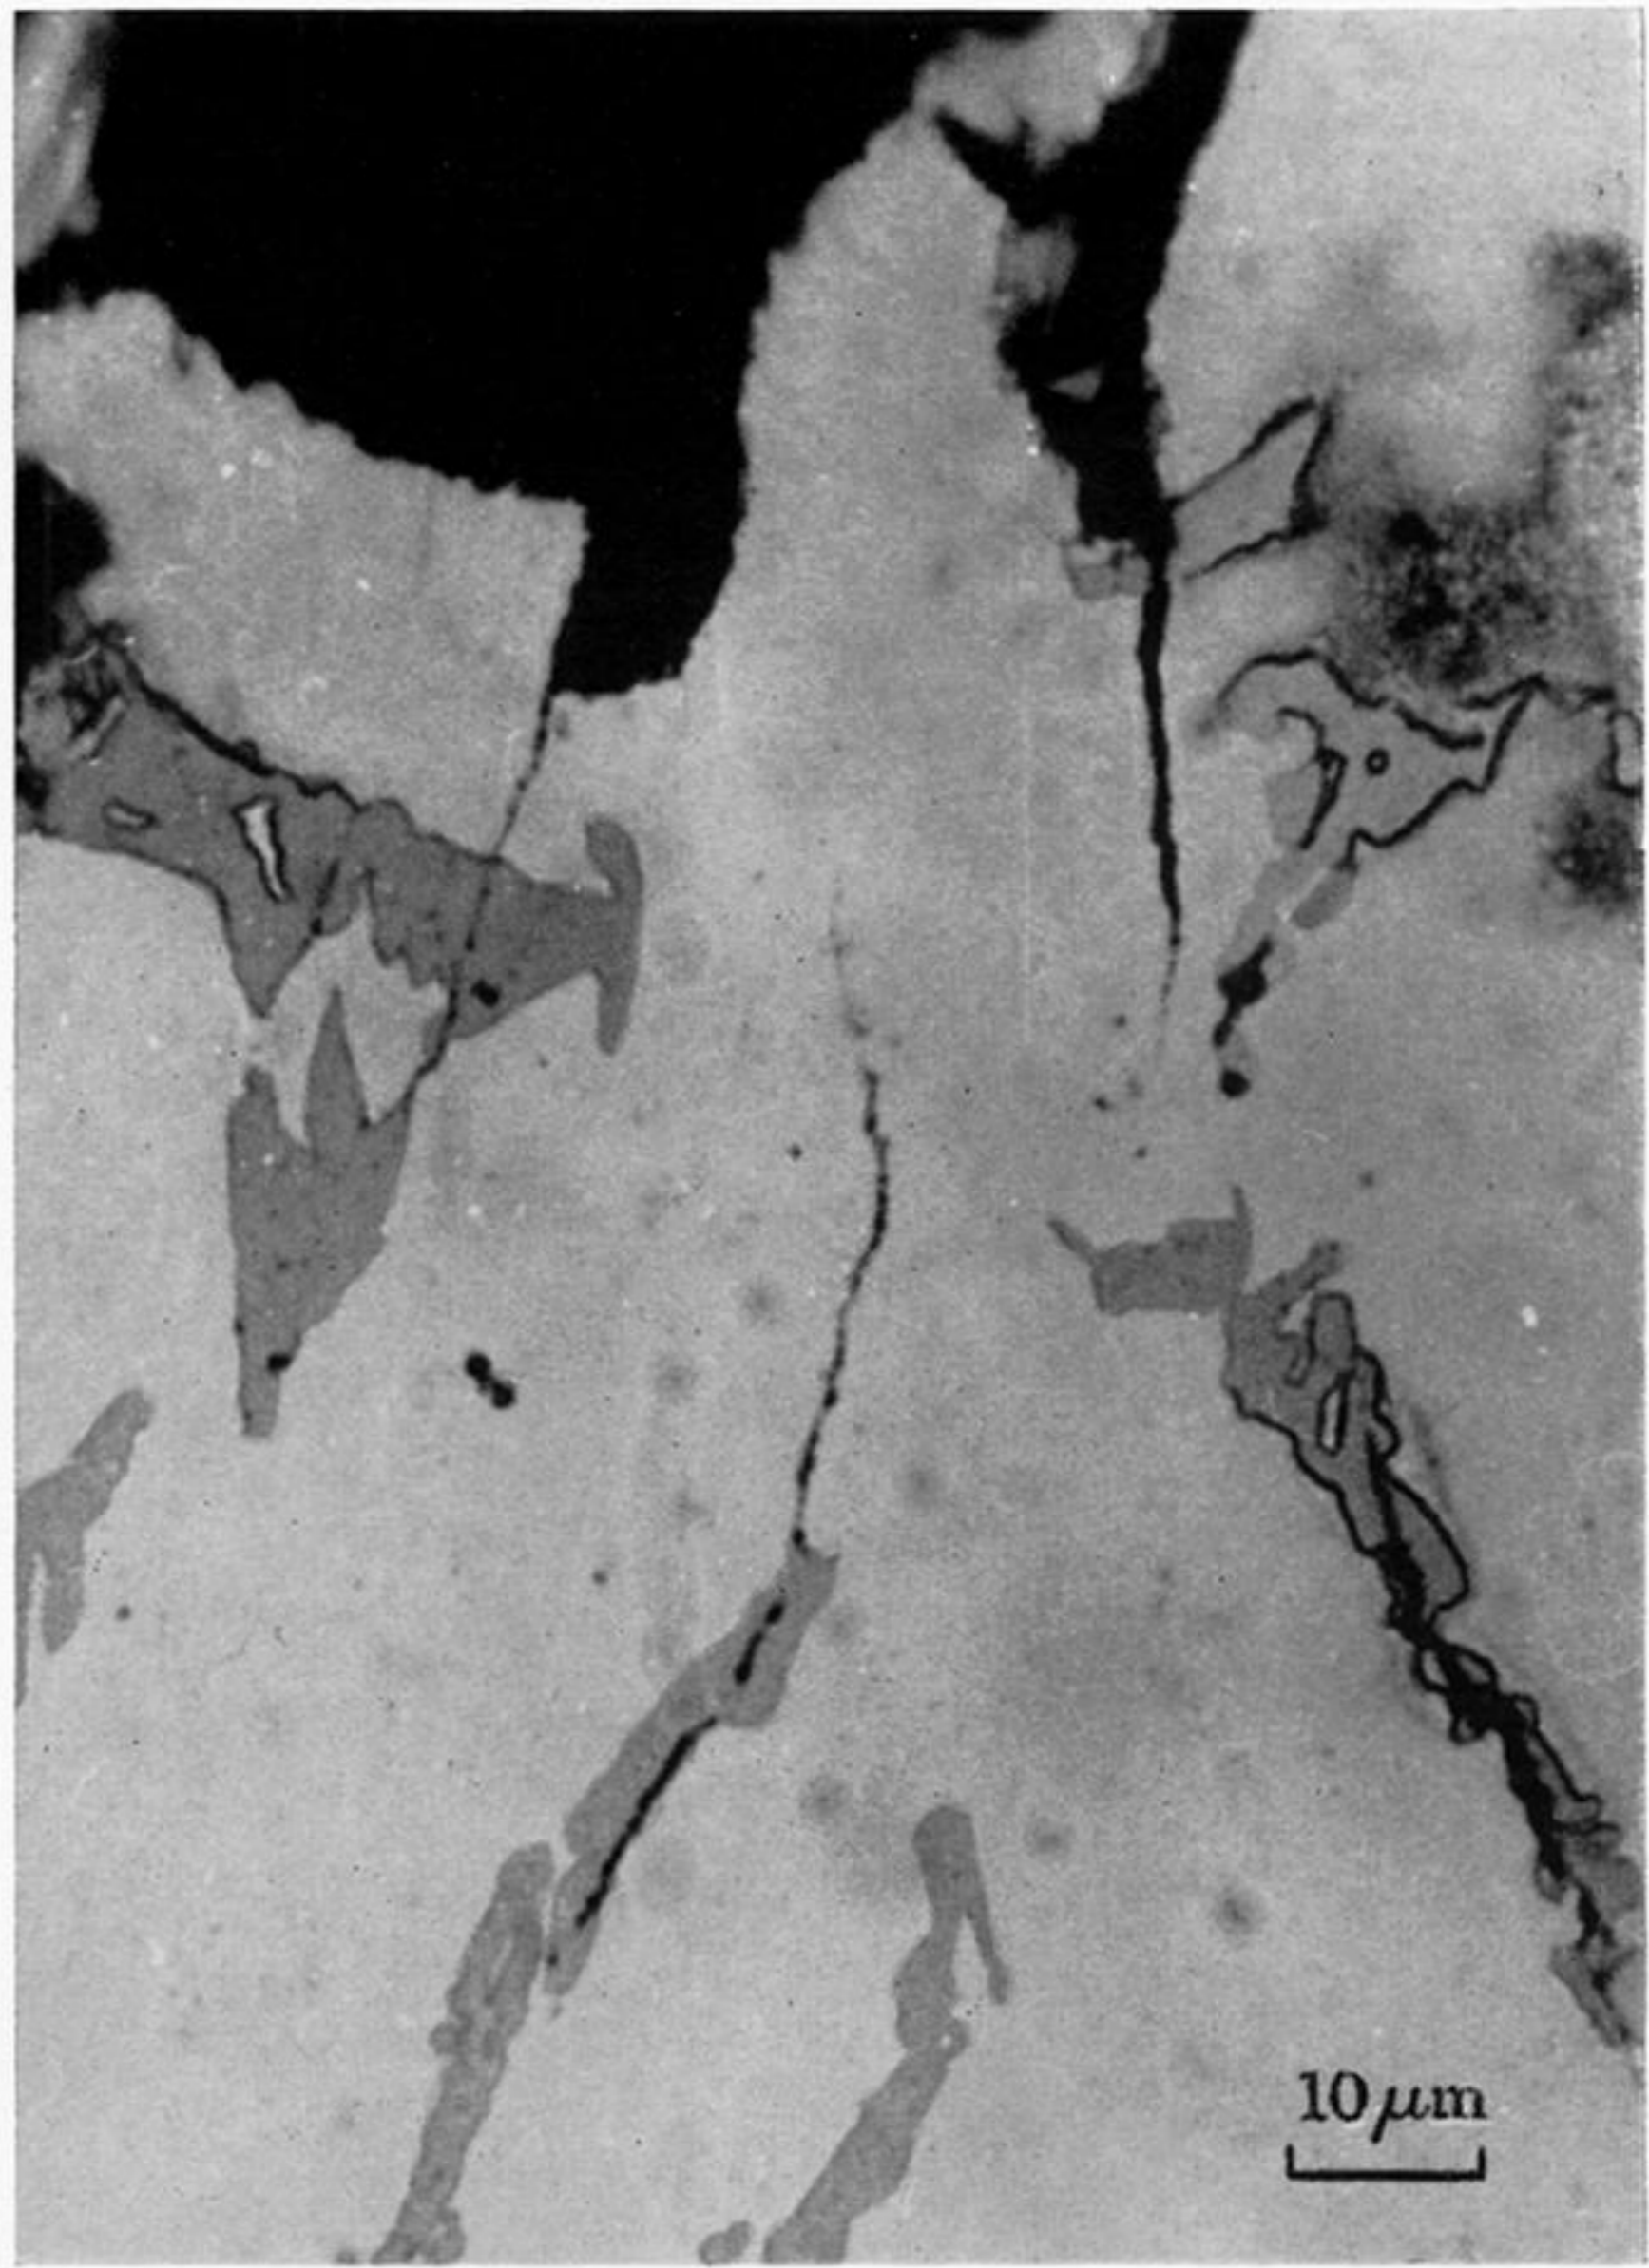
Metallographic examination of sections taken from the eroded shields revealed a normal cast structure of cobalt/chromium alloy dendrites in a carbide eutectic. Figure 2 (a), plate 24, shows several cracks radiating from a typical erosion pit.

FIGURE 2. (a) Cracking associated with erosion pit in cast Stellite 6 erosion shield.
(b) Cracking associated with erosion pit in cast Stellite 6 erosion test specimen.

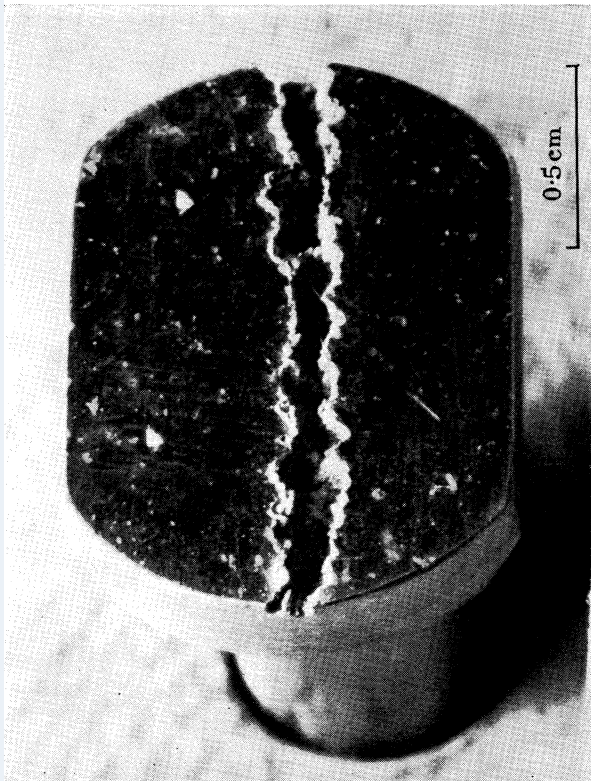
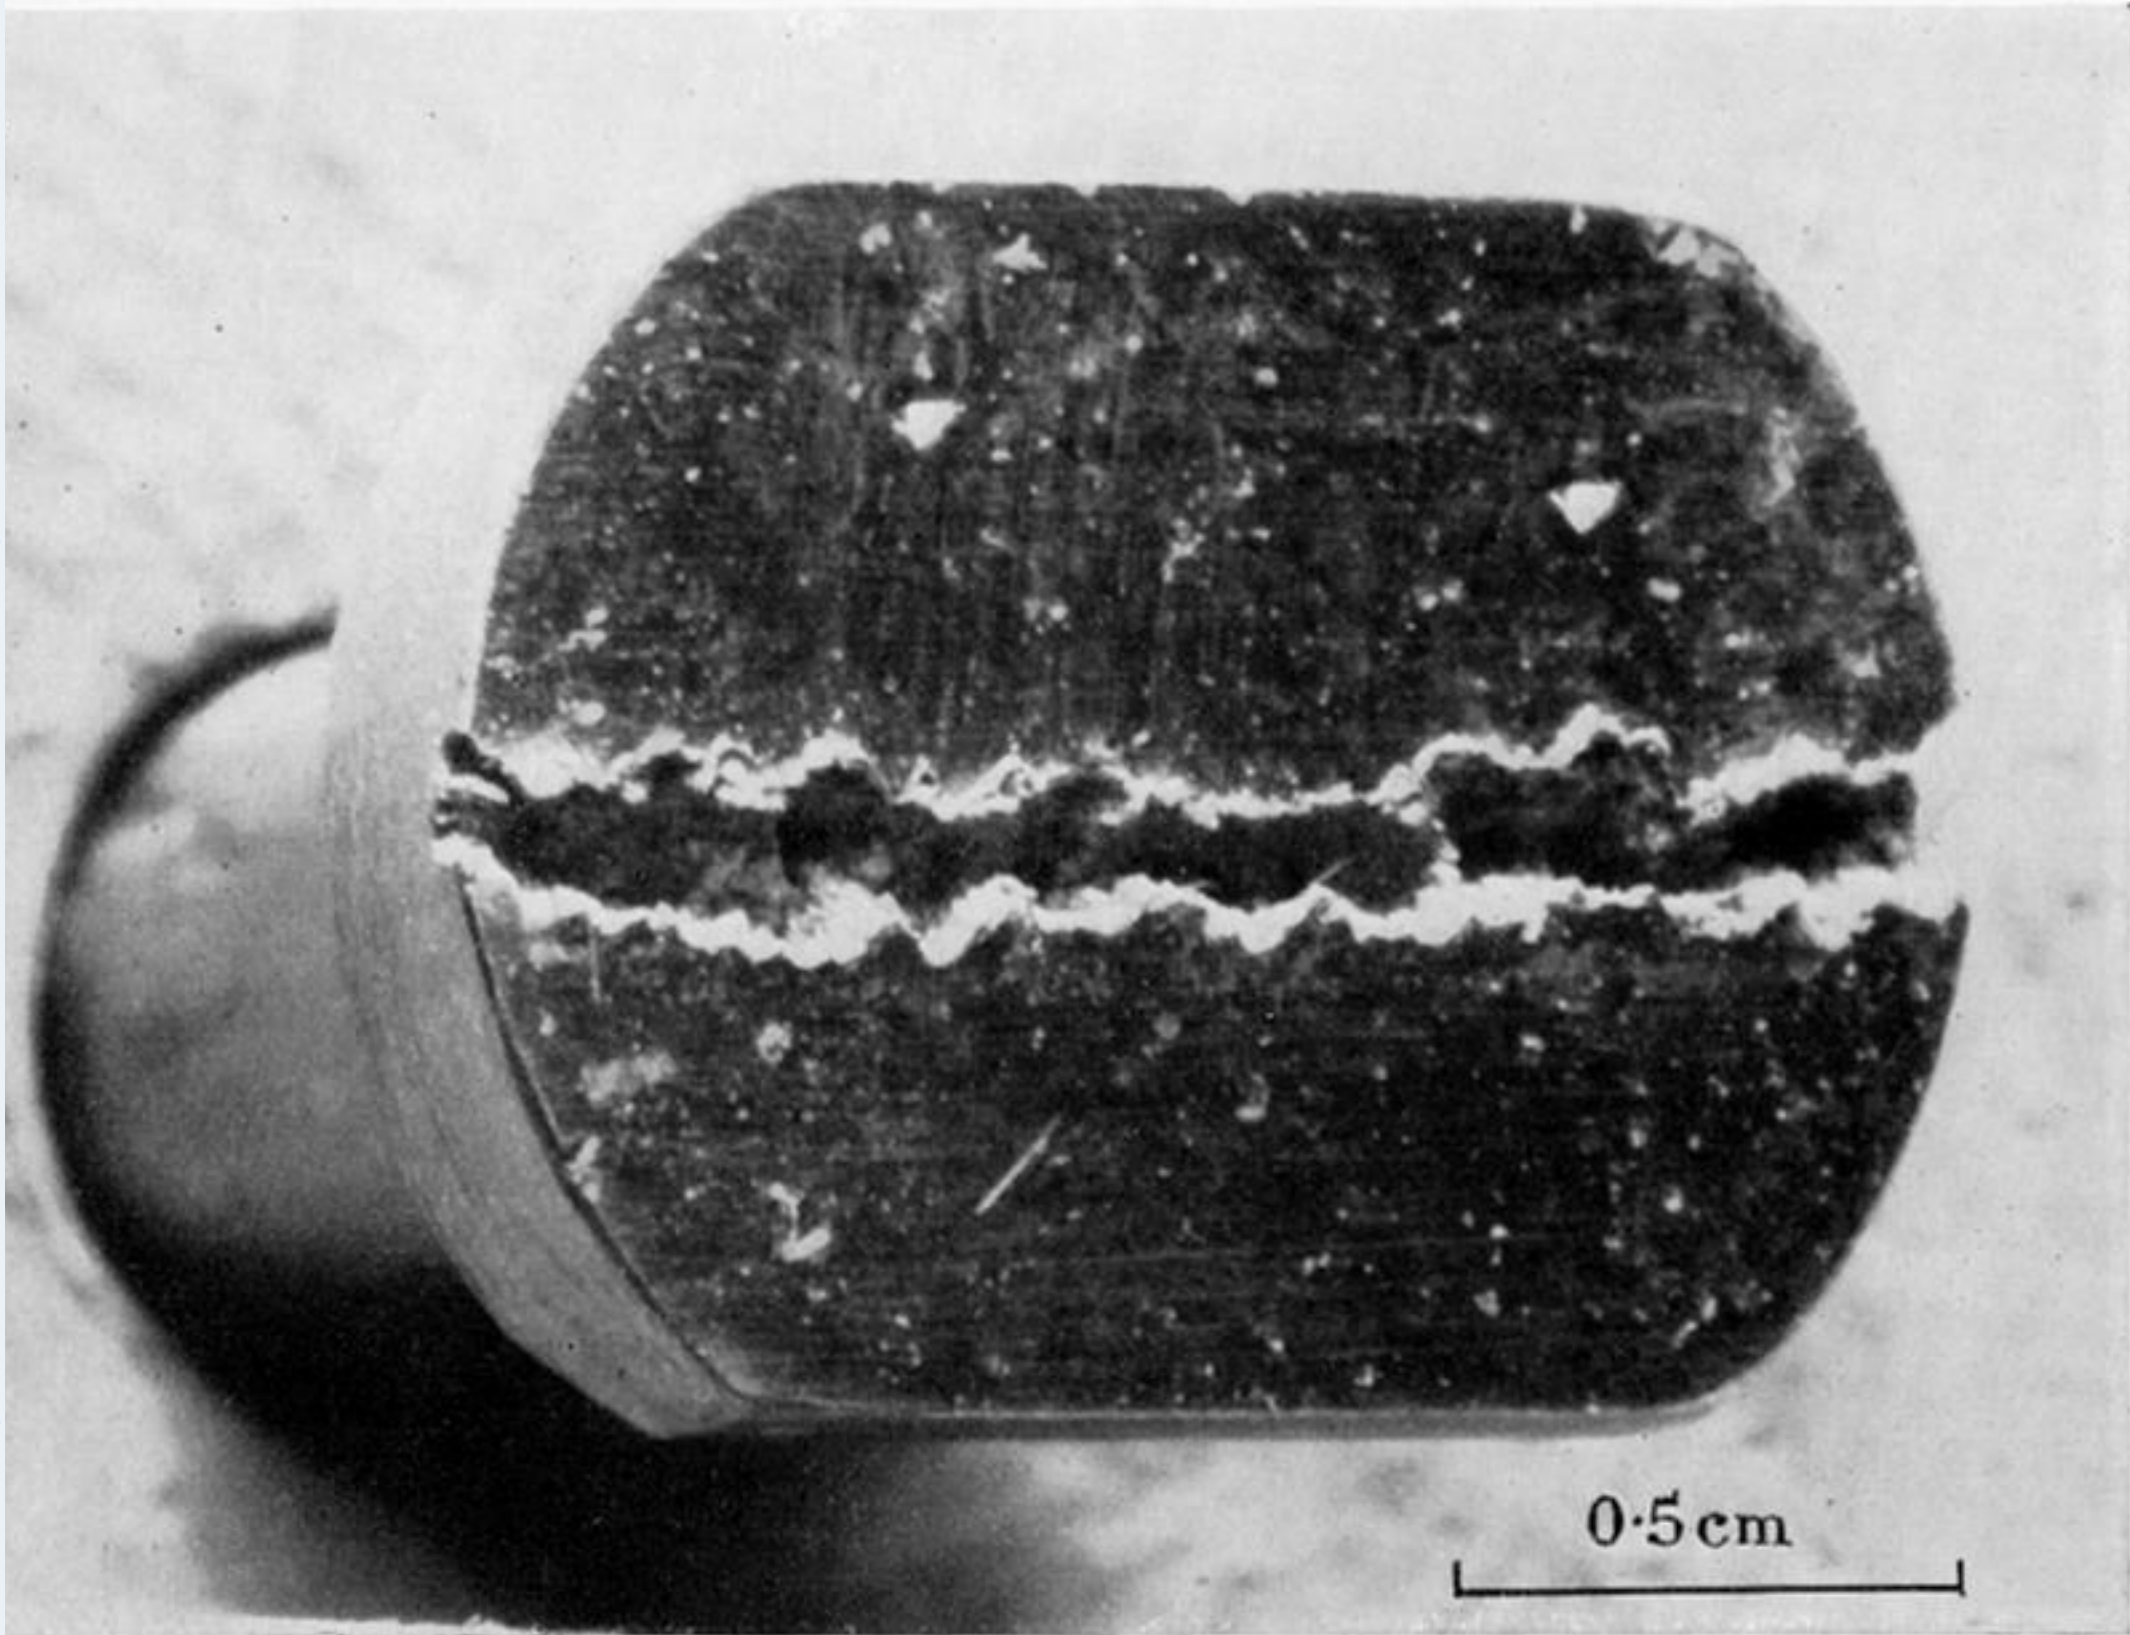
FIGURE 5. Specimen after erosion testing.

After testing to 200 000 impacts a deep track of erosion damaged material can be seen in the test face as indicated in figure 5, plate 25. In the cobalt-chromium alloy being considered here the track is approximately 0.030 in. wide and 0.020 in. deep. Metallographic examination of sections taken from this area of damage indicates the presence of pits and cracking which show similarities to those observed on shields removed from service (figure 2 (b)).

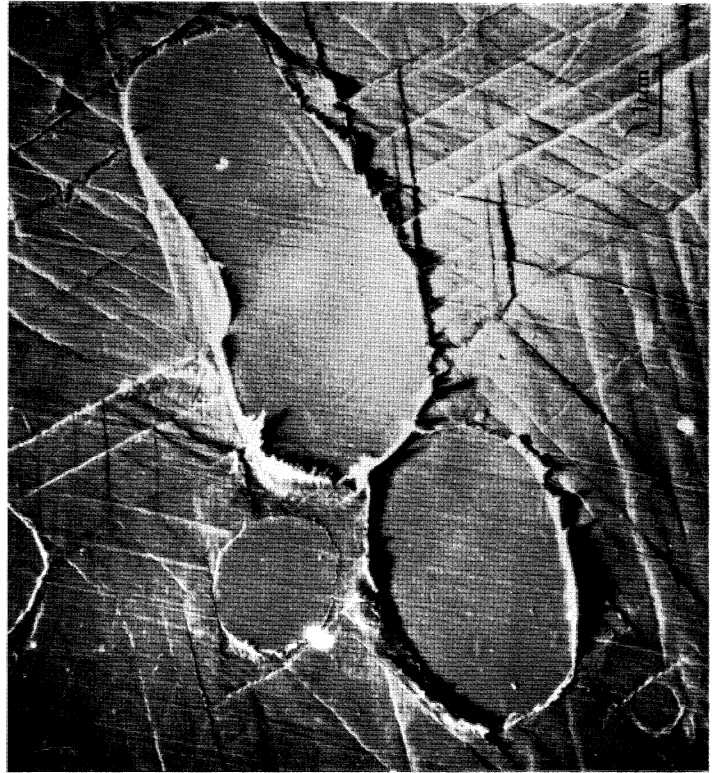
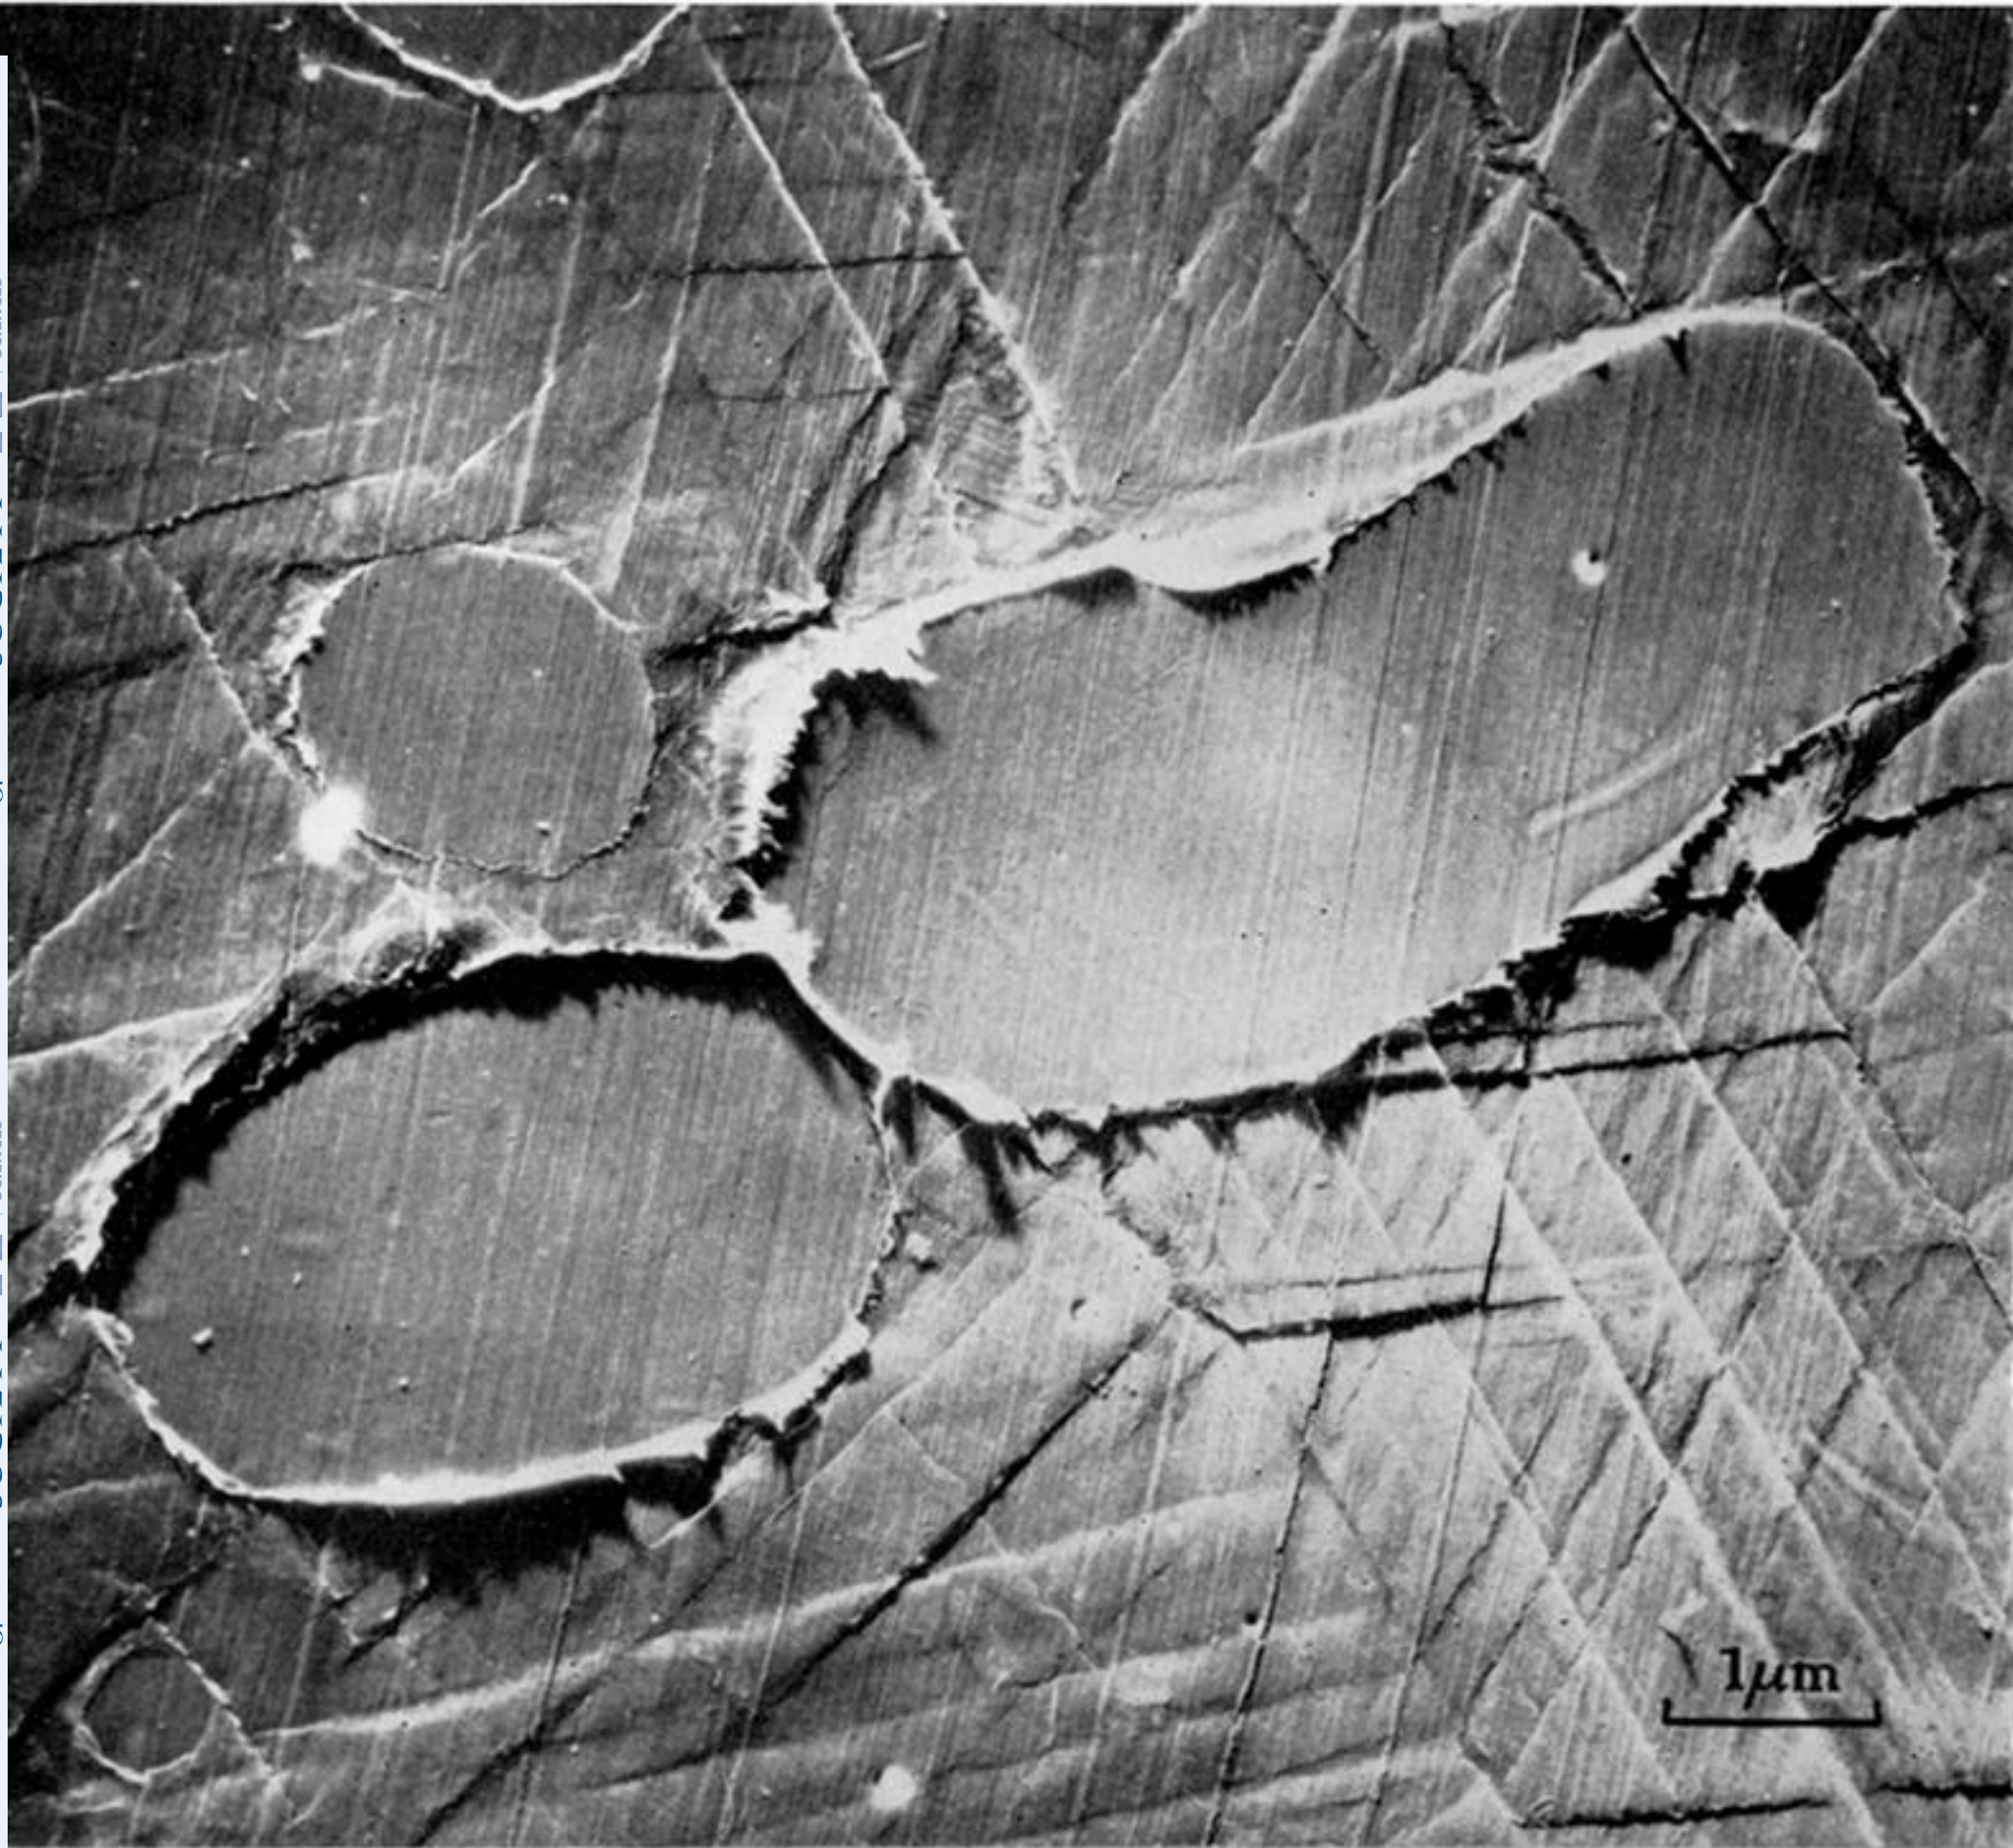
FIGURE 8. Cracking at carbide/matrix interfaces.

In order to examine in detail some of the features observed in the series of optical micrographs in figure 7, electron microscopy was used. Examination of replicas taken from a specimen after 5000 impacts reveals the presence of cracks at the carbide/matrix boundaries (figure 8, plate 25). These cracks propagate along the boundaries with increasing exposure so that by 40 000 impacts separation at these boundaries is visible optically and, as seen in figure 9, plate 27, loss of some particles results.
