The Erosion of a Cobalt-Chromium Alloy by Liquid Impact [and Discussion]

IX. The erosion of a cobalt–chromium alloy by liquid impact

BY J. B. MARRIOTT AND G. ROWDEN

The English Electric Co., Whetstone, nr Leicester

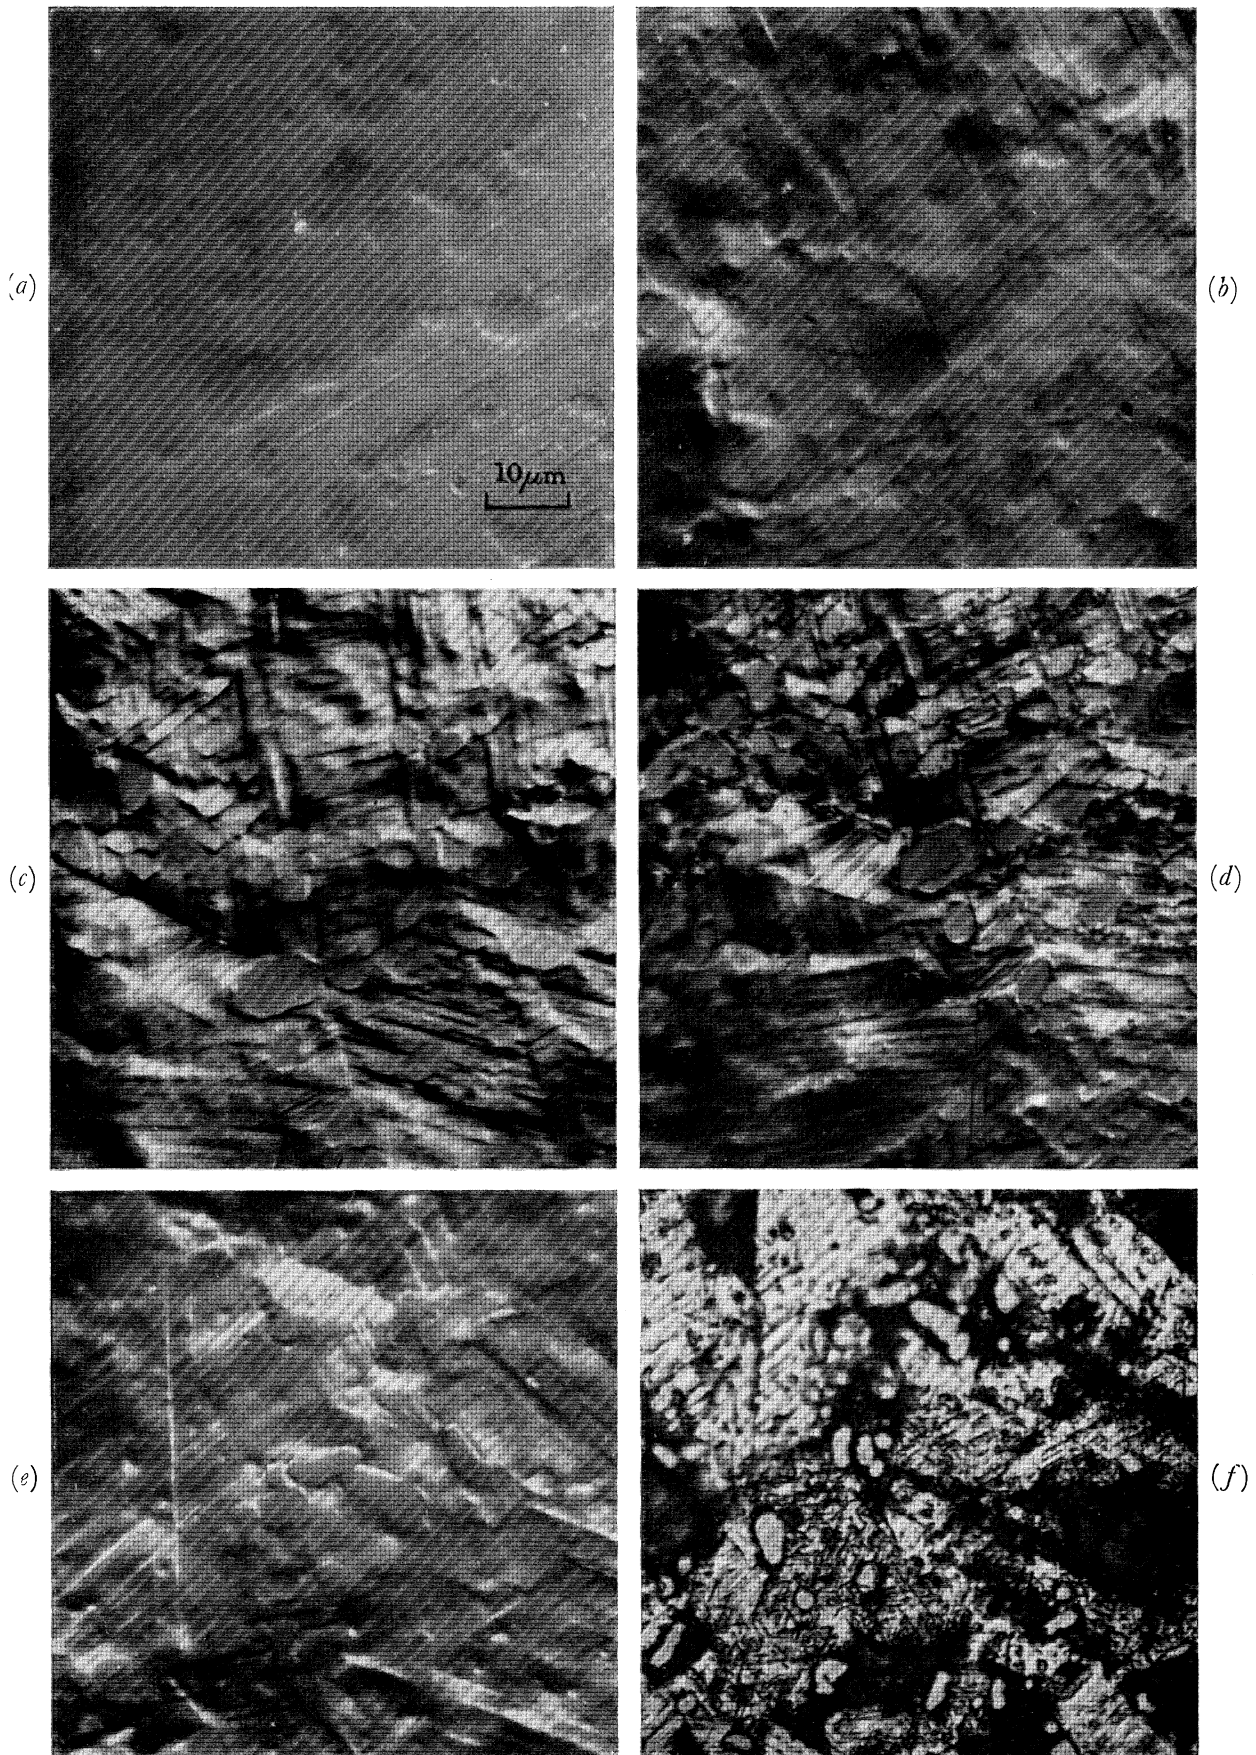
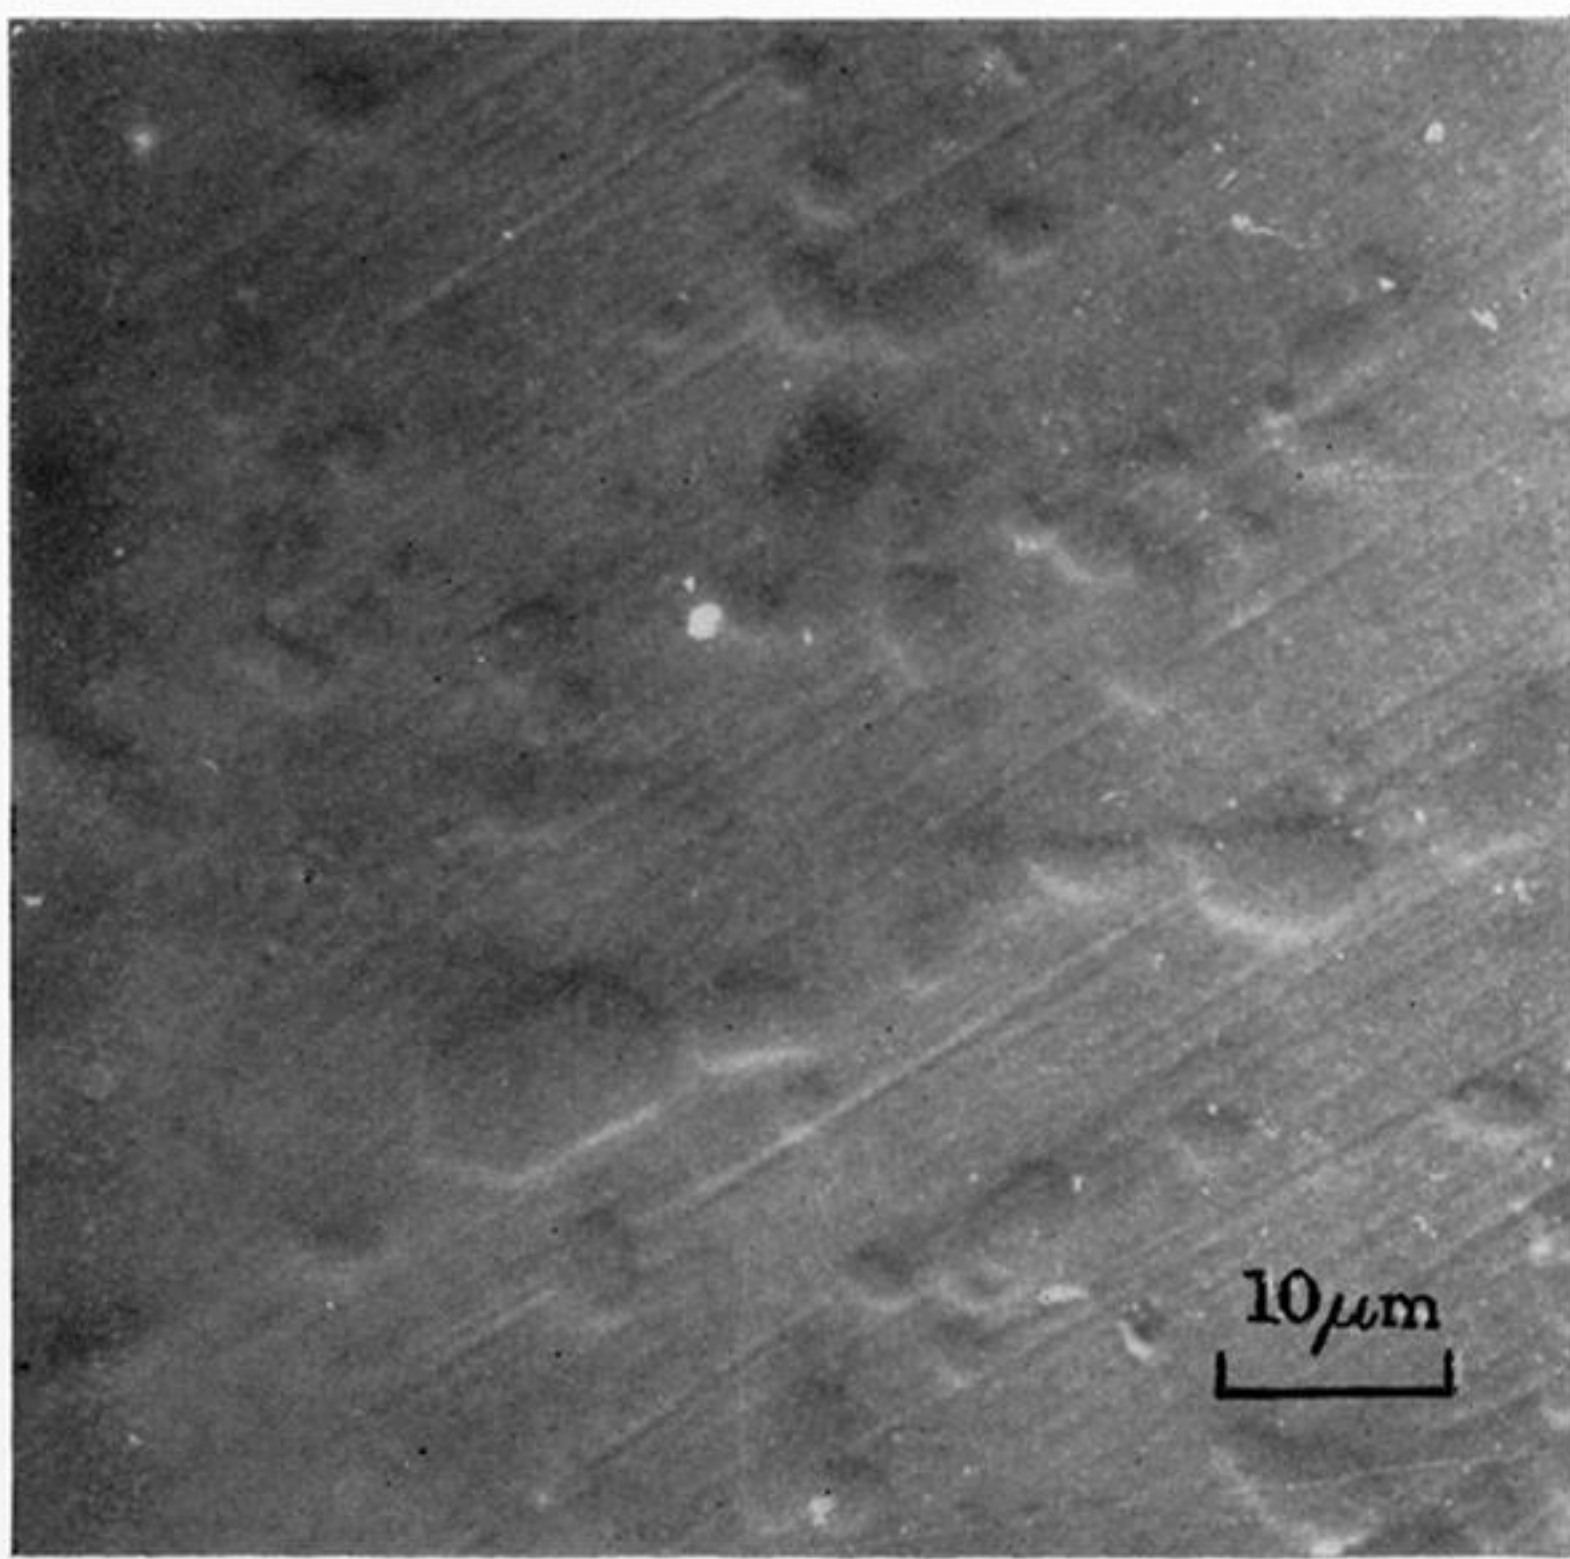
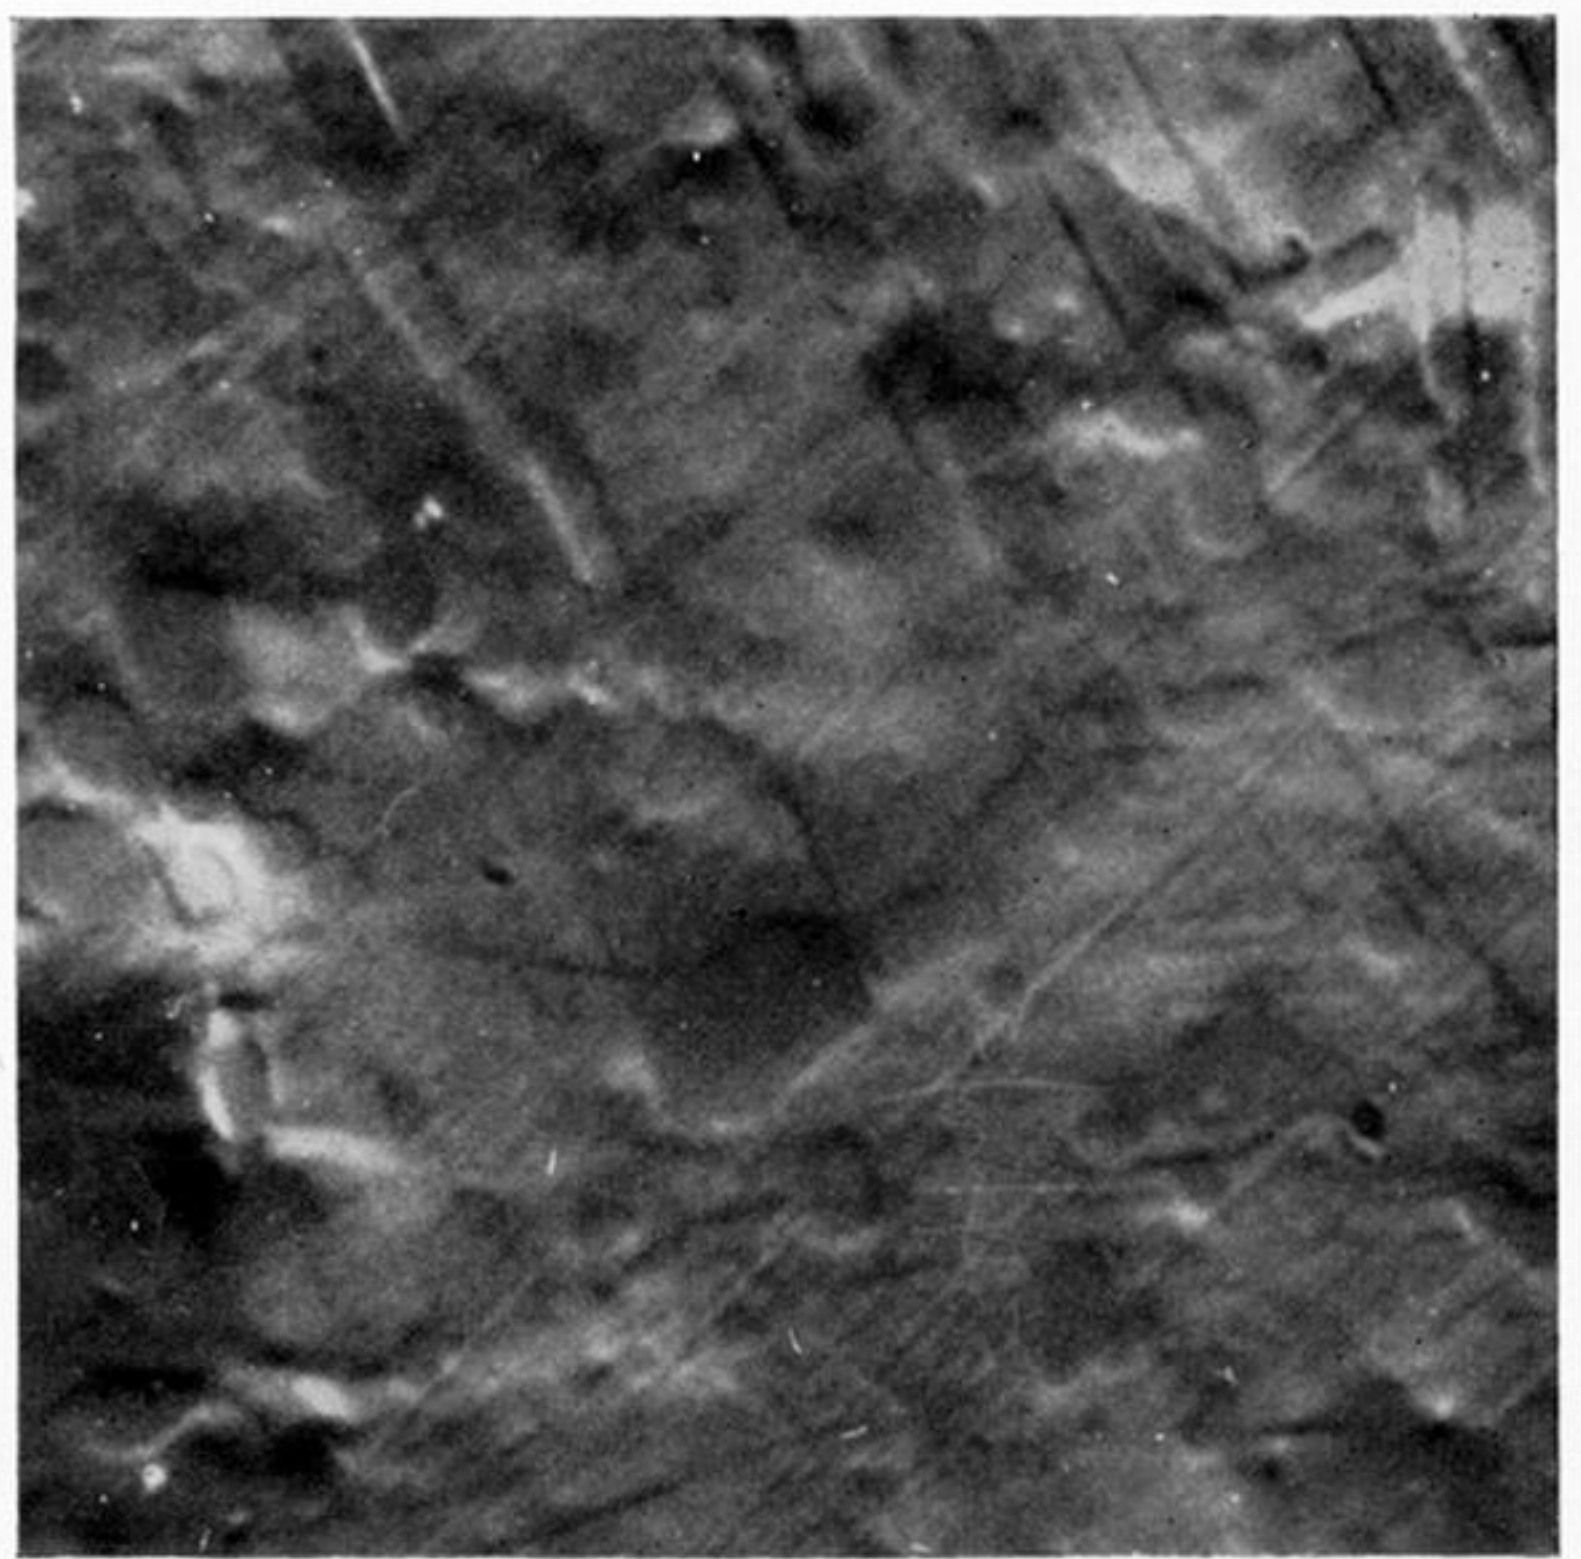
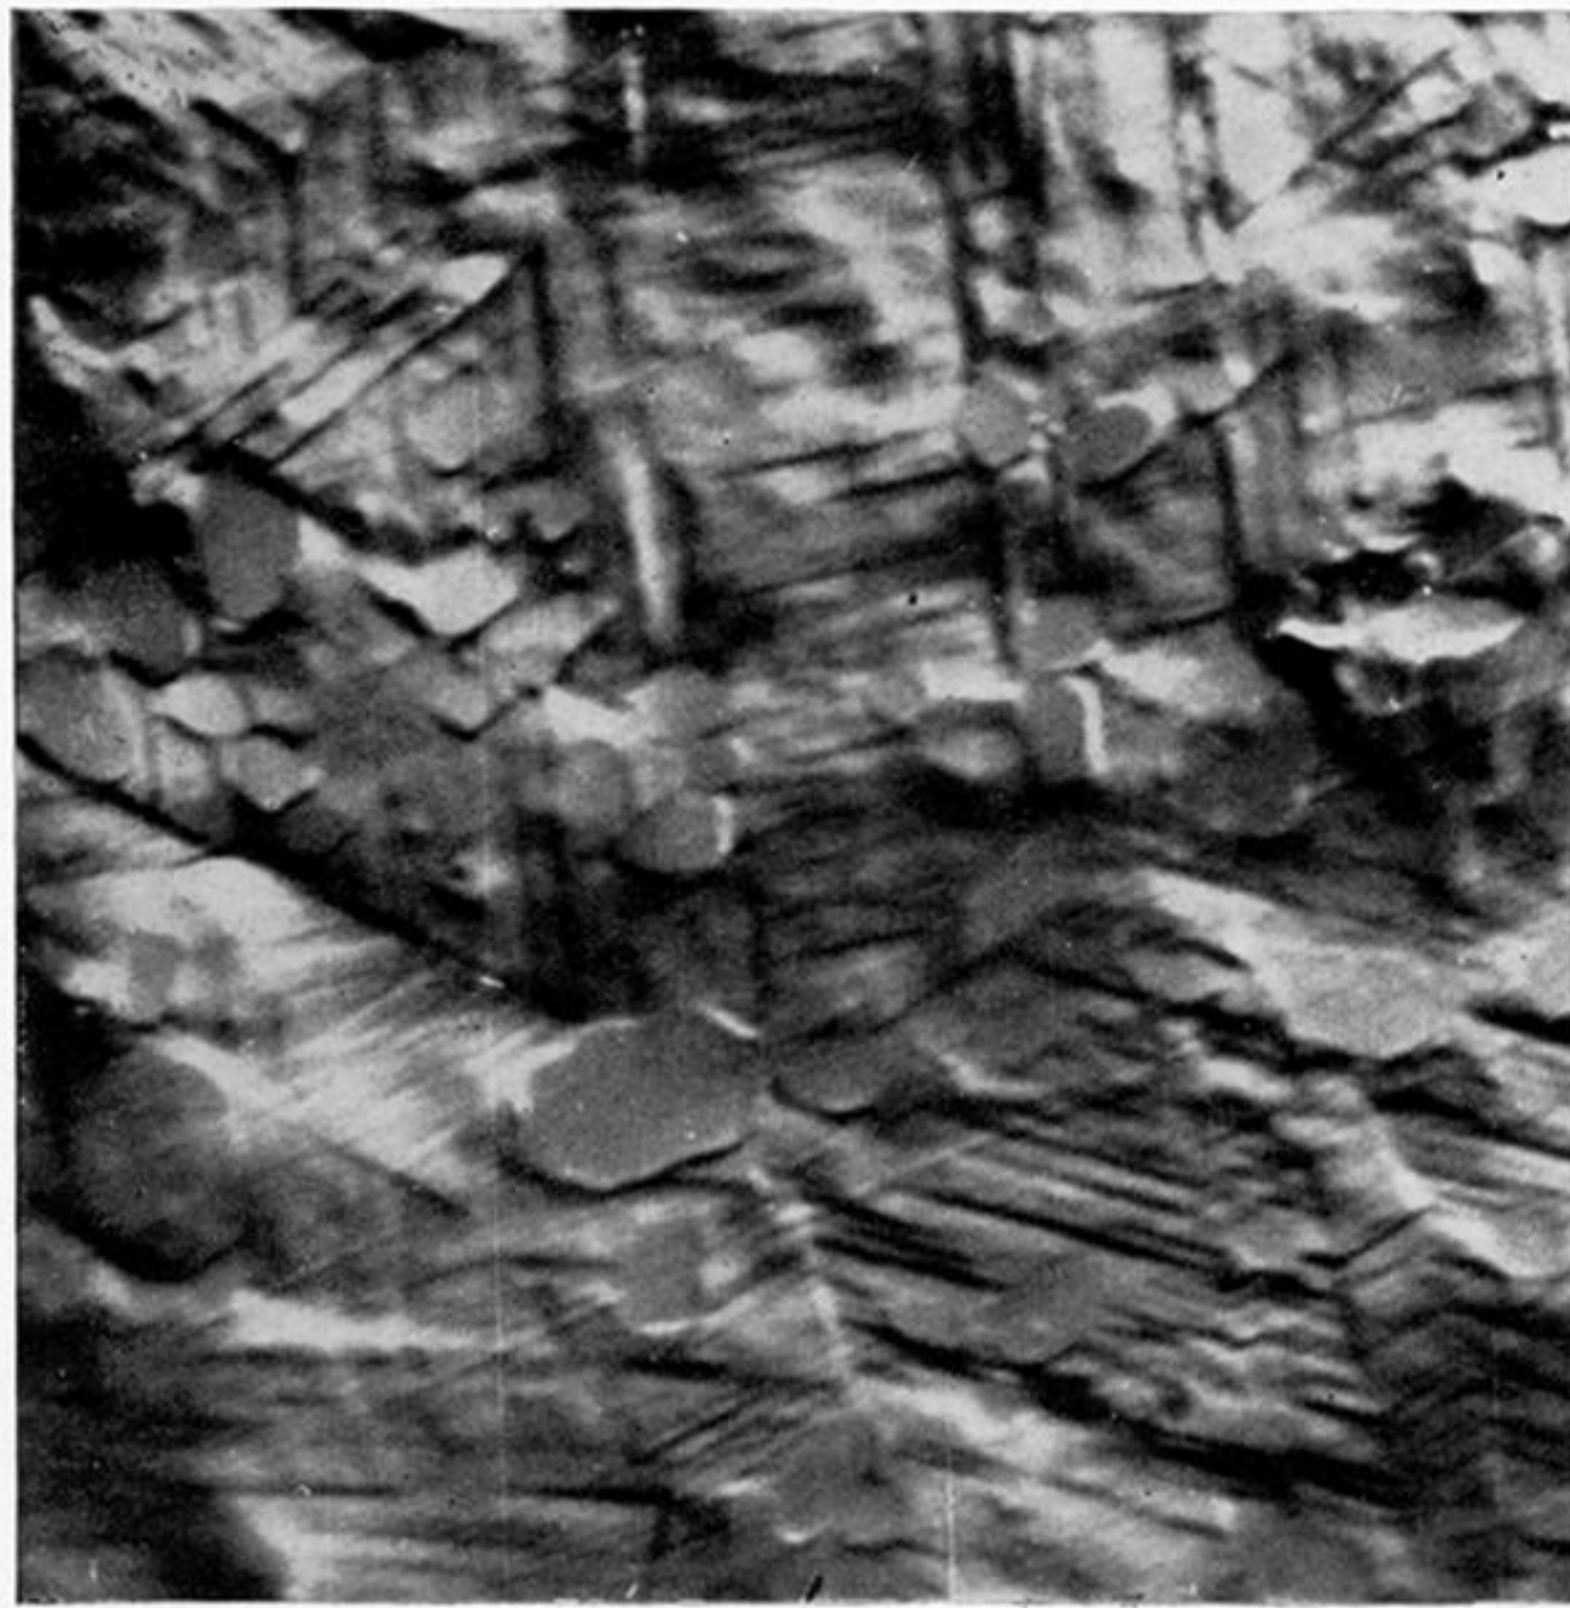
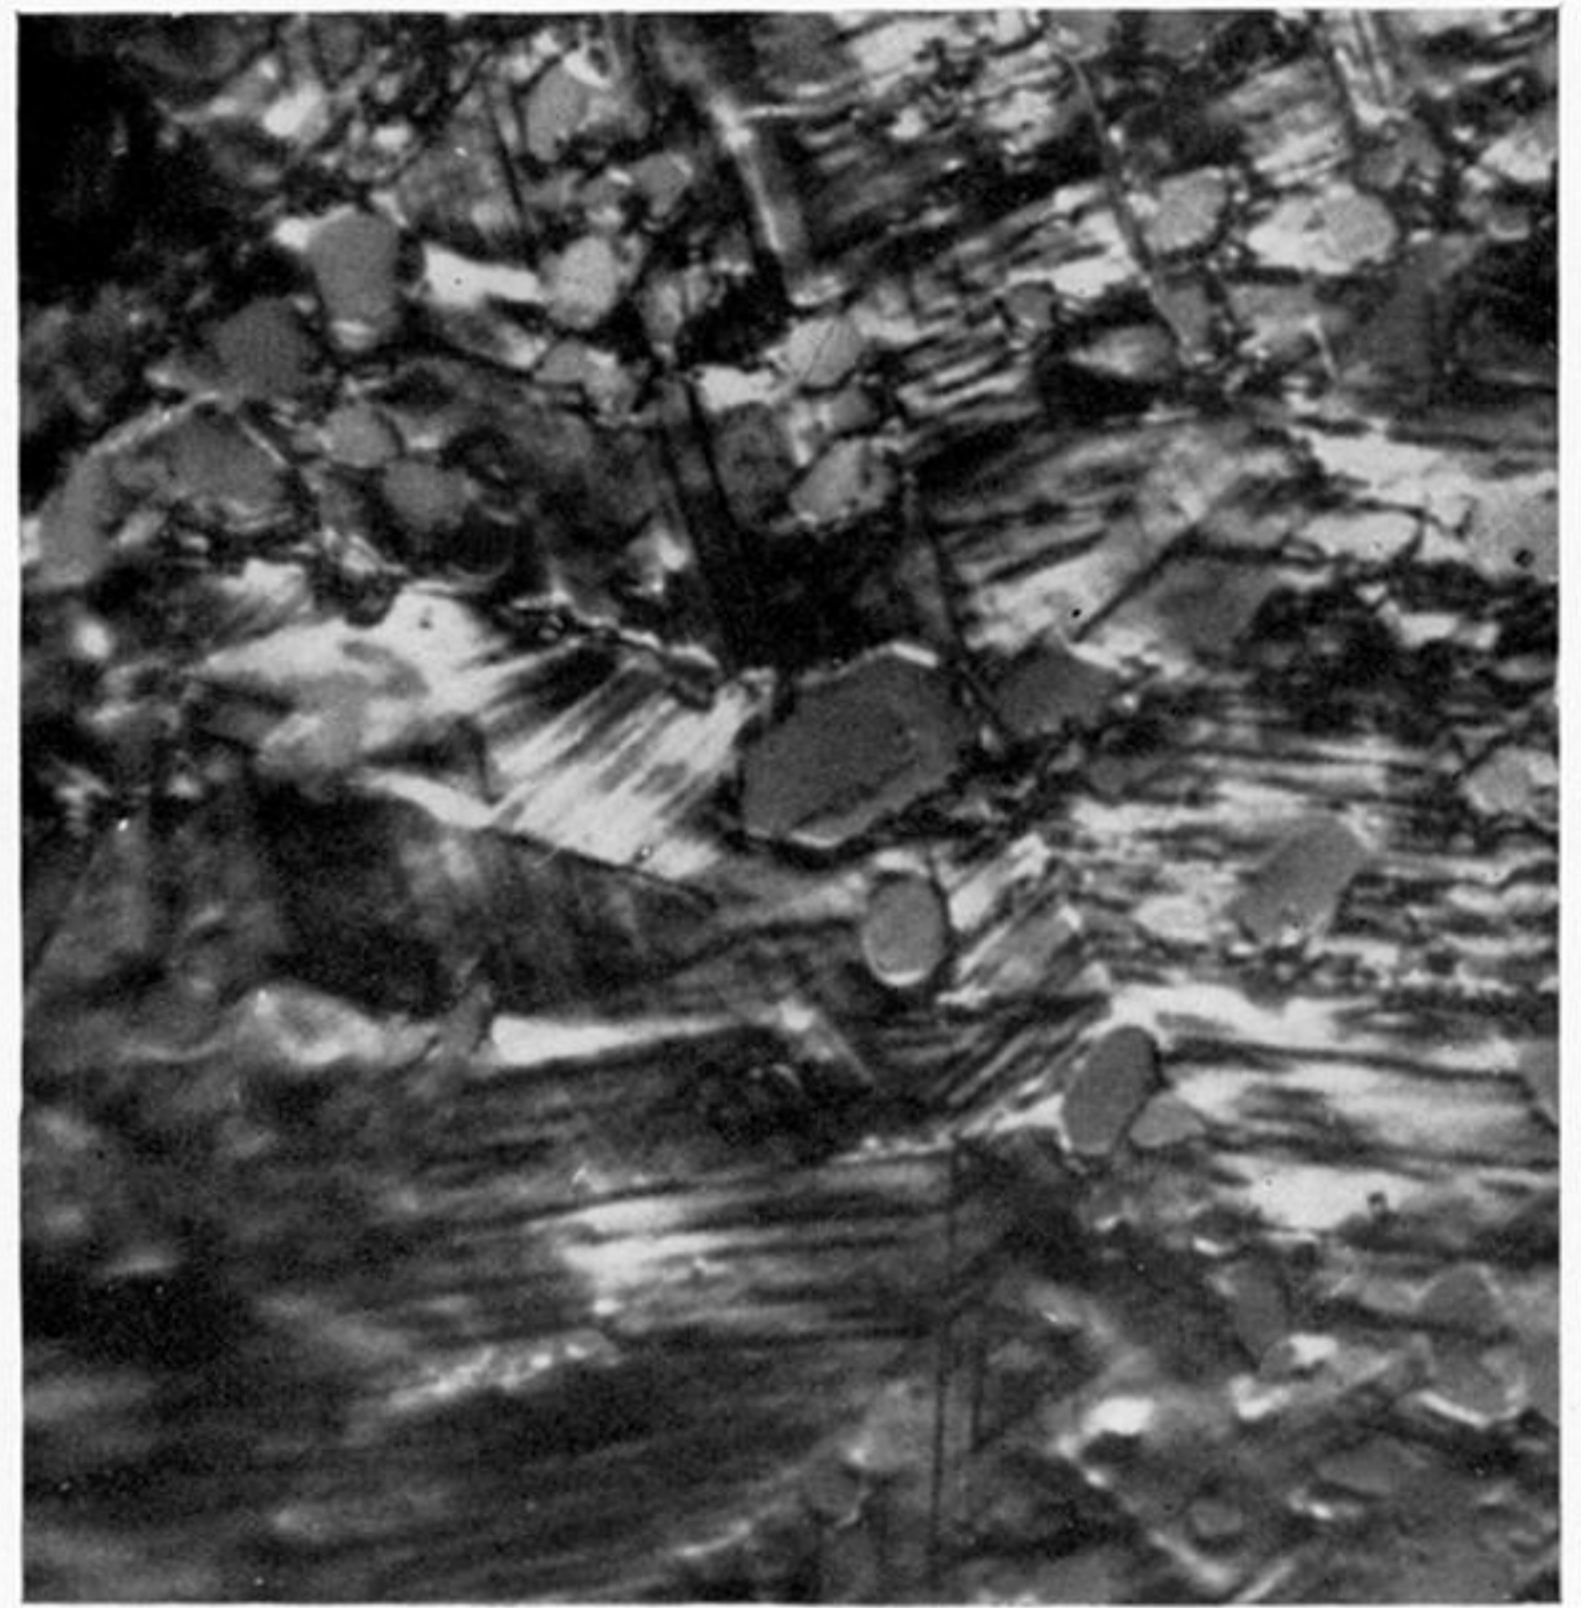
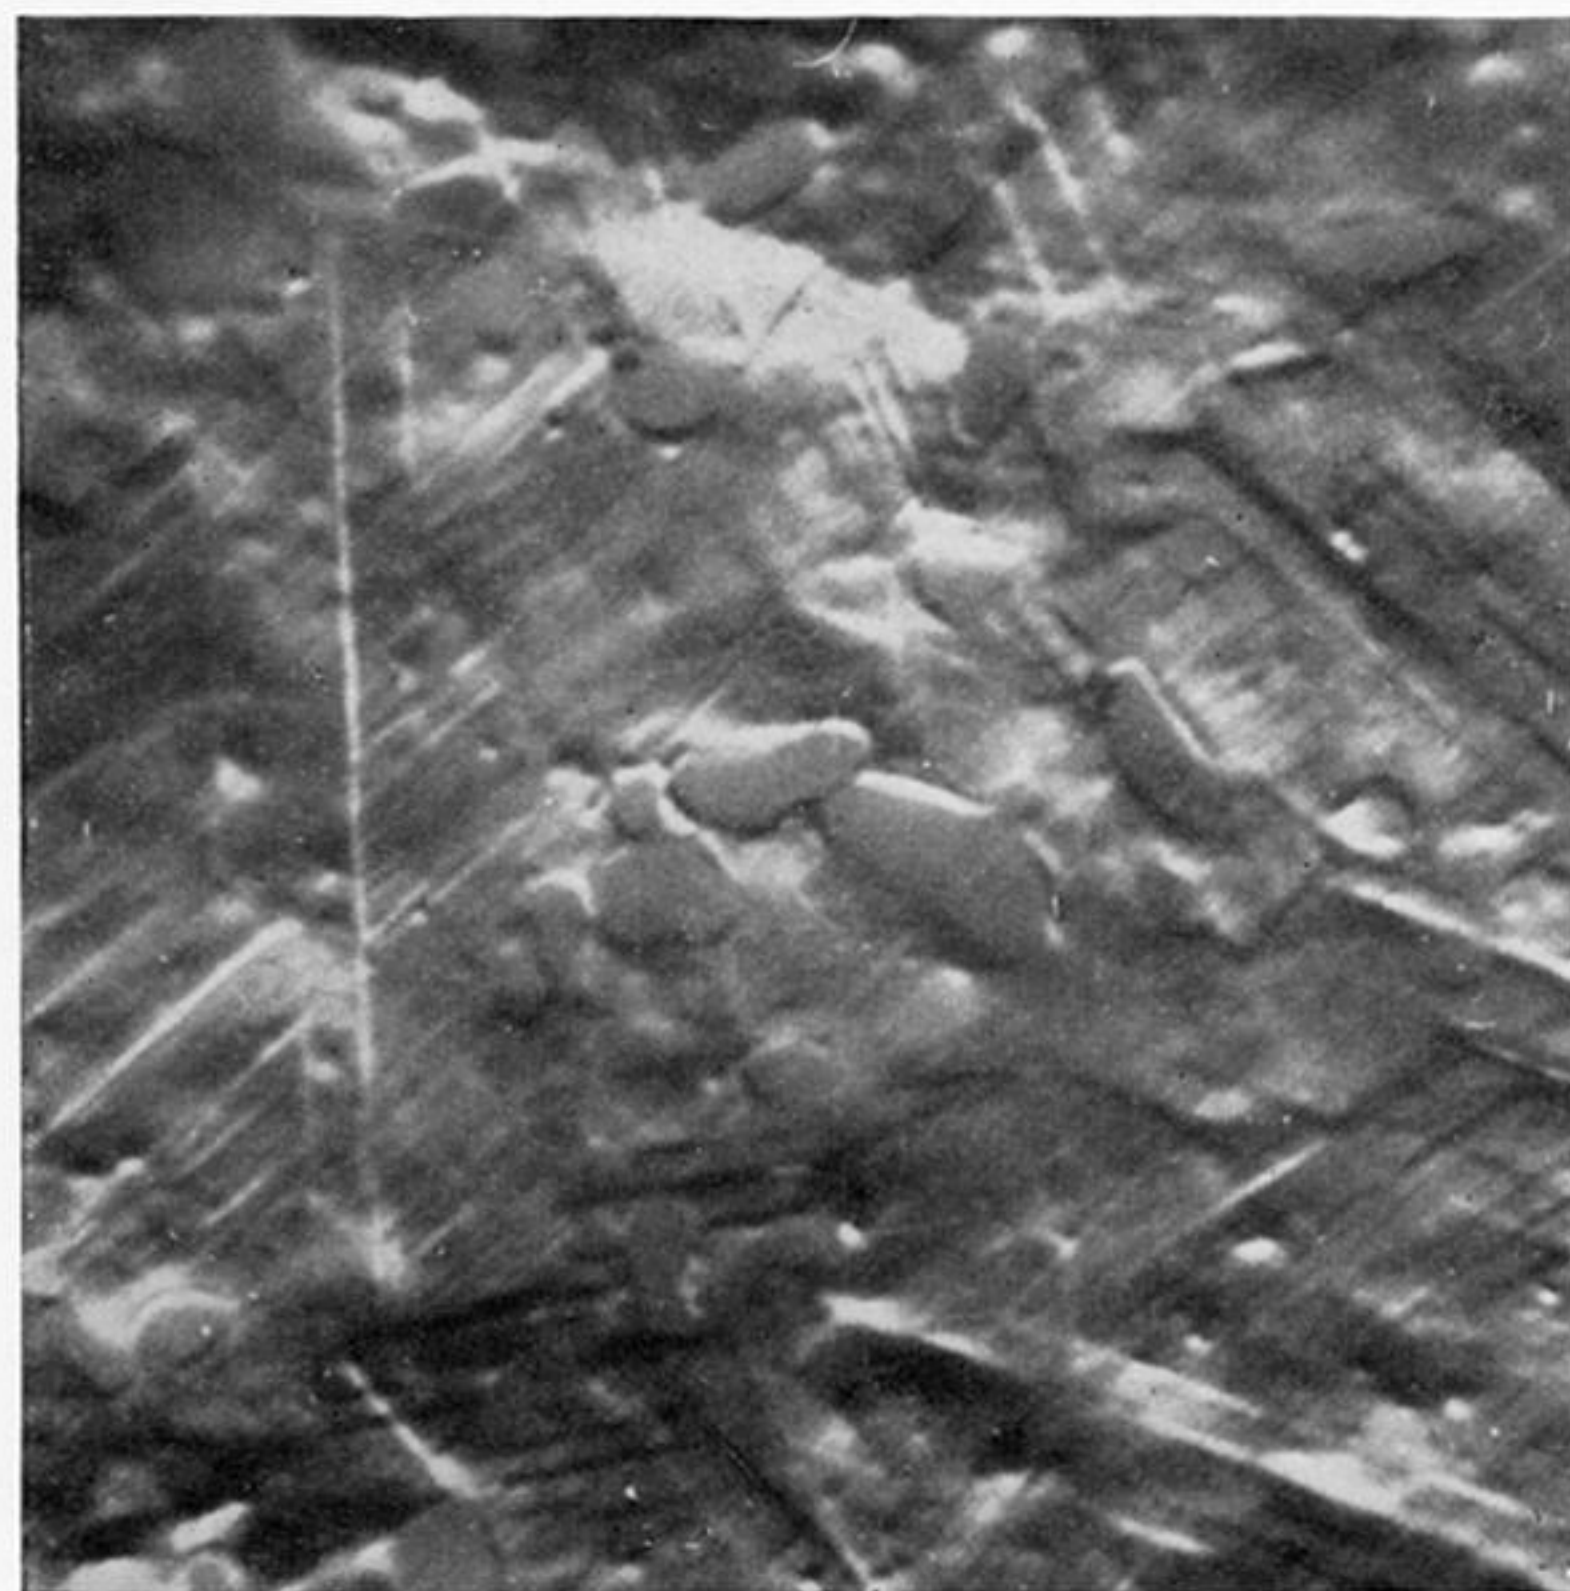
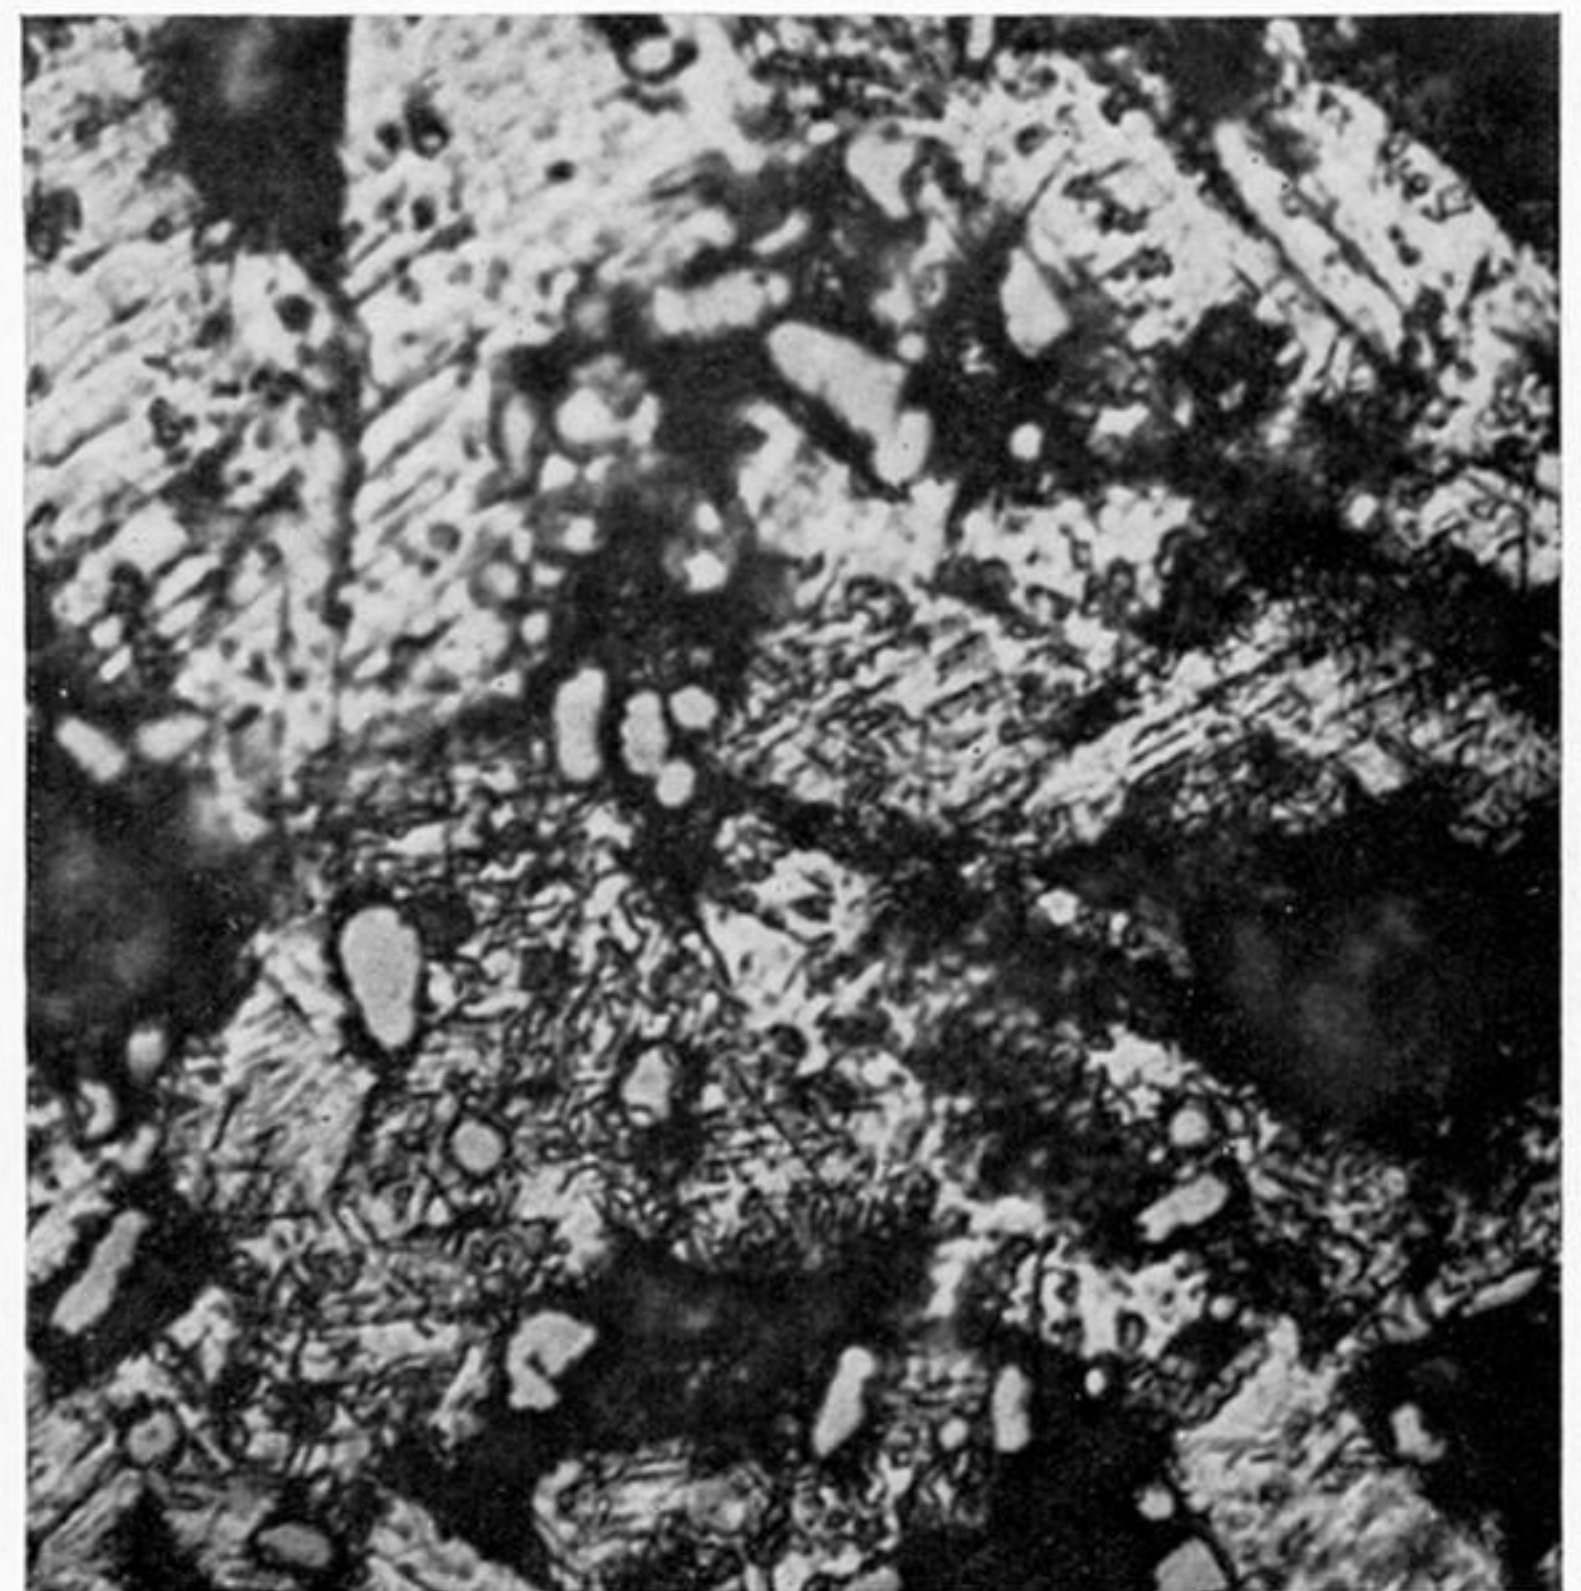
FIGURE 7. Development of erosion damage on surface of Haynes 6B specimen tested at a velocity of 1030 ft./s.

Figure 7, plate 26, indicates for two typical fields the progress of erosion damage on the surface of a specimen tested at 1030 ft./s as seen under the optical microscope.

After 3000 impacts (figure 7 (b)) extensive slip patterns can be seen, indicating deformation of the surface. It has been found that the surface scratches present on the material before test are still visible after these first few impacts, therefore no material has been lost at this stage. As testing continues the slip patterns remain basically the same but become more definite and certain slip lines become persistent.

The erosion track present after 40 000 impacts has been shown by Talysurf measurements to consist of a shallow, shouldered, depression some $4 \mu\text{m}$ below the general level of the specimen surface. At this stage a few small pits can be detected, adjacent to carbides (figure 7 (c)). With further testing larger pits develop. One seen in the upper left of figure 7 (d) has appeared in an area where considerable slip had occurred close to a carbide cluster. It should be observed that some of the small pits previously noted have not enlarged significantly. The development of pitting is also shown by comparing figure 7 (e) and (f), which show major pitting appearing on certain pronounced slip lines and among carbide clusters.

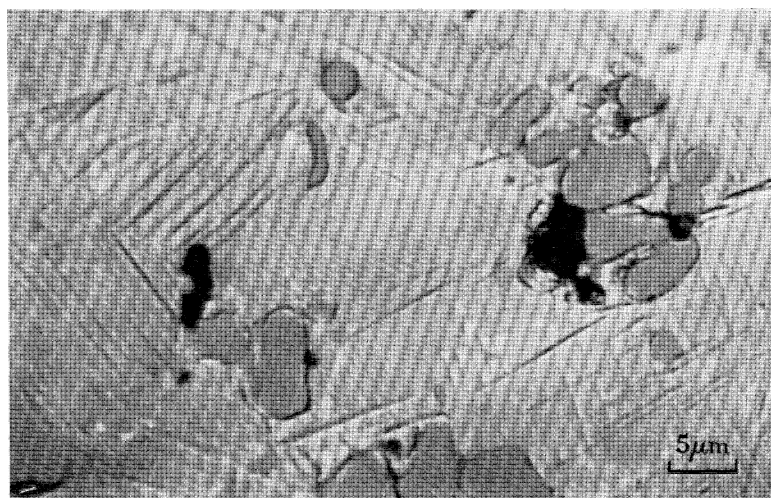
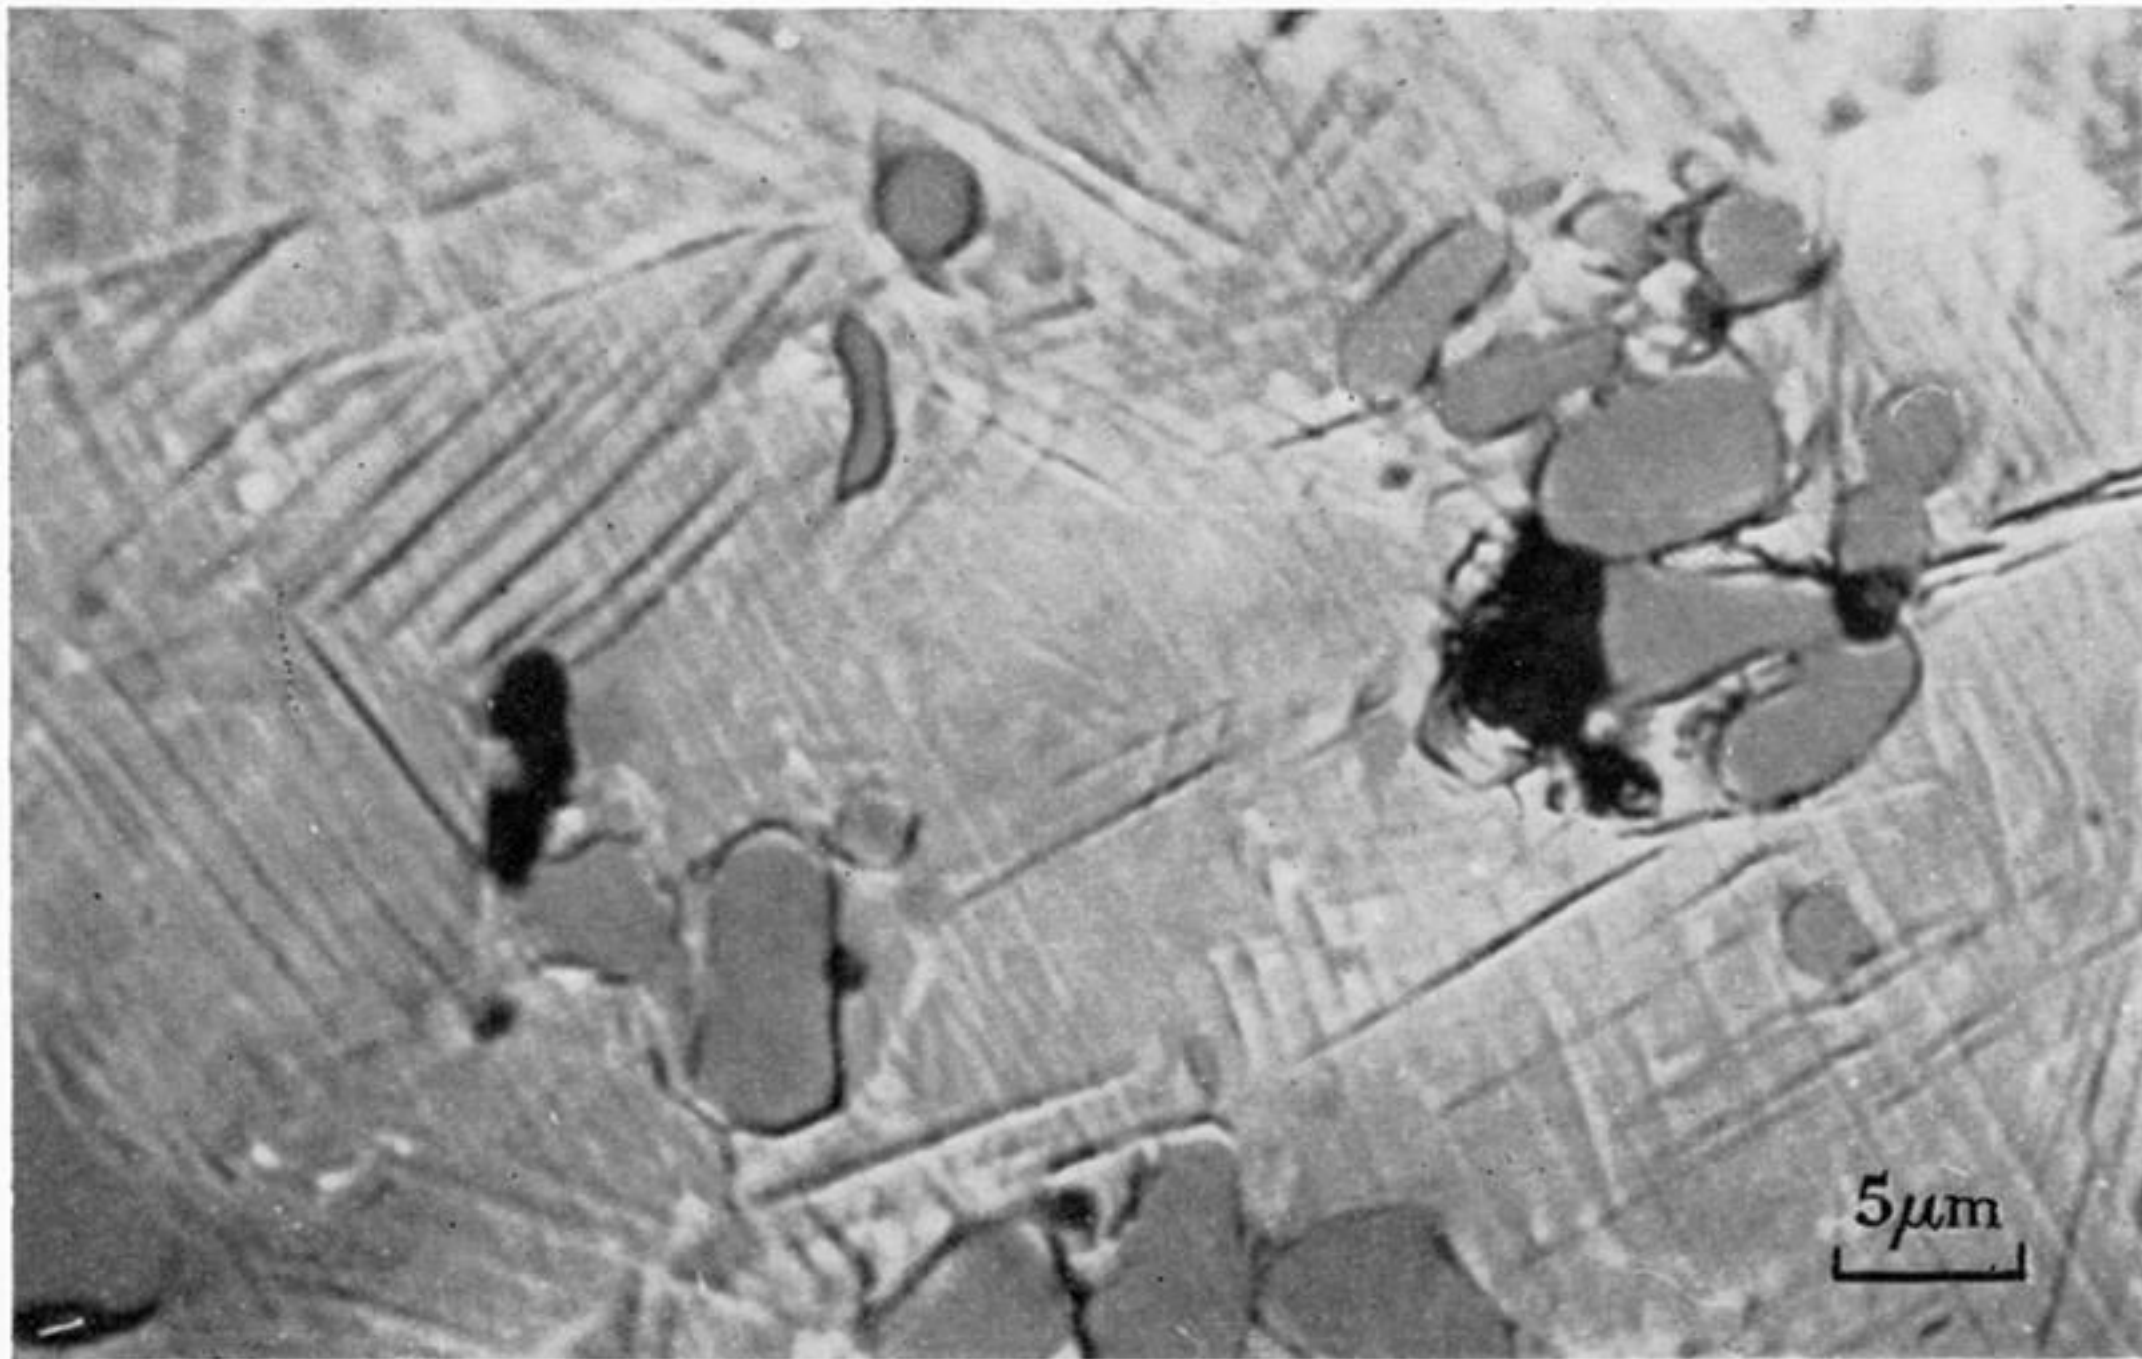
FIGURE 9. Cavities left by loss of carbide particles at specimen surface.
