The Erosion of a Cobalt-Chromium Alloy by Liquid Impact [and Discussion]

IX. The erosion of a cobalt–chromium alloy by liquid impact

BY J. B. MARRIOTT AND G. ROWDEN

The English Electric Co., Whetstone, nr Leicester

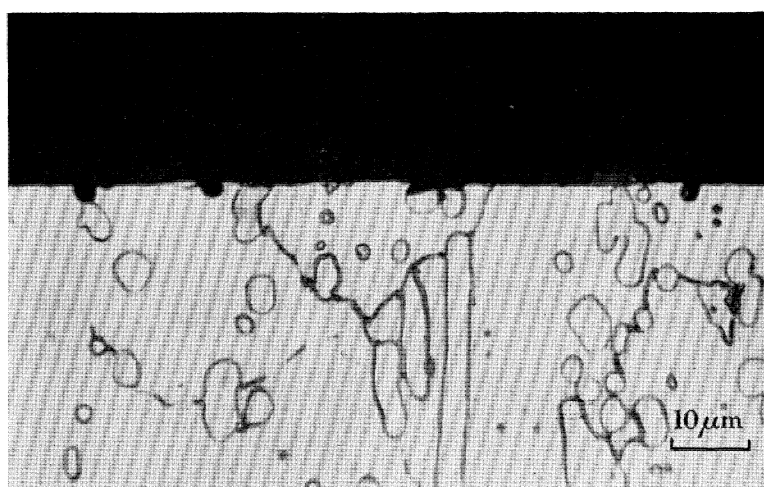
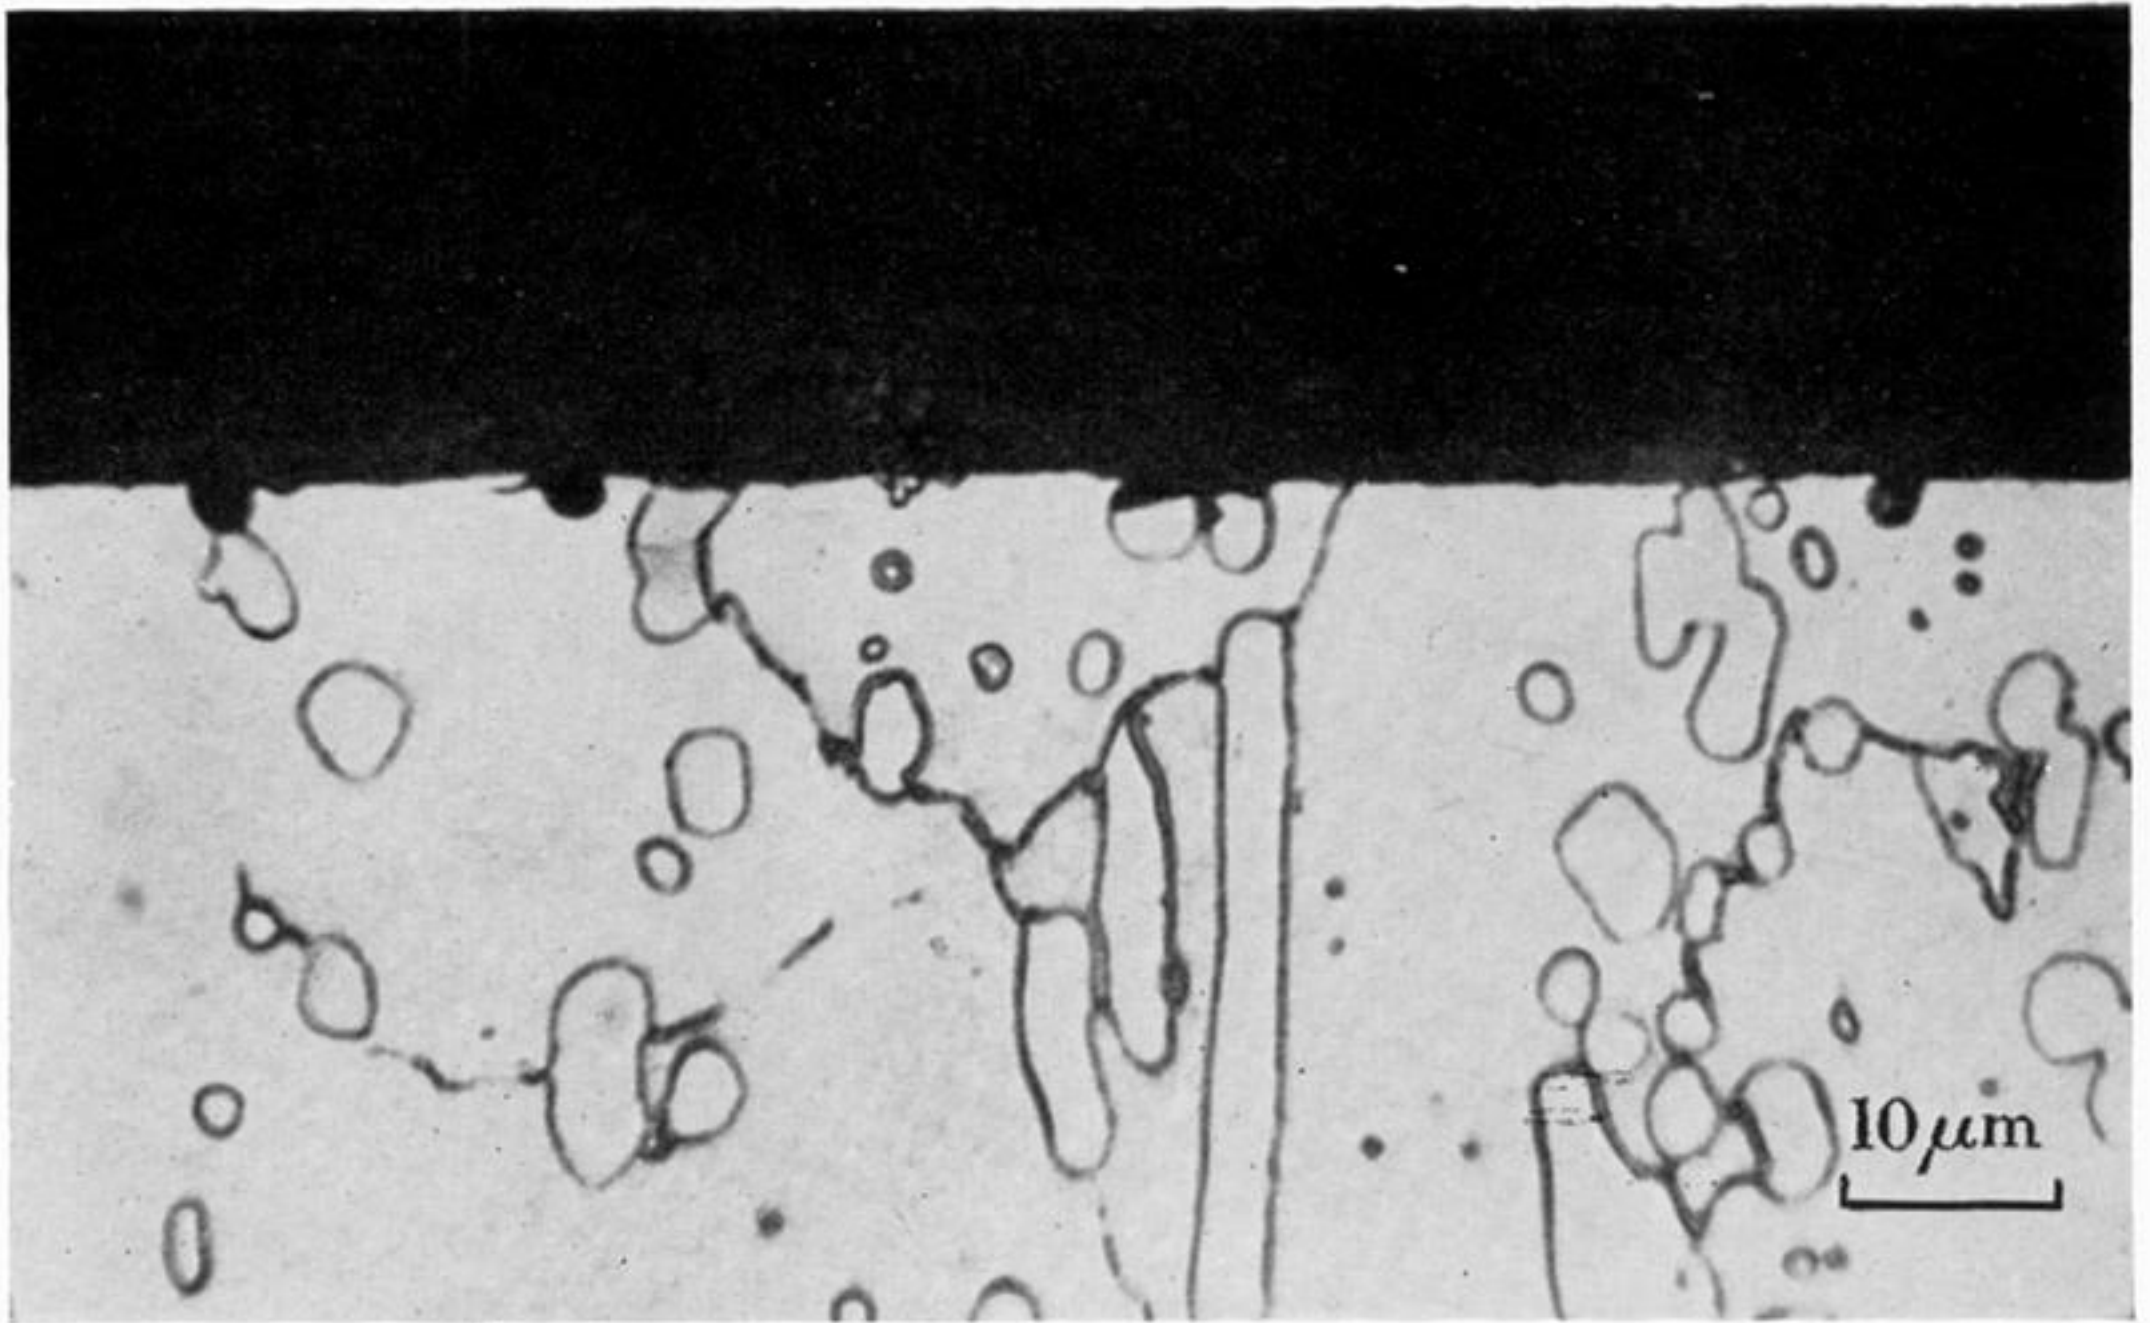
FIGURE 10. Section through eroded surface showing cavities left by carbide particle loss (etched).

Sections taken through the erosion track at this stage show that the formation of surface cavities results from the loss of the less deeply seated carbides (figure 10, plate 27), others

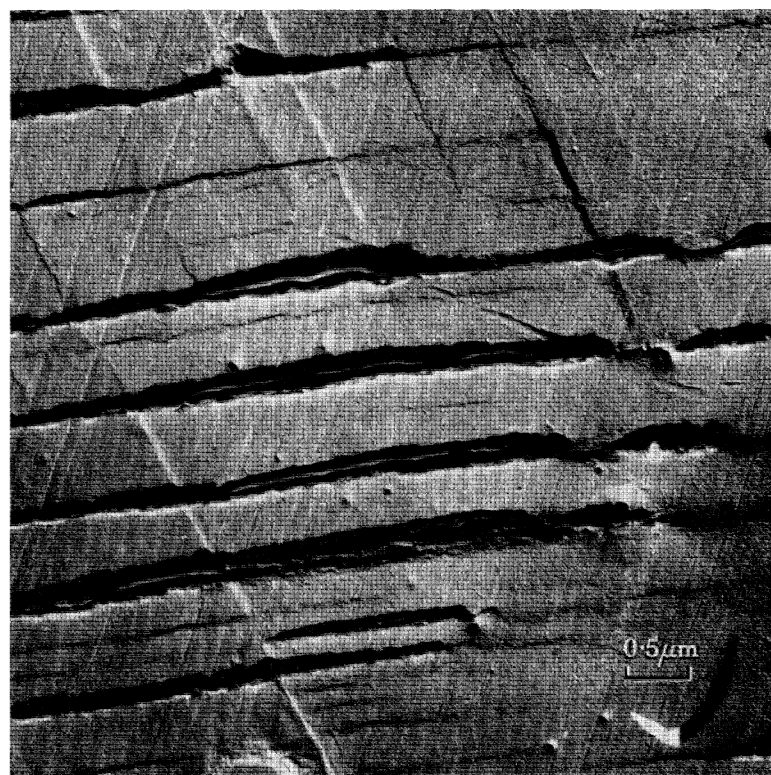
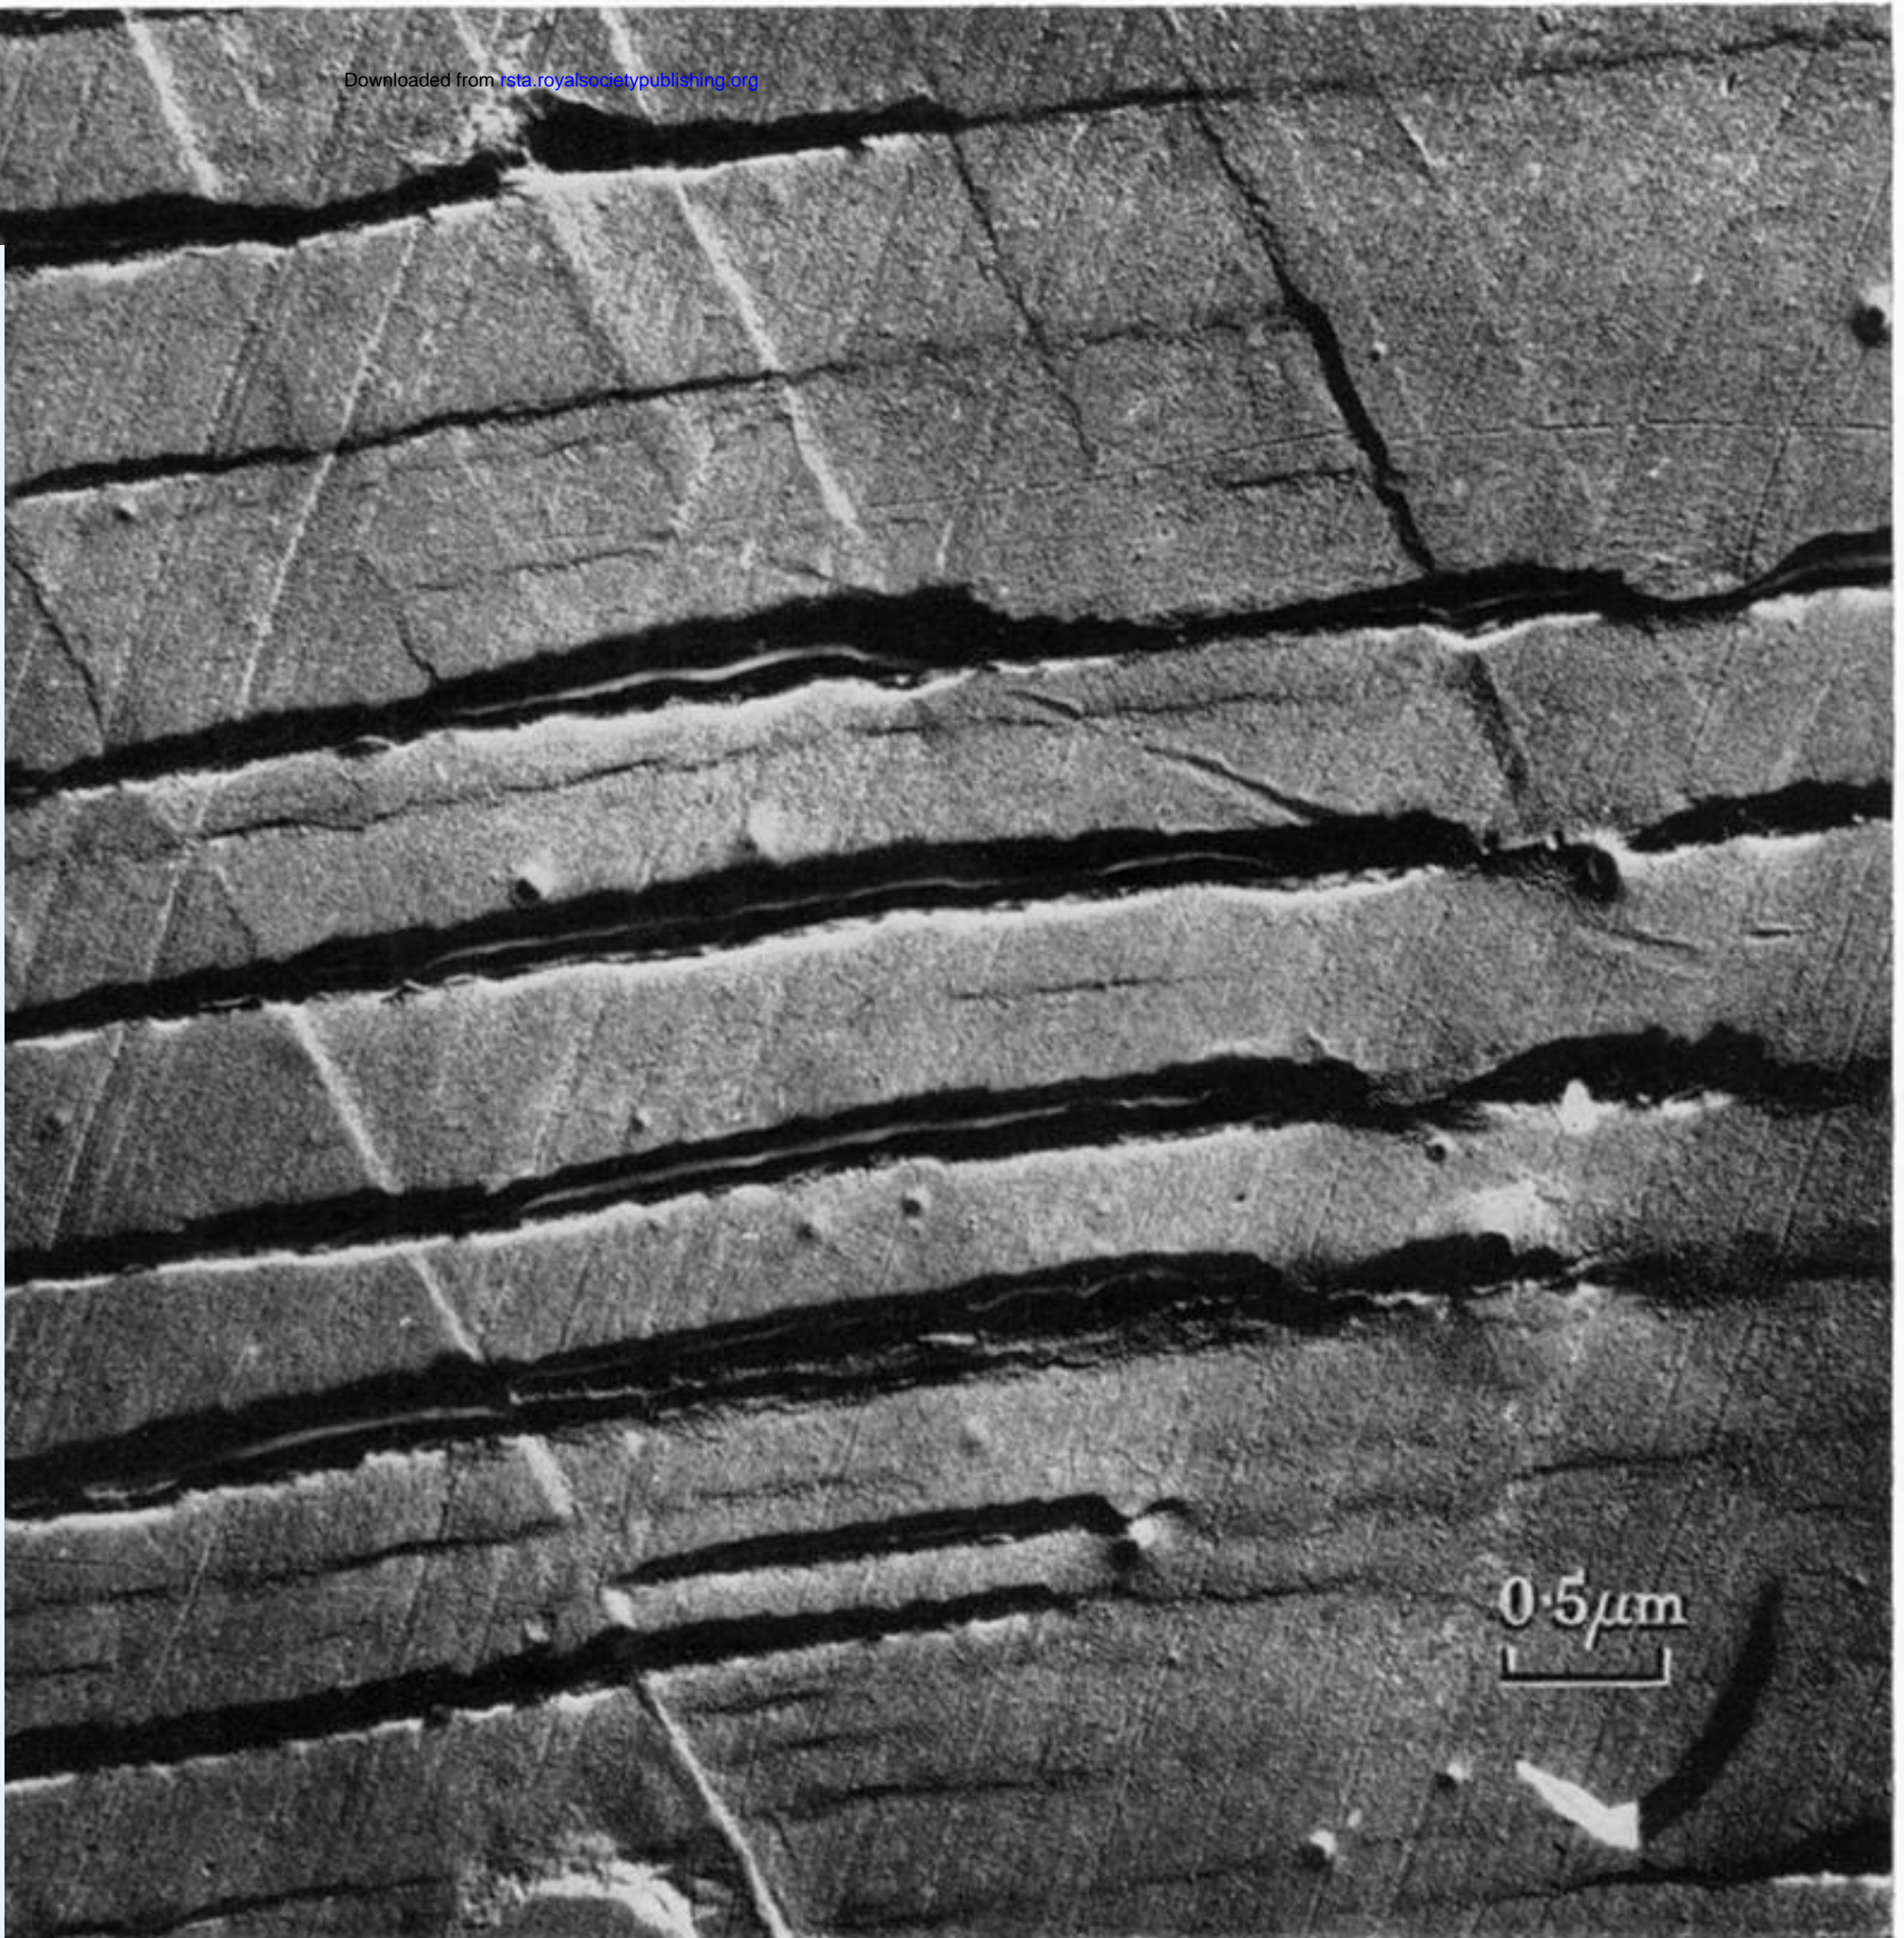
FIGURE 11. Intrusion formation at slip lines.

Electron microscopy has also revealed the presence of intrusions along certain slip lines after 10 000 impacts (figure 11, plate 27). With increasing exposure these slip lines tend to broaden and the damage along them becomes more pronounced.
