The explosion and fire on the Piper Alpha platform, 6 July 1988. A case study

D. D. Drysdale and R. Sylvester-Evans

Phil. Trans. R. Soc. Lond. A 1998 **356**, 2929-2951
doi: 10.1098/rsta.1998.0304

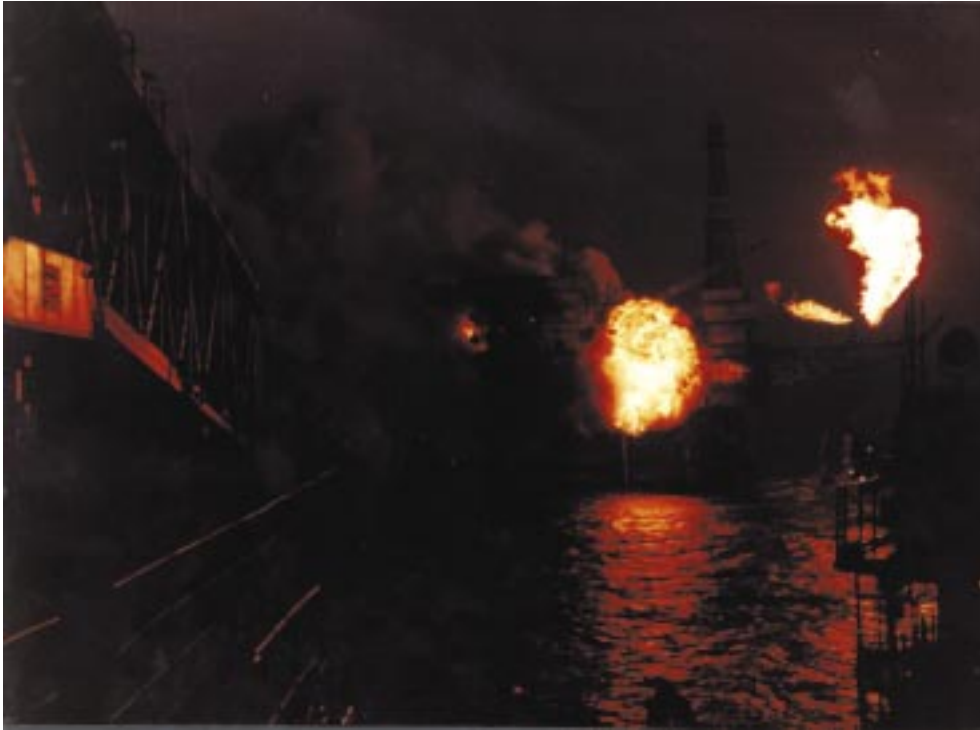
4. Some 15 s after the initial explosion, the 4 inch diameter condensate pipeline failed, releasing some 75–100 kg of condensate into the existing fire and creating

Figure 7. Fireball seen emanating from west face of Module B (cf. figure 2). The HP flare is seen to the right and the fire on the north face is seen to the left. Photograph taken some 15 s after initial explosion.

a fireball at the west face of module B. This was captured on film by a mobile diving unit pilot from the deck of MSV *Tharos* (figure 7). The size and duration of the fireball are discussed further in § 6.

It was important to establish the source of fuel for the fireball photographed emanating from the west face of module B (Drysdale 1989). The shape and symmetry of the fireball suggested that the fuel was a flashing liquid under pressure. The colour, together with the uniformity of mixing within the fireball, supported this view. There was no evidence of smoke generation and there were significant momentum effects to cause the fireball to be ejected from the west face of the platform. A photograph of the fireball is shown in figure 7.

The second difficulty was that there was no clear method of determining the depth of the fireball. The dimensions, as measured from the photograph, indicated a height of 33 m and a width of approximately 23 m. From these dimensions the average diameter would have been 28 m. As the fireball illuminated much of the end of the module of the platform it was clear that it was ejected from the west face by at least some 20 m. However, the extent of burning within module B was unknown; therefore, it was quite possible that the average diameter of the fireball could have been smaller as its dimensions were scaled against the known dimensions of the west side of the platform.

Regarding the cause for the delay of some 15 s after the initial explosion before generation of the fireball, a number of possibilities were examined. Clearly, the 4 inch diameter condensate pipeline was not severed immediately by the missiles otherwise there would have been no significant delay. However, the available energy was sufficient for severe disruption of the pipeline to have occurred (Palmer 1989). The delay could have been caused by additional stresses being applied to the pipeline due to movement of other equipment and piping, or by the reaction forces associated with a small leak. An alternative theory was advanced to suggest that the initial leak from the pipeline was crude oil, the most likely point of fracture being close to the tie-in point with the MOL (Drysdale 1989). It was only after pressure in the MOL subsided, as the main oil-line pumps run down, that the release of condensate occurred. In any event, the qualitative interpretation of the characteristics of the fireball, supported by the application of empirical equations, was sufficient for Lord Cullen to conclude that the fireball was caused by the failure of the 4 inch diameter condensate pipeline.

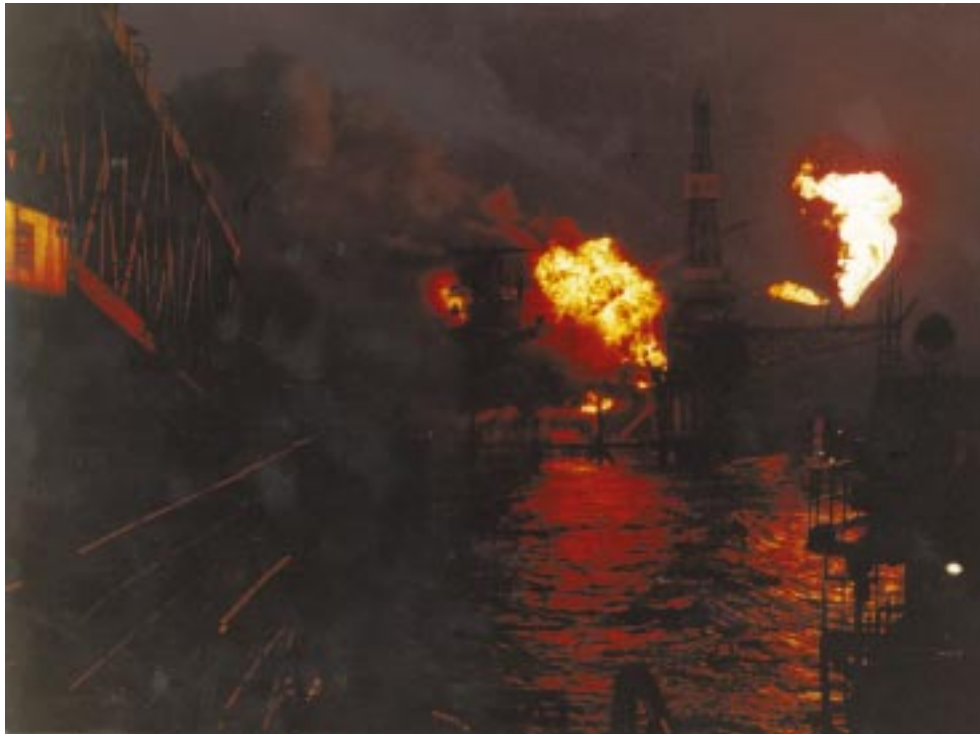
5. The overpressure created by the failure of the condensate pipeline together with the development of the fireball was sufficient to expel unburnt fuel-rich gases developed from the fire in module B, together with residual fuel from module C, out towards the north face so as to produce a fire beneath the ERQ at the 133' level on the north face of the platform. This can also be seen in figures 7 and 8.

6. For some seconds after the fireball started to lift from the west face, flames could be seen at the 68' level immediately below module B (figure 8). This is consistent with burning condensate vapour being pushed through the main oil line (MOL) pipe penetration.

Figure 8. Lift off of fireball; photograph taken some 2 s after figure 7. Transient flame visible at and below the 68' level.

A similar approach may be adopted when examining the duration of the fireball. Examination of the photographic evidence suggested that the visible fireball had burnt out within 4 s (figure 8). A correlation derived by Roberts (1981/82) predicts a duration of between 2 and 4 s, while that of Dorofeev *et al.* (1995) gives a duration of between 3 and 4 s. The predicted results are therefore consistent with the inventory of the 4 inch diameter condensate pipeline. In any event, the duration would be expected to be somewhat longer because of the partial confinement associated with the initial release.
