XLI. *An Account of the Effects of Lightning in St. Bride's Church, Fleet-street, on the 18th of June 1764: In a Letter to Mr. Benjamin Wilson, F. R. S. from Edward Delaval Esq; F. R. S.*

Read June 28, 1764. **T**HE inclosed is an account of the effects of the lightning on the steeple and spire of St. Bride's church, with drawings [TAB. XIV. XV.] which very accurately express the parts damaged by it.

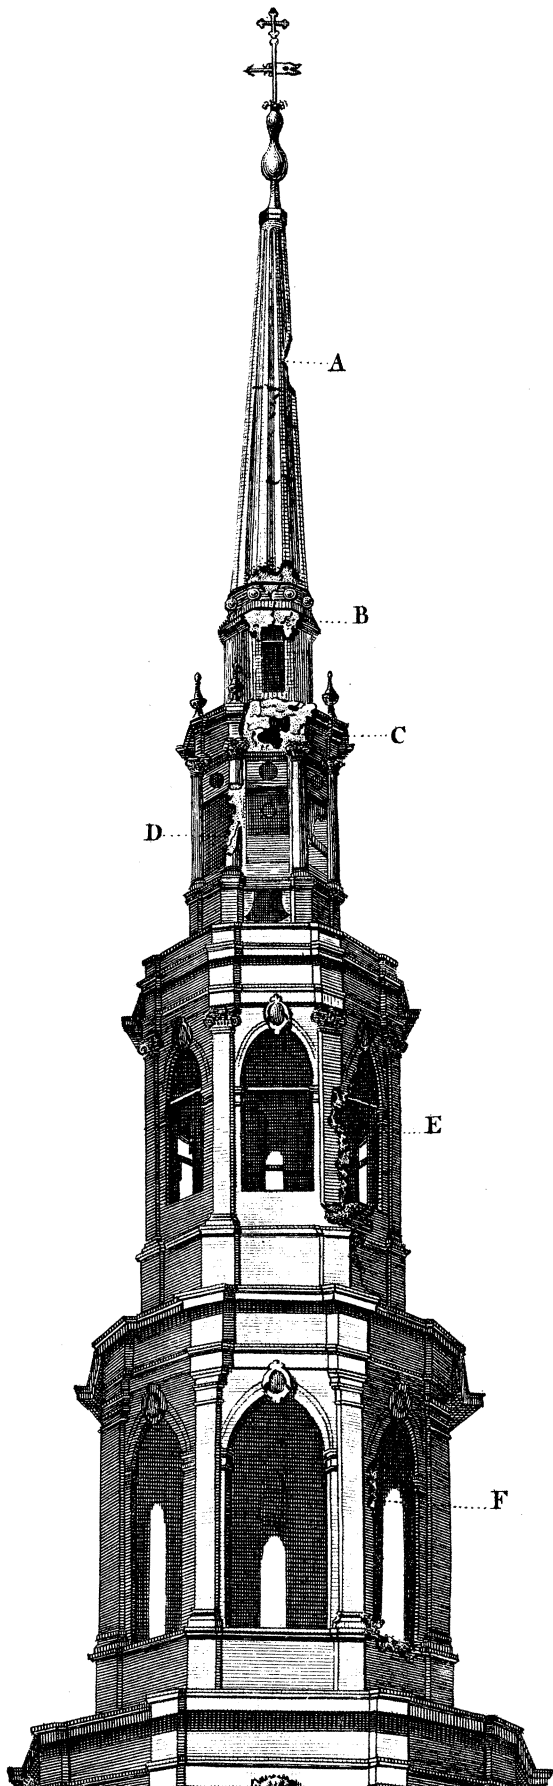
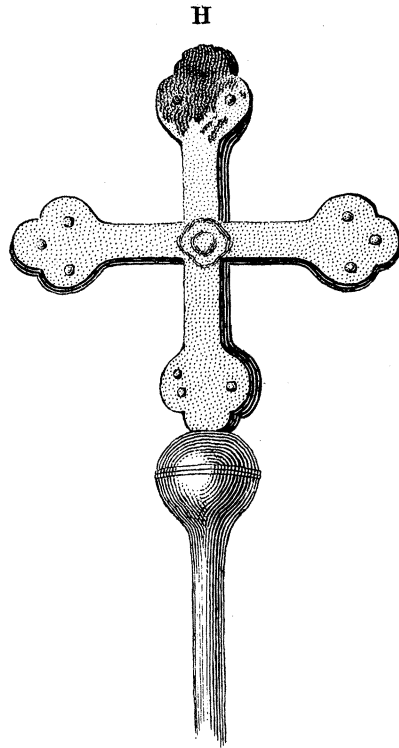
At this place the first marks of it are seen: at H the top of the copper cross, which is the highest part of the building, the gilding is by the explosion partly torn off and partly discoloured, so as to differ remarkably from the rest of the cross where the gilding is very well preserved. Some small pieces of solder are melted; and all this part appears as if it had been exposed to the fire.

The lightning seems to have entered here, and to have been conducted as low as the hole at A, by an iron spindle twenty feet in length, and two inches in diameter; of which ten feet were surrounded by the copper ball, vane and cross; and the lower half was inclosed in a groove cut through the middle of the solid stones which composed the upper part of the spire, and rested at A on the bottom of that groove, which was sunk five inches deep into the lowest of those solid stones: this last mentioned stone being three feet broad and one deep. The interval between the sides of the spindle and the groove made to receive it was filled up by melted lead poured in between them.

The lightning accumulated in the metal, having its passage towards the earth strongly resisted at this place, has in expanding itself formed the hole A, by burst-

bursting off from the lower part of the spindle the stones contiguous to it on that side.

At each of the angles of the metal, the stone on which it rested is cracked, which probably was occasioned by the lightning issuing with greater freedom from those parts, than from the flat surface.

From hence, as low as to the corniche B, it seems to have been conducted along the surface of the spire, which was wetted by the rain that had fallen in the morning, before the lightning: and having been accumulated in the iron bars B and C, in discharging itself from them, it has made the greatest explosion at this place.

It is evident that these effects would have been prevented, if a sufficiently large metallic conductor had been extended from the metal at the top of the spire down to the earth, communicating with the other metallic parts of the building that lay in its way.

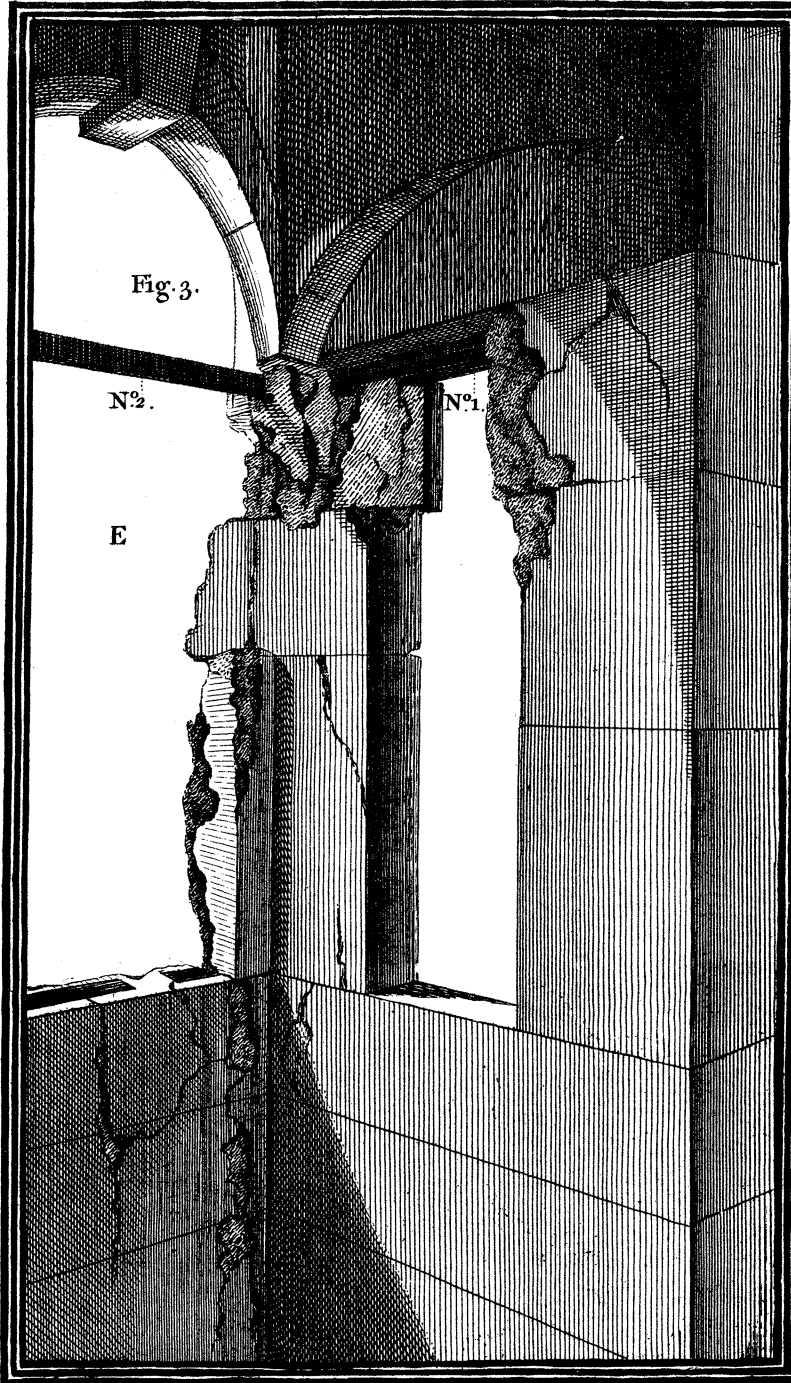
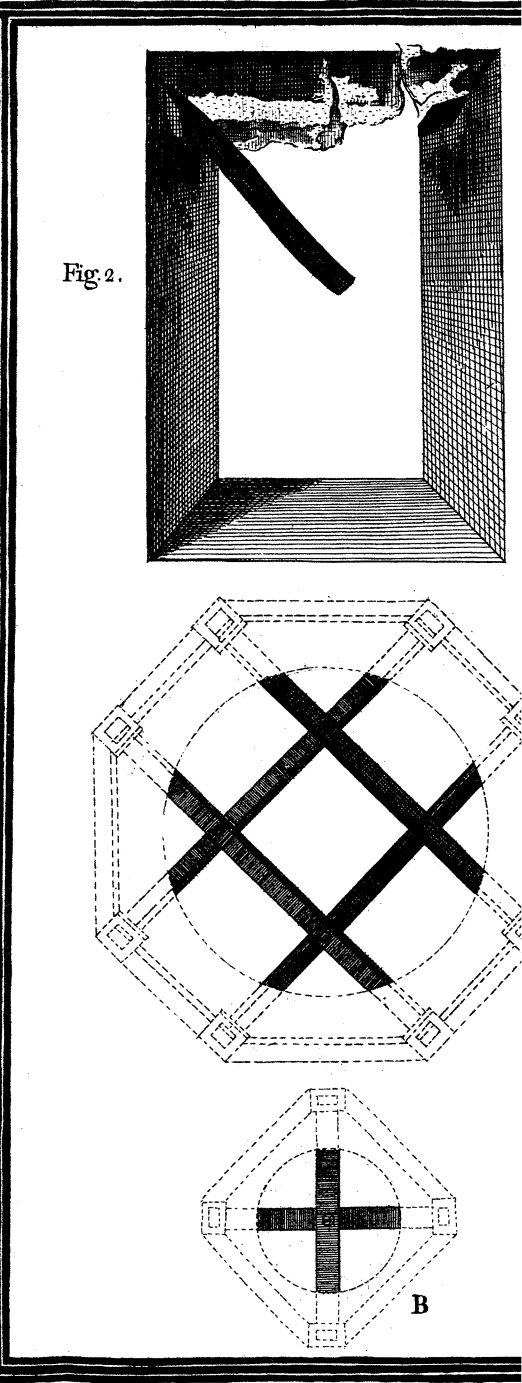
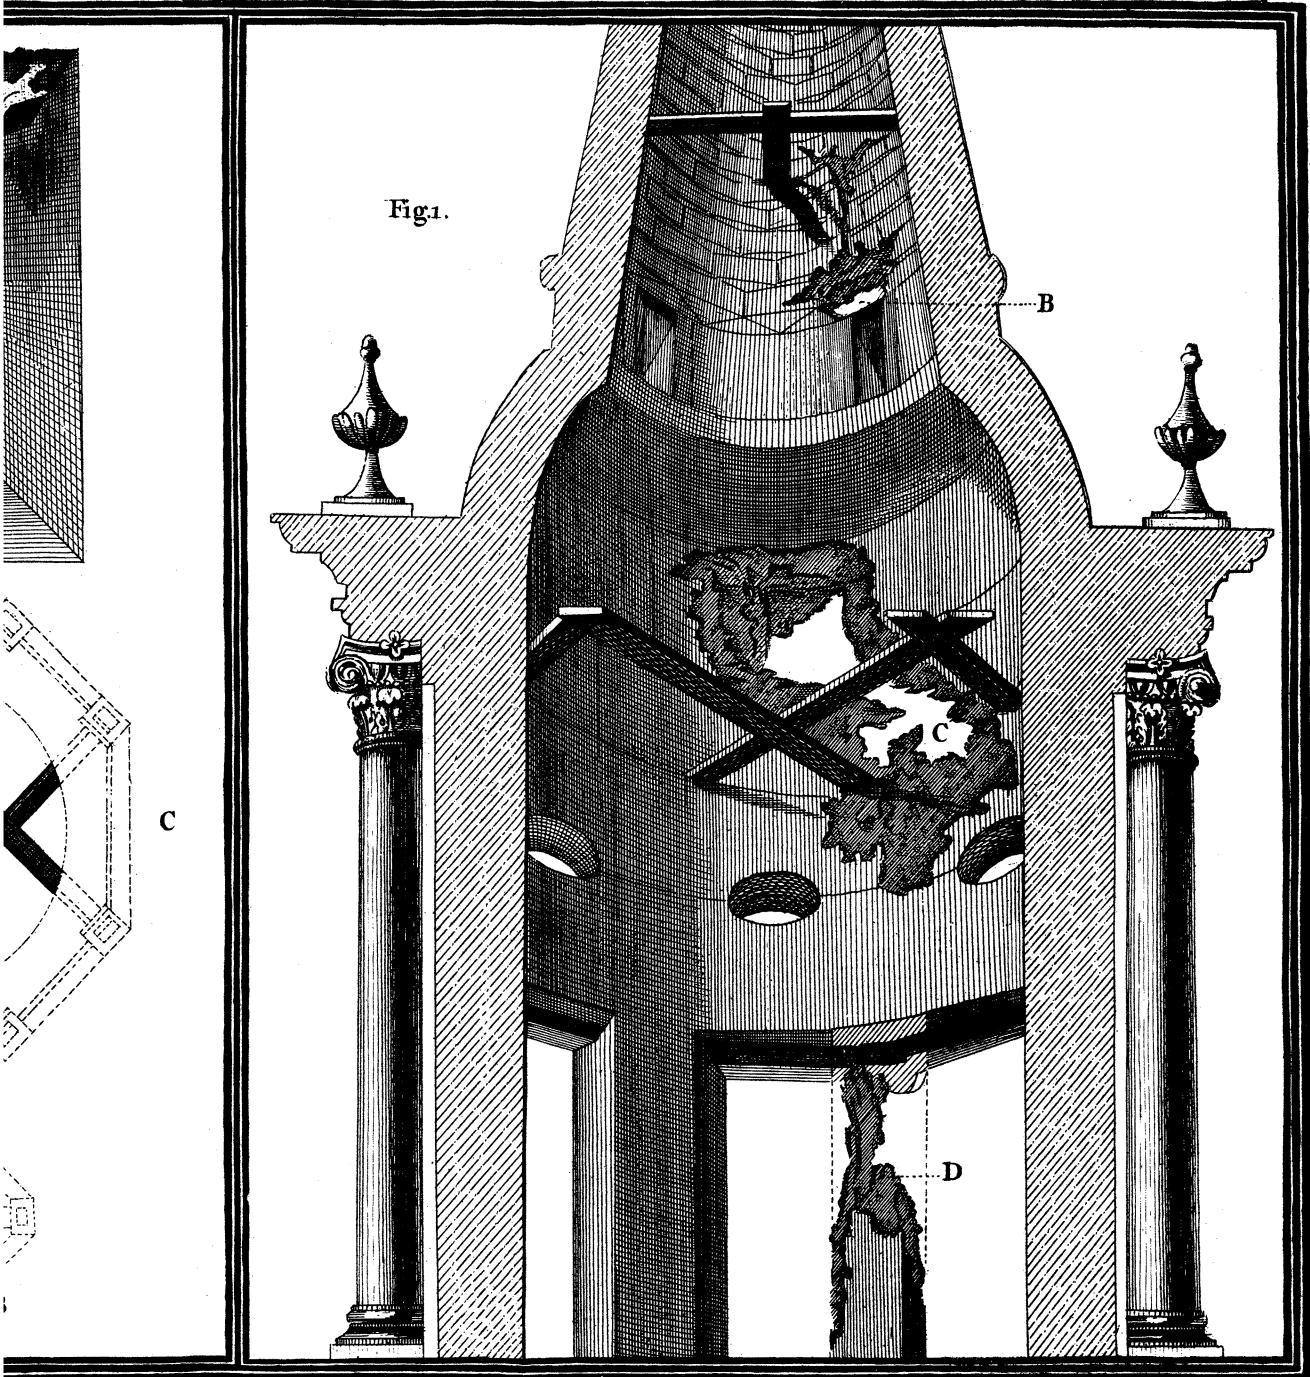
At Fig 2, a bar of iron, which served to support the top of the window in the same manner as those last mentioned, 21 inches long clear of the stonework, and half an inch thick, is broke and bent into the position expressed in the drawing; and the stones immediately above it are shattered and disjointed.

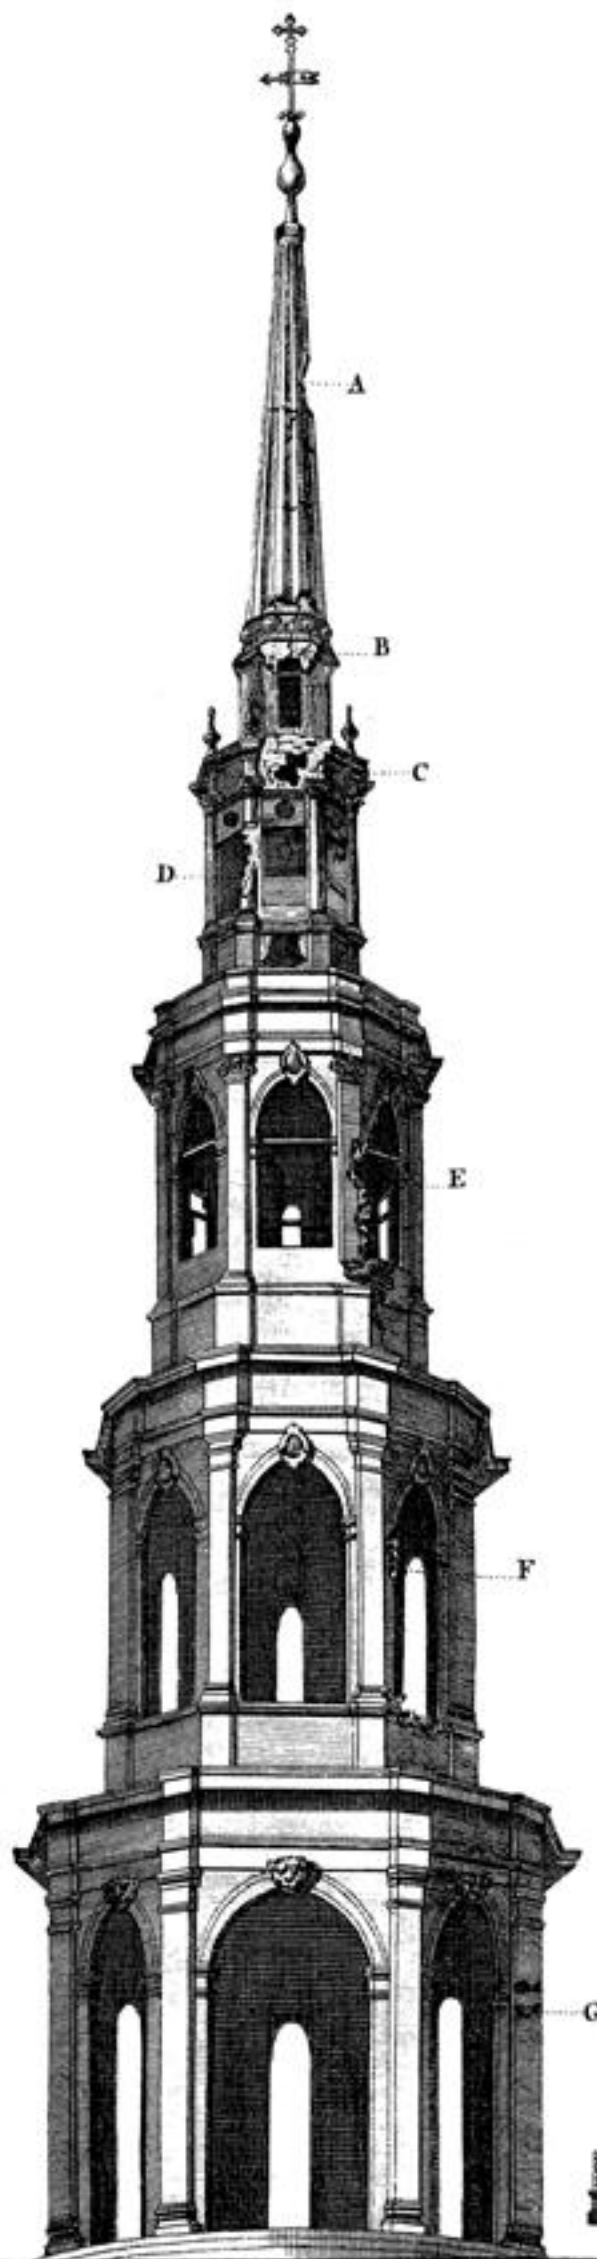
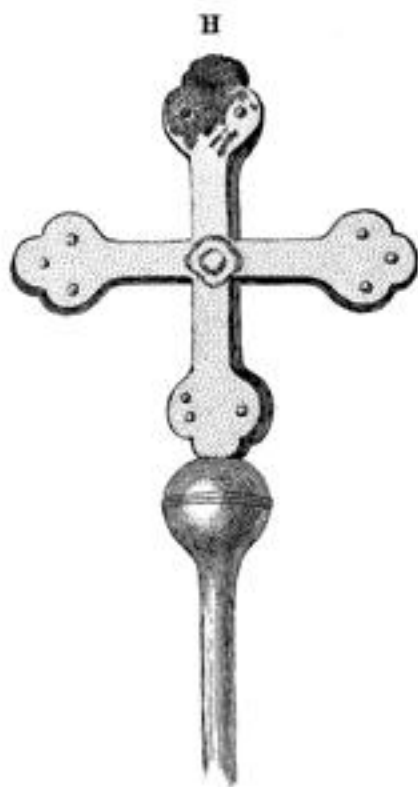
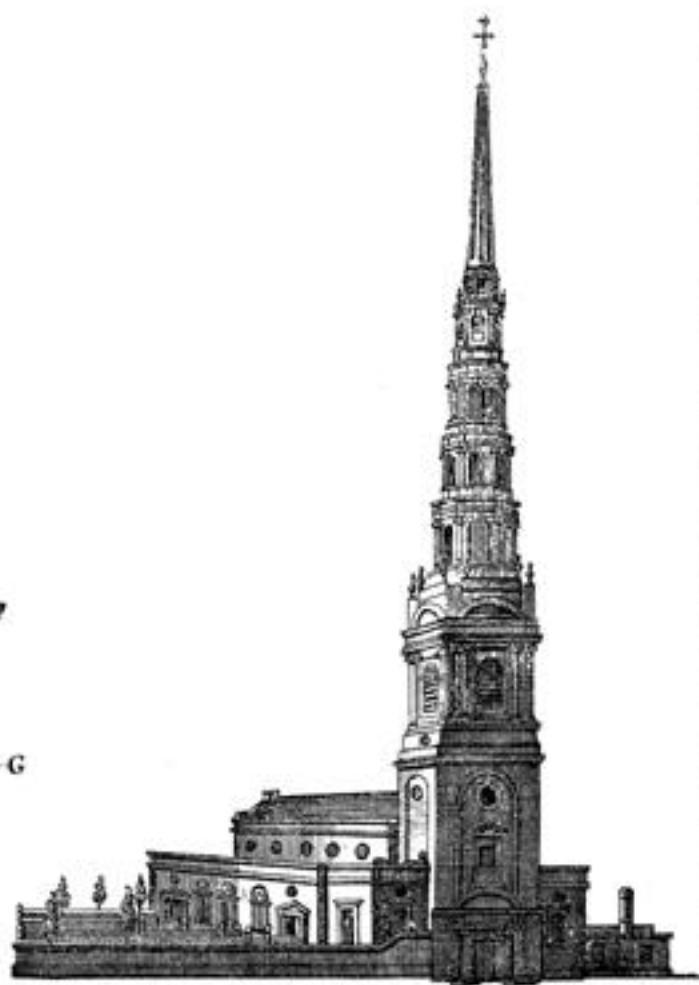
On examining the inside of the steeple beginning from the top, the first effect of the lightning that appears is a hole in the stone work at B, beginning immediately above an iron bar which served to support the top of the window or opening, and running upwards towards the two cross iron bars: this, when viewed from the outside of the church, is seen to have spread round most of the lower part of the spire, so that it seems in great danger of falling.

The next stroke is about four feet below: at this place four iron bars lie horizontally across the spire, and are tied together by chain bars which are inclosed in the stonework: where the end of one of the cross bars is inserted in the stone, the lightning has burst open the hole described at C, and, when the same is viewed at the outside, a great part of the cornice appears to be broken off.

At D, where the two iron bars serving to support the top of the windows meet and are joined together, the lightning accumulated in them has broken off the pier by which they were inclosed.

At E, an iron bar N°. 1. about twenty five inches long, was inclosed nine inches deep in the stonework of the pier, separating the East arch from the arch next it towards the North: the end of this bar joins at a right angle another bar, N°. 2, which is laid across the arch. The lightning accumulated in the iron (N°. 1.) which was inclosed in the stonework, has burst off all the stone that surrounded it, and part of the pier adjoining. The flaw is continued downwards, as expressed in the drawing, meeting with smaller iron cramps in it's way.

At F, the next arch lying immediately under the last mentioned one, an iron was inclosed in the stone in the same manner as the bar at N°. 1. The stone is torn off from this iron exactly in the same manner as at N°. 1: but the damage has not reached much further than the stone which was contiguous to and covered this bar. At the bottom of this arch the fill stone, which covered some cramps of iron, is torn off from it's place.

At G, the next arch under this, the force of the lightning seems to have been much diminished, a small part of one stone only being broken.
