XXII. *Proceedings relative to the Accident by Lightning at Heckingham.*

Report of the Committee.

PURSUANT to your resolution, appointing us a committee to examine the House of Industry at Heckingham in Norfolk, which had been struck by lightning although it was armed with conductors, we arrived there on the 21st of January. Seven months had then elapsed since the accident, yet we had the satisfaction to learn, that no material changes had been made in the conductors or the building in that period; some laths that had been burnt, some bricks and pantiles which had been damaged or thrown down, were replaced; but we found means to procure distinct information of those repairs from the workmen who had been employed to execute them. In order to communicate a clear idea of the accident, it will be necessary to premise a general account of the building; then to represent the manner in which the conductors were applied; and, lastly, to describe the stroke of lightning, with its effects.

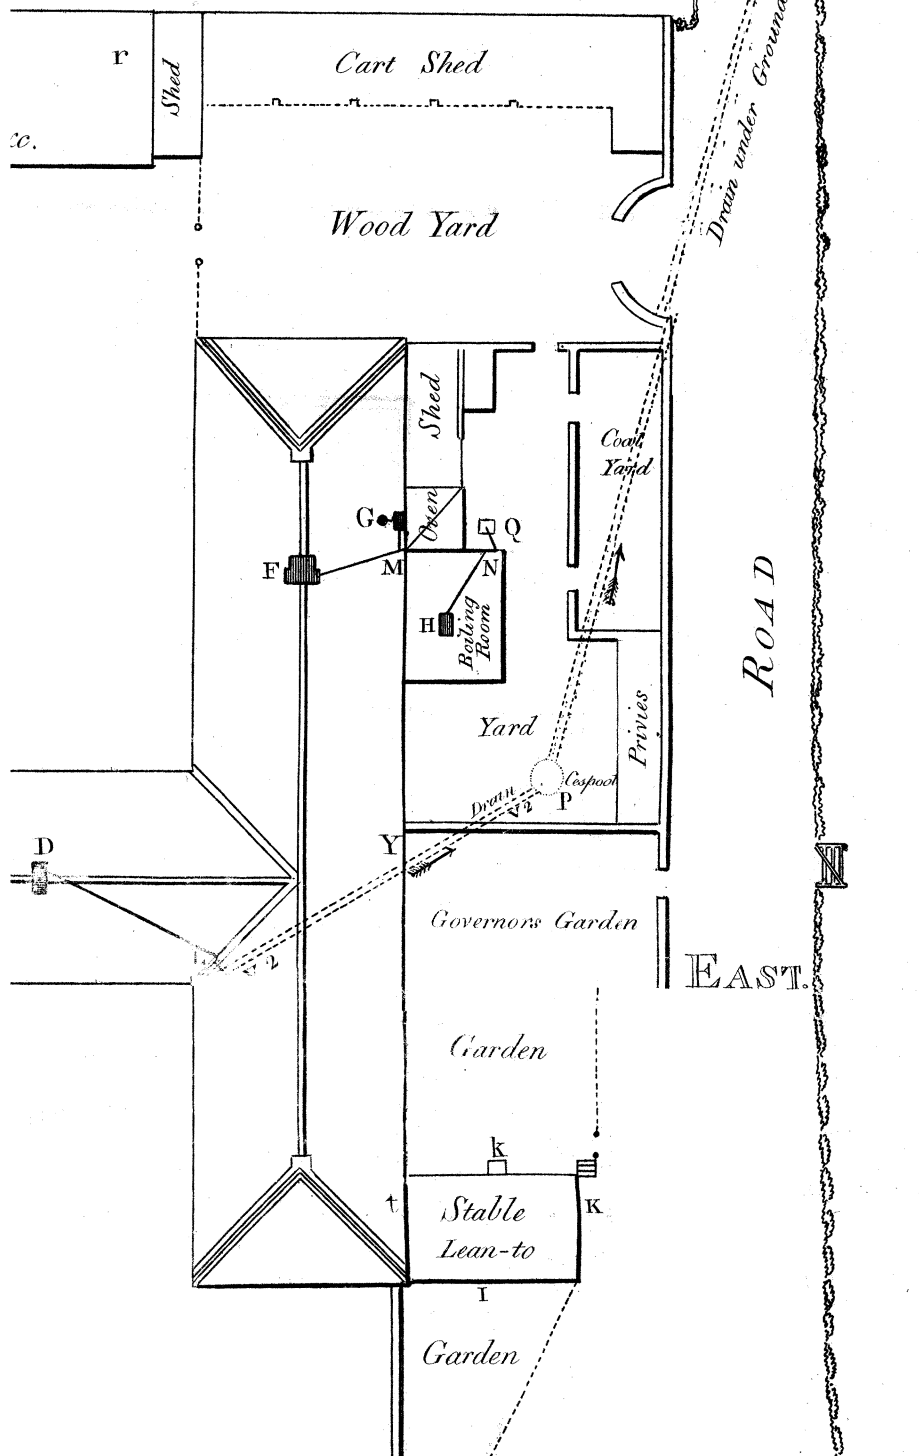
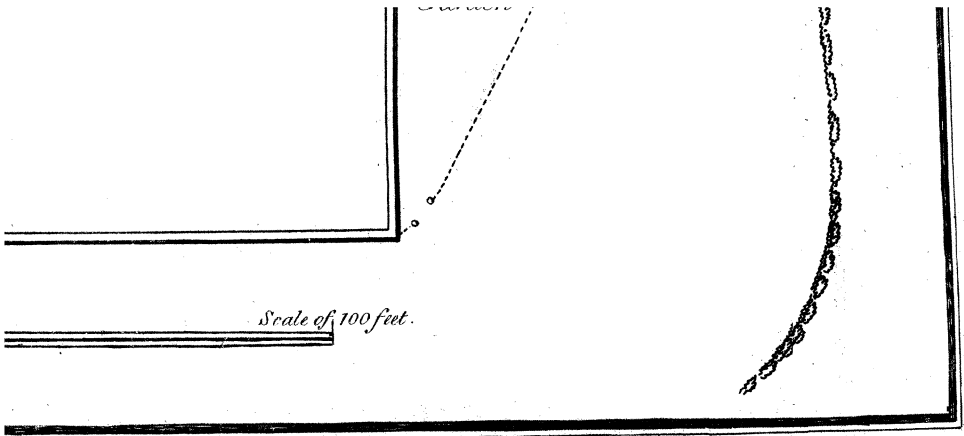
Figure 1.

The general form of the building is that of the Roman letter H (see the general plan, fig. 1.), consisting of a center range (Z) and two flanks (Y and X). It stands on a gentle rising, which can by no means be termed a hill, with its front facing S. 9° W. To the western side of the west flank, and eastern side of the east flank, some lower buildings are annexed, serving as offices of different kinds; and there are two courts, one before and the other behind the house, together with some small gardens and yards on each of the flanks, in all of which stand various detached offices, as will be easily conceived from the general plan (fig. 1.).

The body of the building, including the great house with its annexed offices, is provided with eight chimnies, the position of which is represented in the plan (fig. 1.) at the letters A, B, C, D, E, F, G, H. Of these the six first are all placed on the ridges of the roof; namely, A and B on the ridge of the west flank, C and D on the ridge of the center range, and E and F on the ridge of the east flank; but the chimney G rises from the lower part of the roof on the eastern side of the east flank; and the chimney H from the roof of an annexed office, the boiling-room, which roof is continued down from the general roof, and projects beyond it.

Though there were eight of these conductors reaching above the chimnies, yet they had only four terminations below. For the conductors to the two chimnies D and E (fig. 1. and 2.) being continued toward each other along the roof, united in the valley over the lead gutter there (at L in the 1st, 2d, and 3d figures), and from that point only one conductor was continued down the valley toward the ground. In like manner the two conductors from the chimnies A and C (fig. 1.) united in the valley of the roof between them, and were carried down toward the ground as a single rod. All the three conductors from the chimnies F, G, and H, successively joined together (see M, N, fig. 1.), and only a single rod was continued from them down the lower part of the building. Lastly, the conductor from the chimney B (fig. 1.) went down single all the way, without having formed a junction with any other.

As this drain, then, is the real termination of the conductor, it must now be more attentively considered. It begins at the western sink of the fore-court U (fig. 1.); thence it is continued (V, V, fig. 1.) with a proper declivity to the eastern sink W (fig. 1. 5. and 6.); it then runs under the east flank of the house (V₂, fig. 1. and 5.), and ends beyond it in the side of the cefs-pool P (fig. 1.). From the grating on the sink U to that on the sink W (fig. 1.) is 89 feet, and thence to the cefs-pool P near 69 feet; the breadth of the drain at bottom (z , fig. 7.) is 14 inches; its height to the spring of the arch (fig. 7.) 16 inches, and to the crown of the arch (x , fig. 5. and 7.) 23 inches. When we saw it, the moist filth, or sludge, at bottom (z , fig. 7.) was two or three inches deep; but when the court is overflowed, as the two grates (at U and W, fig. 1.) are laid on purpose to receive the superfluous moisture, there must be some run of water through it. We estimated the fall of the drain, from the eastern sink W (fig. 1.) to its termination in the cefs-pool P, at two feet. The cefs-pool itself resembles a well, walled round in the inside, and has foul water stagnating at the bottom, which cannot rise above a certain height on account of a large drain, leading from it into the great reservoir (at R, fig. 1.), out of which the foul water is ultimately pumped. When we examined this cefs-pool, the water in it stood even with the bottom of that great drain, consequently was almost

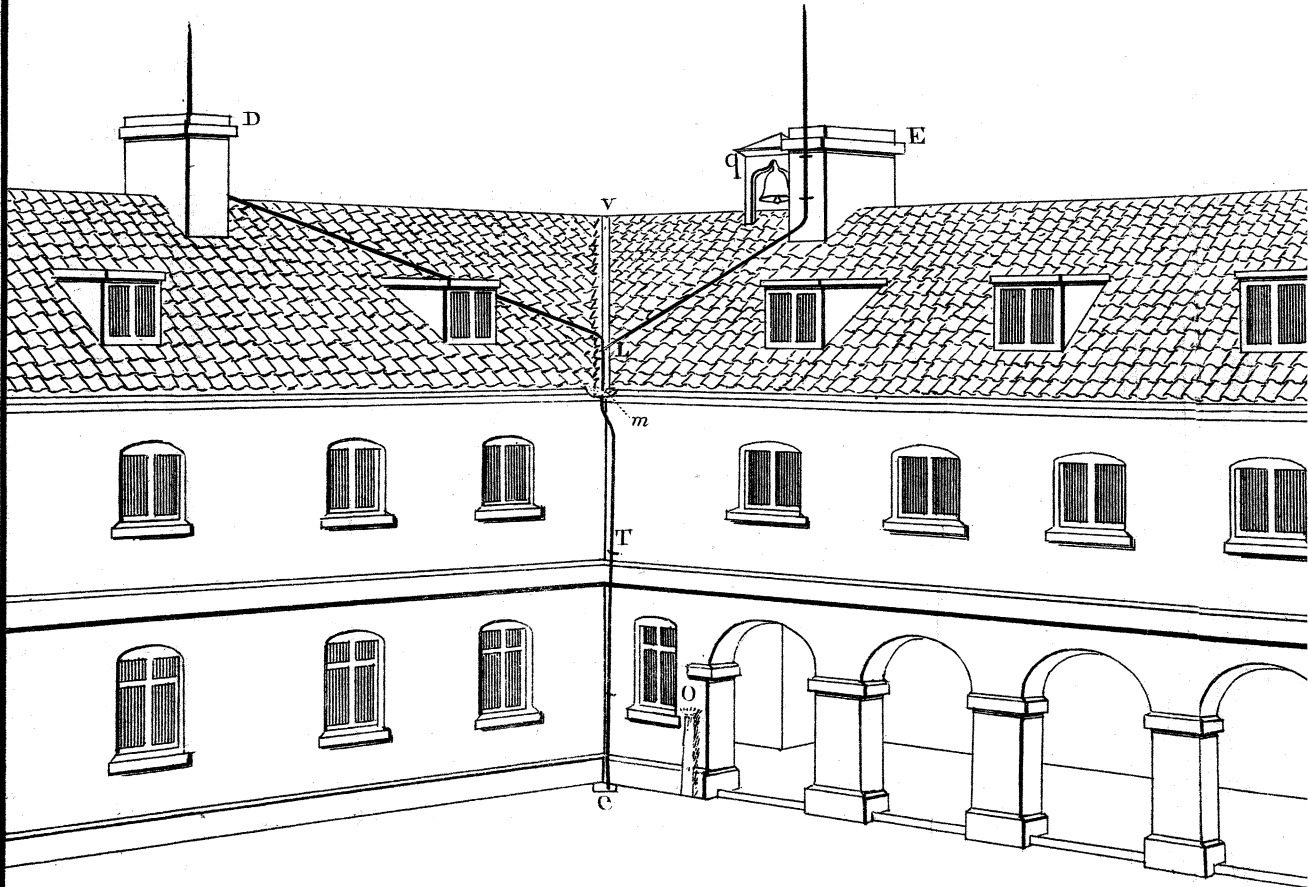
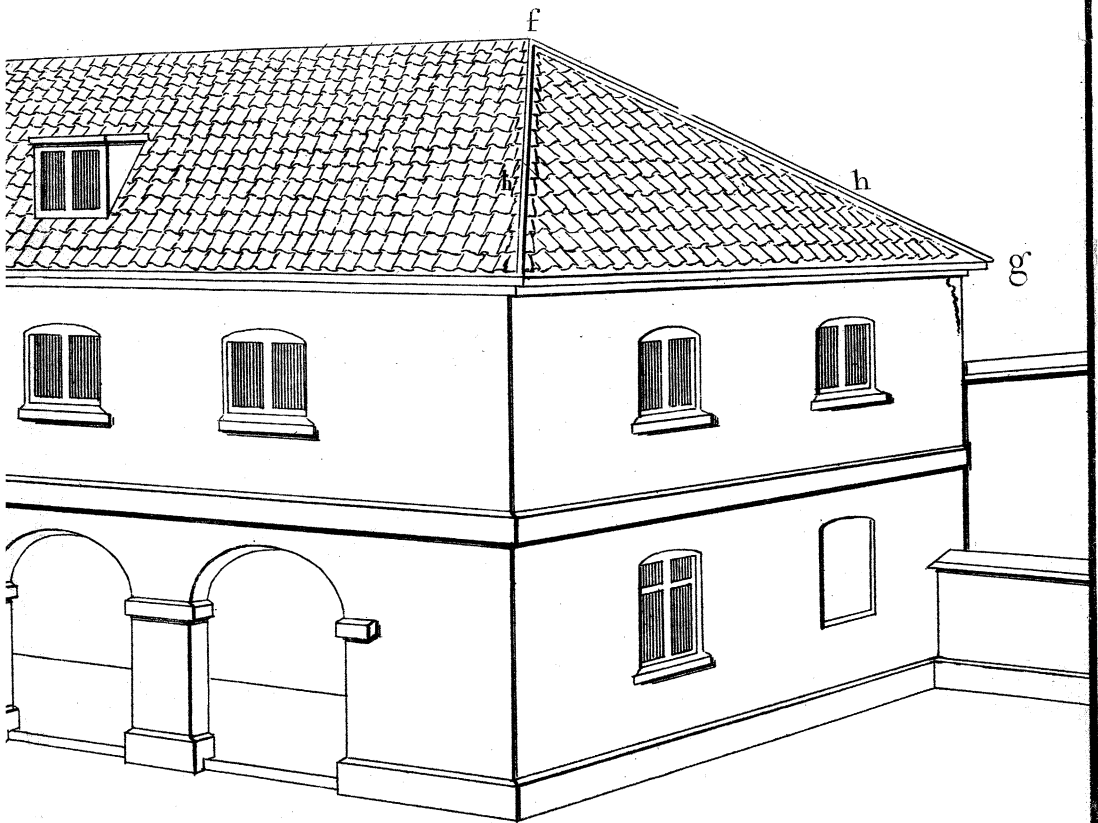
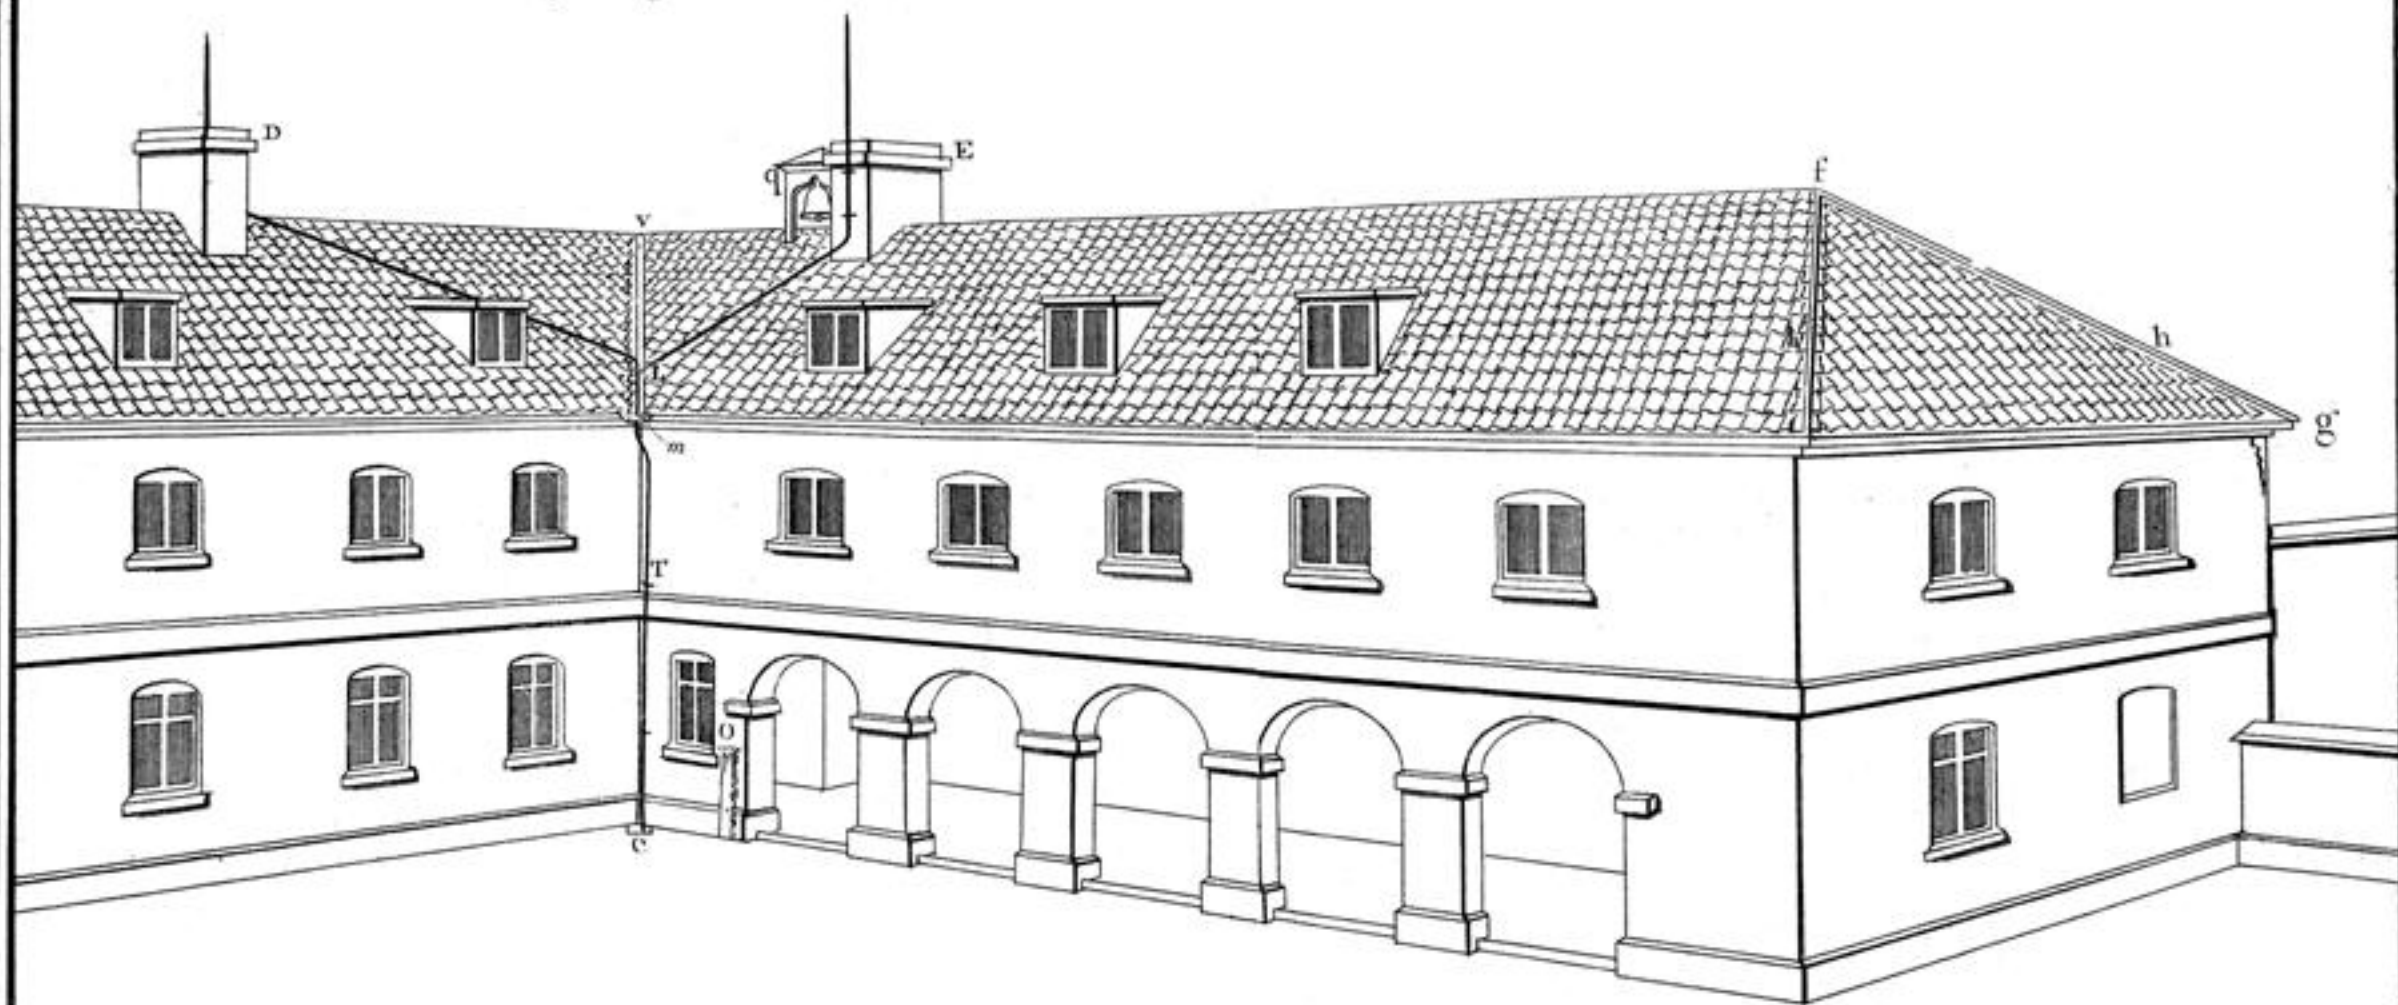
Fig. II.

Tracing the conductor downward from this point of union, we found it descend over the lead of the valley, to the surface of which it gradually approached, till at a hole made on purpose (*m*, fig. 2.) it passed through the lead, whence it was continued down the angle formed by the intersection of the east flank with the front of the center range (T, fig. 1. 2. and 5.). It no where touched the wall of the building, but was kept in its place by ring-staples (*p*, *p*, fig. 3.). Being arrived within two or three inches of the ground, it entered into a channel of brick, enclosed on all sides (at *e*, fig. 5.), in which it was continued down to the arch of the great drain of the fore-court (*x*, fig. 5.); here, having passed through a hole in the haunch of the arch (*y*, fig. 5. and 7.), it was bent off from the house through the middle of the drain, and

Against the east flank, near the corner T (fig. 1.), there rises a leaden pipe with a cock (O, fig. 2.), to which the water is conveyed from a raised cistern (see r, fig. 1.) in one of the detached offices of the back-court. A main of lead from the cistern, which is itself of that metal, after sending out pipes to some other cocks, and passing through the cellars of the house, comes into the fore-court about four yards from the corner T (fig. 1.) and is carried over the drain at the distance of about a foot above its crown, and eight inches below the surface of the ground. Here it divides into two branches, one of which goes straight to the cock at O (fig. 2.), and the other runs westward, to supply a similar cock in the opposite corner. We measured the distance of these pipes and cocks from the conductors, and found that they came no where nearer than five feet and an half.

As both extremities of the hip, therefore, were, in some degree at least, affected by the lightning, we proceeded to ascertain their distances from the nearest conductor, which was that affixed to the chimney E (fig. 2. and 4.). Having determined the necessary measures, and calculated the hypotenuse, the distance from the point of the conductor to the beginning of the lead on the top of the hip (*e*, fig. 4.) came out 42 feet and a quarter; thence to the bend where we found the marks of fusion (from *e* to *f*, fig. 4.) was five or six inches more; and as the hip measured about 27 feet in length, the distance from the conductor to the bottom of the hip (*g*, fig. 4.) may be called 69 feet. From the top or bottom of the hip, to the nearest part of the conductor as it ran downward, the distances were not a foot less than these measures. We then took down the uppermost rod of the conductor, and carefully examined it, especially at the point, and at the hook and screws by which it had been joined to the second rod; but could no where discover the least mark of fusion or other injury. At the bottom of this conductor, however, where, having joined that from the chimney

Close to the chimney E, a dinner-bell hung in a common frame (g, fig. 2. and 4.). Three different persons went up to examine this bell; but could not discover upon it any where the least vestige of the lightning.

*SOUTH WEST VIEW of the EAST WING and
shewing the junction of the two Conductors that*

*G and part of the CENTER RANGE
s that were nearest the Stable Lean-to.*

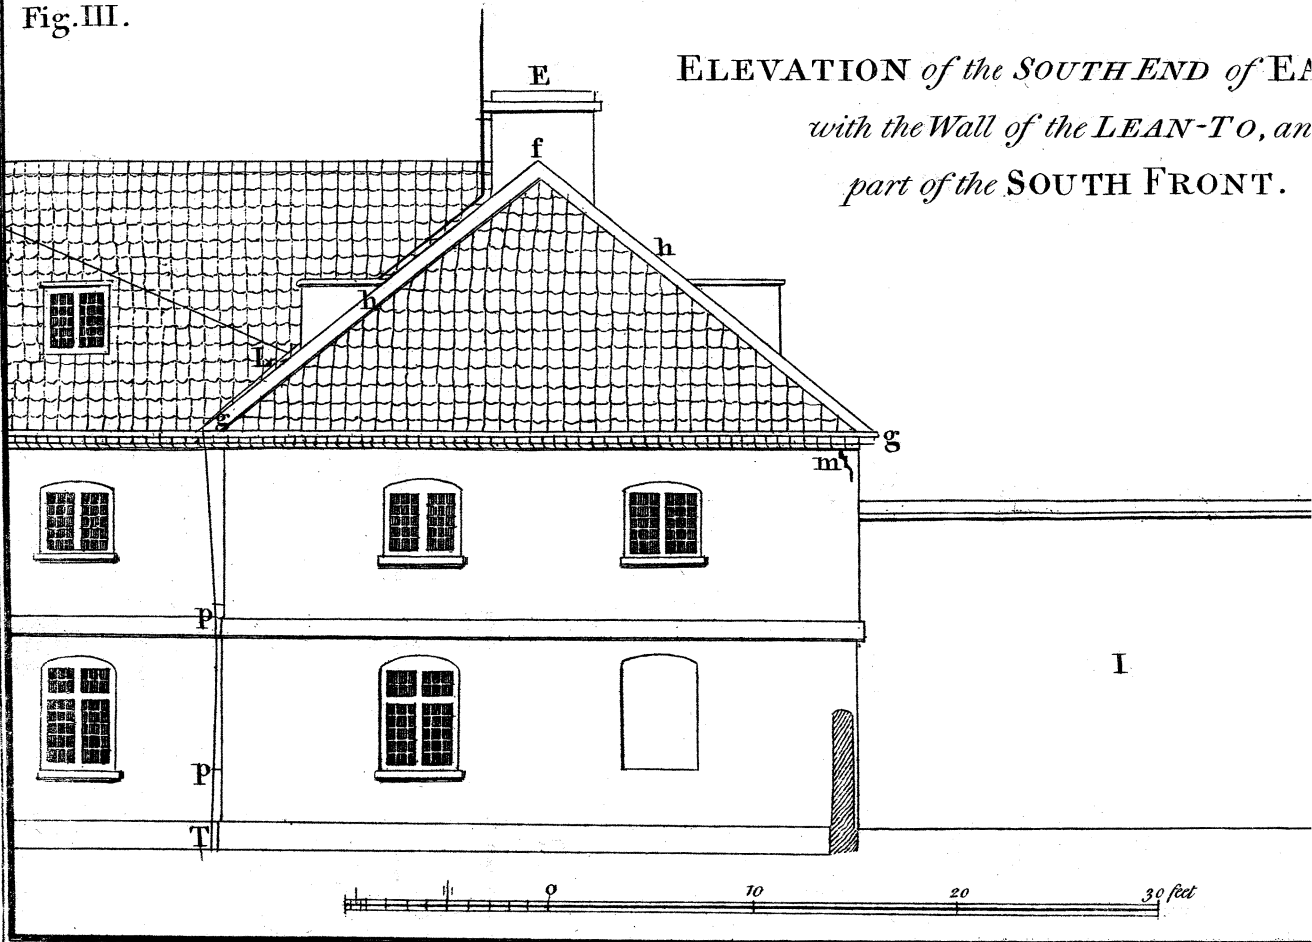
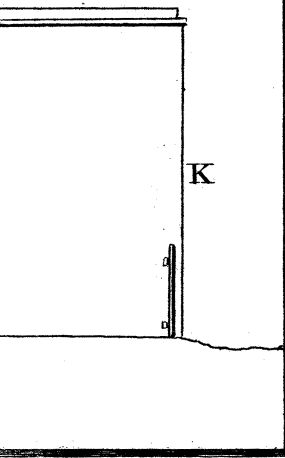
Fig. III.

Under this end of the wall-plate there was a crack in the fourth face of the corner (*m*, fig. 8.), which went down four courses of bricks, and then terminated abruptly (*m*, fig. 3.). The three external courses of bricks above this crack were new, and projected out much farther than the others, to form the cornice of the wall. Whether the bricks of the old cornice had been damaged or thrown down by the stroke, we could not learn with certainty; but the general report among the people we consulted was, that they had not, and were only taken down to extinguish the fire: this opinion seemed probable from the want of marks on the hip-pole which projected out with the cornice, and the appearance of such strong effects of lightning on the wall-plate which lay within any part of the projection; whence it might be concluded, that the lightning passed within the cornice, and no where through it. Between the bottom of the wall-plate, and the top of the crack where it appeared to begin at the foot of the cornice (*m*, fig. 3. and 8.), lay two inner courses of bricks (*o* and *p*, fig. 8.) covered by the cornice. Some damage had evidently been done to the bricks in this part, though we could not distinctly trace the progress of the lightning through them.

ELEVATION of the SOUTH END of EA
with the Wall of the LEAN-TO, and
part of the SOUTH FRONT.

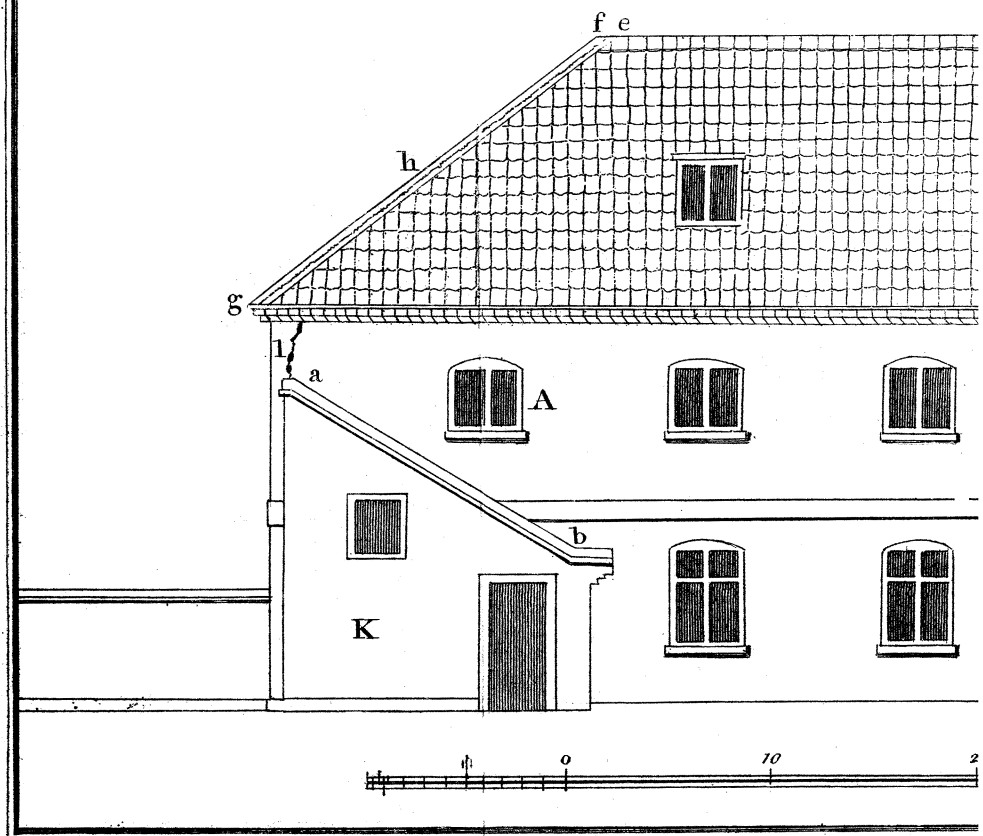
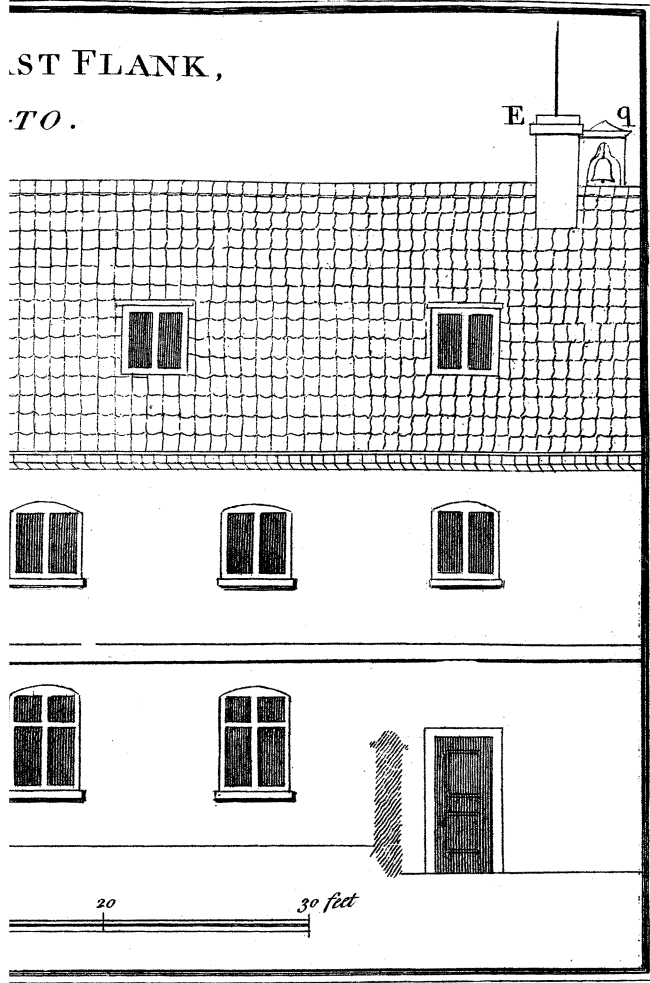
Fig. IV.

Beneath the east edge of the wall-plate, and separated from it in like manner by two courses of bricks, a similar crack descended from the bottom of the cornice (*l*, fig. 4. and 8.) on the east face of the corner, and went through ten courses of bricks till it reached the top of the wall that supported the stable. Here the three bricks next the house, it is said, were shivered into pieces as small as nuts, but not thrown off (*c*, fig. 10. and 11.). The cracks in the bricks on both faces of the

About seven feet from the stricken corner of the building, and almost two feet from the nearest part of the roof of the stable, is a window (A, fig. 4. 10. and 11.) being the southernmost of the upper range on the east face of the flank. It has thirty small panes of glass, set in lead. We were informed, that about half of these had been broken by the accident, chiefly on the side next the corner ; and that the fissures ran in general horizontally, nearly parallel. Very little, if any, of the glass was forced out. As we could not discover any trace of the lightning directly toward this window, a suspicion arose, whether it might not have been broken rather by the general concussion than by any immediate stroke.

Having examined all the marks that appeared between the bottom of the stricken hip and the ground, our next inquiries were directed to the top of the hip (*f*, fig. 2. 3. 4. and 11.). Here the upper plate of lead (*e*, fig. 4.) which served as a capping to the junction of the hip with the ridge of the roof, being taken off, we found, on its under surface, three distinct marks of fusion ; and on the upper surface of the sheet of lead which it covered three corresponding marks, so exactly similar, that the two surfaces of lead seem to have touched one another in a melted state. These fused spots are just in the bend of the lead,

lead, answering to the obtuse angle formed between the hip and the roof (*f*, fig. 4.). We obtained leave to bring away both the pieces of lead, and now present them for your inspection. The workmen who examined the timber underneath reported, that it was not damaged; nor were any other signs of the lightning perceived in the whole length of this strip of lead from the top to the bottom of the hip. In the pieces of lead which exhibit the melted spots on one surface, the other surface is perfectly clear of all marks, though the latter was, in the uppermost plate of lead, that which had lain exposed to the clouds. Neither of them is melted to any depth into the substance of the metal.

ELEVATION of part of the EAST F
with the adjoining LEAN-TO.

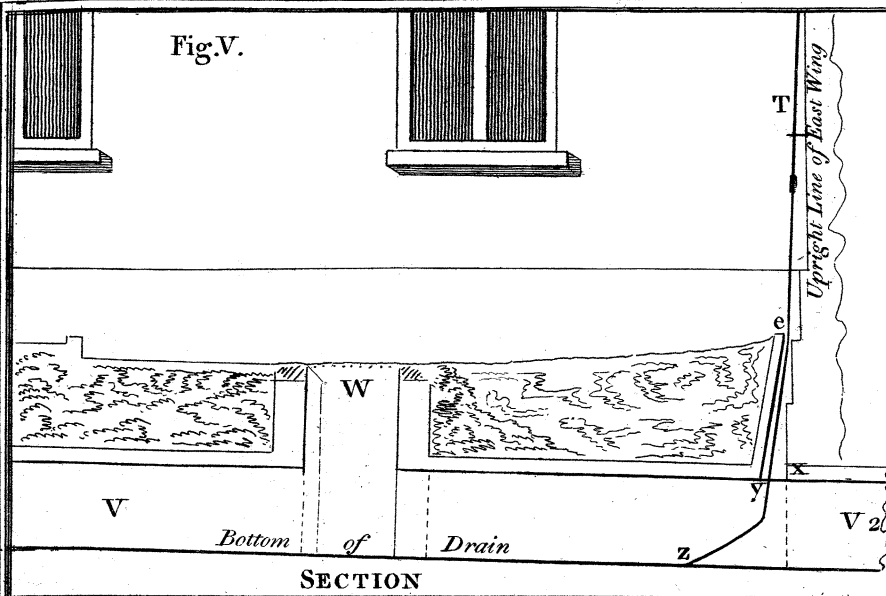
Fig.V.

ultimately terminated in contact with the bricks at the bottom of it (at z , fig. 5. and 7.). This conductor, therefore, in its passage downward, did not communicate, till it reached the bottom of the drain, with any thing better able to carry off electricity than masonry or timber; for the iron-staples fastening it to the wall, and the lead lining the valley, were themselves in contact with such substances only.

D, it terminated in the drain. (see the general plan, fig. 1. and 2, fig. 5.), a small bright spot appeared on one of the angles. As some suspicions were entertained, whether this mark might not have been occasioned by the lightning, we cut off the end of the rod, and have brought it hither for public examination.

Where this conductor entered its channel at the corner of the court (see T, fig. 1. and e, fig. 2. and 5.), the ground is raised so much above the grate of the sink (W, fig. 1. and 5.) that, though the court was overflowed, it is not probable, the water could have risen high enough to run into the channel (at e, fig. 5.), and so communicate with the conductor before it reached the drain.

SECTIONS and PLAN of the
of the Conductor at the South
of the BUILDING

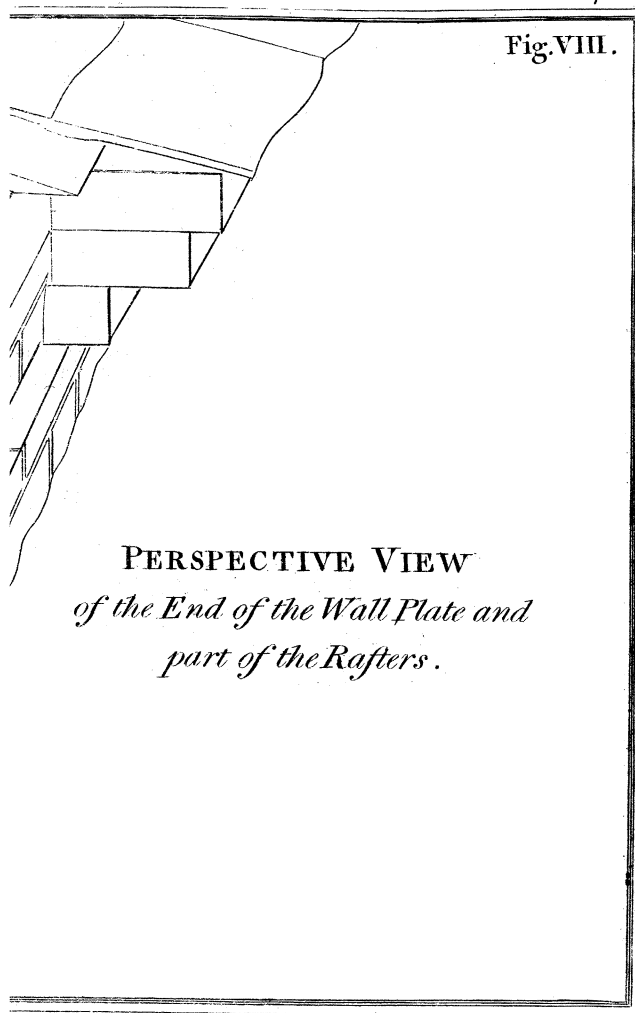
Fig. VIII.

driven into the timber making the tie of the angle, through the bevelled end of the hip-rafter, just without the part where the tenon of the latter is received into the mortise of the former (*a*, fig. 8.). Here it was that the fire seemed to have begun, though neither the holdfast itself, nor the hip-pole resting upon it, shewed any signs of the lightning. From the place into which this holdfast was driven (*a*, fig. 8.) to the outer end of the angle tie (*b*, fig. 8.) there was a considerable loss of substance, occasioning a large hole; but the sides of the hole within were so smooth, and so little charred, shewing plainly the grain of the wood, that it was scarcely possible to suppose the whole had been *burnt* out; we conjectured, therefore, that a large splinter had been forced off by the lightning at this place, and, in the same moment, the tenon of the hip-rafter set on fire where it enters the mortise. Indeed, unless some opening had been made by forcing out such a piece, it does not appear how the fire could have burnt, for want of air, in a part that is always so closely joined by builders: and yet, in this confined place, the tenon of the hip-rafter was so far consumed, that a ruler could be thrust in, almost to the further extremity of the mortise. From this spot the flame seems to have issued out eastward, between the tie of the angle and the wall-plate (*c, c*, fig. 8.) scorching all the timbers it could reach, and setting fire to the laths; but the mischief it had done was very trifling (see fig. 8.).

Just beneath the abovementioned hole at the end of the angle-tie (*b*, fig. 8), is the extremity of the wall-plate which lies upon the eastern wall of the east flank (*d*, fig. 8.). The end of this wall-plate was rent in a remarkable manner (*e, e, e, e*, fig. 8.), and several of the fissures were continued some way upon the sides (*d* and *f*, fig. 8.). Though the other timbers we have

mentioned are of fir, the wall-plate is of solid oak; and the violence done to its extremity was such, that we could not doubt but it had been occasioned by the lightning.

PERSPECTIVE VIEW
of the End of the Wall Plate and
part of the Rafters .

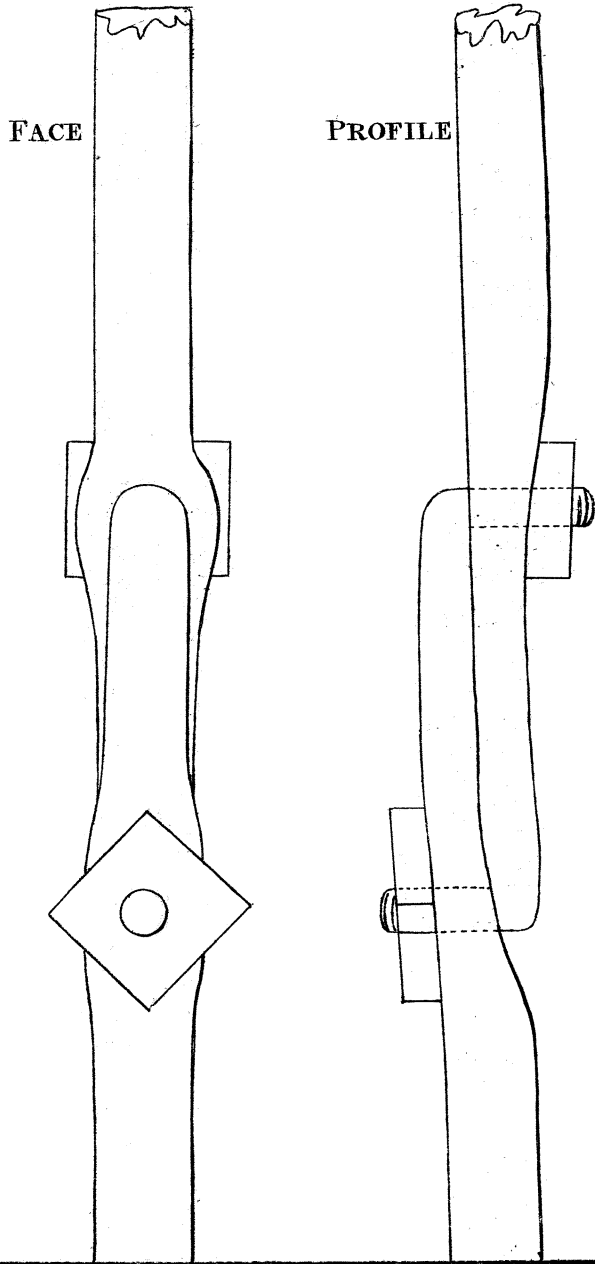
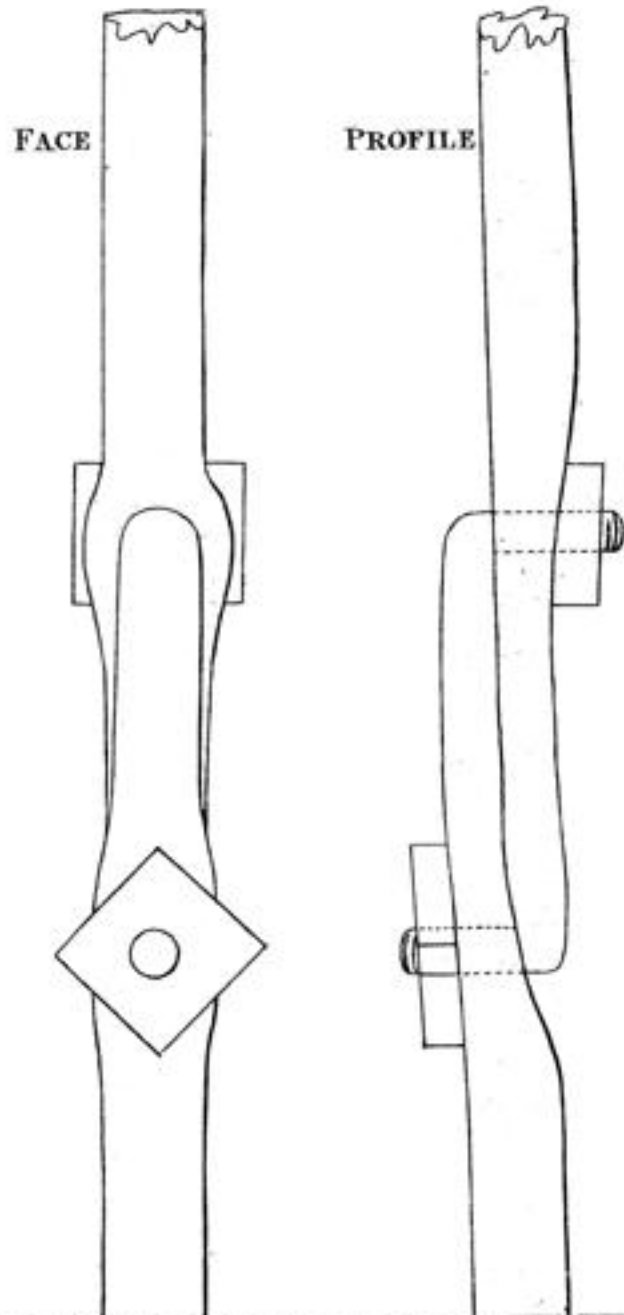
Fig. XII.

just rounded off. These conductors were continued down the building by a succession of similar bars of iron, in general from six to eight feet long, joined to one another by two hooks and nuts (see fig. 12.); that is, the corresponding ends of each bar being formed into a hook bent at right-angles, the hook of the uppermost went into a hole of the lowermost, where it was fastened with a nut, and the hook of the lowermost went into a similar hole of the bar above, where it was fixed in the same manner; the length of each of these joints, from nut to nut, was about two inches.

*FULL SIZE of the CONDUCTORS,
shewing the manner of their being jointed.*

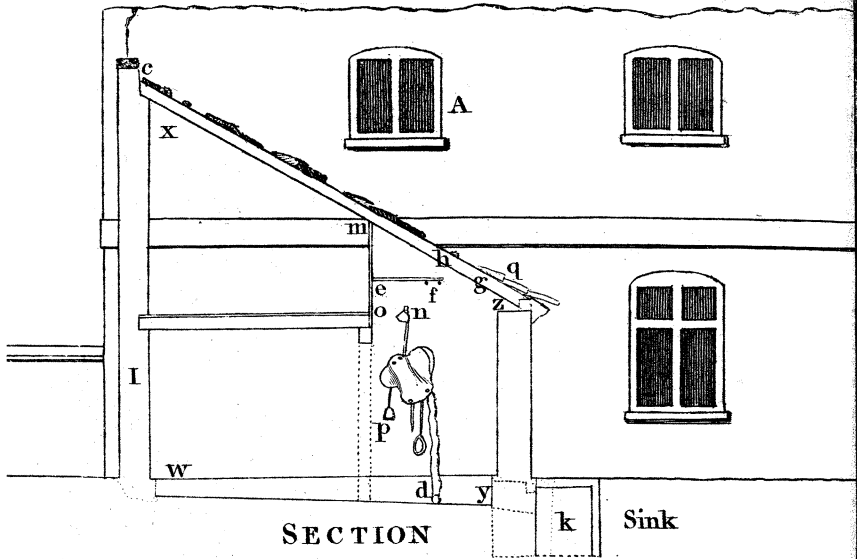
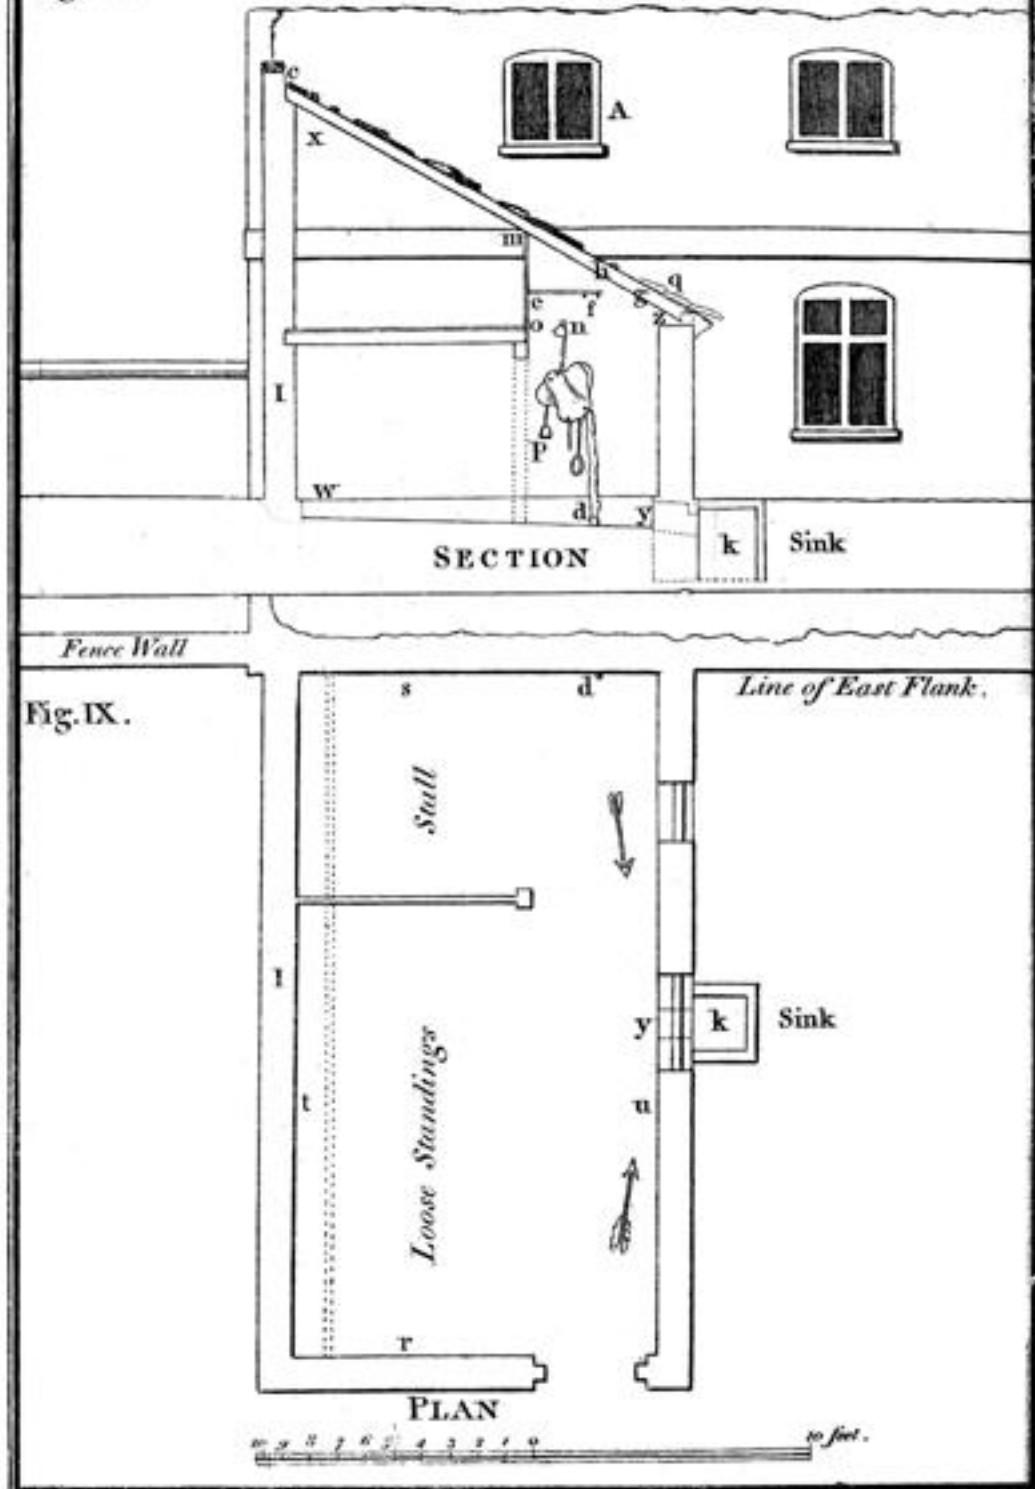
Fig. X.

The stable in its inside is 25 feet long (from *r* to *s*, fig. 9.), 13 feet broad (from *t* to *u*, fig. 9.), 15½ feet high on its south side (from *w* to *x*, fig. 10.), and 7½ feet on the north (from *y* to *z*, fig. 10.). At the west end is a stall for one horse (*s*, fig. 9.). Near the middle of the north wall is a drain (*y*, fig. 9. and 10.), which terminates just without the wall in the garden (*k*, fig. 9. and 10.). Against the west end of the stable, a shelf (*e, f*, fig. 10.) was supported by two nails underneath (*f*, fig. 10.). Seven inches and a half below this shelf was a nail, on which the saddle hung by one of its stirrups (*n*, fig. 10.). The breadth of the shelf was near one foot and an half; its length

length (from *e* to *f*, fig. 10.) two feet five inches; and the pantiles seem to have been displaced a little farther down on the roof (*g*, fig. 10.) than the line corresponding perpendicularly with the north end of the shelf (*b*, fig. 10.). Neither the shelf, nor the nails supporting it, which were both near its north end, shewed any signs of injury; whence it may be conjectured, that if the lightning took its course this way, it passed obliquely between the saddle and the roof, so as to miss the edge of the shelf, leaving it to the southward. The upper part of the south side of the stable was boarded off from the rest, to form a hay-chamber, which occupied so large a portion of the roof (from *x* to *m*, fig. 10.), that the boards of the perpendicular partition (at *o*, fig. 10.) came within ten inches of the nail on which the saddle hung. These boards were fastened to the uprights of the partition, all the way down from the roof, by nails about six inches asunder, consequently some of those nails must have been within ten inches of the stirrup-iron as it hung on the nail in the wall (*o* and *n*, fig. 10.). No tokens of the lightning could be discovered on those boards, or the nails fastening them; we could not, therefore, be certain, whether any part of it had passed that way. The nail which supported the saddle was equally free from marks; but one of the stirrup-leathers was much torn and burnt, and a large piece of the leather was stripped off the seat of the saddle, besides other damage done to it in that part. One of the stirrup-irons, likewise, exhibits some appearances of fusion on the arch through which the stirrup-leather passes. This iron, as well as the stirrup-leather, being the only damaged parts of the saddle that remained, we have brought for your inspection.

Ft.	In.
From the nails supporting the shelf in the stable (at <i>f</i> , fig. 10.) to the nearest nails of the pantile laths of the roof (about <i>b</i> , fig. 10.)	1	3
From the south end of the shelf (<i>e</i> , fig. 10.) to the roof over it (<i>m</i> , fig. 10.)	2	1

N. B. The south end of the shelf was fixed to the partition-boards of the hay-chamber (<i>e</i> , fig. 10), and the two nails under its north side (<i>f</i> , fig. 10.) were $5\frac{1}{2}$ inches apart.		
From the nearest of the nails supporting the north end of the shelf (<i>f</i> , fig. 10.) to the nail on which the fiddle hung (<i>n</i> , fig. 10.)	0	8
Length of the stirrup-iron below the nail (<i>n</i> , fig. 10.)	0	$3\frac{1}{2}$
Length of the stirrup-leather, from the stirrup-iron to the seat of the fiddle	1	9
Breadth of the seat of the fiddle	0	8
Distance from the lower side of the seat, as the fiddle hung, to the bottom of the lowest stirrup-iron (<i>p</i> , fig. 10.)	2	0
Distance from the lowest stirrup-iron (<i>p</i> , fig. 10.) to the floor of the stable (near <i>d</i> , fig. 10. and 9.)	3	6
		As

As the saddle was thus placed by recollection, the girths reached from it to the ground (*d*, fig. 10. and 9.); but neither these girths, nor any other part of the saddle, except one stirrup-iron, one stirrup-leather, and the seat, were said to have been damaged by the accident:

PLAN and SECTION of the Stable Lean-to.

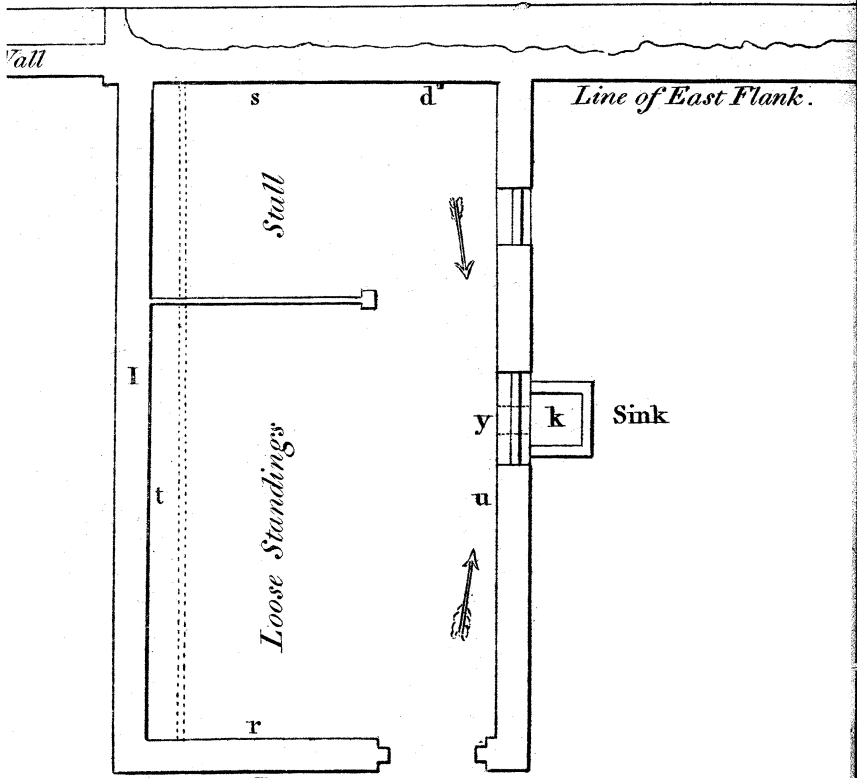
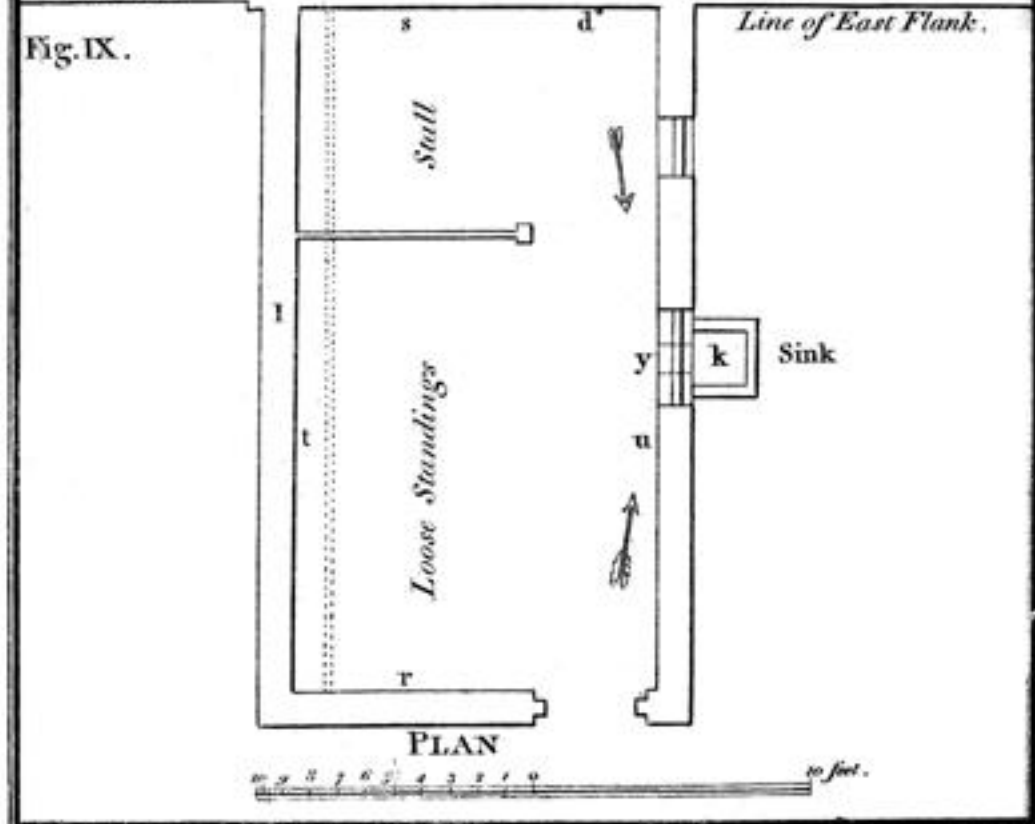
Fig. IX.

From the quantity of rain which fell in the thunder-storm, the stable was overflowed with water, which gradually sunk into the drain (at *y*, fig. 9. and 10.). The leather stripped off the seat of the saddle was found in the stable near this drain; whether thrown there originally, or carried by the water, is uncertain. From the point of the floor immediately under the saddle, to the nearest part of the drain, was about $12\frac{1}{2}$ feet; the width of the drain (*y*, fig. 9.) 14 inches; its length through the wall to the edge of the hole or sink into which it discharges itself 18 inches, and the depth of the sink from the bottom of the drain about one foot and an half. As this sink was merely a hole, without any drain leading *from* it, and was bricked at the sides, the water could not pass off by the drain of the stable any faster than it could soak through the loose soil at the bottom of the sink. And it is evident, from this construction, that the earth under the sink will usually be some of the wettest near the building, and be impregnated with salts from the stale of the horses.
