XXII. *Proceedings relative to the Accident by Lightning at Heckingham.*

Report of the Committee.

PURSUANT to your resolution, appointing us a committee to examine the House of Industry at Heckingham in Norfolk, which had been struck by lightning although it was armed with conductors, we arrived there on the 21st of January. Seven months had then elapsed since the accident, yet we had the satisfaction to learn, that no material changes had been made in the conductors or the building in that period; some laths that had been burnt, some bricks and pantiles which had been damaged or thrown down, were replaced; but we found means to procure distinct information of those repairs from the workmen who had been employed to execute them. In order to communicate a clear idea of the accident, it will be necessary to premise a general account of the building; then to represent the manner in which the conductors were applied; and, lastly, to describe the stroke of lightning, with its effects.

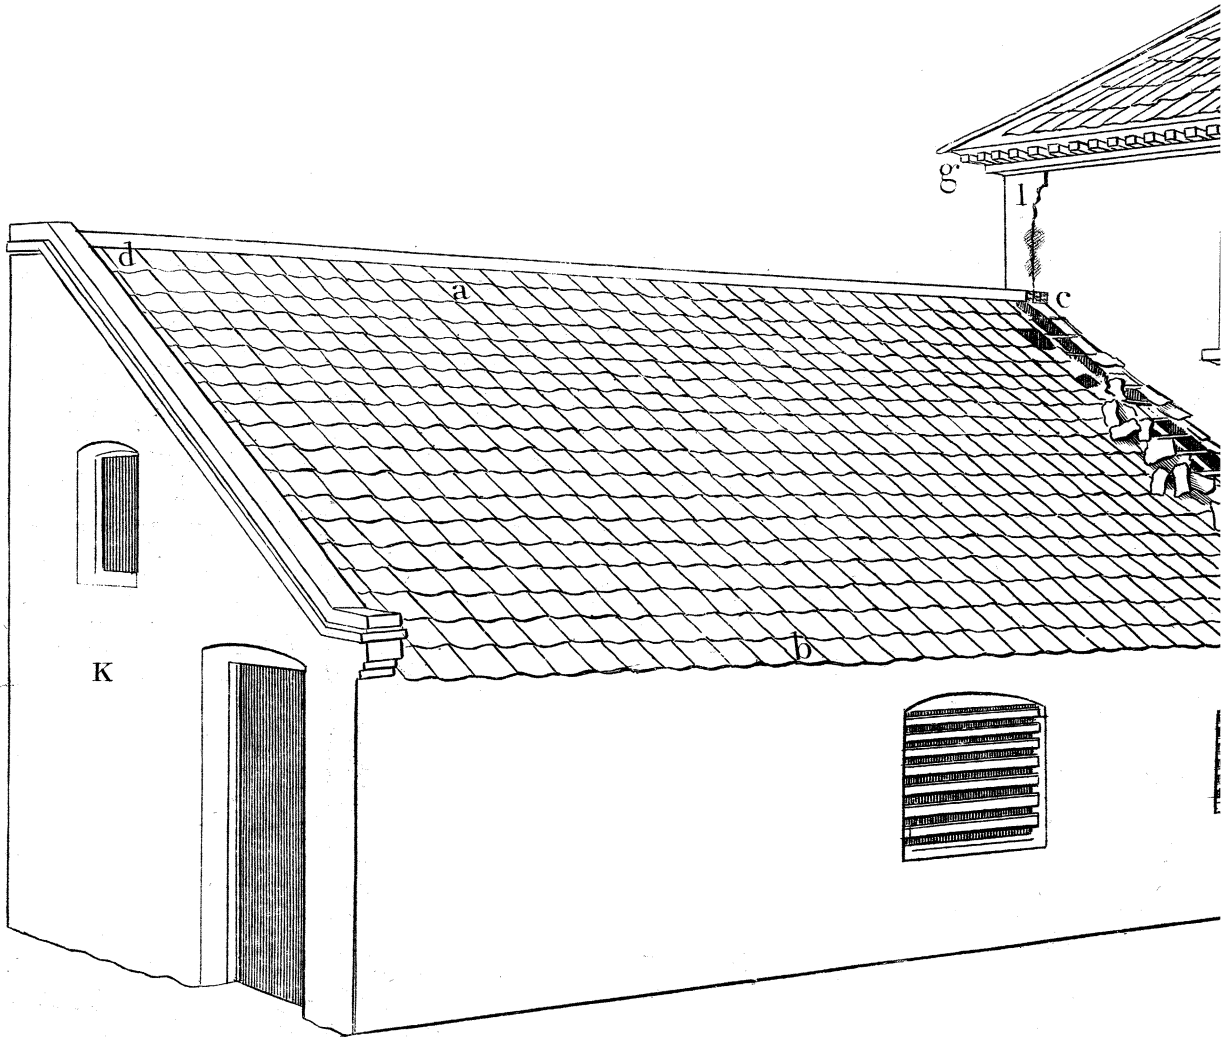
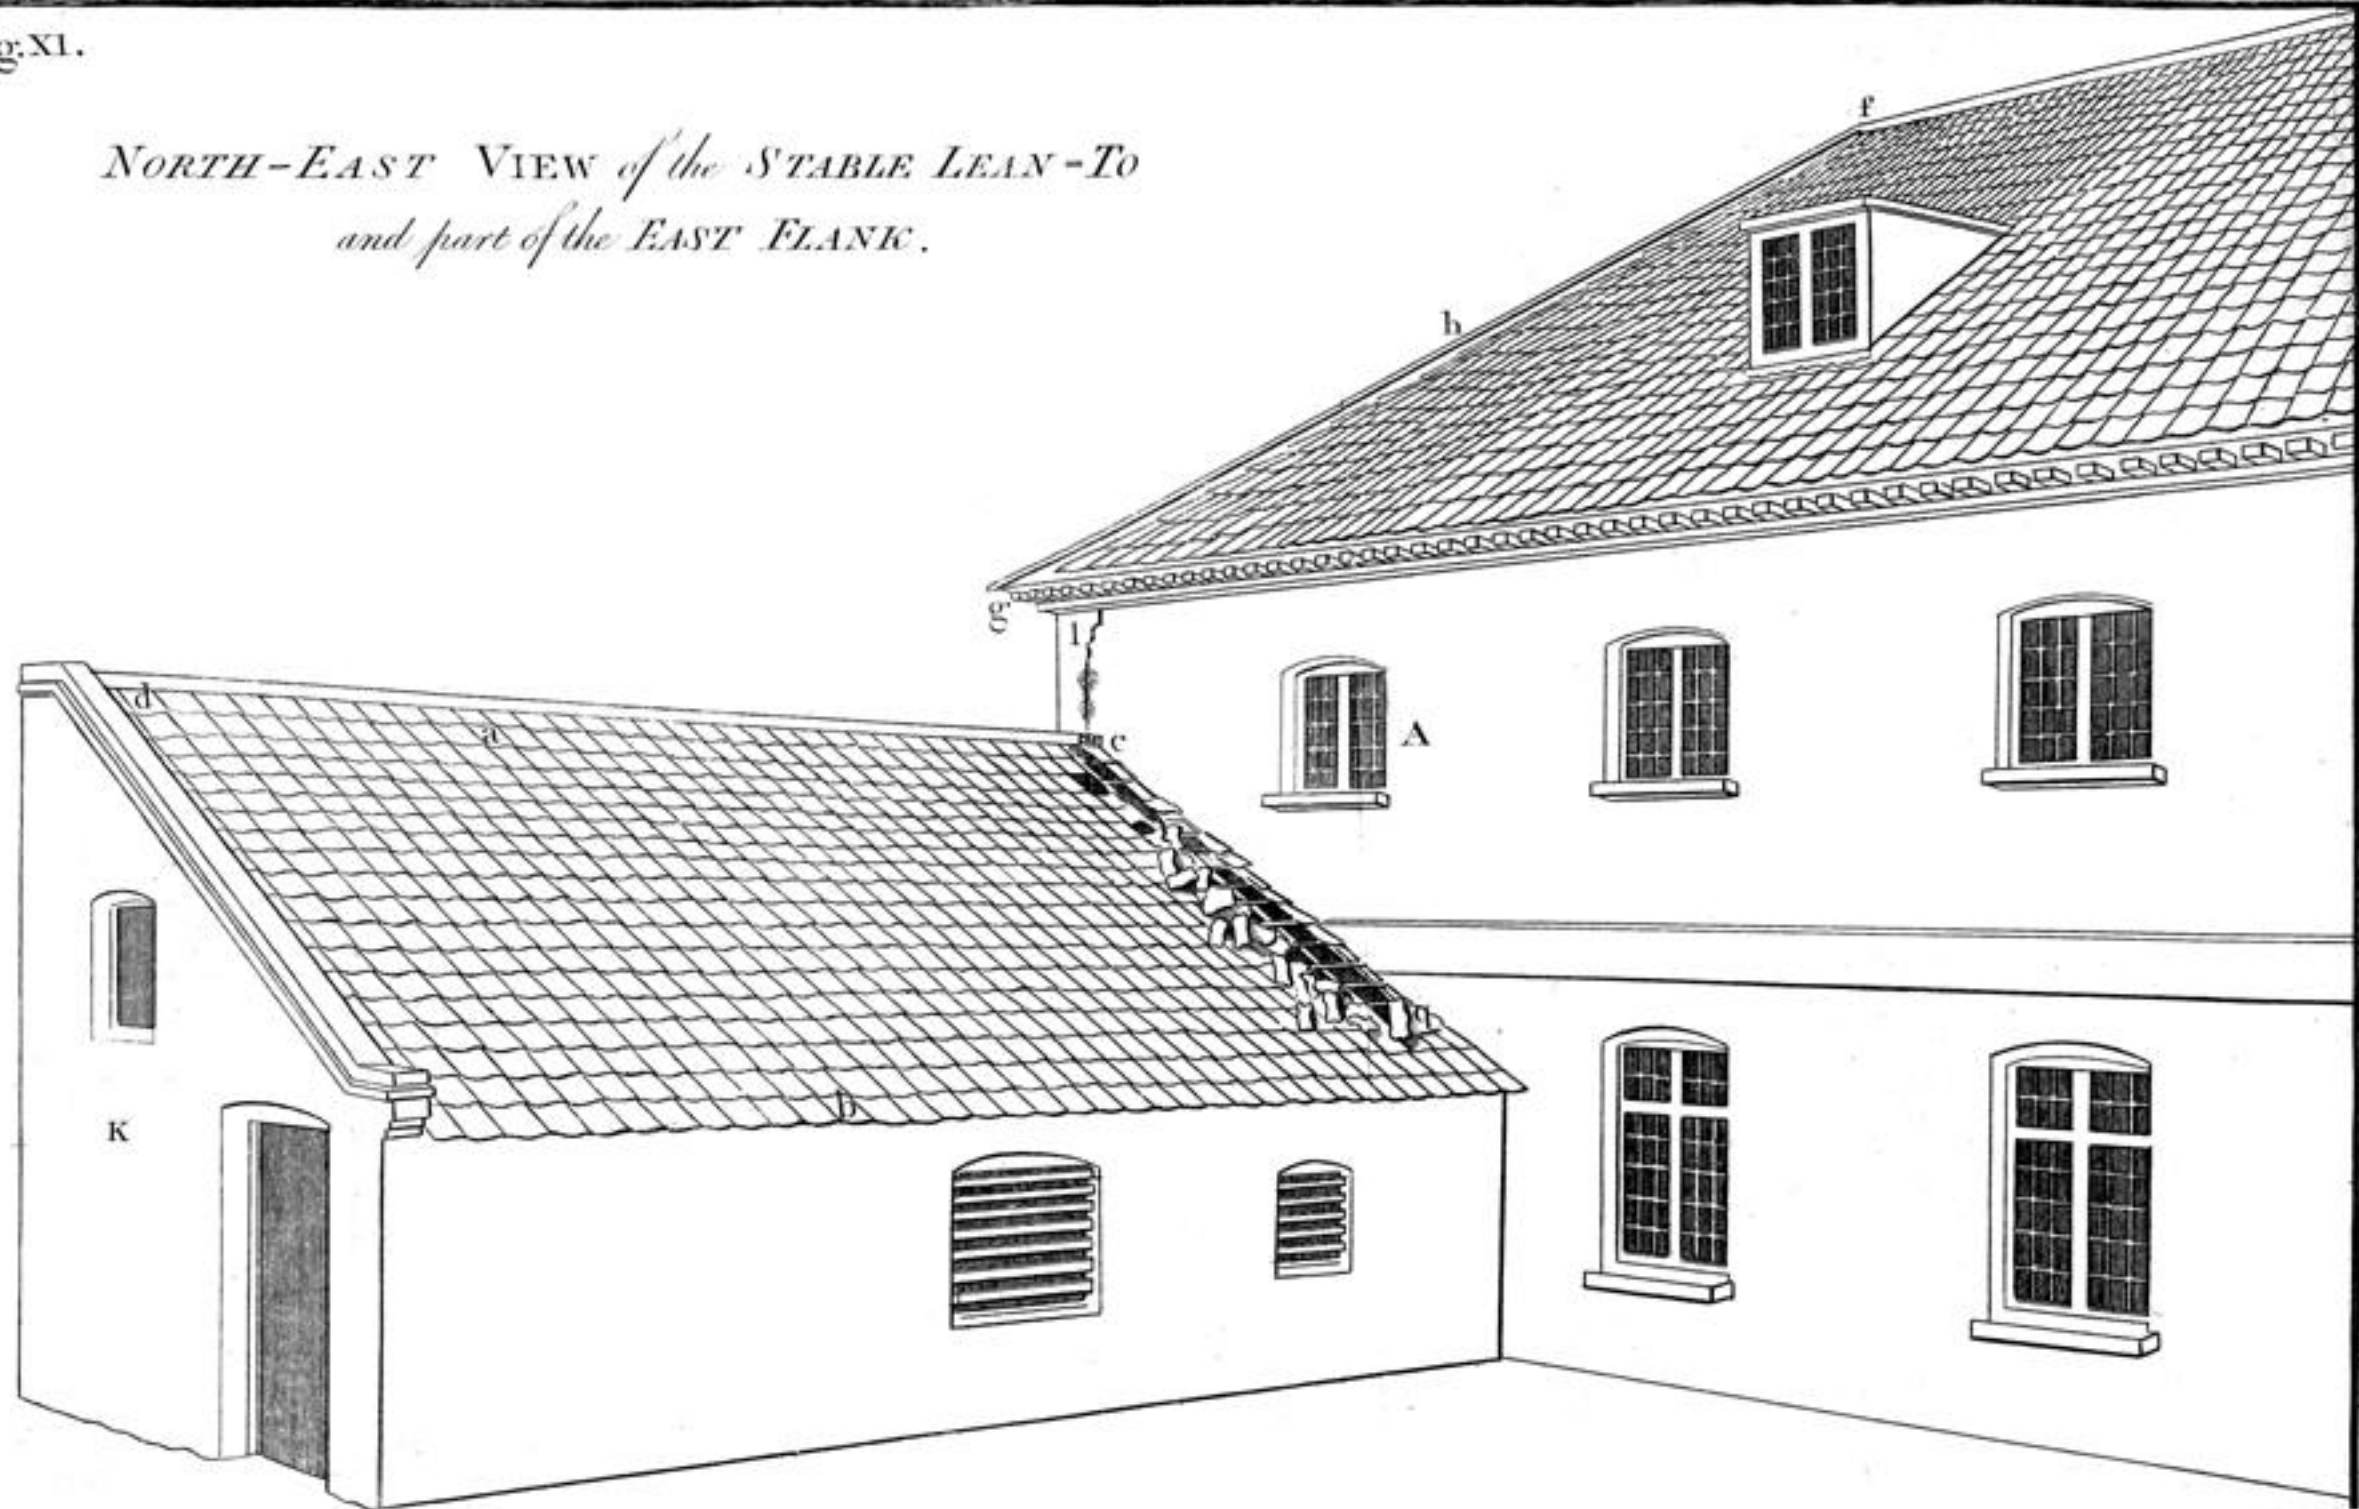
Fig.XI.

Beginning from these three shivered bricks on the top of the wall, three courses of pantiles on the roof of the stable, in the direction downward, were in great measure broken or displaced, except about two feet of the lower end of the courses, near the eaves, where the tiles remained untouched (see *c, m, g, q*, fig. 10. and *c, q*, fig. 11.). All these pantiles rested upon laths, which were fastened to the rafters of the roof by iron nails about eleven inches asunder. Within the stable, and almost underneath the spot where the damage to the pantiles ceased, a saddle hung, at the time of the accident, by a nail driven into the wall at that west end of the stable, which was also the eastern wall of the east flank of the house (*n*, fig. 10.). As this saddle, being much torn by the lightning, seems to have been the step by which it passed through the stable, the respective situations of all their parts shall be minutely described.

*NORTH-EAST VIEW of the STABLE LEAN-TO
and part of the EAST FLANK.*
