# The Repair of Concrete Structures by Injection With Epoxide Resin†

A. C. ROULIN-MOLONEY\* and A. R. BERCHTEN\*\*

The factors to be considered in selecting a material suitable for the repair of concrete structures are discussed. The repair work of the Zeuzier Arch Dam in Switzerland is described including the special problems encountered in this particular application and the supporting experimental programme.

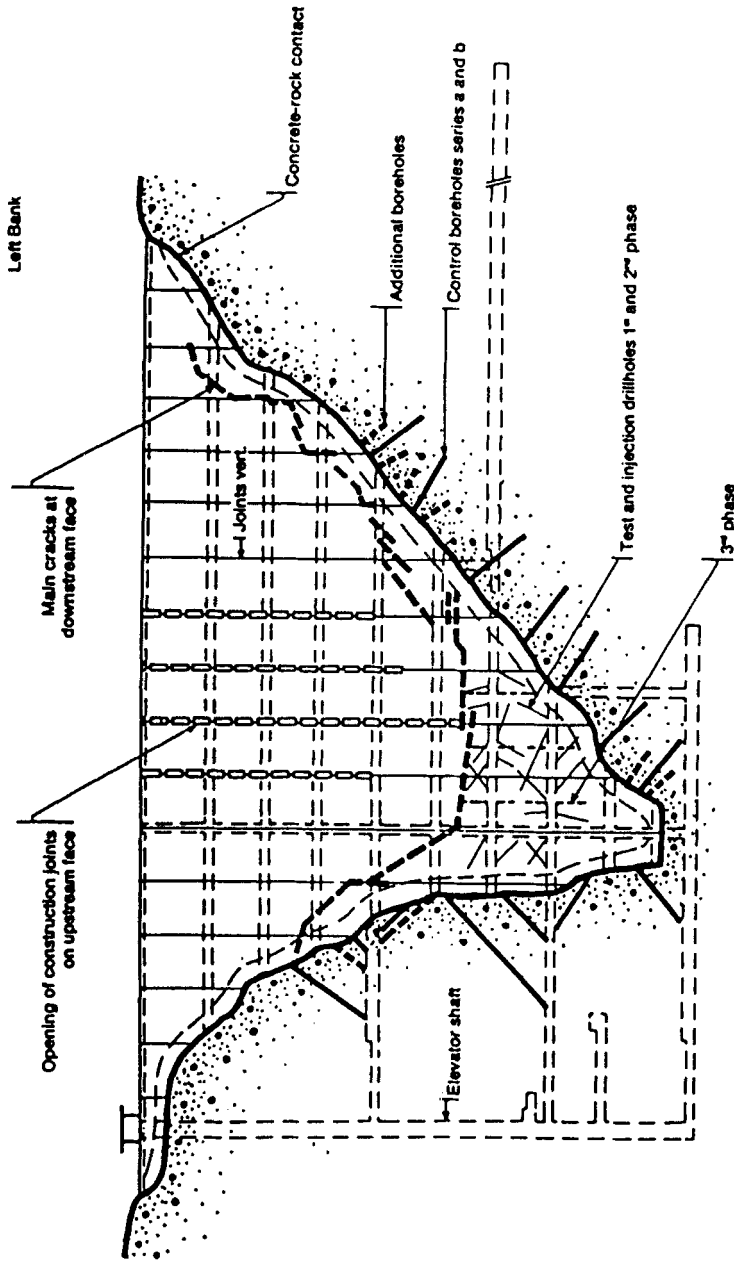
- an opening of the vertical construction joints on the upstream face
- cracks on the downstream face extending locally into the rock abutment
- cracks visible in the inspection galleries essentially towards the abutments.

A schematic diagram of the Dam and the crack network is shown in Figure 1. Extensive investigations as to the causes of the settlement of the Dam were conducted and their results have been published.<sup>4</sup> It was demonstrated that the movements of the Dam were due to a regional settlement caused by the drainage of an exploratory adit for a new motorway tunnel through the Alps. This adit was under construction a distance of 1.5 km. from the Dam and 400 m. lower in altitude than the base of the Dam. It was concluded that a repair of the Dam would be possible if a suitable agent was found. This repair operation was also stimulated by the fact that the Societe de l'Electricite de la Lienne would lose about 6M Sfr. per year by only operating as a "run of river" station rather than accumulating water in summer and generating when demand is high in winter.

FIGURE 1 Schematic diagram of the Zeuzier Arch Dam showing the main crack network and the test boreholes (after Berchten Ref. 5).

The repair was carried out in several stages; firstly, by injection of the cracks visible on the Dam faces and in the inspection galleries. Secondly, by drilling holes 46 mm. in diameter from the inspection galleries and the Dam faces between each vertical joint perpendicular to the axis of the gallery. In total, 228,000 kg. of resin was injected into the Dam during the repair.
