Ultrasonically-Induced Interfacial Changes*

Y.-S. CHAUG and N. ROY

Storage Technology Corporation, Louisville, CO 80028-0001, USA

The ultrasonic wirebond failure mechanism associated with interfacial changes in a thin-film device was studied. The thin-film device was fabricated on a ferrite substrate and composed of a gold layer on top with titanium, nickel-iron and aluminum oxide underneath. The chemical changes at the nickel-iron/aluminum oxide interface, induced by the transfer of ultrasonic energy through the gold and the titanium layers were investigated by Auger electron spectroscopy. The applied ultrasonic energy promoted preferential migration of iron to the interface resulting in weakening of the bond between the nickel-iron and its adjacent aluminum oxide layer.

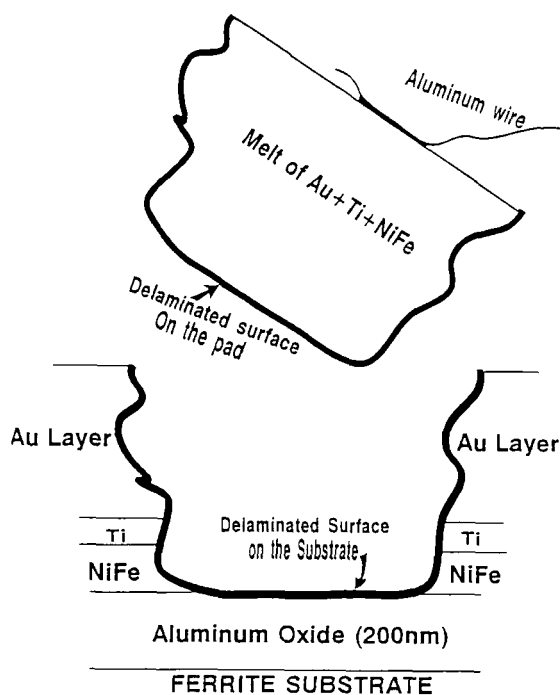
FIGURE 1a The thin-film device structure showing the order of magnitude of thin film layer thicknesses.

FIGURE 1b A schematic presentation of the pad delamination illustrating the “delaminated surface on the pad” and the “delaminated surface on the substrate,” as shown by arrows.

The depth of the pull-out sites was measured with a profilometer. The measurements indicated that the pad delamination occurred at the nickel-iron/aluminum oxide interface. The delaminated surfaces on the pad and on the substrate were examined by an optical microscope. No cratering-defect pattern was found on the delaminated areas.

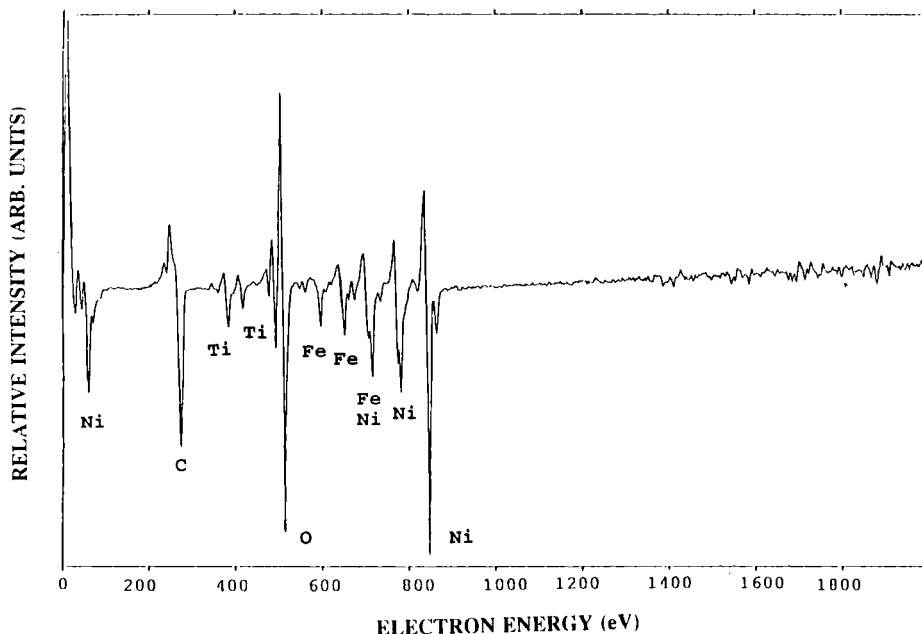
The delaminated surface on the pad was composed of nickel, iron, titanium and oxygen with a small amount of carbon, as shown in the Auger survey spectrum of Figure 2a. The relative Auger intensity ratio of Fe:Ni was much less than 1 and was estimated to be 20 wt.% iron and 80 wt.% nickel, which was identical to that of the nickel-iron film composition. The delaminated surface on the substrate was composed of aluminum, titanium, nickel, iron and oxygen with a small amount of carbon, as shown in Figure 2b. The iron content of this surface was greater than

FIGURE 2a Auger survey spectrum from the delaminated surface on the pad showing the surface was composed of nickel, iron, titanium and oxygen with some carbon. The iron content of this surface was less than nickel. The surface did not contain any aluminum.

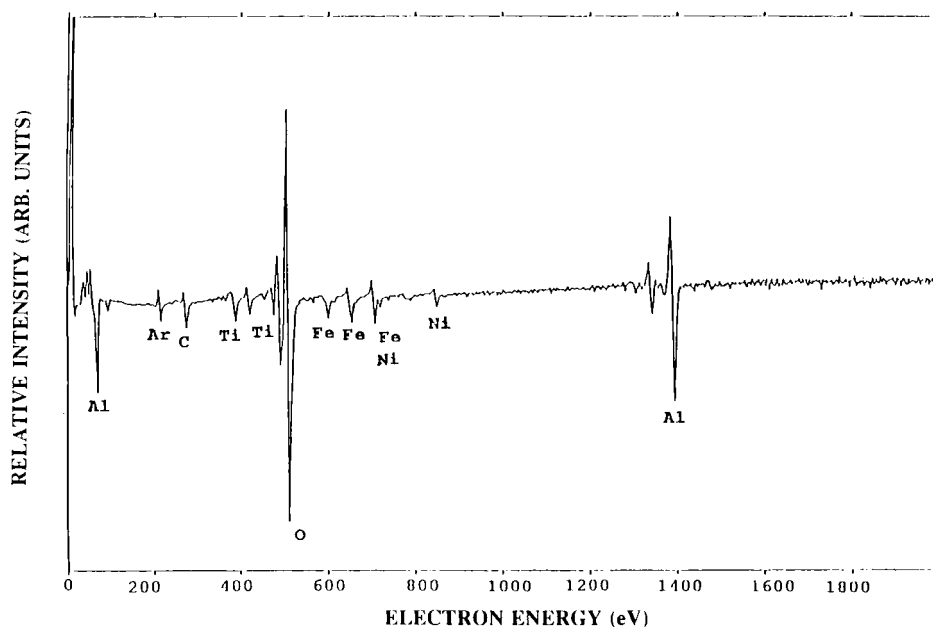
FIGURE 2b Auger survey spectrum from the delaminated surface on the substrate showing the surface was composed of aluminum, titanium, nickel, iron and oxygen with a small amount of carbon. The iron content at this interface was enriched since the relative Auger peak intensity ratio of Fe:Ni was greater than 1.

that shown in Figure 2a. *In-situ* sputter-etching of this delaminated surface on the substrate indicated that the iron-rich film thickness was approximately 40Å.

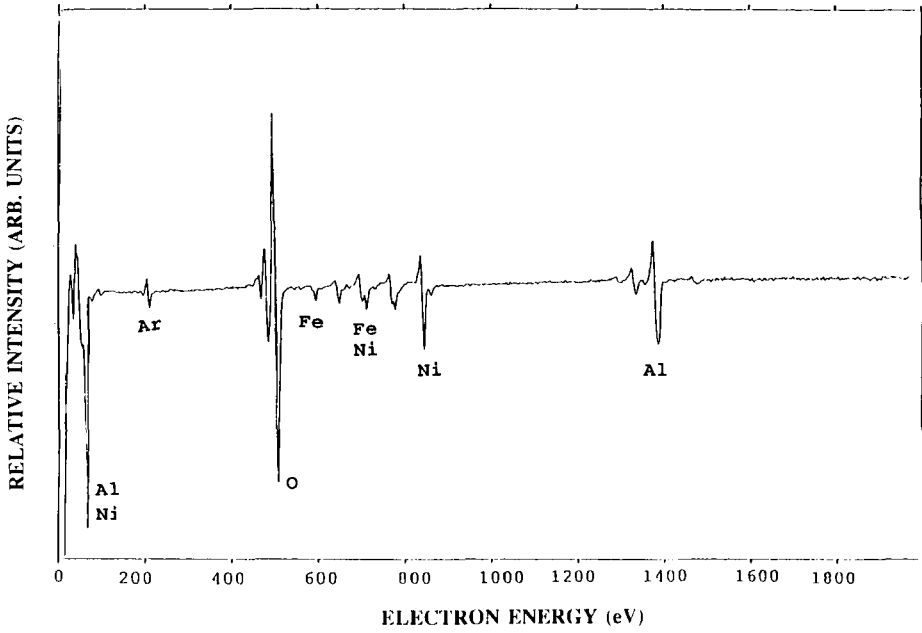
Figure 3 is the Auger general survey spectrum from the nickel-iron/aluminum oxide interface on an area adjacent to a delaminated site. The surface was composed of nickel, iron, aluminum and oxygen. No titanium or any other contaminants were identified on this surface. The relative Auger intensity ratio of Fe:Ni was much less than 1 where the concentration ratio of iron to nickel was estimated to be identical to that of the nickel-iron film (i.e. 20:80 wt. %). No iron enrichment was found at this location.

FIGURE 3 Auger survey spectrum from the nickel-iron/aluminum oxide interface on an area adjacent to a delaminated site. The surface was composed of nickel, iron, aluminum and oxygen. No titanium or any other contaminants were identified on this surface. The relative Auger peak intensity ratio of Fe:Ni was less than 1.

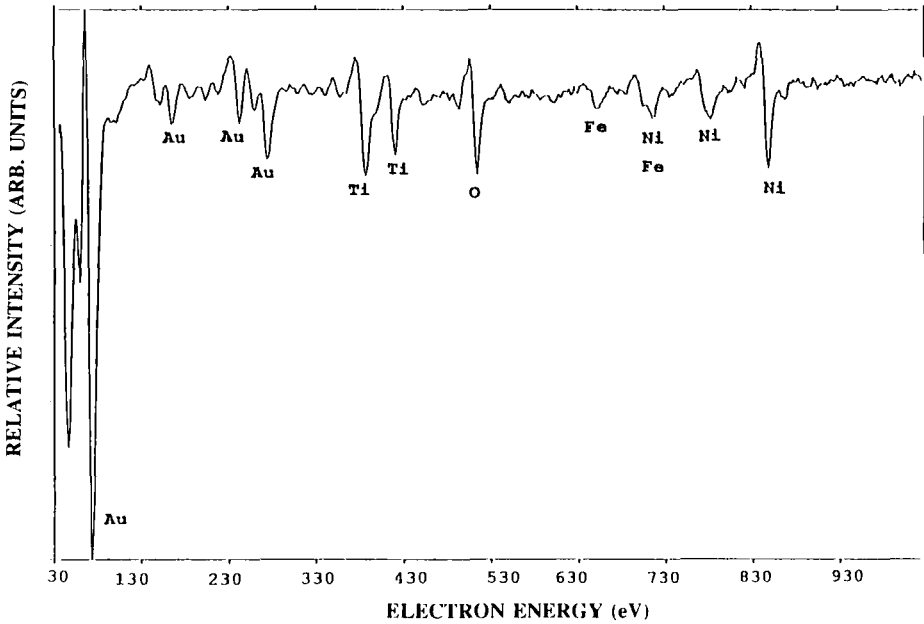
The surface exposed to an ultrasonic bonding operation at the same settings as used for the real bonding process was composed of gold, titanium, nickel, iron and oxygen, as shown in Figure 4a. The nickel-iron/aluminum oxide interface underneath this surface was composed of a mixture of aluminum, gold, titanium, nickel, iron and oxygen, as shown in Figure 4b. The iron content at this interface was high.

FIGURE 4a Auger survey spectrum from the site treated with ultrasonic energy having the same wirebond settings as used for the real bonding process. The surface was composed of gold, titanium, nickel, iron and oxygen.

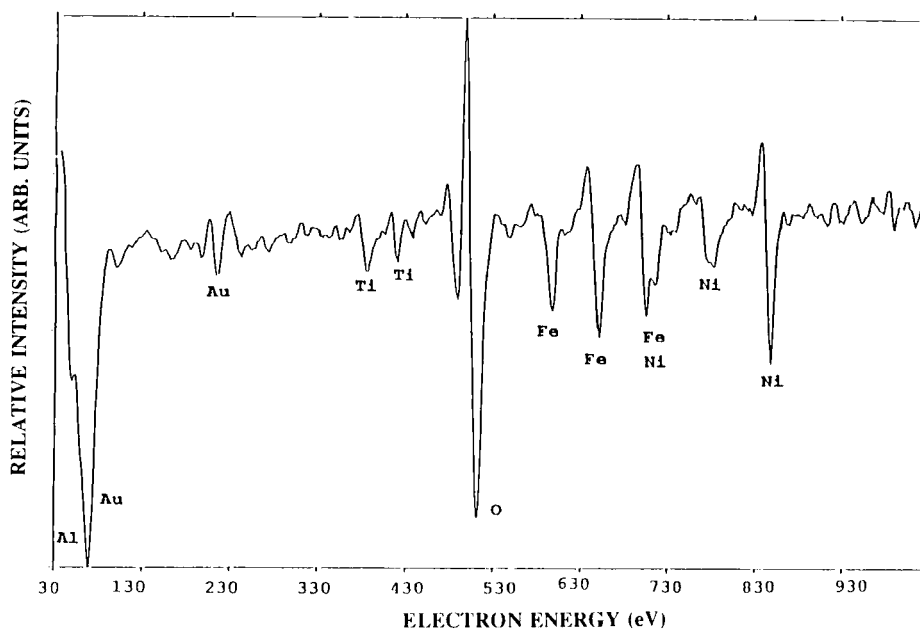
FIGURE 4b Auger survey spectrum from the nickel-iron/aluminum oxide interface of the test site as described in Figure 4a. The surface was composed of a mixture of aluminum, gold, titanium, nickel, iron and oxygen. The iron content at this interface was high, with the Auger peak intensity ratio of Fe:Ni at ≈ 1 .

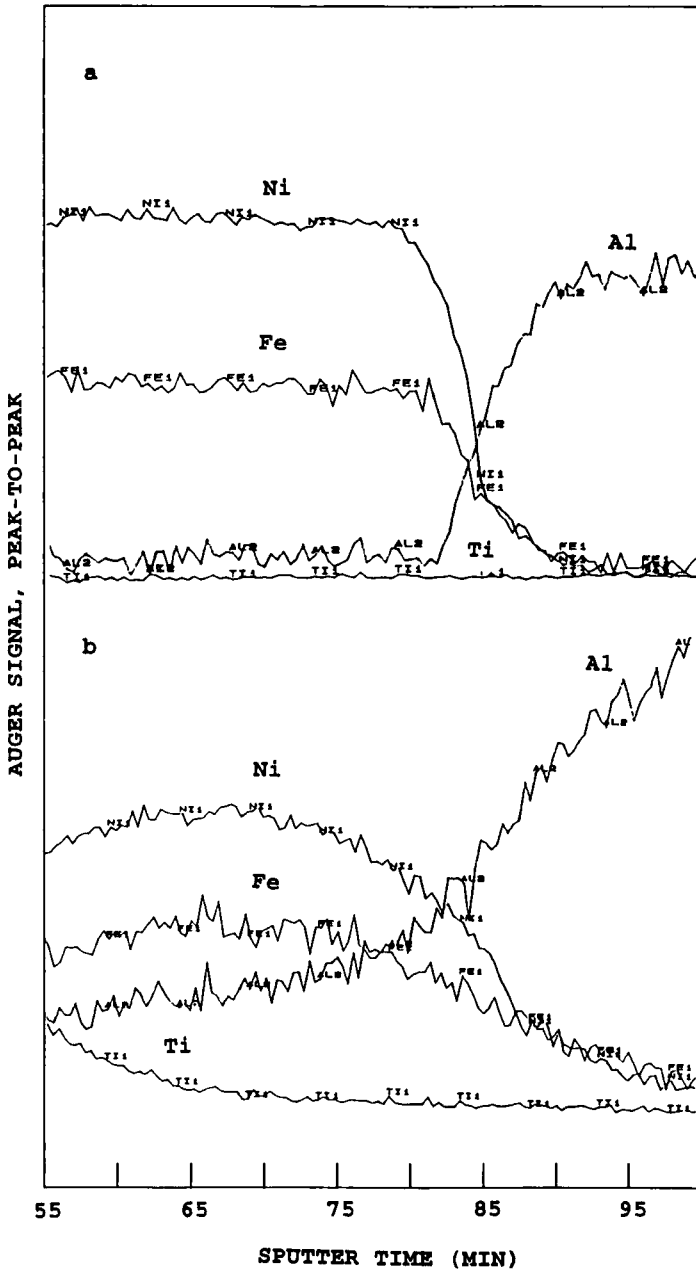
Figures 5a and 5b show the depth profiles at the site where ultrasonic energy was not applied and at the site where the ultrasonic energy was applied at lower settings, respectively. After *in-situ* sputtering of the sample for 55 minutes, the concentration depth profiles showed the presence of titanium in the nickel-iron region only at the site where the ultrasonic energy was applied. This is shown in Figure 5b, indicating that the titanium diffusion into the nickel-iron film was induced by the application of the ultrasonic energy. The nickel-iron/aluminum oxide interface

boundaries could be referenced by the variations of the aluminum intensity. This boundary started at 84 minutes sputter time for the untreated site, whereas it started at 70 minutes sputter time for the treated site. The relative Auger iron signal and the nickel signal decreased within the interface region for the treated site. However, in Figure 5b the ratio of the Auger signal of iron to nickel increased within this region. In order to intensify the variation in the iron concentration across the nickel-iron/aluminum oxide interface, the intensity of the Auger iron signal relative to that of the nickel was calculated by the ratio of the square of the iron intensity to the nickel intensity, *i.e.* $I_{\text{Fe}}^2/I_{\text{Ni}}$.

FIGURE 5 (a) Auger depth profile from the site with no ultrasonic application. Note that there was no titanium detected at the sputter time of 55 minutes. The Auger aluminum signal was detected at the sputter time of 84 minutes. (b) Auger depth profile from the site where the low energy ultrasonic was applied for a longer duration. The Auger titanium signal was identified at the sputter time of 55 minutes. The appearance of the Auger aluminum signal at 70 minutes sputter time indicated an interdiffusion between the nickel-iron film and the adjacent aluminum oxide film took place.

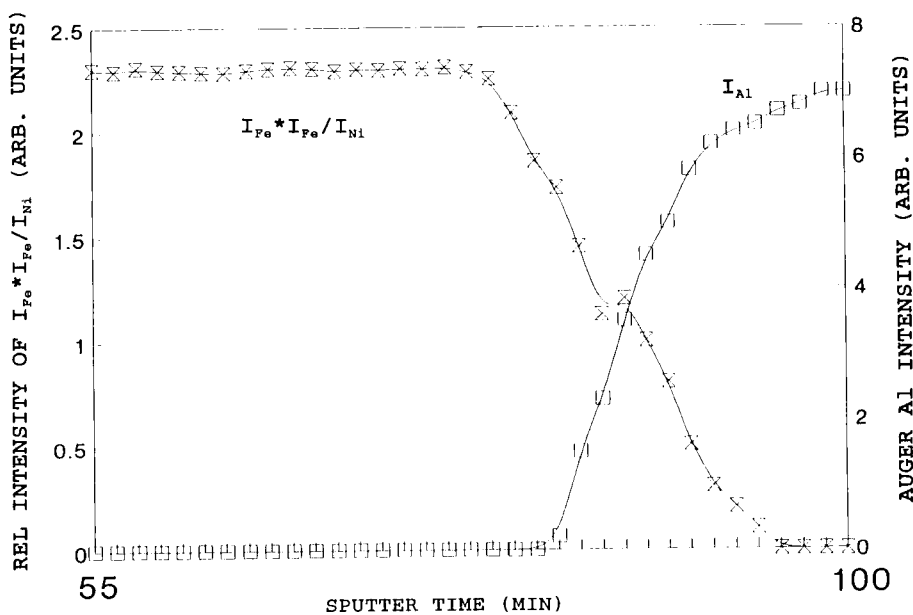
Based on the data in Figures 5a and 5b, the relative intensity of the Auger iron signal to nickel and the intensity of the Auger aluminum signal were plotted in Figures 6a and 6b. Comparison of Figure 6a with Figure 6b shows that the Auger iron signal remained higher and wider within the interface for the treated site.

FIGURE 6a The intensity of the Auger iron signal relative to that of the nickel, and the aluminum signal at the site where ultrasonic energy was not applied. Note that there was a speedy rate of decrease of the relative iron signal within the nickel-iron/aluminum oxide interface.

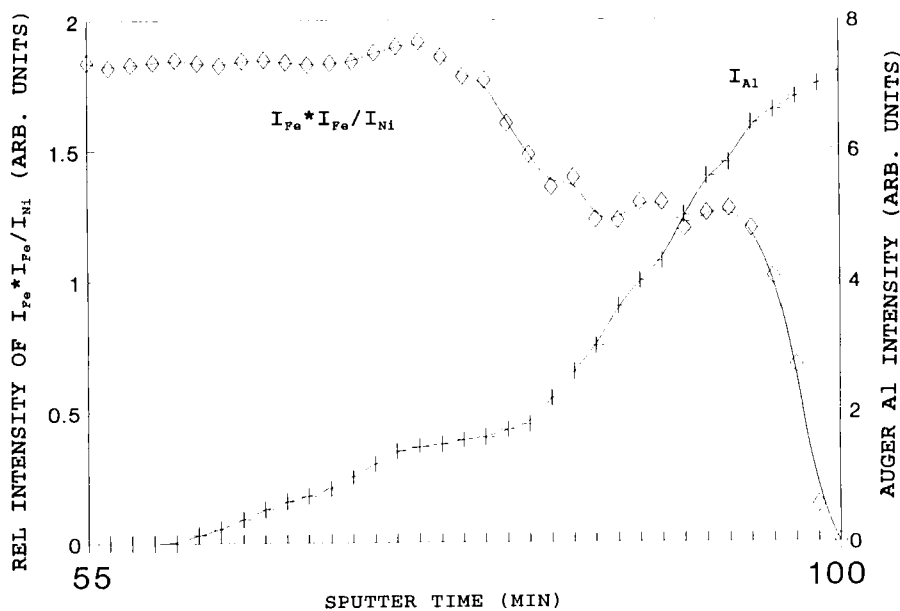
FIGURE 6b The intensity of the Auger iron signal relative to that of the nickel, and the aluminum signal at the site where ultrasonic energy was applied at lower settings for a longer duration. Note that there was a very slow rate of decrease of the relative iron signal within the nickel-iron/aluminum oxide interface, indicating preferential iron migration toward the interface.
