An Engineer Asks: Is it Really More Important that Paint Stays Stuck on the Outside of an Aircraft than that Glue Stays Stuck on the Inside?

L. J. Hart-Smith

Phantom Works, Boeing Company, Huntington Beach,
California, USA

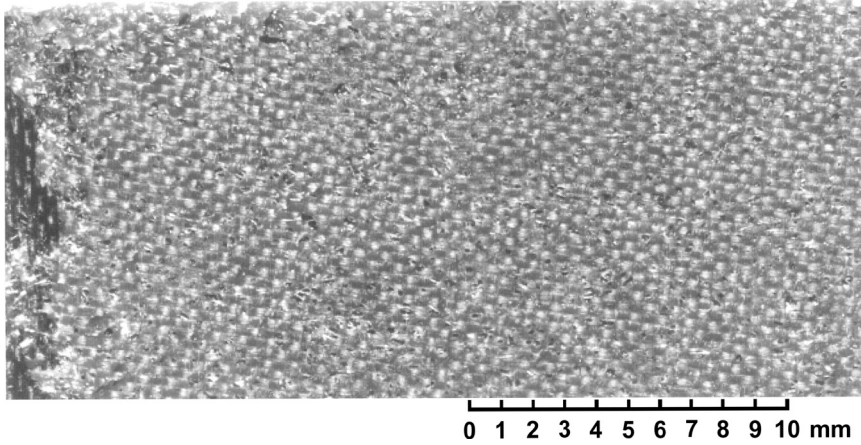
Figure 1 shows a typical peel-ply imprint in a layer of adhesive that had totally separated from the composite surface to which it was believed to be bonded without any visual damage to either the adhesive or the resin in the composite part. In this case, the source of the problem is believed to have been prebond moisture in the cured laminates; in other cases, leaving identical-looking imprints on the surface, the cause has been silicone transferred from released

FIGURE 1 Peel-ply imprint left by failure of adhesive to bond to a composite surface.

peel plies. Significantly, *every* such bond “failure” had remained undetected during initial inspections and, to the best of the author’s knowledge, no such adhesion failures have ever occurred on surfaces that had been prepared by grit blasting. The real wonder is that adhesives or paint *ever* adhere to surfaces created by merely stripping off a peel ply. For the peel ply to strip off cleanly, without causing delaminations between the underlying layers of fibers, it is necessary that the interface

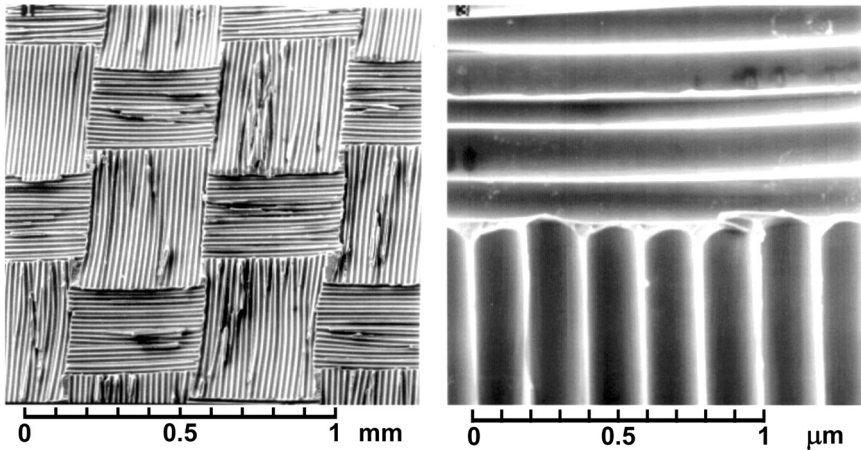
FIGURE 2 Close-up of peel-ply imprint showing slick totally inert bonding surface.

between the peel ply and the resin be totally inert, as is evident in the highly magnified image in Figure 2. Each groove in the photomicrograph on the right is as smooth as glass. And inert surfaces, like dirty glass windows, are notoriously difficult to bond to, unless they are cleaned or etched first. Normally, adhesive and paint will stick to only activated surfaces, not inert ones.

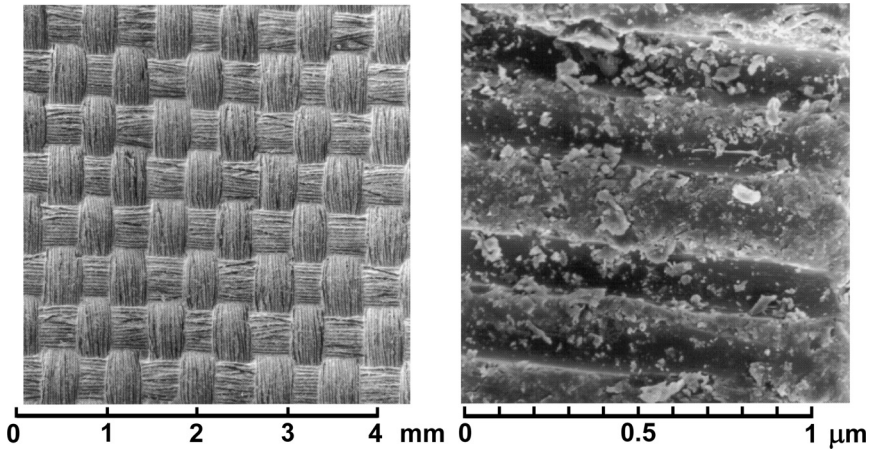
Some researchers have expressed concern about possible damage that might be done to the surface of composite laminates by grit blasting, even with fine grit at low pressure. Although not belittling this concern in the context of overblasting with large grit at high pressure, if this were always a valid concern, should it not apply equally to the widely used practice of paint stripping by low-pressure grit blasting in preference to the use of chemical paint strippers that might well harm the resin in the laminate as well as the environment? Figure 3 shows a lightly grit-blasted carbon-epoxy surface, at two levels of magnification, in which it is clear that not even all of the surface layer of resin has been removed *anywhere*. The imprint of the peel ply is still clearly evident in the left-hand picture, and the pattern of the weave in the underlying carbon fabric (not shown) would be an order of magnitude coarser.

FIGURE 3 Lightly grit-blasted composite surface, retaining imprint of peel ply and showing no damage to underlying fibers.

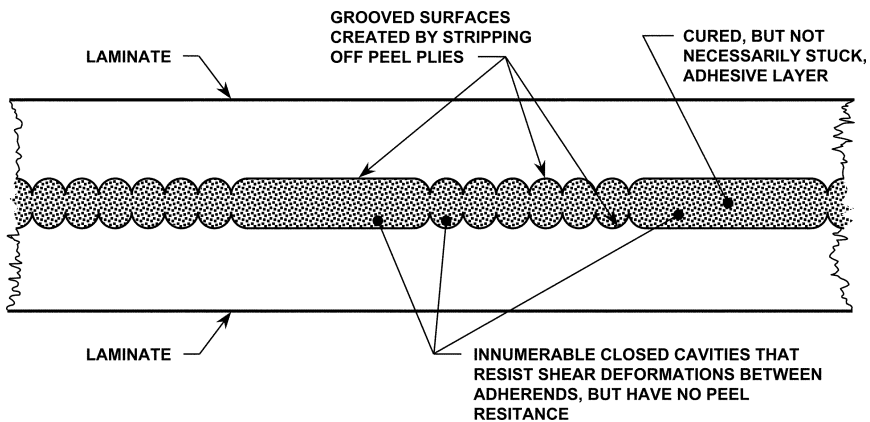
available, whether or not the adhesive remains bonded. The peel-ply texture creates a series of interlocking grooves so that the adhesive does not need to stick to transmit purely in-plane shear loads, which is what bonded joints *should* be designed to do. The texture is characterized schematically in Figure 5 to show how the weave in peel-ply fabrics creates orthogonal ridges that resist shear loads in all directions, like Velcro[®]. The rivets would be too soft to transfer shear loads. And the adhesive could continue to transfer shear loads without even being bonded!

FIGURE 5 Representation of peel-ply imprint showing orthogonal sets of interlocking grooves.

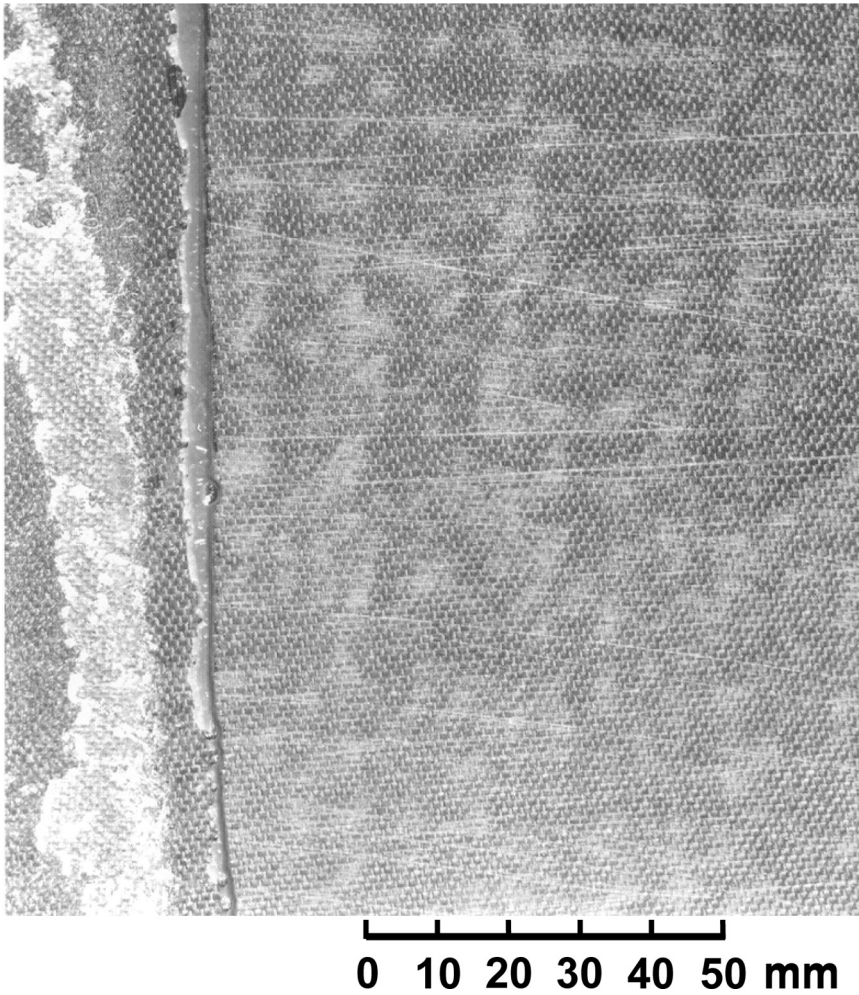
Only some high points were abraded. At the left of Figure 6 is an area where a stiffener was once “bonded.” The lighter area is adhesive still attached to the skin, with the imprint of the peel-ply on the stiffener just as clearly evident as that shown on the skin. There were no traces of adhesion to either surface, yet this bond had passed all ultrasonic inspections at the time of manufacture.

FIGURE 6 Typical totally inadequate scuff sanding used on composite laminates.

The photos in Figures 1 and 6 were all taken on the same component, but multiple airframes on a different commercial aircraft. The response to the discovery of these interfacial failures is very illuminating in that it shows how more still needs to be understood about adhesion by the average aircraft design engineer and manager.

The investigation into this problem confirmed that the adhesive had been cured according to the proper temperature profile and that there had been no transfer of release agent to the bonding surfaces from the peel ply used. Test panels showed that the design had adequate strength. However, the mode of failure was very different. There was no sign of interfacial failures in the test panels. It was later learned from site inspections that the laminates in the structures had not been dried prior to bonding and that they had been cured at another factory months before they were bonded together. Obviously the test panels had been fabricated more rapidly, with no time for the details to absorb moisture. This is the only known explanation for the difference between the failure modes, which is why this is suspected as the cause of the weak-bonded interfaces.

It is significant that the bonding process specifications for the former McDonnell Aircraft Company (now Boeing St. Louis) stated unambiguously at least 30 years ago that there would be no bonding permitted to peel-ply surfaces. They had first to be abraded and the sanding was not to stop until *all* traces of the peel-ply imprint had

been removed! That is possible, on the tape laminates used when composite aircraft structures were in their infancy, but would *require* grit blasting on the later woven-fabric laminates, for which the fine-weave peel-ply texture would have been superimposed on the coarser undulations of the outermost structural layers, if half that top ply were not to be sanded off to remove all of the peel-ply imprint. Significantly, the Boeing St. Louis engineers do not refer to bonding to peel-ply surfaces; instead, they talk about bonding to “sanded” surfaces.
