# Adhesive Bonding to Galvanized Steel

## II. Substrate Chemistry, Morphology and Bond Failure Analysis

ROBERT T. FOISTER

*General Motors Research Laboratories, Warren, Michigan 48090-9055, U.S.A.*

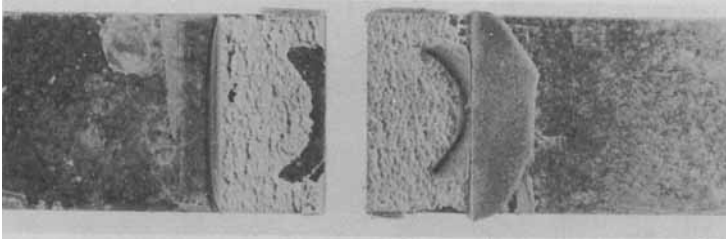
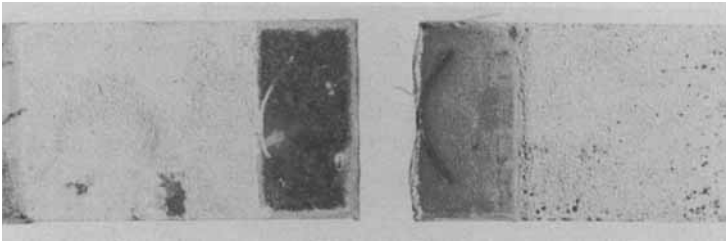
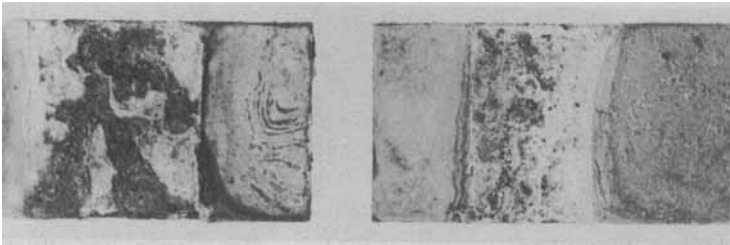
*H2071 two-part epoxy* Of all the adhesives tested, H2071 gave the clearest indication of cohesive failure under initial and control testing conditions. Figure 5A illustrates that matching failure surfaces (minimum spangled substrate) each contain large, uniform layers of adhesive. However, upon water immersion (Figure 5B) and scab corrosion cycling (Figure 5C), the failure mode changed to adhesional. For this adhesive, failure occurred either at very low load levels, or substrate/adhesive delamination occurred during environmental exposure. A general feature of all failure surfaces for samples exposed to accelerated tests involving moisture is evidence of moisture ingress into the bond area *via* diffusion, and subsequent substrate corrosion. This can be seen in Figure 5B (water immersion) as a light-colored rectangular ring on the bond area of the left-hand (metal) failure surface. On the left hand surface shown in Figure 5C (scab corrosion), premature bond failure has occurred,

**FIGURE 5** Matching lap shear failure surfaces for two-part Epoxy H2071 on minimum spangled galvanized steel.

and the rings now cover the majority of the metal side of the failure surface.

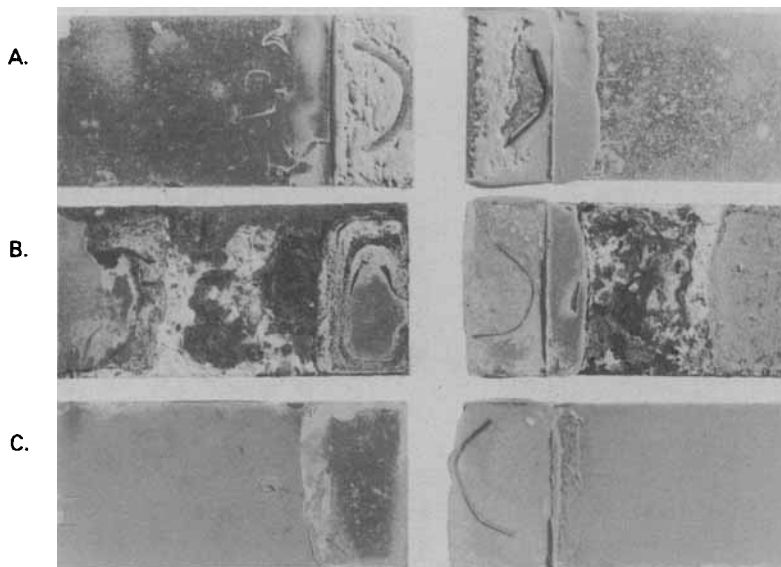
Initial and control sample failure modes for H2071 showed little variation with substrate type. Figures 6A (ultrasmooth) and 7A (electroplated), together with 5A (minimum spangled), all show primarily a cohesive failure of the adhesive. Very clear evidence of substrate corrosion following moisture and (in the case of scab-corrosion environments) salt solution ingress is evident in Figures 5C, 6B, and 7B. Note again, in all cases, the characteristic

FIGURE 6 Matching lap shear failure surfaces for two-part Epoxy H2071 on ultrasmooth galvanized steel. (a) initial, (b) six-week scab corrosion, (c) one-week water immersion (sample ELPO-primed before exposure).

annular areas of corrosion. Bond deterioration was sufficient on ultrasmooth substrates to give total loss of adhesion after six weeks in scab corrosion.<sup>1</sup> However, small residual strengths were found in some cases for minimum spangled and electroplated substrates. No qualitative differences in failure surfaces for these substrates could be found to correlate with the observed variation in strength retention. When bonded samples were electrodeposition-primed prior to exposure, deterioration was sufficiently retarded to give a mean bond strength retention of around thirty percent, compared to zero on average for non-primed samples.<sup>1</sup> Figure 6C shows a typical primed sample after six-week scab-corrosion cycling. Bond corrosion as well as adhesional failure have evidently occurred. The extent of corrosion, however, is much less than for the unprotected sample (Figure 6B) above, since the primer coating has retarded (but not entirely eliminated) moisture ingress into the bond.

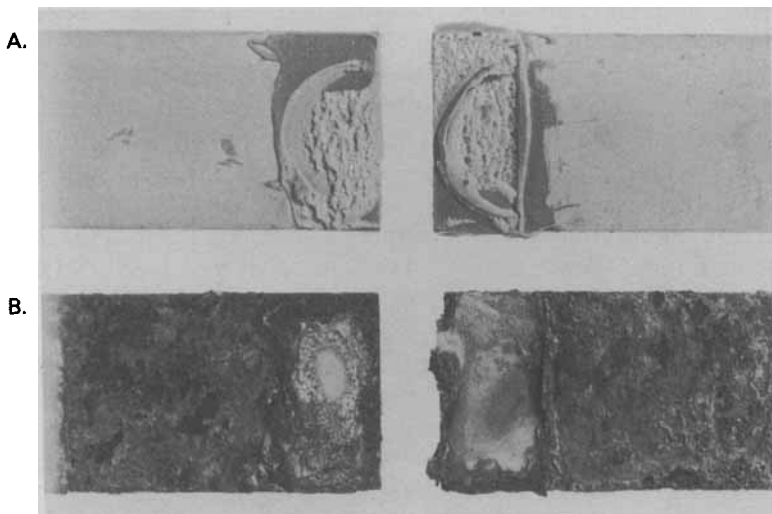
FIGURE 7 Matching lap shear failure surfaces for two-part Epoxy H2071 on electroplated galvanized steel. (a) initial, (b) six-week scab corrosion.

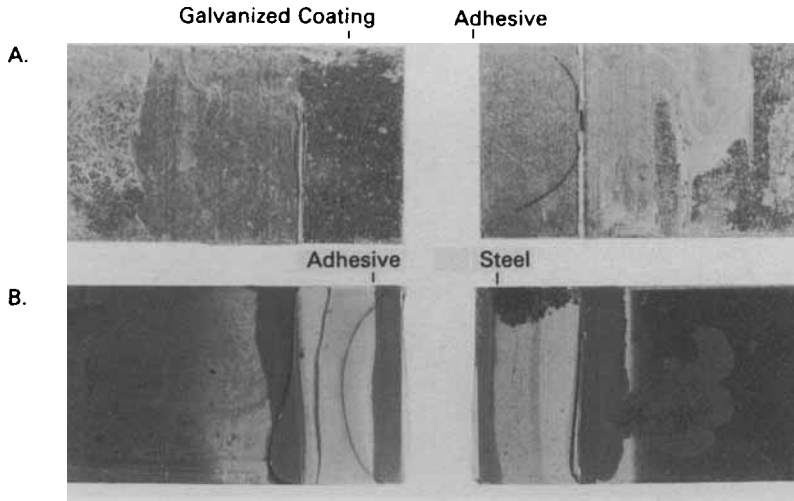
FIGURE 8 Matching lap shear failure surfaces for two-part Epoxy-EA2 on (a) ultrasmooth galvanized steel (initial) and (b) cold-rolled steel (initial).

to achieve on the ultrasmooth surface, adhesive strengths for EA2 on cleaned steel (of the same substrate thickness) are approximately twice as high as those recorded for the ultrasmooth galvanized surface. Corresponding differences in failure mode can be seen in Figures 8A (ultrasmooth) and 8B (cleaned steel). Adhesional

failure is evident for ultrasmooth galvanized, while a mixed-mode failure is the case for cleaned steel (note the difference between these two modes illustrated schematically in Figure 3).

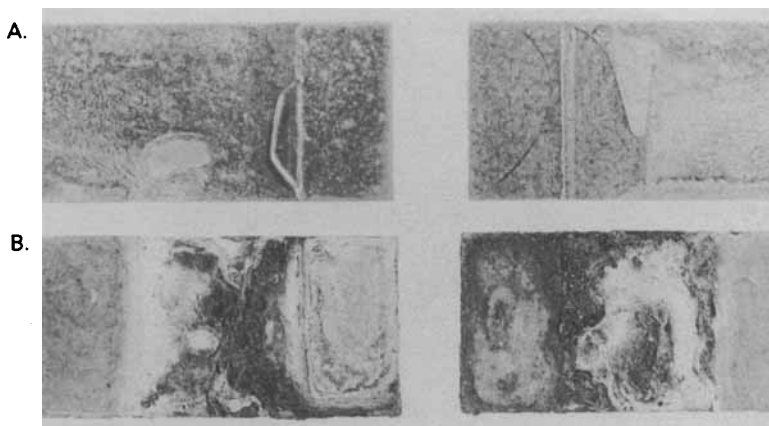
*EA2 two-part epoxy* Similar results were obtained for the EA2 adhesive as were obtained for the H2071 system on ultrasmooth and minimum spangled substrates, *i.e.*, low strengths (4000–8000 kPa) and poor to non-existent strength retention after environmental exposures. There was some improvement for EA2 on the electroplated substrate, however. In terms of failure modes, the most obvious difference between H2071 and EA2 is that EA2 failed adhesively under initial and control testing conditions, rather than cohesively. One reason for this is that EA2 is a brittle, unfilled, high modulus adhesive, while H2071 is considerably less brittle and is highly filled. Figure 8A (EA2 on ultrasmooth), and Figure 9A (EA2 on minimum spangled) can be contrasted with Figure 6A (H2071 on ultrasmooth) to illustrate this difference. Since the mean strength for EA2 was somewhat less than that measured for H2071 (for initial and control samples), H2071 showed slightly better adhesion to the ultrasmooth substrate. However, the effects of water immersion and scab corrosion cycling were more evident for H2071 than for EA2, as can be seen by comparing six week scab corrosion failure surfaces for H2071 on minimum spangled (Figure 5C) to those for EA2 on minimum spangled (Figure 9B). For EA2, the area of corrosion occupies a smaller portion of the total bond surface than is the case for H2071 after the same exposure time.

FIGURE 9 Matching lap shear failure surfaces for two-part Epoxy EA2 on minimum spangled galvanized steel. (a) initial, (b) six-week scab corrosion.

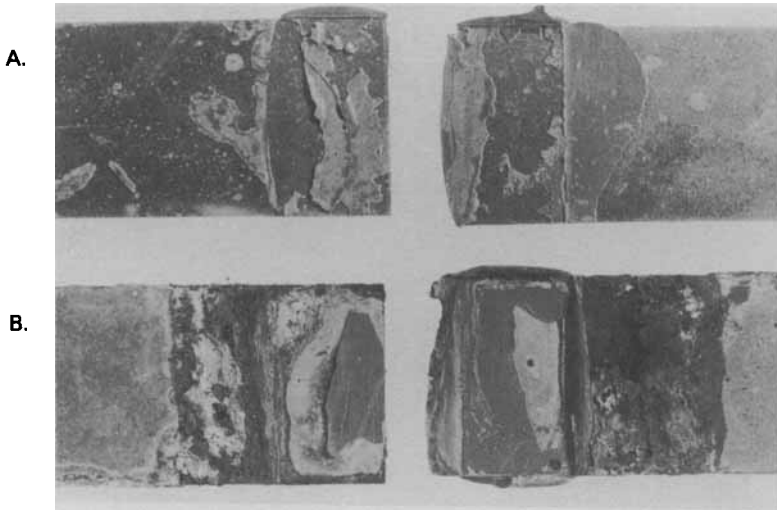
FIGURE 10 Matching lap shear failure surfaces for two-part Epoxy H5188 on ultrasmooth galvanized steel. (a) initial, (b) six-week scab corrosion.

In addition to differences in strength and durability, the failure modes for H5188 also differed from those for EA2 and H2071. Figure 10A shows mixed adhesional/cohesional failure on ultrasmooth substrates, but failure of the adhesive appears to be brittle. This type of failure is illustrated by the crack path in Figure 3C. While also showing a mixed-mode failure, Figure 11A, on the other hand, shows that for H5188 on electroplated galvanized, the crack proceeded in large part through the adhesive itself. This corresponds to the more gradual path illustrated in Figure 3C. Also, cohesional failure of H5188 was observed on the 2.7 mm thick

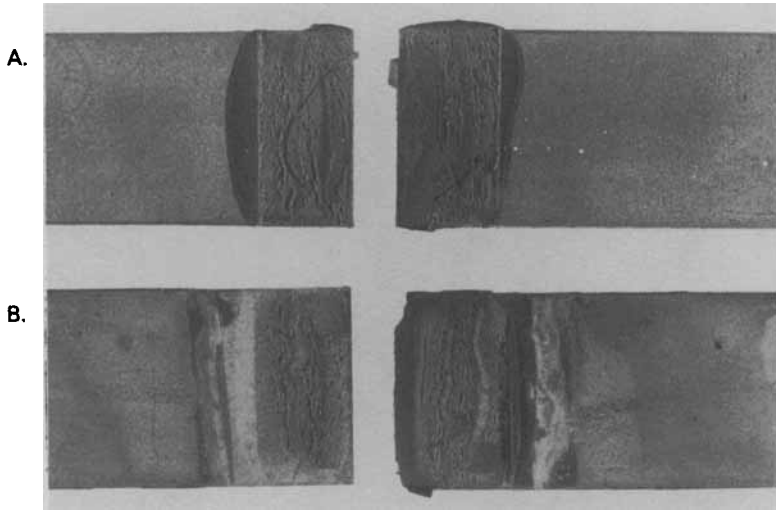
FIGURE 11 Matching lap shear failure surfaces for two-part Epoxy H5188 on electroplated galvanized steel. (a) initial, (b) one-week water immersion.

cleaned steel substrates (Figure 12). Thus, it appears that the failure mode for H5188 is quite specific to substrate type for initial and control testing conditions. This specificity persists in accelerated testing environments as well. Figure 11B shows the mixed-mode failure after water immersion for electroplated galvanized, and Figure 10B shows the more brittle mixed mode for ultrasmooth substrates after scab-corrosion cycling.

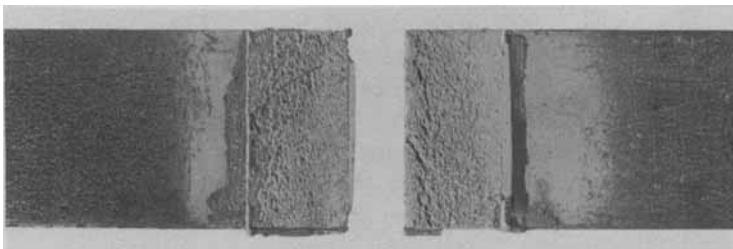
FIGURE 12 Matching lap shear failure surfaces for two-part Epoxy H5188 on cleaned cold rolled steel (coupon thickness is 2.7 mm).

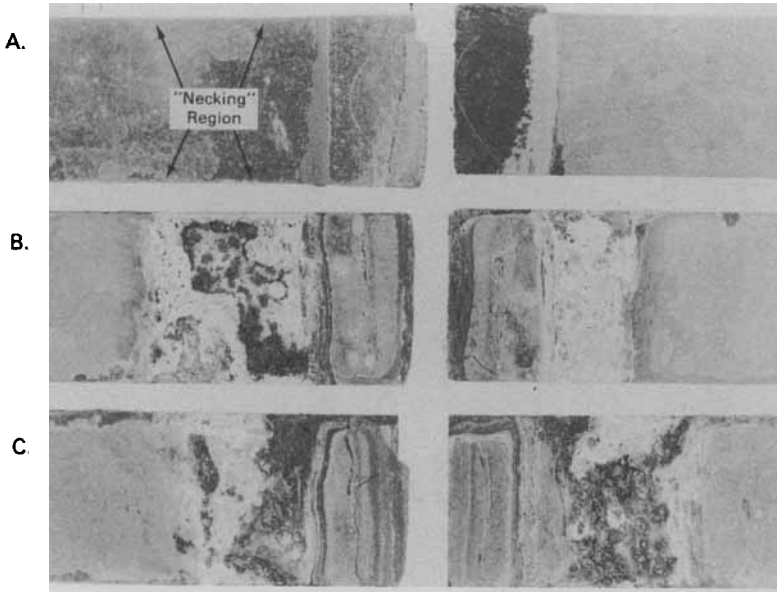
FIGURE 13 Matching lap shear failure surfaces for one-part Epoxy H1989 on ultrasmooth galvanized steel. (a) initial, (b) three-week scab corrosion, (c) six-week scab corrosion.

Characteristics of the failure modes for H1989 remained constant for a given substrate as test conditions ranged from initial and control, to water-immersion and to scab-corrosion exposures. The progressive influence of corrosion with increasing exposure time (increasing cycles in scab corrosion) can be seen by comparing Figures 13B (three weeks, or fifteen cycles) and 13C (six weeks, or thirty cycles). For the three-week exposure, corrosion has occurred primarily at the two edges of the bond overlap, while for six-weeks exposure, corrosion has occurred around the entire perimeter.

Since the mean lap shear strength for H1989 on ultrasmooth after six weeks in the scab-corrosion environment is almost half that for the electroplated substrate, it is instructive to compare three and six week failure surfaces for the two substrates. Figure 16 shows three (16A) and six (16B) week failure surfaces for electroplated substrates, which have distinctly less corrosion than do the corresponding surfaces for ultrasmooth substrate (Figure 13B, C). This evidence, together with the difference in mixed mode failure, suggests that the two cases may have qualitatively different underlying adhesion. It is likely that the different type or quality of adhesion is, as we noted in the discussion above, a function of vastly different surface morphologies, and surface chemistries, for the two substrates.

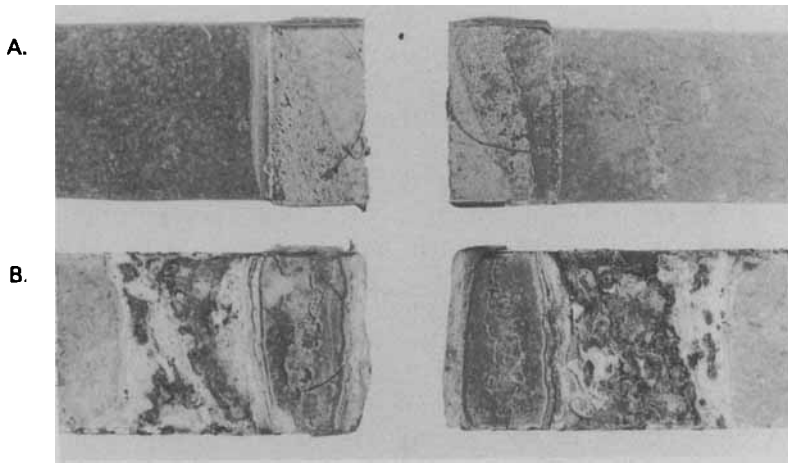
FIGURE 14 Matching lap shear failure surfaces for one-part Epoxy H1899 on minimum spangled galvanized steel (a) initial, (b) six-week scab corrosion.

however, with improvements of some 25% recorded for the electroplated samples. The fact that the failure mode is the same for minimum spangled and for electroplated substrates suggests that the higher strength of H1989 on electroplated may be attributable to differences in substrate thickness (1.1 mm for electroplated *versus* 0.091 mm for minimum spangled and ultrasmooth). For a given load level, the stress distribution in the bond will vary with substrate thickness, with thicker coupons giving a more uniform stress distribution.<sup>9</sup>

A likely sequence of events leading to the observed corrosion products is as follows. During exposure of the bonds to 49°C, 85% relative humidity in the initial part of the cycle, water diffuses into the bond a certain characteristic distance, which is a function of humidity level and the moisture diffusivity of the adhesive. As is well known and documented,<sup>10</sup> bonds are susceptible to degradation in the presence of moisture. Subsequent soaking of the samples in 5% NaCl at room temperature (the second step of the cycle) provides the opportunity for formation of the corrosion product. Every subsequent cycle introduces a new annular ring of corrosion products (see Figure 14B, for example).

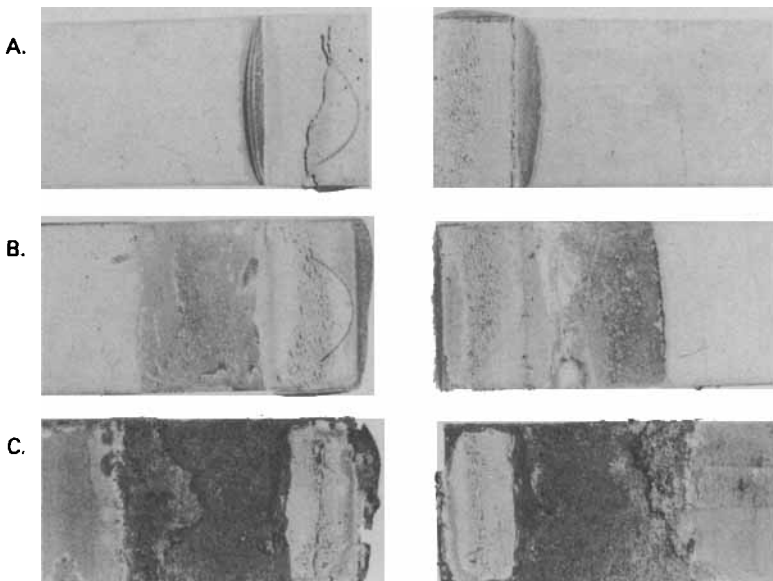
FIGURE 15 Matching lap shear failure surfaces for one-part Epoxy H1899 on electroplated galvanized steel. (a) initial, (b) one-week water immersion, (c) six-week scab corrosion.

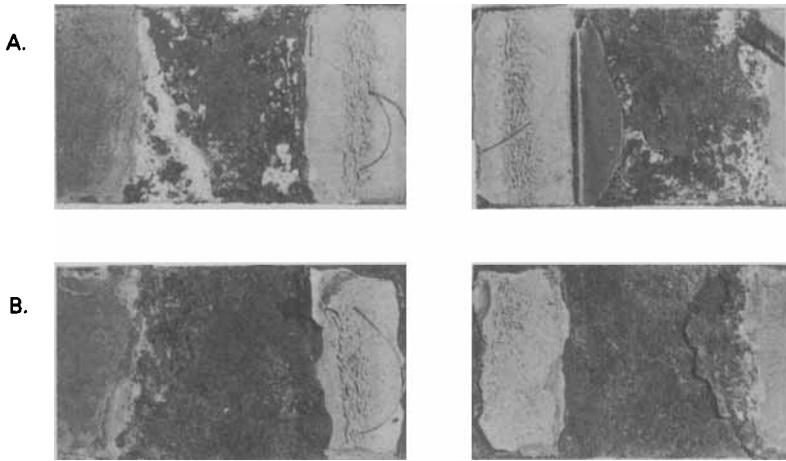
FIGURE 16 Matching lap shear failure surfaces for one-part Epoxy H1989 on electroplated galvanized steel (a) three-week scab corrosion, (b) six-week scab corrosion.

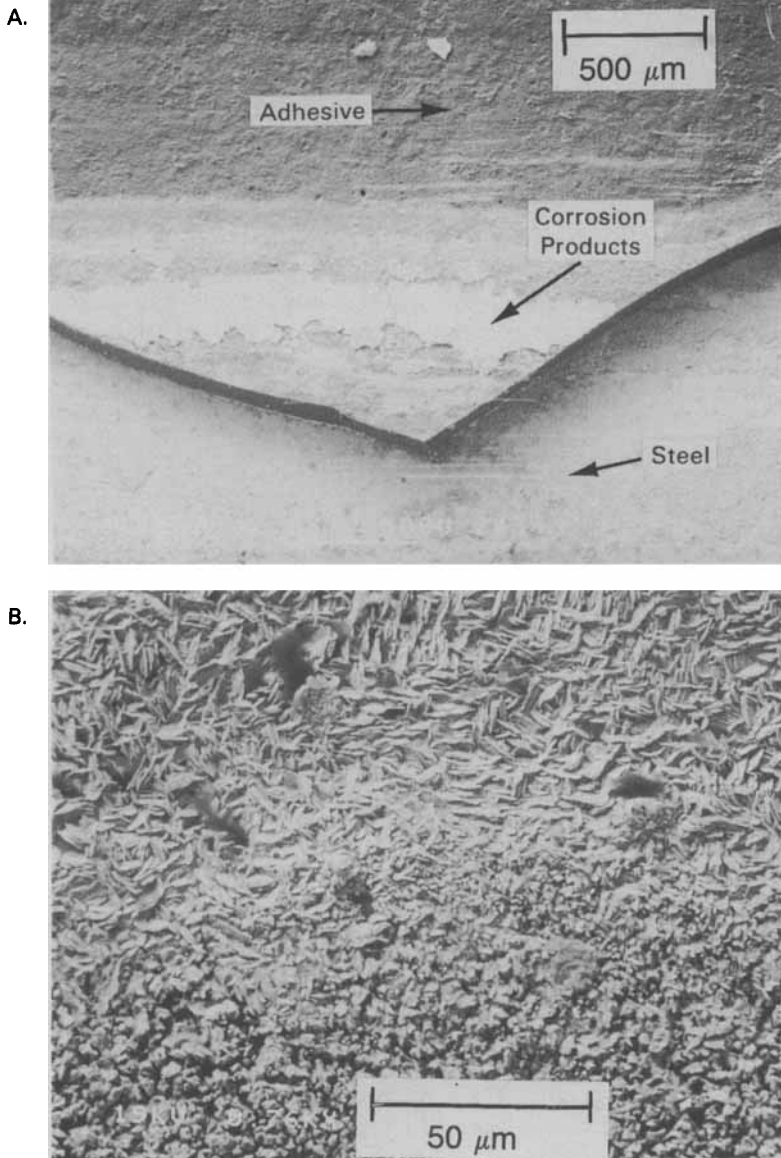
Figure 17A is a scanning electron micrograph of a portion of adhesive remaining on the failure surface after scab corrosion. This illustrates that the basic zinc salt collects on the adhesive surface, as well as on the metal surface, since the adhesive no longer adheres to the substrate. Figure 17B shows the boundary between electro-deposited zinc crystals (upper portion of micrograph) and the corrosion product (lower portion). Note especially the different morphologies of the two regions. An X-ray map of the distribution of chlorine confirmed that the lower portion was high in chlorine, as we would expect from the presence of the basic zinc chloride salt.

FIGURE 17 Scanning electron micrographs of corrosion product on (a) adhesive surface and (b) substrate surface after bond failure.
