To cite this Article Hemminger, Carol S.(1994) 'Interfacial Chemistry of an Aluminum-to-EPDM Rubber Bonding System', *The Journal of Adhesion*, 47: 1, 51 – 64

Interfacial Chemistry of an Aluminum-to-EPDM Rubber Bonding System*

CAROL S. HEMMINGER**

The Aerospace Corporation El Segundo, California 90245, USA

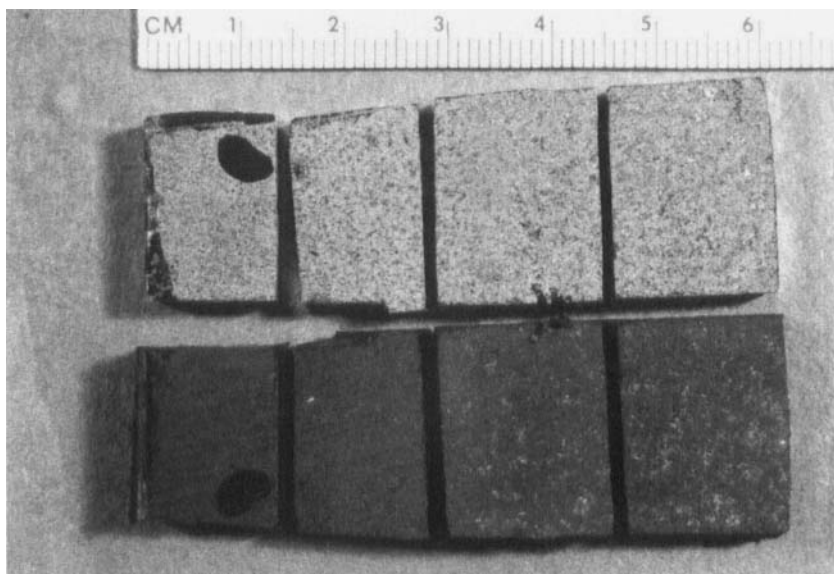
Visual inspection of the ruptured polar boss sample bondlines showed that rupture appeared to occur, predominantly, close to the Al/primer interface. Significant flecks of primer/adhesive did remain on the Al surface. On ruptured “good” bonds, there was no visual sign of Al surface corrosion, even after the ruptured bondline was exposed to atmosphere for several weeks. The EPDM side of the rupture appeared uniformly dark gray in color. Ruptured “poor” bonds had a spotted appearance on both the Al and EPDM sides of the interface, and a high density of corrosion product was observed on both surfaces under an optical microscope. Some ruptured bondlines were considered “fair” in appearance. The fair bondlines had a lightly mottled Al surface, but the rubber surface appeared relatively clean. Small patches of corrosion product were observed on both surfaces under an optical microscope. Figure 3 shows the progression from fair to poor in the condition of a bondline from the aft polar boss of motor case 1 (segment A12), moving from the ID edge (left side) to the midsection. The progression is most readily seen in the exposed EPDM rubber surfaces of the coupons.

FIGURE 3 Progression from fair to poor in the condition of a bondline from the aft polar boss of motor case 1 (segment A12), moving from the ID edge (left side) to the midsection. The progression is most readily seen in the exposed EPDM rubber surfaces of the coupons.

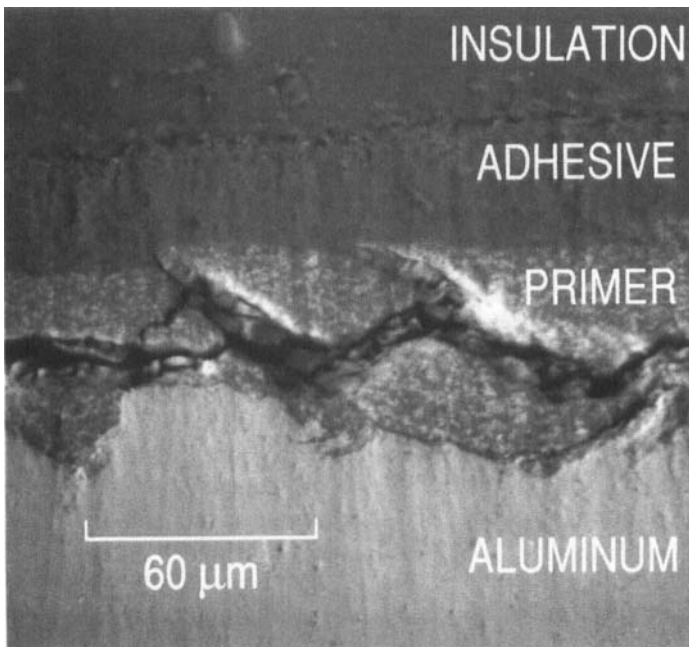
FIGURE 4 SEM micrograph showing primer layer cracks filled with corrosion in a cross-section study of a corroded bondline.

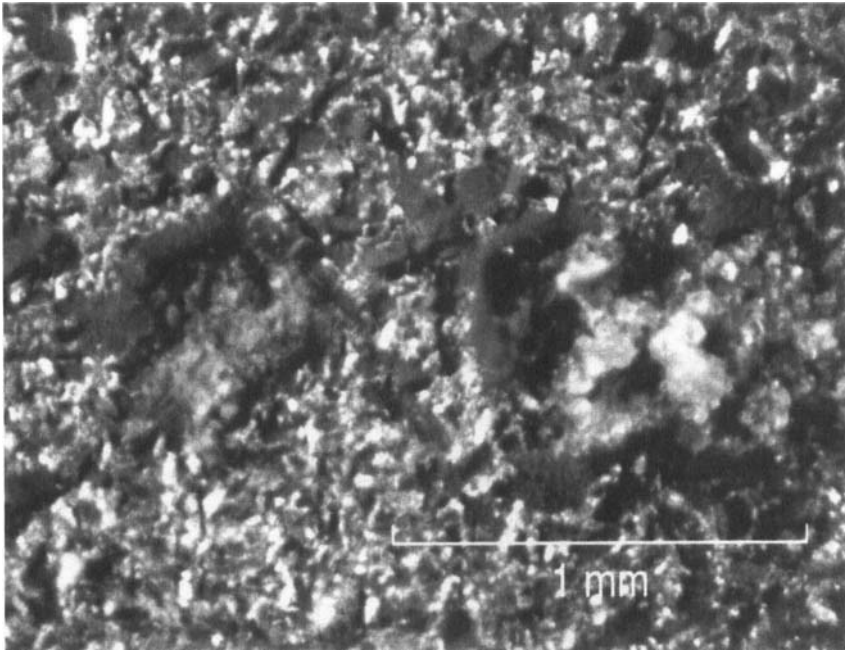
Microscopic examination showed that pockets of primer pullout were associated with the corrosion spots. Corrosion product had expanded into cracks through the primer layer towards the adhesive and rubber layers. Upon rupture, the primer layer in areas of heavy corrosion remained on the aluminum side, as seen in Figure 5; intact primer was observed on the insulation side in noncorroded areas. This suggested that corrosion may initiate at pre-existing defect sites correlated with small brittle cracks in the primer layer. Areas that were corrosion resistant, after the longest exposure times and near ID and wingtip edges of the hardware, may have a relatively defect-free primer layer that prevents moisture from reaching the aluminum surface. Cross section analyses of intact bondlines² did not detect any cracks through the primer layer that were not filled with corrosion product. The failure of corrosion spots to coalesce readily

FIGURE 5 Optical micrograph of primer pockets remaining in areas of heavy corrosion on the aluminum side of the interface after bondline rupture. Sample exposed for 23 days.

suggests that large-area debonds in hardware are unlikely to result from moisture-induced corrosion at the Al/rubber bondline.
