# The Fatigue and Durability Behaviour of Automotive Adhesives. Part II: Failure Mechanisms

In part I [1] a fracture mechanics approach has been successfully used to examine the cyclic fatigue behaviour of adhesively-bonded joints, which consisted of aluminium-alloy or electro-galvanised (EG) steel substrates bonded using toughened-epoxy structural paste-adhesives. The adhesive systems are typical of those being considered for use, or in use, for bonding load-bearing components in the automobile industry. The cyclic fatigue tests were conducted in a relatively dry environment, of 23°C and 55% RH, and in a “wet” environment, namely immersion in distilled water at 28°C. The “wet” fatigue tests clearly revealed the significant effect an aggressive, hostile environment may have upon the mechanical performance of adhesive joints, and highlighted the important influence that the surface pretreatment, used for the substrates prior to bonding, has upon joint durability. The present paper, Part II, discusses the modes and mechanisms of failure for the two adhesive systems in both the “dry” and “wet” environments. The failure surfaces of the joints tested in Part I have been examined using

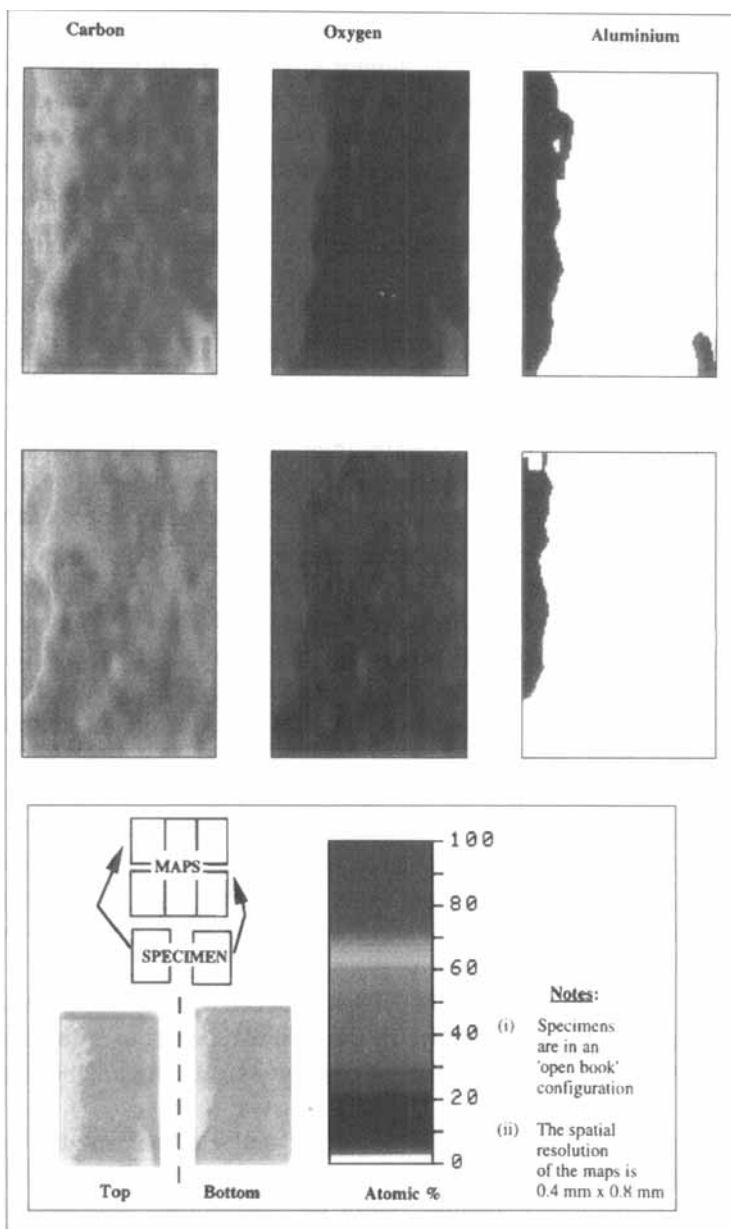
**FIGURE 6** EM-XPS results for the fracture surfaces of the aluminium-alloy (GBD pretreated) joint bonded using the XD4600 adhesive after "dry" fatigue testing. (See Color Plate III).

The use of elemental mapping – X-ray photoelectron spectroscopy (EM-XPS) confirmed that the failure at the edges of the joint was indeed *via* a crack propagating along the adhesive/aluminium-oxide interface. Figure 6 illustrates the results from the EM-XPS studies. In this Figure, two photographs are given of the opposing halves of the fracture surfaces, taken from a specimen which had undergone fatigue testing in the “dry” environment. These two opposing halves of the fracture surfaces were actually cut from the specimen shown in Figure 5, and the bar marked on Figure 5 represents the location from where these two fracture surfaces were obtained. The XPS quantitative elemental maps for these two fracture surfaces are shown in Figure 6, as indicated on the figure. There are several noteworthy points. Firstly, the photographs in Figure 6 clearly show that over much of the joint the locus of joint failure was mainly cohesive in the adhesive layer, but with some apparent interfacial failure at, or close to, the edges of the joint. Secondly, within the resolution of the EM-XPS technique, there is no aluminium detected on the surface of the retained adhesive – even on those surfaces of the retained adhesive which corresponded to where apparent interfacial failure had occurred. This reveals that failure was not through the oxide layer. Thirdly, on what visually appears to be the aluminium-oxide surfaces, there are, indeed, relatively high concentrations of aluminium and oxygen, which indicates an aluminium-oxide surface. Fourthly, also, in these regions there is a substantially lower concentration of carbon, and this low concentration of carbon is typical of that associated with post-failure contamination of the aluminium oxide. These observations reveal that failure in these regions did not occur *via* fracture of the adhesive, even albeit close to the interface.

Thus, to summarise, the EM-XPS studies confirm that the locus of joint failure is mainly cohesive in the adhesive layer but with some adhesive/aluminium-oxide interfacial failure along the edges of the joint.

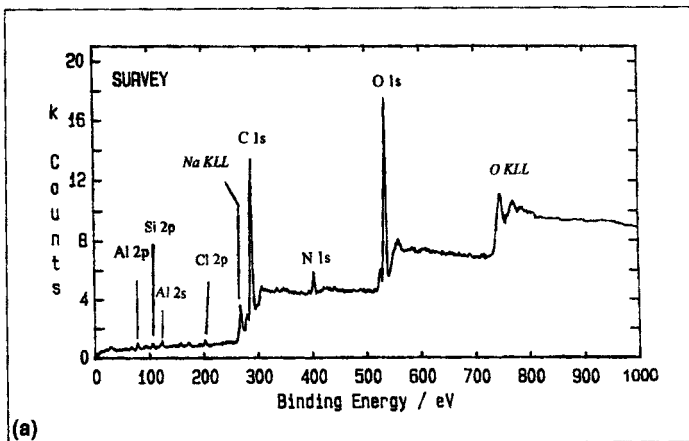
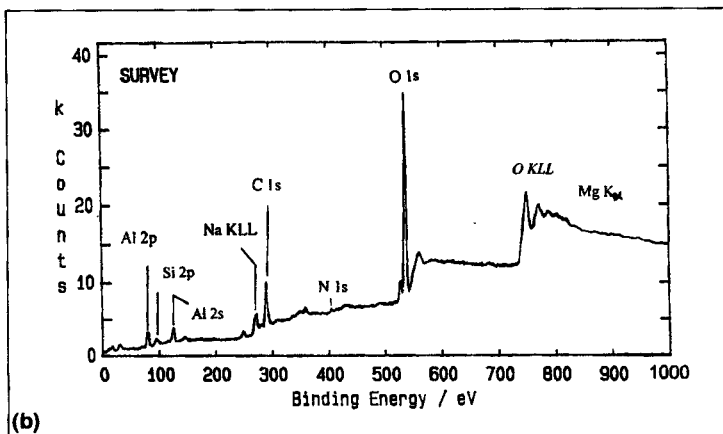
FIGURE 8 XPS survey spectra of the fracture surfaces of the aluminium-alloy (GBD pretreated) joint bonded using the XD4600 adhesive after "wet" fatigue testing. (a) Adhesive side (b) Metal side.

The XPS survey spectra are shown for the adhesive' side and for the metal side in Figures 8a and b, respectively; both spectra were recorded using  $MgK\alpha$  radiation for the reasons outlined above. It may be clearly seen that there are aluminium signals on both fracture surfaces, and they are associated with aluminium oxide. However, if the results for the metal side of the failed joint (see Fig. 8b) are compared with those prior to bonding (see Fig. 1b), then the additional presence of nitrogen may be seen in Figure 8b. This nitrogen is likely to be associated with adhesive remaining on the metal side, as may be seen from comparing Figures 4a, 8a and 8b. Thus, it appears that the failure of the aluminium-alloy (GBD)/"XD4600"

joints in the “wet” environment is complex with the crack propagating partially through the aluminium oxide, partially through the adhesive (but close to the interface) and, possibly, partially along the aluminium-oxide/adhesive interface. The sodium present undoubtedly arises from contamination of the fracture surfaces from sodium ions in the water, in which the joints were subjected to cyclic fatigue crack growth.

The results from the EM - XPS and detailed XPS spot-analyses also confirmed the above interpretations, but also added to these conclusions. These results clearly supported the fact that partial failure of the joint was *via* the fatigue crack travelling through the aluminium-oxide layer. These techniques indicated that, from the aluminium signal on the adhesive side, about 10 to 15% of the failure path was *via* crack propagation through the aluminium oxide and, from the nitrogen signal on the metal side, that about 25 to 20% of the failure was *via* fracture through the adhesive; the remaining 60 to 70% being *via* interfacial failure along the adhesive/aluminium-oxide interface. The most likely explanation for such a locus of failure is that the water attacks the interface, possible due to the disruption of the interfacial secondary bonds between the epoxy adhesive and the oxide [17, 18], and that the weakened interface now fails. The crack then travels along, or very close to, the interface. However, due to the relatively

high degree of surface roughness generated by the grit-blasting pretreatment, sometimes the fatigue crack passes through the top of an oxide asperity and sometimes passes through the adhesive which is filling the “valleys” between the oxide asperities, rather than follow the very tortuous path along the interface.

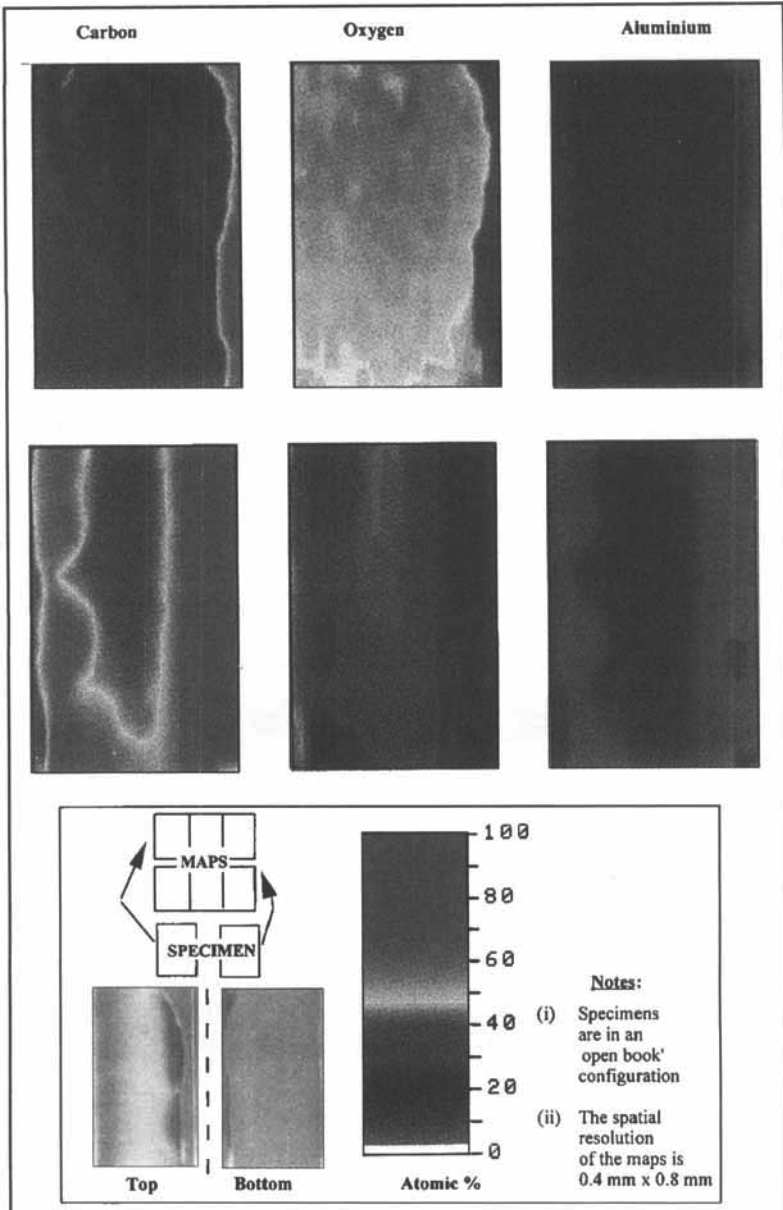
FIGURE 10 EM - XPS results for the fracture surfaces of the aluminium-alloy (CAE pretreated) joint bonded using the XD4600 adhesive after "wet" fatigue testing. (See Color Plate VI).

The EM - XPS results are shown in Figure 10. These results clearly show the presence of aluminium covering the entire surfaces of both the metal side and the adhesive side of the failed aluminium-alloy (CAE)/"XD4600" joints. Also, in those regions of the adhesive side where the aluminium signal is relatively low, then the carbon signal is stronger. This suggests that the crack has propagated through the aluminium oxide, but not at a constant distance below the adhesive/aluminium-oxide interface. Thus, the conclusion is that fatigue testing in the "wet" environment leads to a locus of joint failure mainly through the oxide layer.

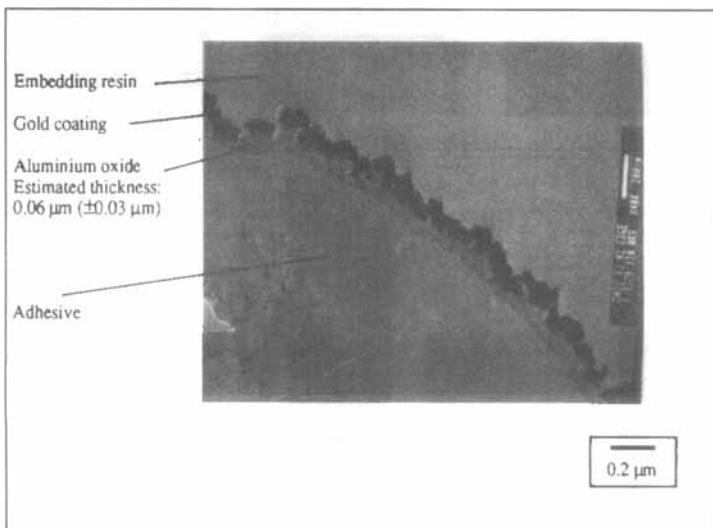
of the failed joint, with an impervious layer of gold-palladium and mounting the coated sample in an embedding resin. This provided a clear indication of the locus of failure, since the failed region of the joint lay immediately below the sputter-coated layer. The embedded specimens were cut perpendicular to the fracture surface using an ultramicrotome. The thickness of the microtomed slices was about 20 nm and these were floated onto a microscope grid and examined using a transmission electron microscope. The micrograph shown in Figure 11 is from a failed point, and a cross-section taken from the adhesive side is being viewed. As may be seen, the adhesive is covered by a layer of aluminium oxide, about  $60 \pm 30$  nm in thickness. This is in complete agreement with the results from the various XPS studies. However, this information alone clearly does not yield the thickness of the aluminium-oxide layer at fracture, since some of the aluminium-oxide layer was retained on the metal side of the failed joint. However, the important question of the thickness of the oxide layer in the joints which were subjected to fracture *via* the wet fatigue test may be answered by considering Figure 12. This micrograph is again from a

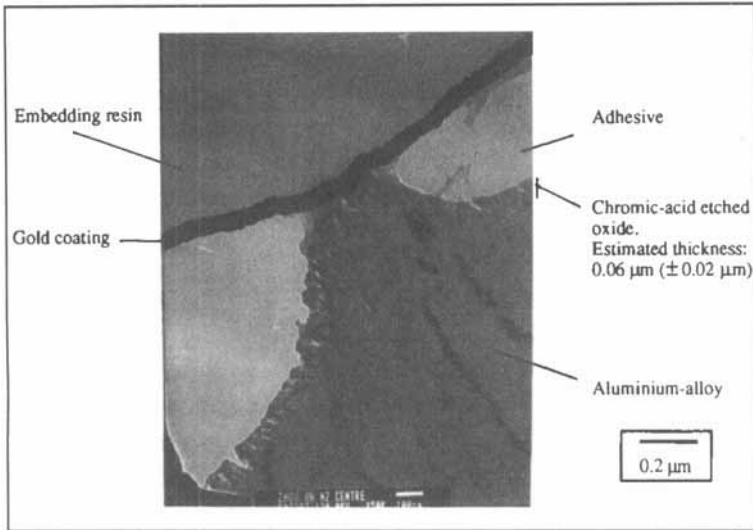
FIGURE 12 Transmission electron micrograph of a section through the metal side of the fracture surface of the aluminium-alloy (CAE pretreated) joint bonded using the XD4600 adhesive after “wet” fatigue testing. (The gold coating was placed on top of the original fracture surface to act as a marker.)

section of a joint which had been subjected to the wet fatigue test, but this section is taken from one of the isolated regions where adhesive has been retained on the metal side. Hence, the oxide layer thickness may be determined. The value is about  $60 \pm 20$  nm. This value is very similar to that reported for the oxide initially produced by the chromic-acid etch (CAE) treatment and suggests that there has not been a major increase in the thickness of the oxide, due for example to a relatively gross corrosion mechanism occurring during the “wet” fatigue tests.

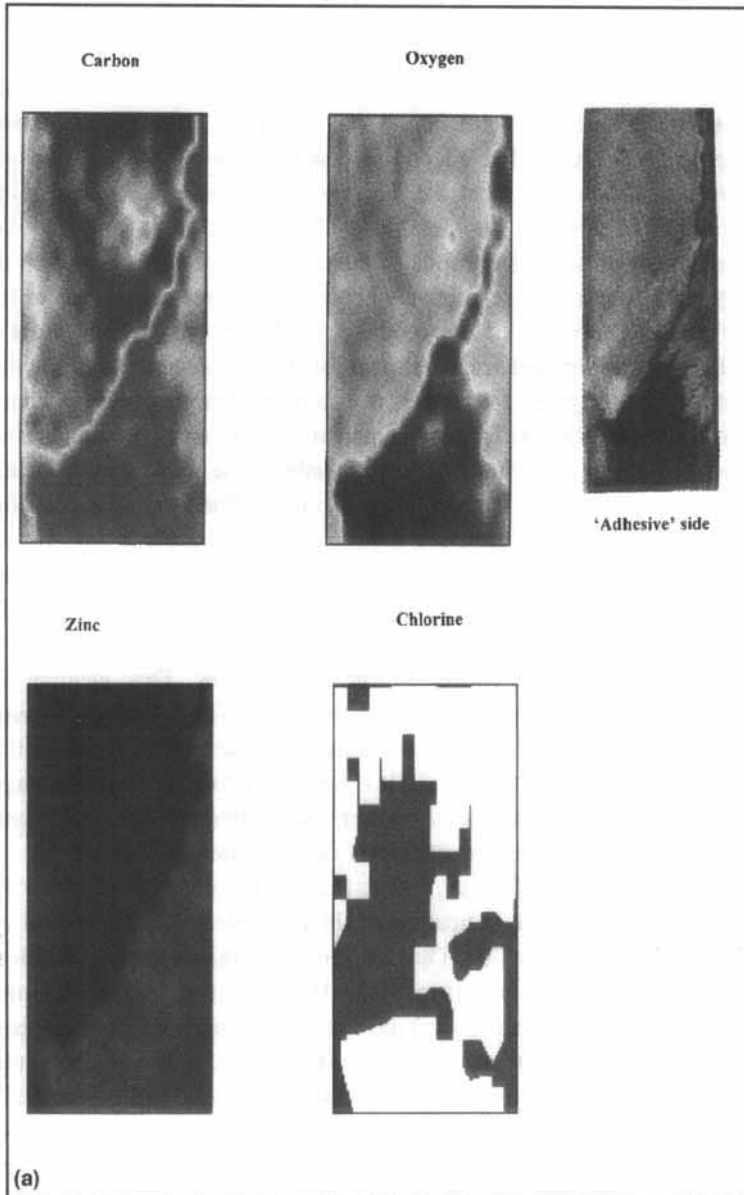
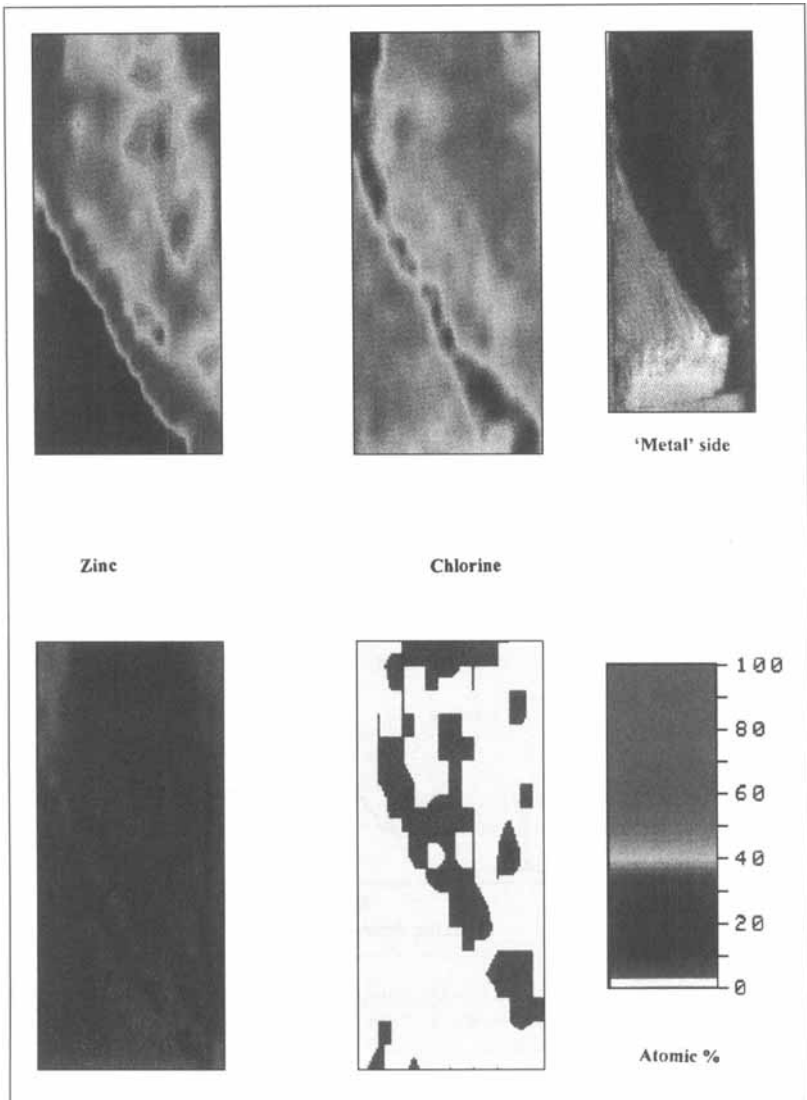
FIGURE 13 EM-XPS results for the fracture surfaces of the electrogalvanised (EG) steel joint bonded using the Terokal 4520-34 adhesive after "wet" fatigue testing. (a) Adhesive side (b) Metal side. (See Color Plate VII).

Returning to the EM-XPS images of Figure 13, it is clear that the chlorine concentration is extremely low and, bearing in mind the poor photoelectric cross-section of the Cl2p core level, it is probably around the detection limit of XPS analysis in this form. Neither the (area-integrating) survey spectra of the metal side nor the adhesive side failure surfaces (see Fig. 14) indicate the presence of chlorine. This is consistent with sparsely-distributed regions of low concentration of chloride ions, which is the scenario indicated by the EM-XPS data. Thus, in terms of the chemistry of the failure process, the concentration of chlorine is so low that it can be excluded as a component of the reaction product, thus ruling out zinc chloride or basic zinc chloride. Another indication of the composition of the corrosion product is the carbonate group, since this may point to basic zinc carbonate. The C1s spectra of both failure surfaces do show the presence of a relatively minor concentration of carbonate ions, some 4.2 eV from the main peak. In the past, this has been suggested to arise from degradation of polymeric species [33], and the adsorption of these ions from aerated solution [34], in addition to the possibility of a major degradation product. Another possibility for the presence of carbonate species is that of post-failure degradation. However, whatever the source of the carbonate species, the concentration (about 5 atomic-%) of such groups is not sufficient to account for the high concentration of zinc ions, and the presence of carbonate ions is considered to be of relatively minor importance as far as the failure mechanism is concerned. Finally, no sodium ions were detected on either surface from the failed joints.

The EM-XPS data reinforce, and rationalise, the high concentration of zinc which is found to be present on both surfaces from the spectra shown in Figure 14. The physical images of the two regions examined by EM-XPS (Figs. 13a and 13b) both contain different coloured

regions which represent mirror-images of the metal side and the adhesive side of the failed joint. As expected, the higher concentration of zinc in the EM-XPS images is associated with the metal side of the failed joint. However, the main conclusion from Figure 14 is reinforced, namely that the adhesive side of the failed joint has a relatively high concentration of zinc completely covering the adhesive material. Furthermore, the concentration of zinc on this failure surface is much higher than would be expected if it were merely a result of the post-failure adsorption of corrosion products from solution. This observation, together with the chlorine analysis, the low concentration of carbon on both surfaces and the absence of sodium ions, indicates that failure is associated with gross corrosion, *via* anodic dissolution, of the zinc layer on the EG steel substrate.

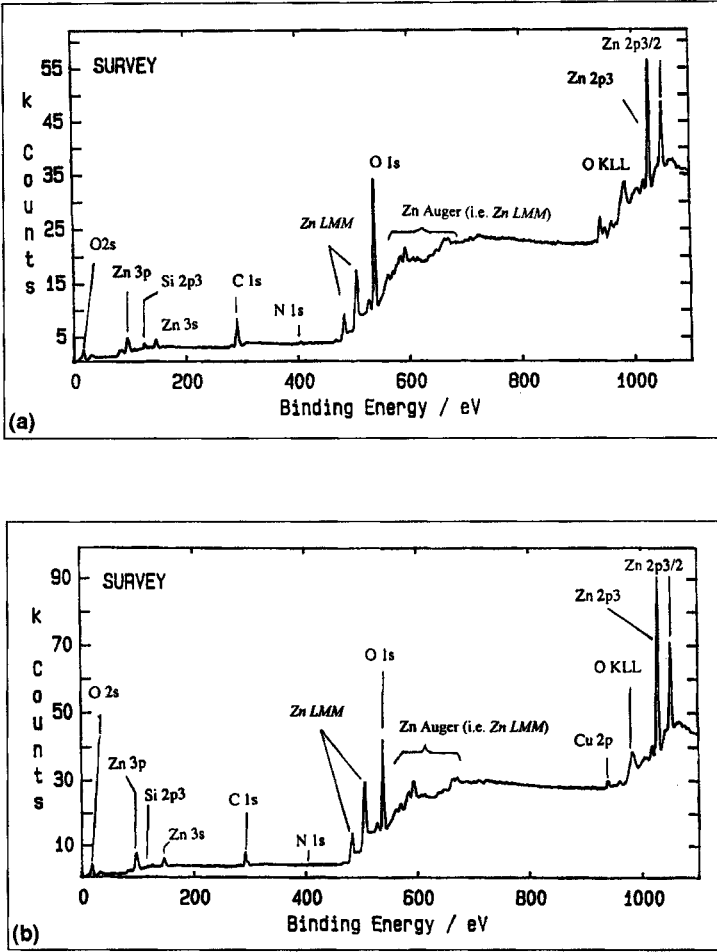
FIGURE 14 XPS survey spectra of the fracture surfaces of the electrogalvanised (EG) steel joint bonded using the Terokal 4520-34 adhesive after “wet” fatigue testing. (a) Adhesive side (b) Metal side.

The XPS survey spectra are shown for the adhesive side and for the metal side in Figures 14a and b, respectively. The similarity of these two spectra is striking. There is a concentration of zinc (present as zinc oxide) of about 35 atomic-% on each side of the joint, with a rather low concentrations of carbon being recorded. The level of carbon on the metal side of the joint, see Figure 14b, is particularly low and is consistent with a voluminous (i.e. high surface area) corrosion product. The lack of sodium ions indicates that cathodic conditions do not exist at this surface, but the EM - XPS data of Figure 13 show a low, but significant, concentration of chlorine. This element is presumed to be an impurity within the test medium but also serves the useful purpose of acting as a marker for corrosion (that is, the anodic dissolution of the metal). It is perhaps informative at this stage to describe, briefly, the use of marker ions in this manner, and relate such comments to the environmental degradation of EG steel.

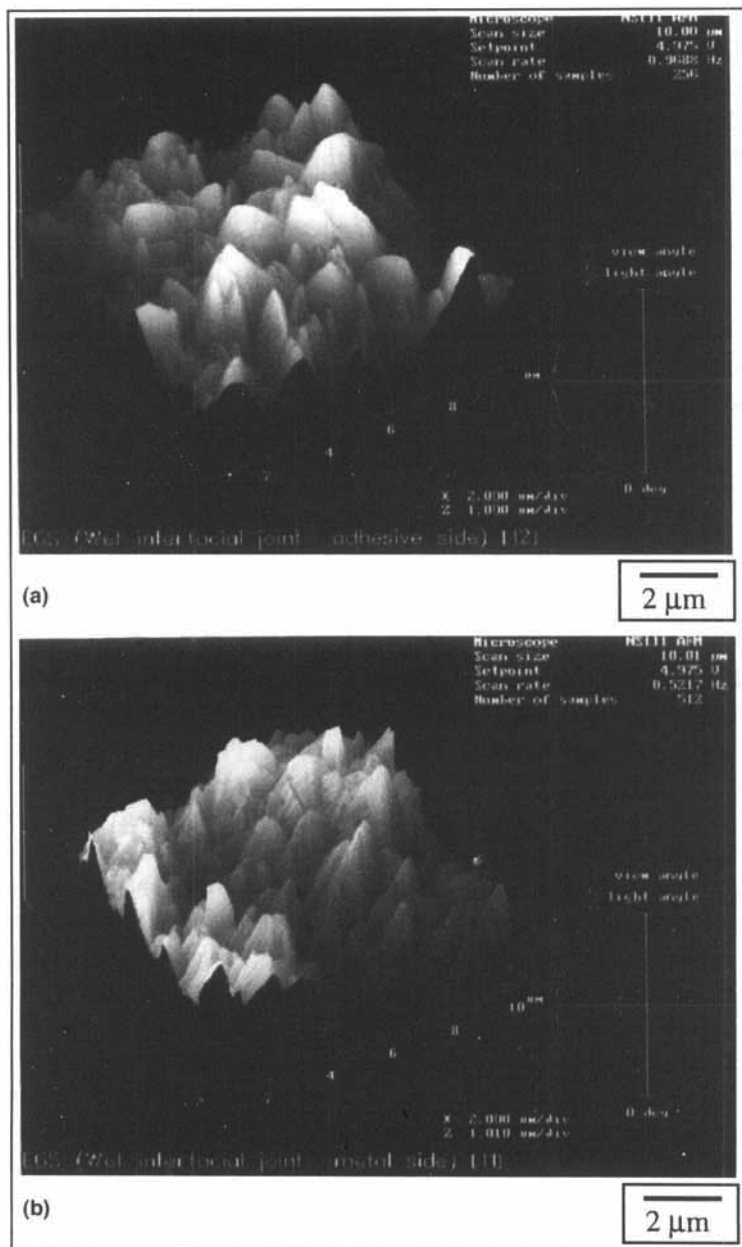
FIGURE 15 Atomic force microscopy (AFM) images of the fracture surfaces of the electrogalvanised (EG) steel joint bonded using the Terokal 4520-34 adhesive after “wet” fatigue testing. (a) Adhesive side. (b) Metal side. (See Color Plate VIII).

From using both atomic force microscopy and scanning electron microscopy, it was readily confirmed that on both the adhesive side and the metal side of the failed EG steel joint there was a surface which had the distinct appearance of a metallic oxide. For example, Figures 15a and b show the images from AFM for the adhesive side and the metal side of a failed joint, respectively. The surface topography appears to be identical in both cases and, furthermore,

is identical to that of the EG steel surface prior to bonding, the needle-like columns on the surface being, from the XPS studies, zinc oxide.

Thus, the combination of microscopy and surface analysis suggests that the EG steel joints bonded using the "Terokal 4520-34" adhesive have failed in the "wet" fatigue tests *via* a crack propagating through a weakened zinc-oxide layer. As commented above, it is thought unlikely that failure simply occurs within the "bulk" of the original zinc coating, which is some 10  $\mu\text{m}$  thick. It is considered that the mechanism of environmental failure involves anodic activity at the adhesive/metal (i.e. zinc oxide) interface, leading to the creation of a voluminous corrosion product with little cohesive strength, and that the fatigue crack propagates close to the adhesive/zinc oxide interface, but within the corrosion deposit (i.e. within the "white rust").
