THE USE AND EXTENDED LIFETIMES OF MICROFURNACES FOR THERMOGRAVIMETRY. PART II. REPAIR OF BROKEN FURNACE STEMS

C.M. EARNEST and DWIGHT KINZER

Department of Chemistry, Berry College, Mt. Berry Station, Rome, Georgia 30149 (U.S.A.)

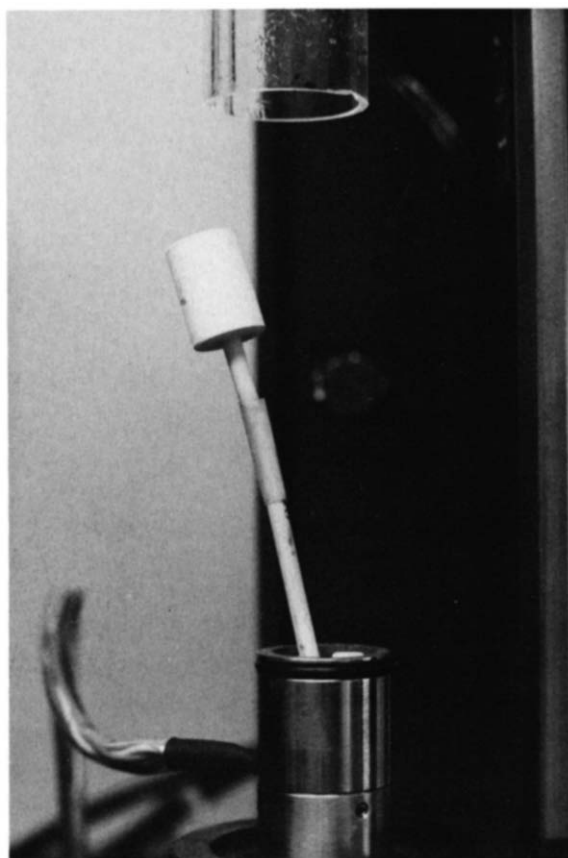
We have categorized the broken microfurnaces into three different groups depending on the type of stem damage incurred. The first type of damaged furnace might well be the most commonly encountered and represents the least problem to the operator. This is shown in Fig. 4 and has been named "basal dislocation of the furnace stem". In this case, contact with the furnace tube during removal has separated the base of the mullite stem from the stainless steel assembly such that the furnace is no longer perfectly

Fig. 4. Broken TG microfurnace suffering from "basal dislocation of furnace stem".

vertical (90° to the bench surface). The vertical wire, stirrup and sample pan cannot enter the furnace nor can the Pyrex furnace tube be placed around it without constant contact with the furnace.

For repair of furnaces suffering only basal dislocation, the 2.0 inch (50.8 mm) split tubing is all that is required for complete repair. In this case, the mullite 'sleeves' are fitted between the basal support posts and the furnace stem. The mullite sleeves are then wired together at the top with 26 gauge wire (Pt is preferred) such that it does not interfere with the placement of

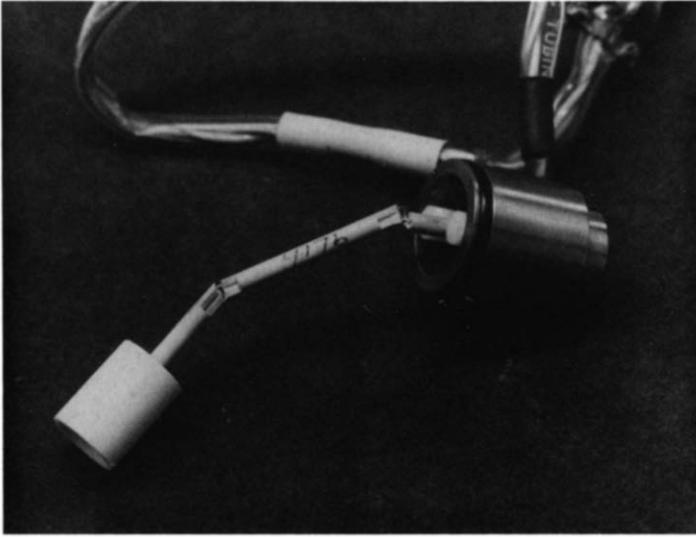
Fig. 5. Broken TG furnace suffering from “severe cumulative damage” (SCD).

The second category of furnace damage is described as “stem fracture”. In this case, the mullite stem is broken somewhere between the points where the mullite stem joins the furnace mandrel and where the stem enters the stainless steel base-assembly. Obviously, this type of damage may be either simple (one break) or compound (more than one break) for a particular furnace stem. Our repair procedure, given below, has been effective in repairing both simple and compound fractures. The furnace shown in Fig. 4 not only suffers from basal dislocation but also has a simple stem fracture which for photographic purposes is held together, at near mid-height of the furnace, by several rounds of Scotch Tape.

Obviously, the third group of broken furnaces is the most severely damaged and possess both stem fractures and basal dislocation of the mullite stem. Figure 5 includes such a microfurnace which we have categorized as suffering from “severe cumulative damage” (SCD). As bad as this damage may appear, the procedures described below will generally repair these furnaces as well.

The choice of length of the mullite sleeves (either 50.8 mm or 61.0 mm) depends on the position of stem fracture. Furnaces having stem fractures low on the stem may require only 50.8 mm sleeves and thus the repair procedure is the same as that for those furnaces having stems with basal dislocation only. On the other hand, furnaces having stem fractures in the vicinity of the thermocouple orifice, or higher, require the use of the 61.0 mm sleeves to achieve the repair.

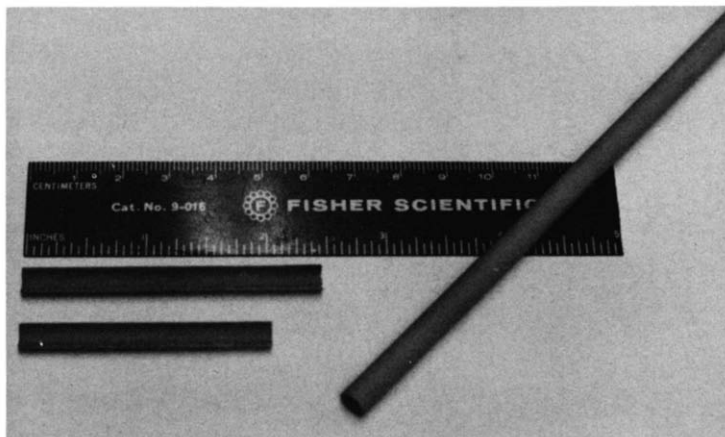
Fig. 6. Mullite tubing and two mullite sleeves (50.8 and 61.0 mm) cut from the tubing and used in the repair procedure.

(Golden, Colorado) in 12 inch lengths. The mullite tubing was cut into the proper lengths which were then split into two halves in order to facilitate furnace repair. The cutting and splitting of the mullite tubing was achieved by a high speed hand grinder (Sears) employing a cut-off wheel of diameter 1 in. The cutting stock of mullite was cooled by a jet of water as it was cut. Figure 6 shows a portion of the original mullite tubing together with halves of two different lengths of split mullite tubing: the plastic ruler is shown for scale.

We have found that we can repair all furnaces from the above categories by choosing one of two sets of different lengths of split mullite tubing: 2.0 in (50.8 mm) and 2.4 in (61.0 mm). Both lengths are shown in Fig. 6.

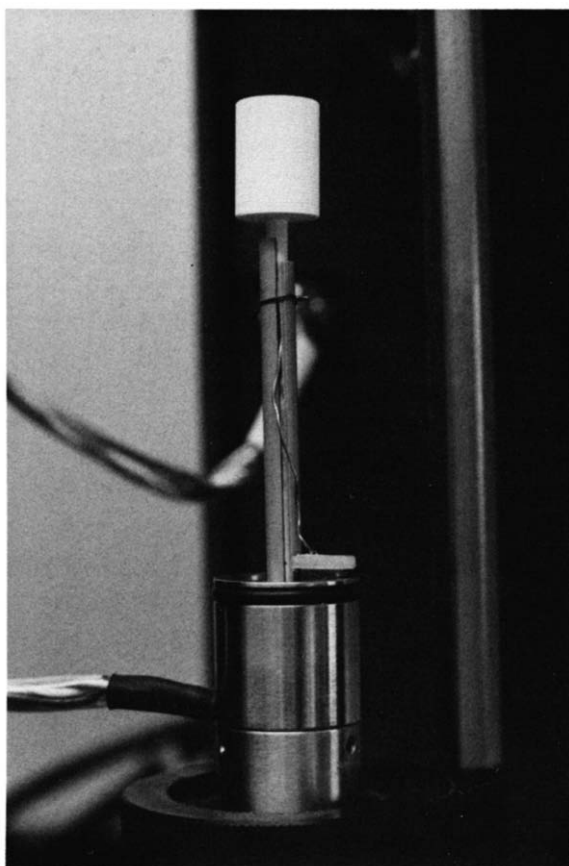
Fig. 7. Repaired TG microfurnace.

Figure 7 shows a furnace which has been repaired with cut mullite tubing secured in place at the top with 26 gauge (0.40 mm) copper wire. The two sleeves are positioned so that the thermocouple enters the usual orifice for its placement in the furnace. The furnace shown here suffered from simple stem fracture as well as basal dislocation prior to repair with the mullite sleeves.

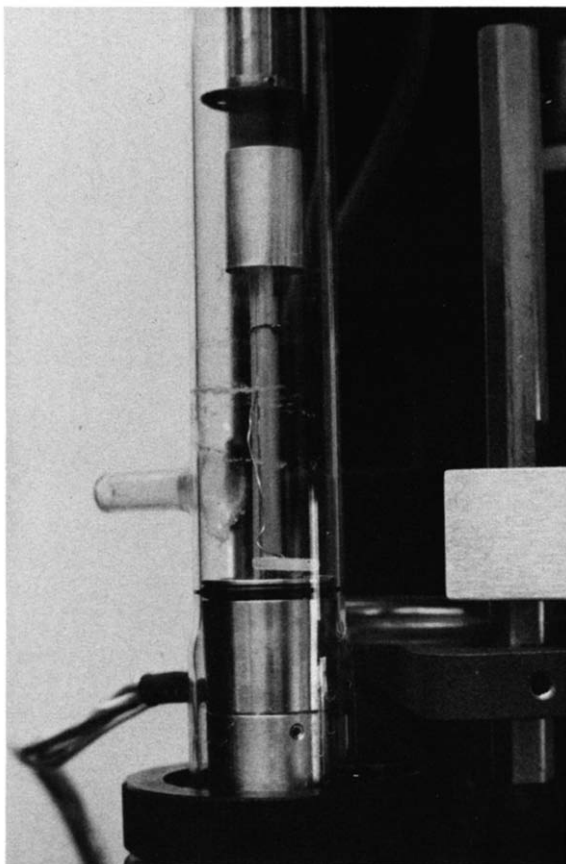
Fig. 8. Repaired TG microfurnace back in use in TGS-2 system.

Figure 8 shows a repaired TG furnace in use inside the Pyrex TG furnace tube. This represents the ultimate goal of the repair effort. To date we have repaired a total of 6 broken furnaces which is all we have had available to us. We believe the repair procedure is applicable to all broken furnaces of this type. The only requirement is that the lead wires to the furnace mandrel must not be broken.
