Technical Letter No. 1110-2-360

31 December 1993

Engineering and Design BRAKE WHEEL PROBLEM ON TAINTER GATE HOIST MACHINERY

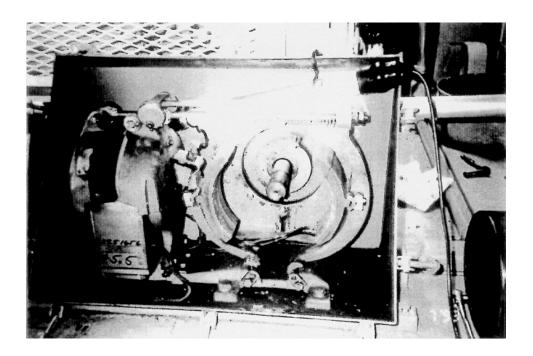
a. On 6 July 1993 the No. 2 tainter gate at Old River Auxiliary Structure fell a distance of 2 m (6-1/2 ft) from its opened position and impacted the gate sill. The damages included the service bridge's downstream concrete parapet wall and handrail, a line shaft segment and its support brackets between piers, and a cooling fan attached to the motor. A team from New Orleans District made a field investigation. The team concluded that the brake failed on the motor controlling the operation of gate #2. The brake failed when the brake drum "walked off" from its shaft (Figure 1). An inspection of other gate motor brake drums at the same facility revealed that another

- b. The brake is a Cutler-Hammer Type GH505, 254-mm (10-in.) D-C Magnetic Shoe brake manufactured by EATON Corporation. The brake drum to the shaft has a loose fit which is not adequate for this type of application. A key held by a set screw is used to transmit the torque.

Figure 1. Brake assembly where the brake drum "walked off" from the shaft

a. All facilities having this type of arrangement should be checked immediately. If the above condition exists, the drums should be repositioned and a positive mechanical stop placed on the end of the reducer shaft to secure the brake drums from "walking off." For example, the shaft can be threaded at the end and fitted with a A325 high-strength bolt with thread locking compound (Locktide) and a large plate washer to hold the drum in place (Figure 3). Locking compound can be used between the brake drum and the shaft.

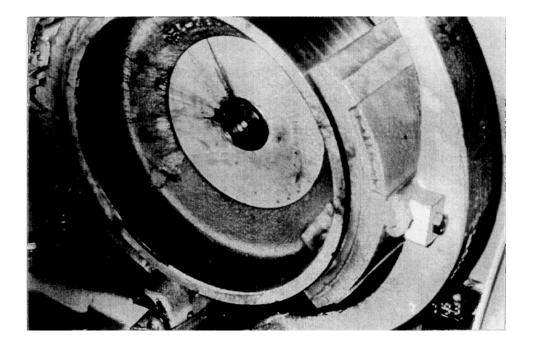
drum had also begun to "walk off" from its shaft (Figure 2).

Figure 2. Brake drum that has "walked off" slightly from its shaft

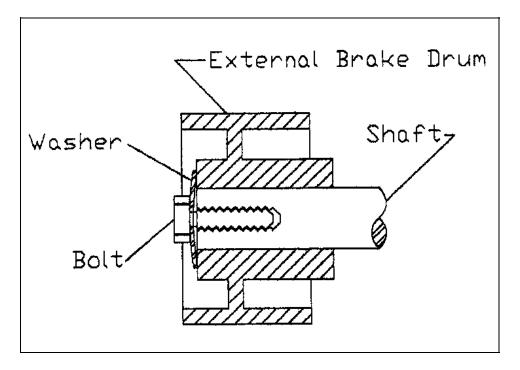
Figure 3. Shaft fitted with a high-strength bolt (no scale)
