MWO 55-1520-241-30-4 \*CHANGE NO. 3

#### REMOVAL OF TWO INLET HOUSING COVER CAPSCREWS

#### **T55 SERIES ENGINES**

### CH-47A, CH-47B AND CH-47C HELICOPTERS

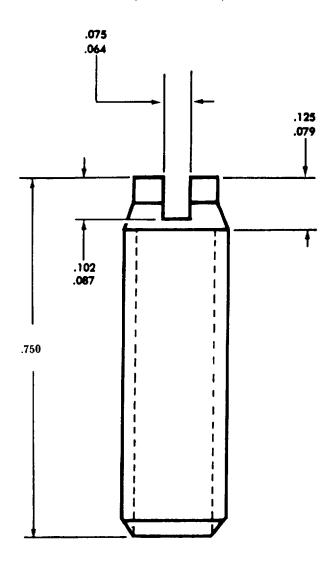
Figure 1. Special Plug.

Make from MS 9566-12, NSN 5306-00-143-1547, FSCM 96906, TM5-2840-234-23P, Figure 22, Item 6A.

- 8. Supply Kits, Parts and Disposition.
- a. Parts required to accomplish MWO. Two special plugs made from bolts P/N MS9566-12 required for each engine or use two setscrews, P/N NAS1081C4A14L. Four required per aircraft. (See figure 1 for special bolt description.
- **b.** Requisitioning and issue Instructions. TM 55-2840-234-23P, Fig 22, Item 6A, NSN 5306-00-143-1647, P/N MS9566-12. TM 55-2840-234-23P, Fig 55, Item 42A, NSN 5305-00-904-0899, P/N NAS1081C4A14L.
  - c. Parts Disposition: Bolts, P/N AN101110, P/N MS9519-10 and Key washers, P/N STD3018K11 discard.
- *d. Bulk and Consumable Materials.* Retaining compound (Loc-tite Grade AA) MIL-S-22473, NSN 803000-081-2330.
- 9. Special Tools, Jigs and Fixtures. None required.
- 10. Modification Procedures (Authority ECP A-P0001).

- **a.** Clamp bolt P/N MS9566-12 in bench vise and using a hacksaw, cut head of bolt off at the point where remaining shank length is 0. 750 IN. See figure 1.
- **b.** Using a hacksaw, cut a common screwdriver slot in shank end of bolt to a depth of 0.087 to 0.102 IN. See figure 1.
  - c. Remove all burrs with suitable file.
  - d. Remove previously installed nuts.
  - **e.** Prepare aircraft for safe ground maintenance.

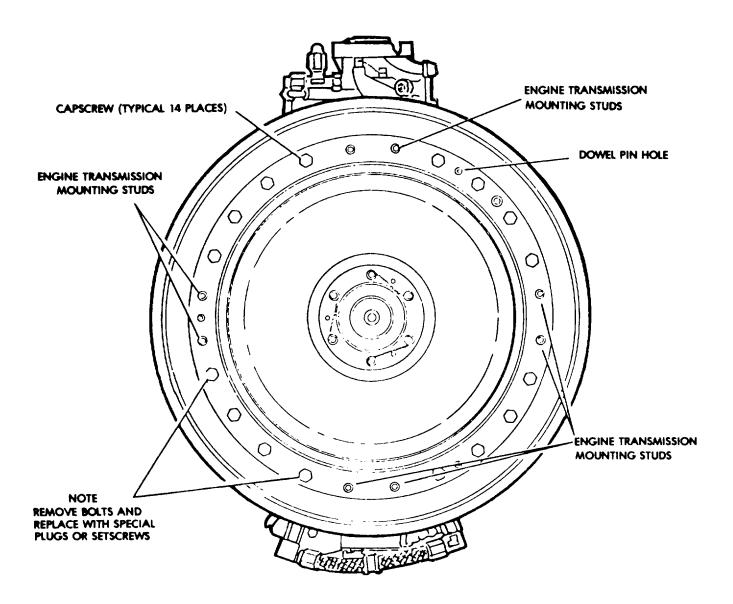
Figure 2. Installation Special Plugs.

If the proper bolts are not removed, engine to transmission will mount misaligned to the centerline of the engine and cyclic loading of the engine output shaft splines will occur, causing fatigue failure of the shaft, loss of power turbine speed signal to fuel control and catastrophic failure of the power turbine as a result of overspeed.

These two bolt holes are not to be used and must be plugged to prevent their usage. Plug wirh (2) Special Plugs P/N 5306-T55-000-1.
Frabricate from MS9566-12. Refer to TM55-2840-249-23, Para2-11.
Setscrews P/N NAS1081C4A14L may be used as an alternate.

- *f.* Remove either left or right engine transmission (ref TM55-1520-227-23-2, Para 6-120 or TM55-1520-20923-2, Para 6-118 as required). Remove engine transmission only to the extent necessary to accomplish this MWO.
  - g. Remove two bolts (P/N MS9519-10 or AN101110) from cover assembly (See figure 2).

- **h.** Apply retaining compound (Loc-tite Grade AA, MIL-S-22473, NSN 8030-00-081-2330) to the threads of either two special plugs or setscrews. Install special plugs or setscrews in place of the bolts removed in previous step g and tighten as required. (See figure 2.)
  - *i* Insure special plugs or setscrews are installed flush or below surface of cover assembly.
  - j. Reinstall engine transmission (refer to TM 55-1520-227-23 or TM 55-1520-209-23).
