*TB 1-1520-210-30-01

DEPARTMENT OF THE ARMY TECHNICAL BULLETIN

MANDATORY RECURRING INSPECTION OF TAIL BOOM VERTICAL FIN SPAR ASSEMBLY FOR ALL UH-1 SERIES AIRCRAFT

Headquarters, Department of the Army, Washington, D. C.
4 November 2005

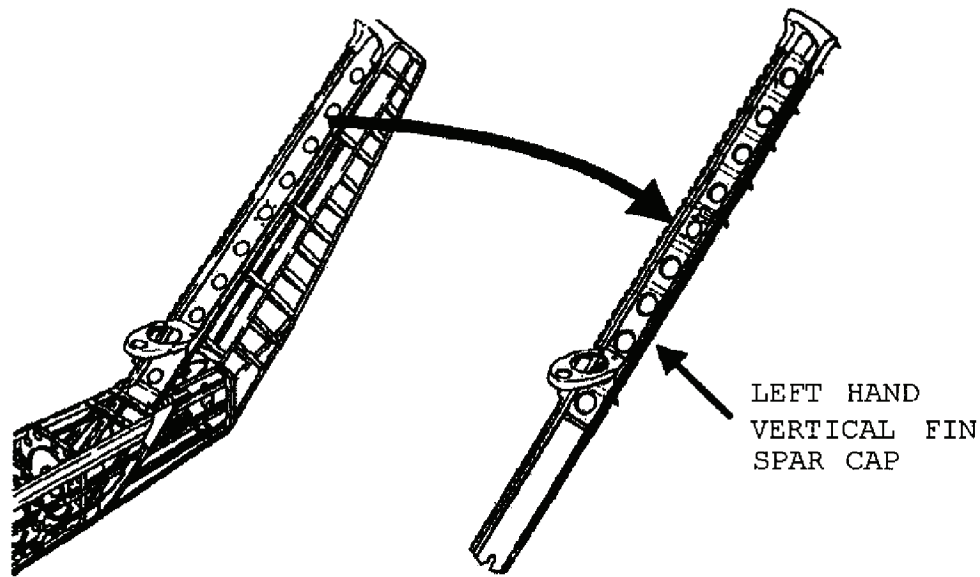
Figure 1: Vertical Fin Spar

a. Tail Boom Fin Spar Assembly, Part Number 205-030-846-(all dash numbers), shall be inspected as specified herein. The area of concern is the Left Hand Vertical Fin Spar Cap shown in Figure 1. These inspections pertain to the left-hand spar cap only.

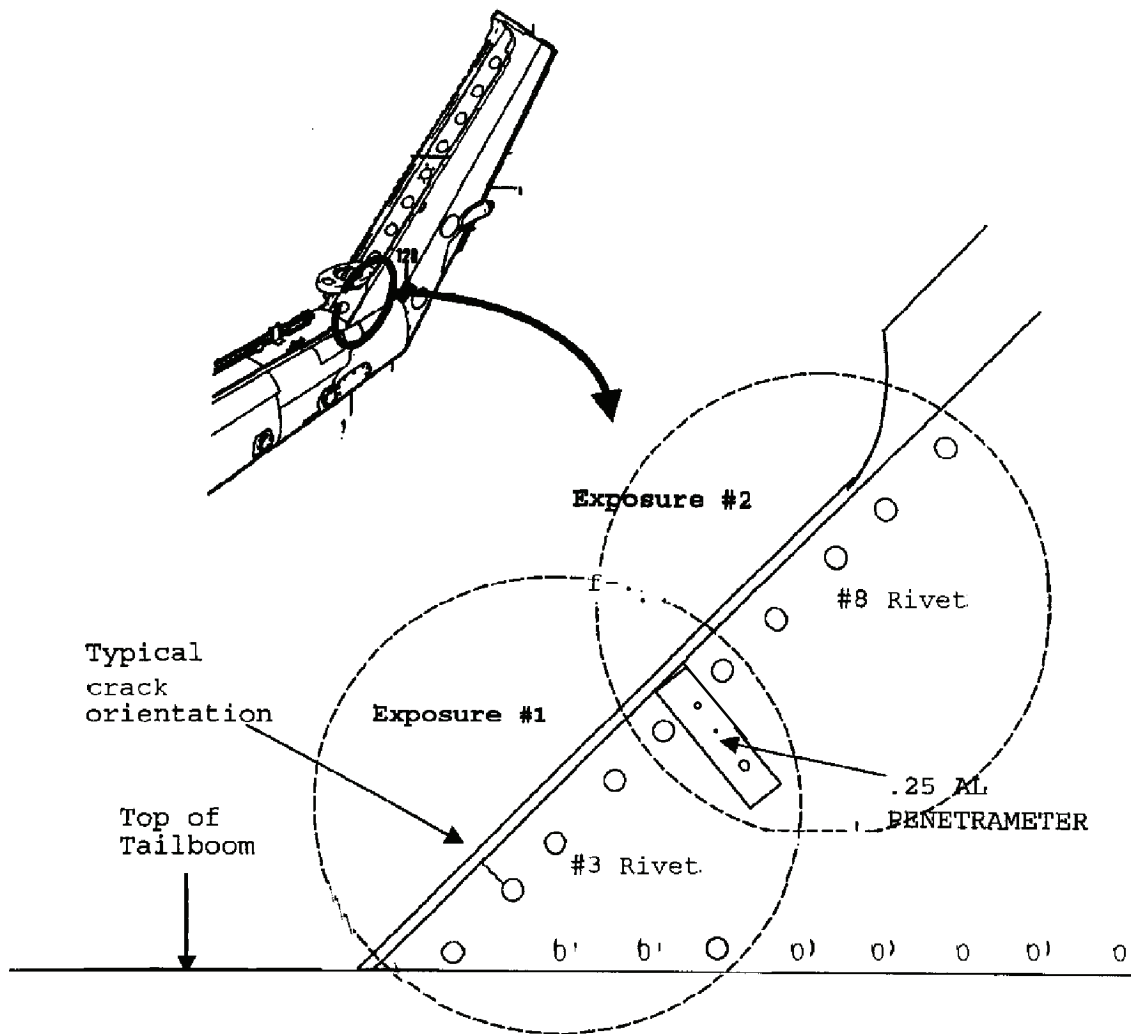
Figure 4: Radiographic Exposures #1 and #2

A crack will appear as a dark, fine, line usually emanating from a rivet hole, and propagating toward the edge of the spar cap in either direction. (See Figure 4) A skin crack will appear similar to a spar crack.

(a) If a crack is indicated remove as many rivets as necessary, so that the skin may be pulled back and secured away from the spar in the area of crack indication. Repeat the radiograph of the spar with the skin removed.

(b) If a crack is still indicated, refer to paragraph 9 for corrective action. If a crack is not indicated, inspect the vertical tail fin skin for cracks. Repair skin cracks as allowable per TM 1-1500-204-23 and TM 55-1520-210-23-1.

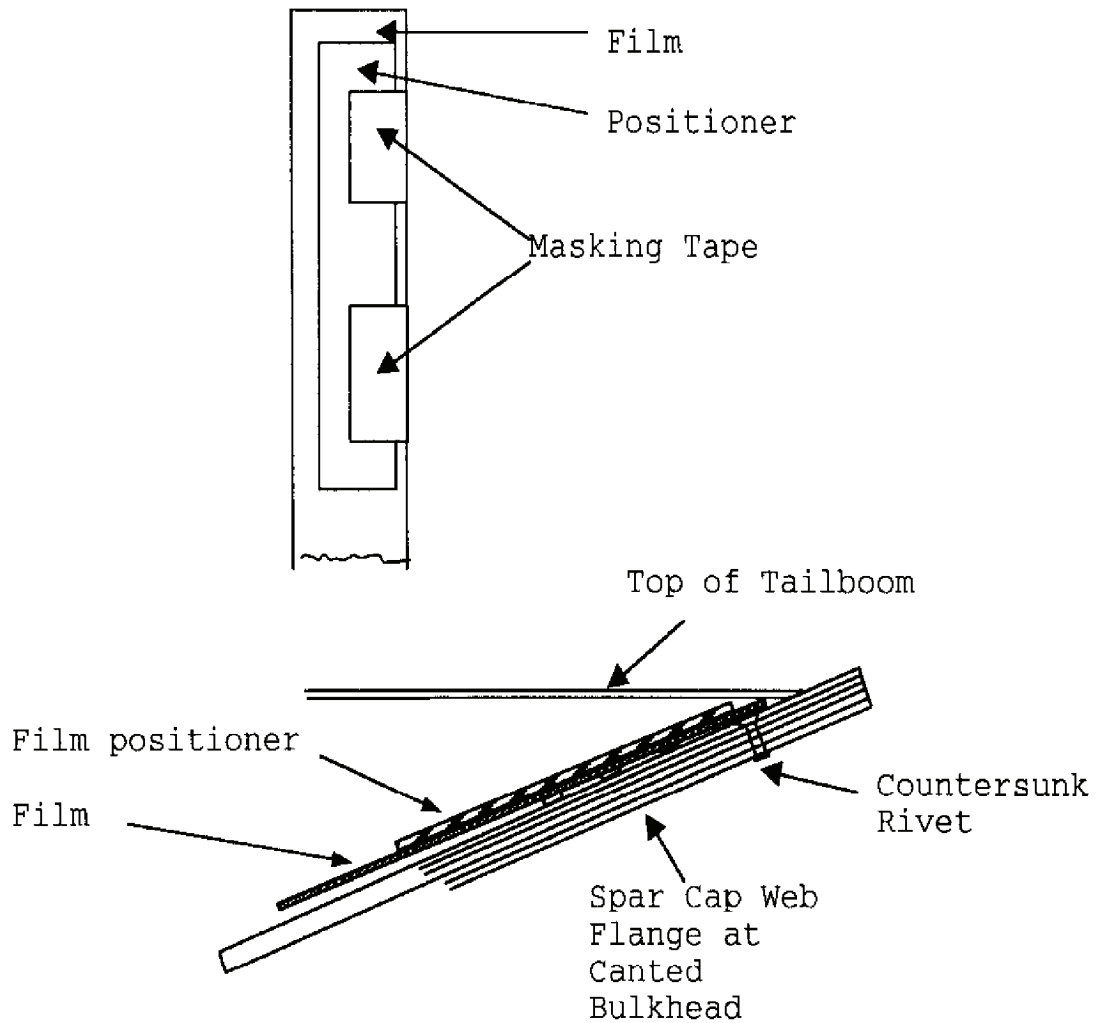
Figure 6. Placement of Film for Exposure 3

Exposure Number 3 is designed to show the area of the first three rivets on the left hand fin spar horizontal web flange below the tail boom interface. The upper most (first) rivet is countersunk on the upper side of the spar and is difficult, if not impossible to see with the naked eye.

NOTE: It is important that the film be placed as far up the spar web flange and as far outboard (into the nested angle) as possible to assure that the first rivet is exposed on the film

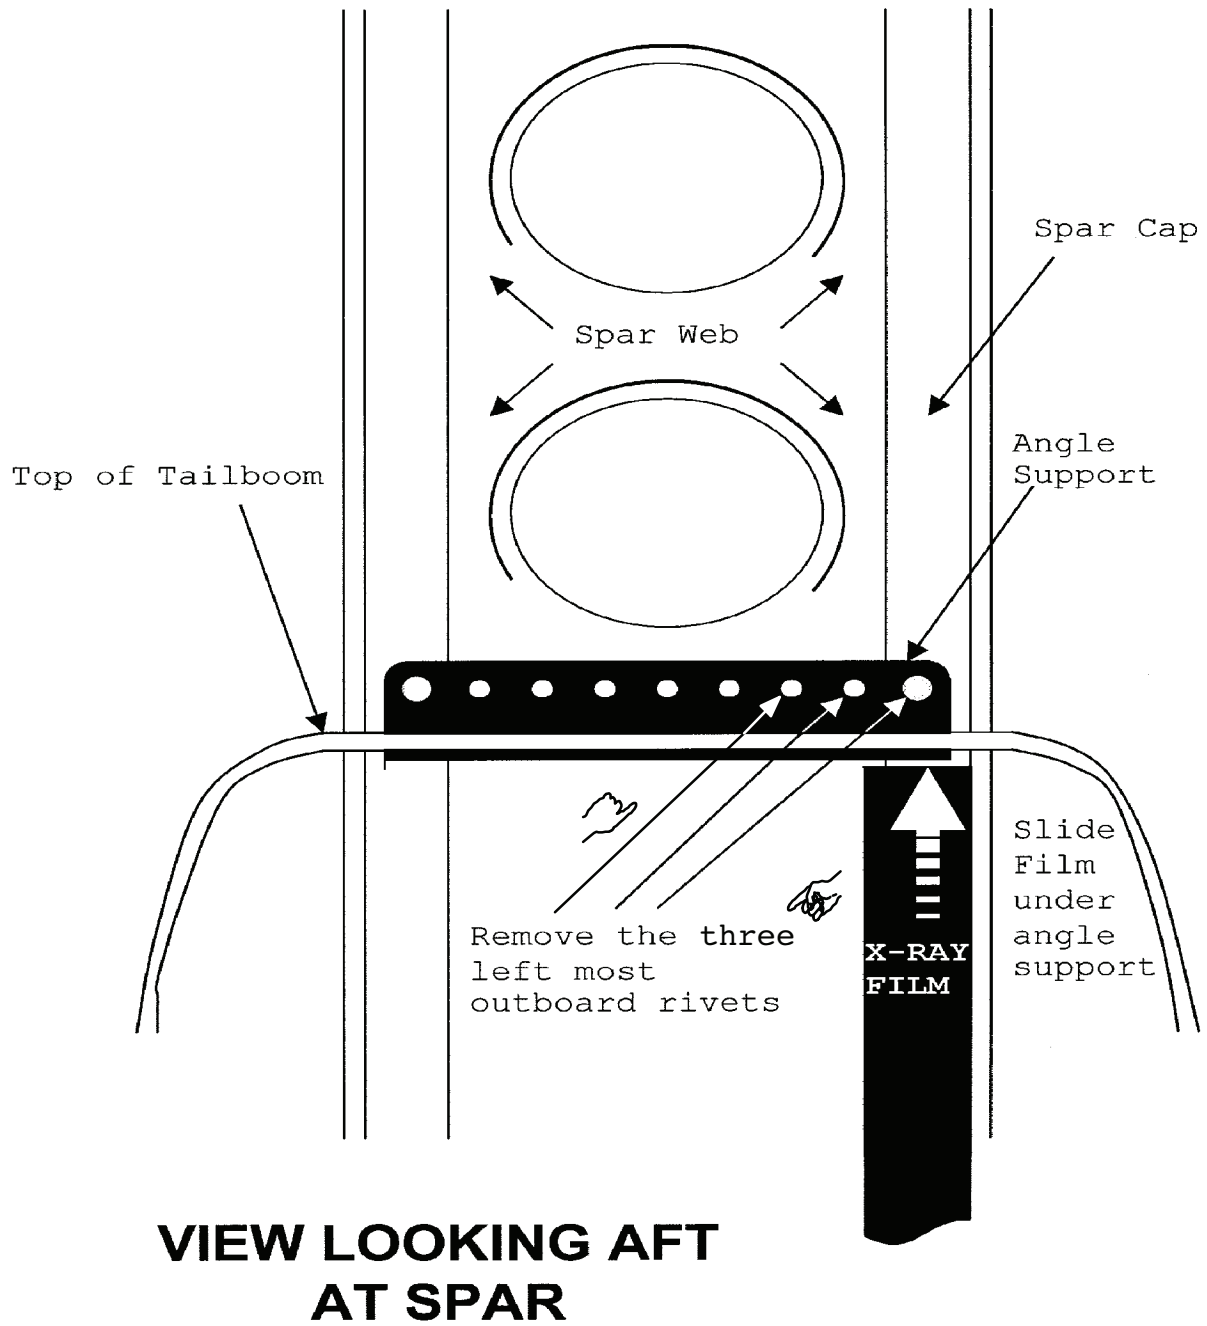
Figure 9A, Rivet Removal for Exposure #3

(a) Carefully examine exposure to assure that a single rivet is shown above the penetrometer and at least two rivets are shown below the penetrometer. At least 0.2 inches of film beyond the top of the single (countersunk) rivet located above the penetrometer must be visible on the X-ray to determine the status of the spar for this exposure. If the rivet is located under the angle support, which ties the left and right spar caps together aft of the 42 degree gearbox, it is possible that the entire rivet circumference will not be visible. In this situation, the radiograph must be retaken using the following method:

1 Carefully drill out the three most outboard rivets (left hand side) in the angle support. (See Figure 9A)

(27) If the X-ray inspection required the removal of the three most outboard rivets attaching the angle support to the spar cap (reference figure 9A), and no cracks were found during this inspection, the rivets shall be replaced with the following fasteners: (NAS1303-5 or equivalent.)

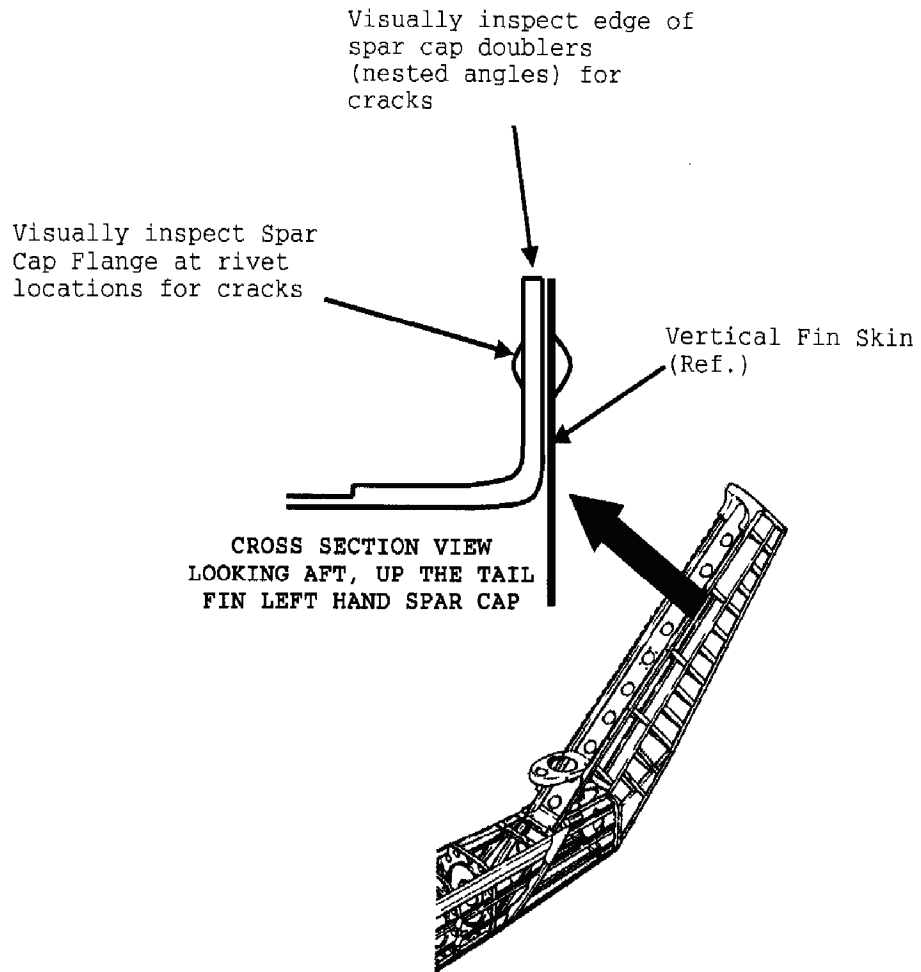
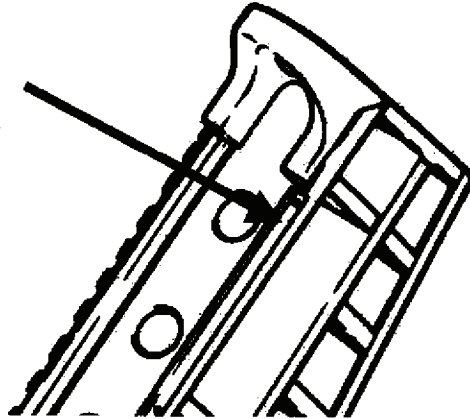
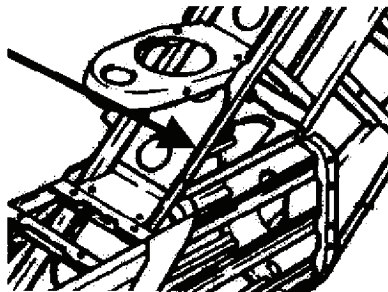
Figure 11: Visual Inspection of Spar.

(2) Using a flashlight, inspect the inboard side of the entire left hand spar cap flange above the tail boom interface for cracks. (See Figure 10) Cracks would usually emanate from a rivet hole and could also be visible on the edge of the spar cap flange doublers (nested angles). Pay particular attention for cracks emanating from the radius where the spar cap flange transitions and intersects the 90 degree gearbox mount. Use a 10x magnifying lens to inspect the following areas (See Figure 11):

(a) The outboard side of the left hand spar cap flange, between the upper most Zeus fastener receptacle and the 90 degree gearbox mount. Pay particular attention for cracks emanating from the radius where the spar cap flange transitions and intersects the 90 degree gearbox mount. If a doubler repair is installed, or has been previously installed in this area, per TM 55-1520-210-23-1, paragraph 2-296.1, figure 2-73.1., visually inspect the underneath/aft side of the spar to detect crack growth using an inspection mirror through the uppermost lightening hole in the spar web.

(3) If a crack is found, accomplish correction procedures of paragraph 9.

(1) Cracks on the outboard side of the left hand spar cap flange between the upper most DZUS fastener receptacle and the 90 degree gearbox mount may be repaired using the criteria contained in TM 55-1520-210-23-1, paragraph 2-296.1, figure 2-73.1, however, the crack cannot exceed the repairable length limits specified in the TM.

(2) All other cracks, to include those on the outboard side of the left hand spar cap flange between the upper most DZUS fastener receptacle and the 90 degree gearbox mount that exceed the repairable length limit specified in TM 55-1520-210-23-1, paragraph 2-296.1, figure 2-73.1, shall not be repaired and the tailboom shall be considered discrepant.
