TB 1-1520-238-20-127

DEPARTMENT OF THE ARMY TECHNICAL BULLETIN

INITIAL AND RECURRING INSPECTION OF TAIL ROTOR BLADES FOR ALL AH-64 SERIES AIRCRAFT

Headquarters, Department of the Army, Washington, D. C.
28 June 2002

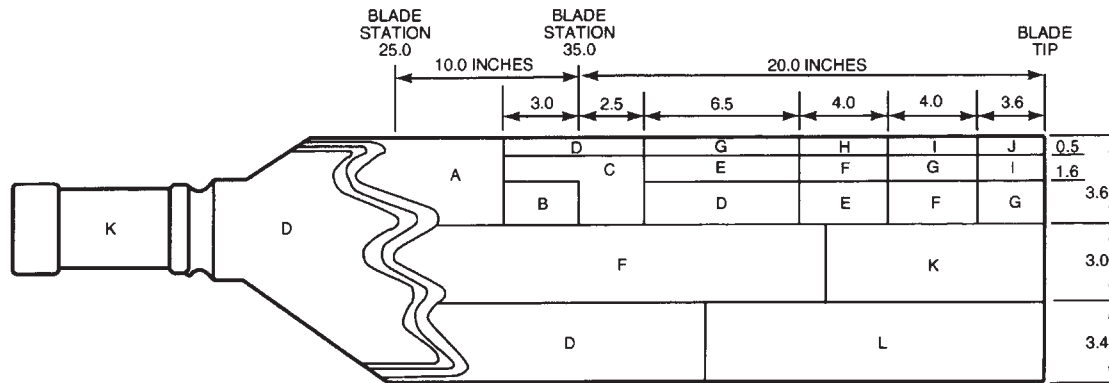
FIGURE 1.

REPAIR LIMITS FOR SCRATCHES, GOUGES, AND CORROSION

1. ALL DIMENSIONS ARE IN INCHES.
2. LIMITS APPLY TO BOTH INBOARD AND OUTBOARD SURFACES
3. INSPECTION WITH MAGNIFIER REQUIRED.
4. CORROSION MUST BE TREATED PER TM PARAGRAPH 5.55.
5. DAMAGE UP TO THE MAXIMUM DEPTH MUST BE REPAIRED PER TM PARAGRAPH 5.5

Do not use TM 1-1520-238-23 damage repair limits. For AH-64A damage/repair limits, use AMCOM approved Figure 1 for scratches, nicks, gouges, and corrosion; and Figure 2 for dents and depressions. The damage/repair limits as listed in the current AH-64D IETM are the same and can also be used.

- a. If a crack is found, remove blade IAW AH-64-02-04 (TB 1-1520-238-20-118).
- b. If damage other than cracking is found, correct IAW AH-64-02-04 (TB 1-1520-238-20-118) and Figure 1 and/or Figure 2 as indicated in the note above.

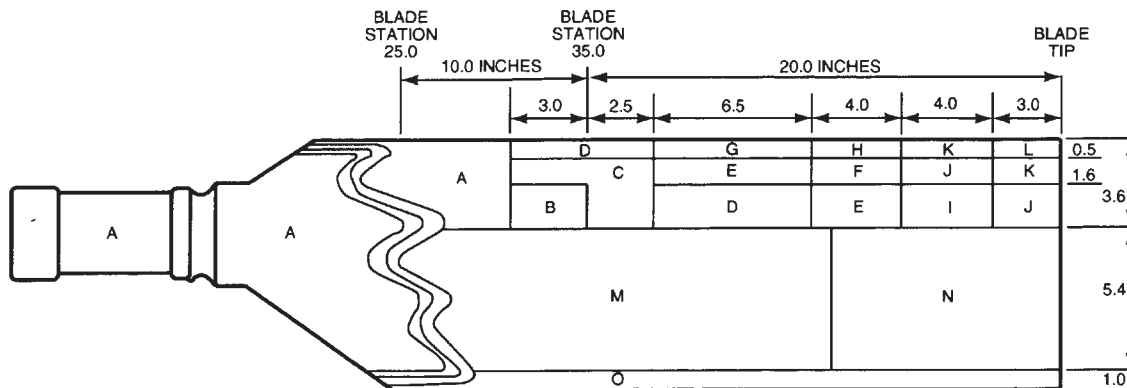
FIGURE 2.

1. ALL DIMENSIONS ARE IN INCHES.
2. USE STRAIGHT EDGE AND DEPTH GAGE. NO VISIBLE DENT SHALL EXIST DURING STRAIGHT EDGE TEST.
3. INSPECT FOR BOND DEPLAMINATION IN AREA DENT AND DE-ICING BLANKET ELECTRICAL CONTINUITY.
4. NO SHARP CREASES ALLOWED.
5. SMOOTHLY ROUNDED DENTS ARE ACCEPTABLE TO THE MAXIMUM DIMENSION SHOWN.
6. DAMAGE UP TO THE MAXIMUM DEPTH MUST BE REPAIRED PER TM PARAGRAPH 5.56.

REPAIR LIMITS FOR DENTS AND DEPRESSIONS
