***TB 1-1520-238-30-15**

DEPARTMENT OF THE ARMY TECHNICAL BULLETIN

TAIL ROTOR (T/R) HEAD ASSEMBLY INSTALLATION AND INSPECTION, AH-64 HELICOPTER

30 June 1999

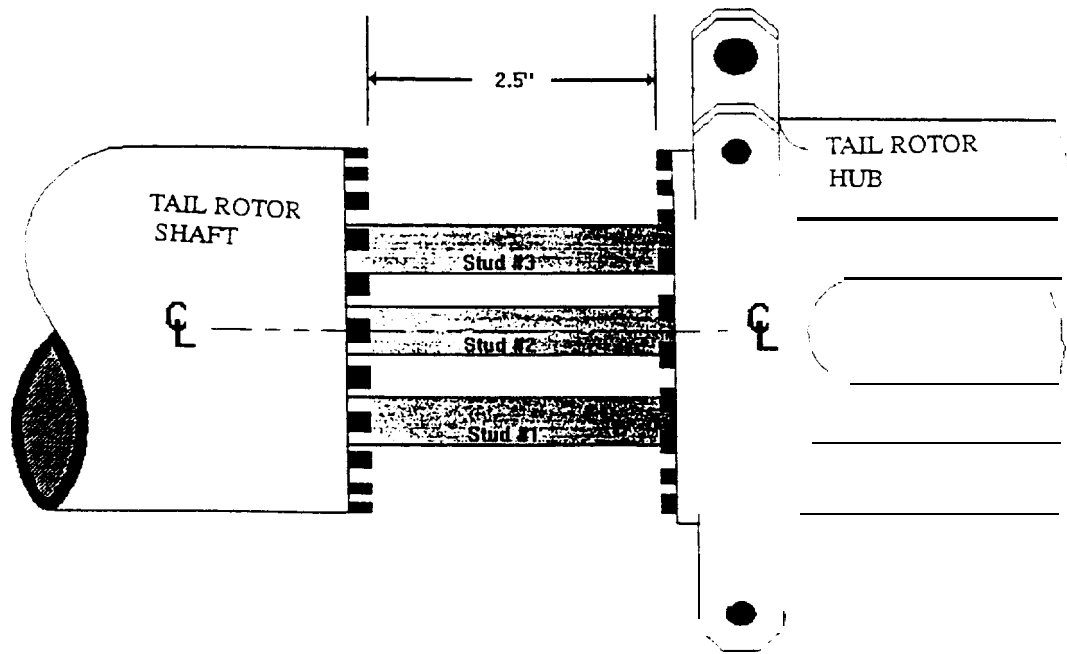
Figure 1. Tail Rotor Shaft, Hub, and Stubs.

g. Identify and number the studs using figures 1 through 3. The number 2 stud is the only stud centered on a spline tooth. Mark the end of the number 1 stud, located counterclockwise from the number 2 stud, using torque stripe paint.

h. If the number 1 stud marked above does not correspond with the number 1 fork hole marked in paragraph 8.d., the fork was incorrectly indexed during installation. Replace all three studs per paragraph 9.

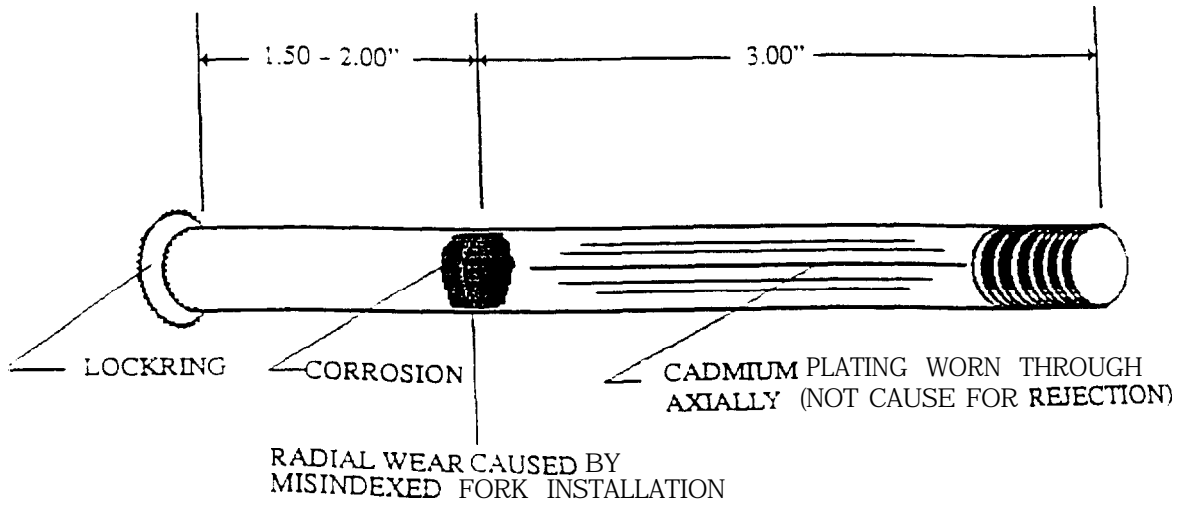
Figure 4. Stud Inspection Area.

j. Check for radial wear marks (smiles) between 1-112 and 2 inches outboard of the lockring, as shown in figure 4. If these marks exist or corrosion prevents inspection in the area between 1-112 and 2 inches outboard of the lockring, replace all three studs using paragraph 9.
