TB 1-1520-240-20-154

## DEPARTMENT OF THE ARMY TECHNICAL BULLETIN

### MANDATORY MAINTENANCE ON TRANSIENT AND AVOID BANDS ON THE CRUISE GUIDE INDICATOR ON ALL CH-47D AIRCRAFT

Headquarters, Department of the Army, Washington, D. C.  
3 May 2004

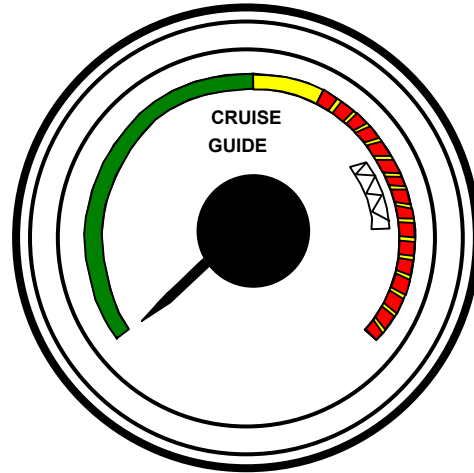
RE-MARKED CGI

The yellow band on the re-marked CGI represents 100% to 120% rotor control/drive system design load. The red (avoid) band on the re-marked CGI begins at 120%.

....Insure that the diameter of the diagram matches the  
 ....diameter of the gauge. The inner diameter of the bands is 1.4".  
 ....Measuring with a protractor placed in the center of the  
 ....gauge, the red band of the new avoid region begins at 63  
 ....degrees above horizontal. The Red Band Arc length of the  
 ....new avoid region is 1 7/16". The new Yellow Band Arc is  
 ....5/16" long.

- c. Re-marking of the CH-47D CGI, part number 152BUA34-2 or 114VS805-3 shall be performed within 10 flight hours/14 days per the instructions below.

- (1) Utilizing Figure 1, cut out the “re-marked” Cruise Guide Indicator template.
- (2) Cut out the red/yellow striped (avoid) band from the Figure 1 “re-marked” CGI template.

- (3) Center the “re-marked” template on the aircraft CGI (P/N 152BUA34-2 or 114VS805-3).
- (4) Tape the outside edges of the “re-marked” template to the CGI.

- (5) Apply red instrument marking tape to the CGI display glass at the location where the red/yellow striped band was removed from the Figure 1 template. If instrument tape is unavailable then a piece of red tape placed on the glass at the beginning of the new red/yellow striped region denoted by the “re-marked” template is sufficient.

- (6) Remove the “re-marked” template and outside edge tape to detach the template from the CGI display.
- (7) To ensure the CGI glass is always positioned correctly, a torque stripe (also known as slip-page mark) shall be applied extending from the outer edge of the display glass to the edge of the instrument.
