*TB 1-1520-248-20-42

DEPARTMENT OF THE ARMY TECHNICAL BULLETIN

INSTRUCTIONS FOR REPLACING OH-58D T703-AD-700B ENGINE WITH T703-AD-700A

Headquarters, Department of the Army, Washington, D. C.
20 July 2000

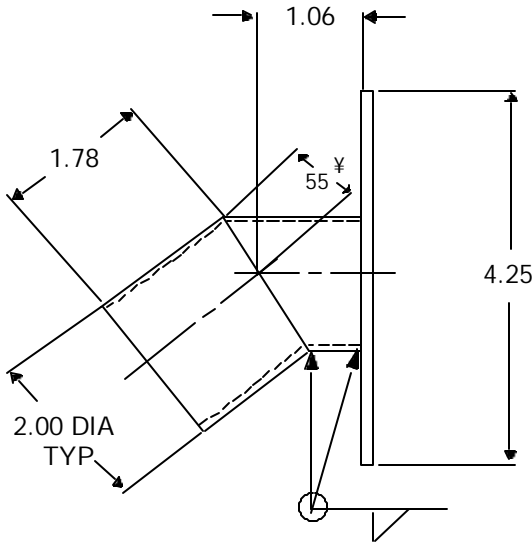
Figure 1. Locally Manufactured Discharge Duct Assembly

(3) Locally fabricate a cowl duct. Fabricated duct should have a 2.0 inch outside diameter (OD) inlet tube, and approximately a 4.25 inch OD flange. See Figure 1.

(4) Match drill eight equally spaced 3/32 inch diameter holes through locally fabricated cowl duct, removed flange/screen, and cowl.

(5) Install fabricated cowl duct and flange/screen on inside of cowl using eight MS20470B3 rivets and eight 104-001-11 washers.
