DEPARTMENT OF THE ARMY TECHNICAL BULLETIN

RECOMMENDED OPERATIONAL PROCEDURES AND  
MAINTENANCE ACTIONS WHEN OPERATING OH-58D  
HELICOPTERS IN DESERT/SANDY CONDITIONS

Headquarters, Department of the Army, Washington, D.C.

30 OCTOBER 1998

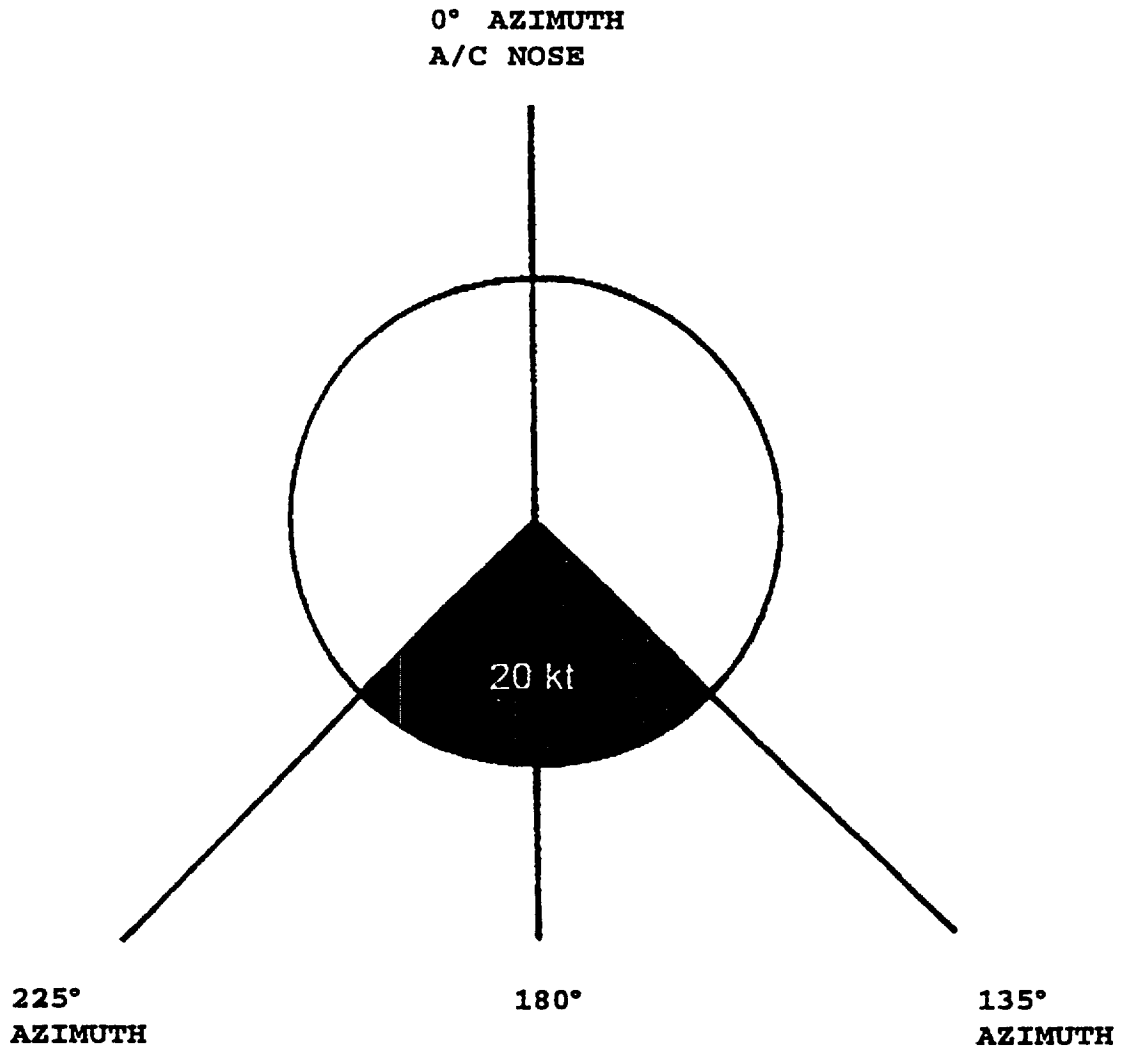
Figure 1. REARWARD AIRSPEED LIMITATION DIAGRAM

(b) When operating at gross weights in excess of 4500 pounds, the maximum rearward airspeed shall be as shown on the Rearward Airspeed Limitation Diagram (Figure 1). The envelope restricts rearward airspeed to a maximum of 20 knots when relative airspeed is from 45 degrees either side of the tailboom. A maximum sideward airspeed of 35 knots is authorized, except for rocket firing as noted above. Airspeed is defined as the speed of air relative to the helicopter, whether produced by flight or wind.
