TB 1-1520-248-20-67

### REPAIR/RE-ROUTING OF COMPRESSOR INLET TEMPERATURE (CIT)

SENSOR HARNESS 406-075-625-139

FOR OH-58D AIRCRAFT

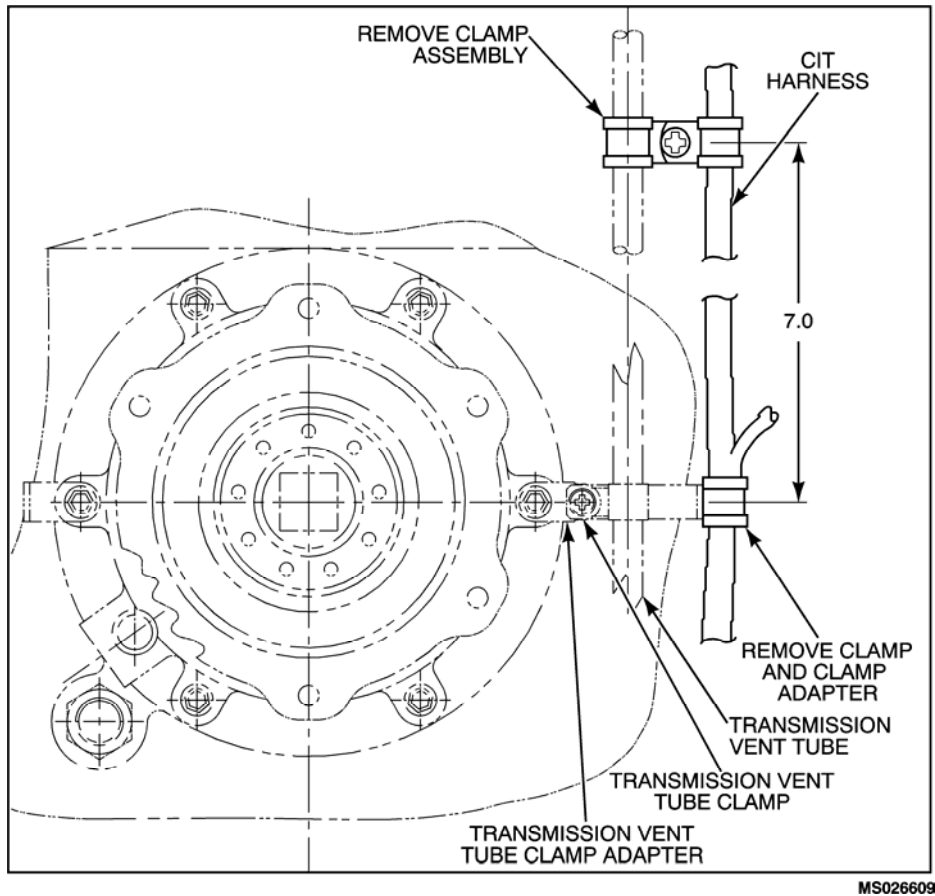
Figure 1. Transmission Vent Tube View Looking Down

1. **Purpose.** The Compressor Inlet Temperature (CIT) sensor wiring harness P/N 406-075-625-139 is routed beneath the transmission right hand pylon beam assembly and restraint spring assembly, causing chaffing of the pylon beam and restraint spring.

Presently the CIT sensor wiring harness is clamped to the transmission vent tube and prevents fouling with the main drive shaft. The transmission vent tube pulls the wiring harness as the transmission moves, leading to contact and chaffing of the pylon beam and restraint spring that are securely mounted to the deck. The CIT sensor is mounted in the induction fairing. The connector plug is positioned with the 90-degree elbow and wiring harness pointing up, creating additional tension on the wiring harness before it can descend to the deck. The CIT sensor is off center preventing the unit from being turned 180 degrees and allowing the wiring harness to point down to allow greater slack.

- 1) Gain access to work area and perform re-routing of CIT harness.
  - a) Remove forward fairing per IETM TM 1-1520-248-23, task 2-2-47.
  - b) Disconnect the CIT sensor connector plug to allow the CIT and NR sensor wiring harness to be re-routed together.
  - c) Disconnect the transmission NR sensor connector plug to allow the CIT and NR sensor wiring harness to be re-routed together.
  - d) Remove clamps securing CIT sensor harness to the transmission vent tube. These clamps will not be re-installed. Refer to figure 1.

- e) Remove the CIT sensor harness clamp adapter from the transmission vent tube clamp adapter attached to the transmission input quill housing. Refer to figure 1.

- f) Re-install the transmission vent tube clamp to the clamp adapter attached to the transmission input quill housing. Refer to figure 1.
- g) Remove pan head screw from the bottom side of the induction fairing, just above the aft end of transmission right hand pylon beam assembly.
